Three Island Homes Pass Hurricane Dolly's Test

Full Mitigation Best Practice Story

Cameron County, Texas

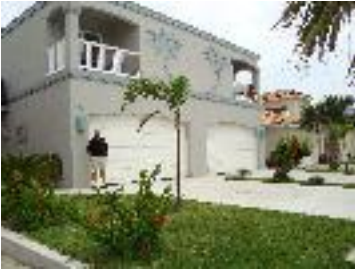
Ehrlich's hurricane-tested home

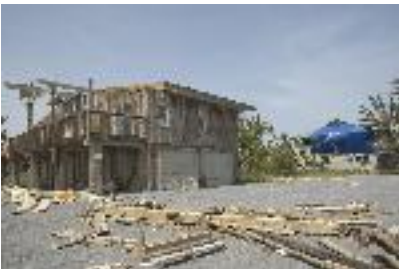
Dolly damaged many South Padre buildings, some severely
