# **EPA CHEMICAL ACCIDENT INVESTIGATION REPORT**

**Pennzoil Product  
Company Refinery  
Rouseville, Pennsylvania**

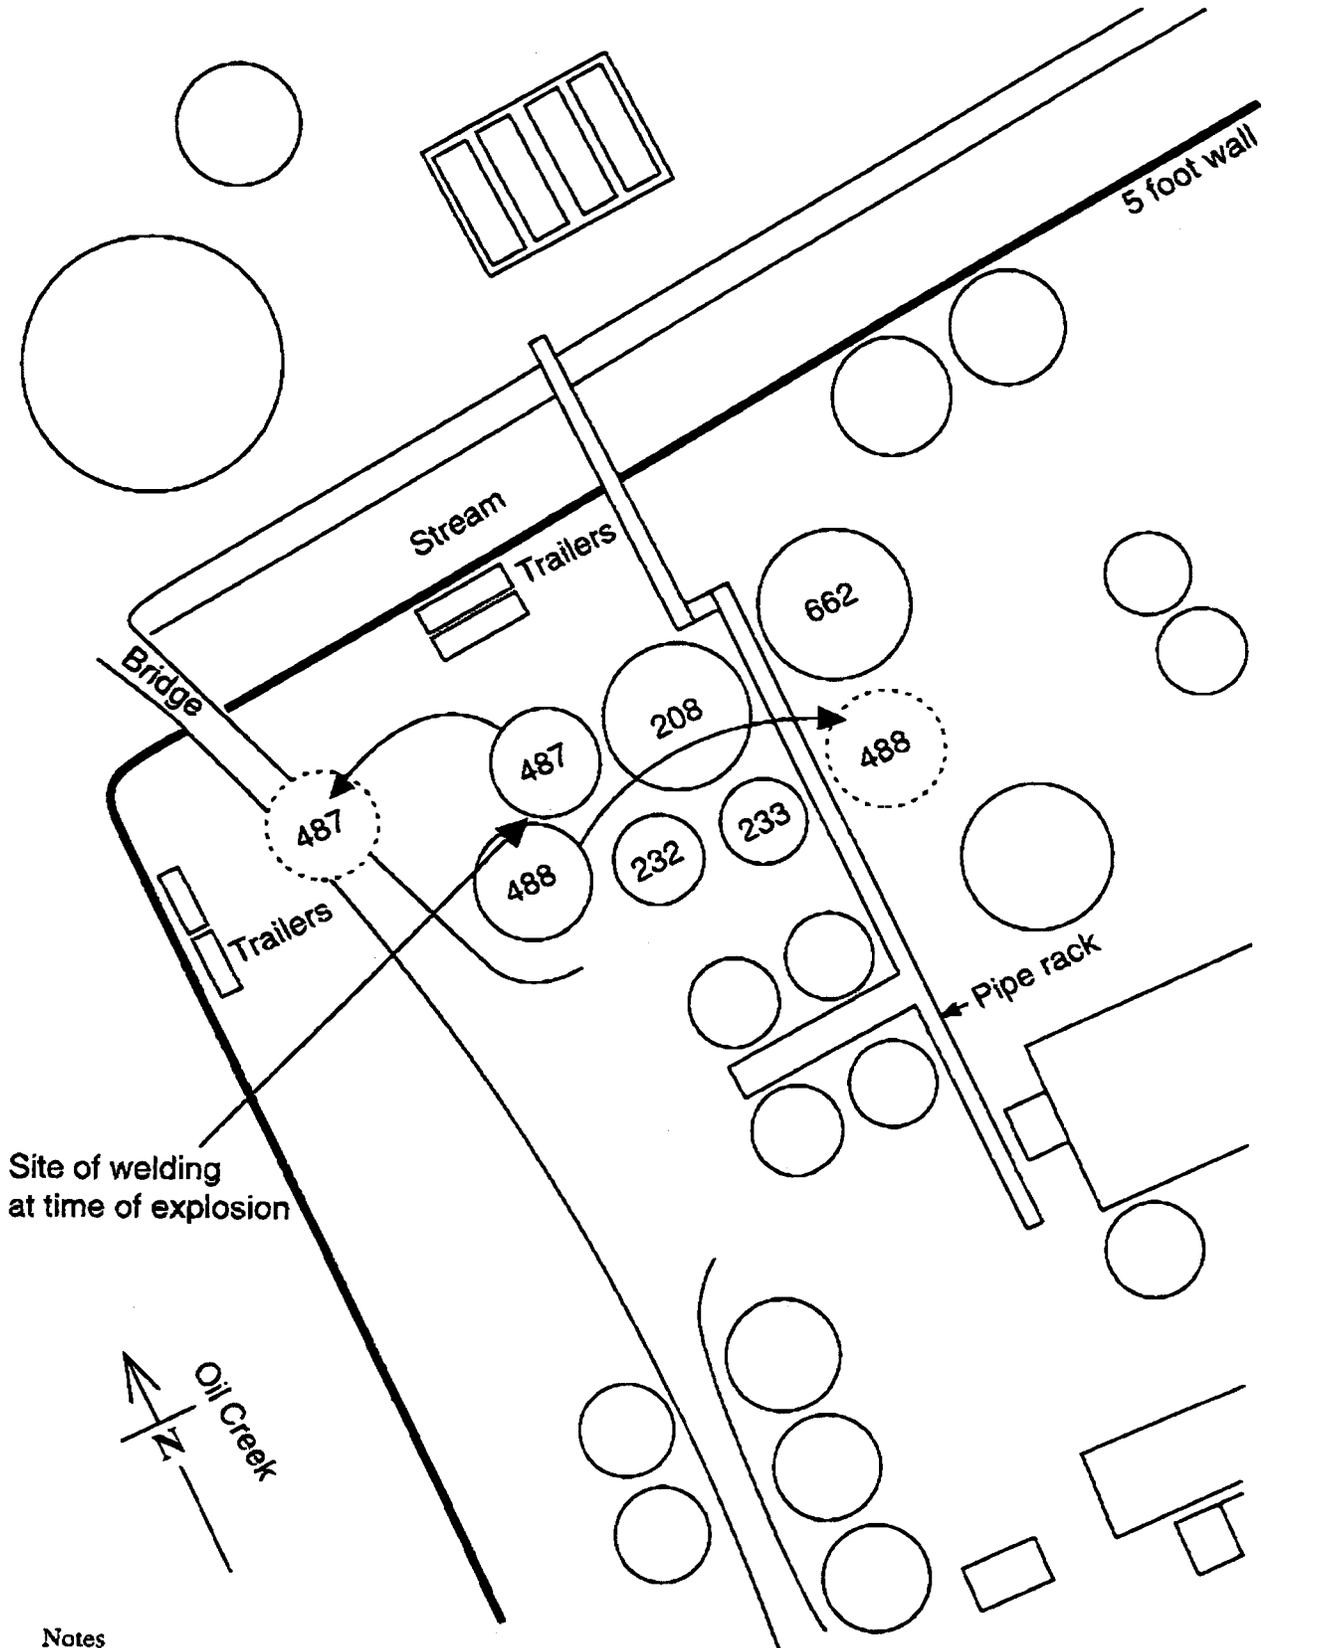
Exhibit 3  
Area of Explosion and Fire at Pennzoil Refinery

Curved lines indicate trajectory of tanks 487 and 488

Tank 208: Naptha; burned in place

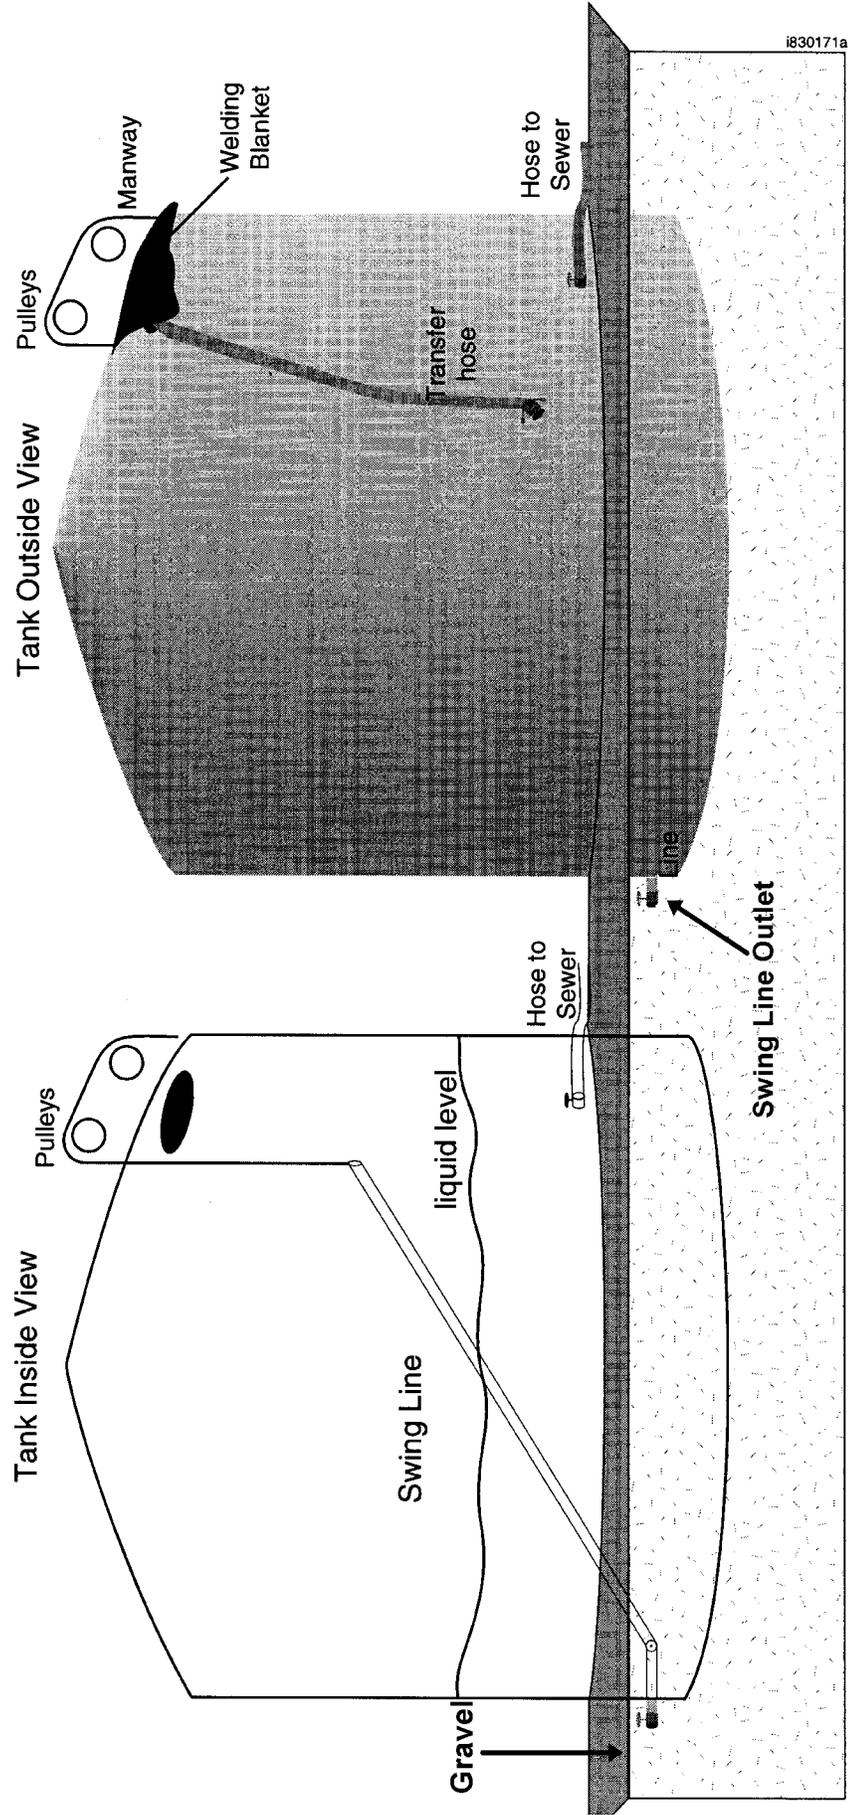
Exhibit 4  
Inside and Outside Views of Tank 487

Tanks 487 and 488, which were similar in size and design, were 30 feet in diameter with 25-foot high sidewalls and five-foot high domes. The tanks, built in 1937, were constructed of steel plates riveted together. The riveted "umbrella" domes were replaced in 1950. The tanks were about four feet apart and shared a common set of stairs leading to the top for employee activities such as gauging the volume of liquid in the tank or inspections. These tanks were not individually diked; i.e., they did not have a secondary containment wall around them. However, they were located in a general tank farm area that had walls and berms to prevent any spilled materials from reaching the Oil Creek.

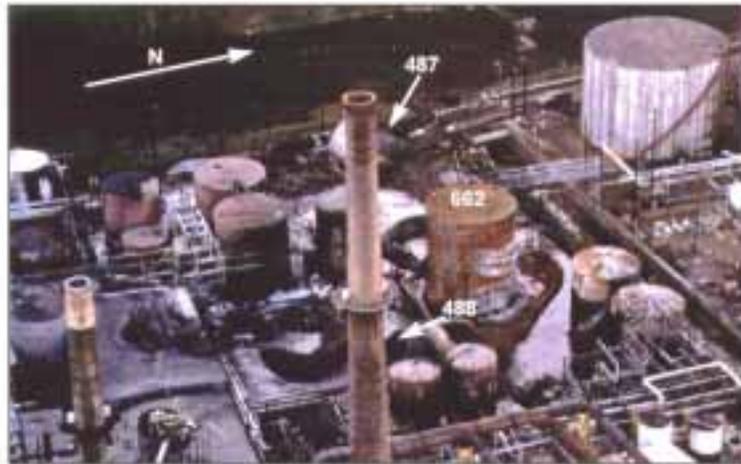
A. Overhead view of explosion area.

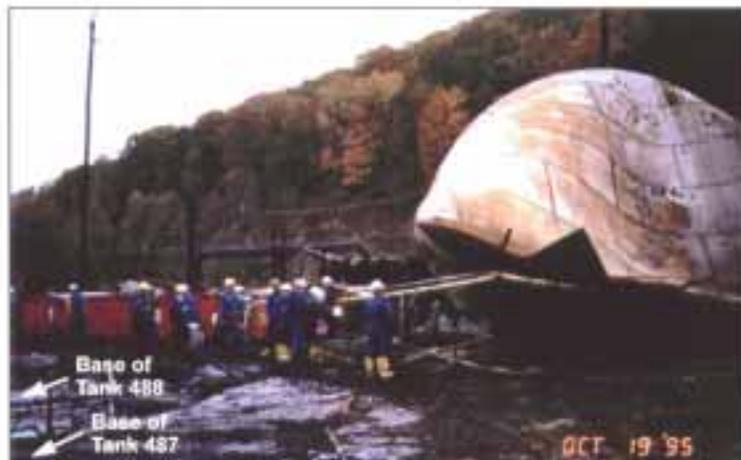
B. Dips in ground showing the original site of tanks 487 & 488. Tank 487 in background.

- The bottoms of the tanks at the shell wall seam may have been weakened through corrosion. The tanks generally contained water at the bottom. Gravel was also built up around the bottoms and sides of the tanks, which may have allowed moisture to collect on the outside, on the bottom and tank wall edge, leading to corrosion and weakening of the bottom seam at the shell wall. (Evidence of this gravel can be seen in Exhibit 5-B, which shows the indentations left in the ground by tanks 487 and 488.)

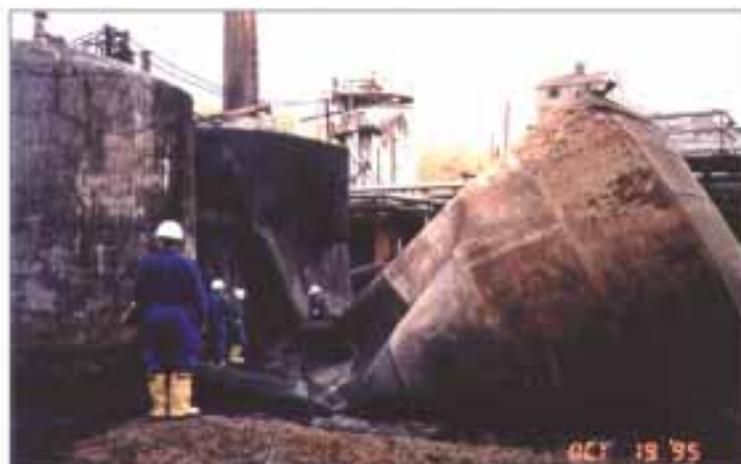
As a result of the explosions, each tank failed catastrophically at the bottom seam where the vertical sidewall of the tank was connected to the bottom horizontal floor plate, lifting the tanks up in opposite directions. Tank 487 lifted off its base and landed about 20 feet to the west. Tank 488 landed about 50 feet to the east after clearing a storage tank and a pipe rack. The burning contents of the tanks, released when the tanks failed, created a wave of burning hydrocarbon that engulfed the entire area.

C. Tank 488, after explosion.

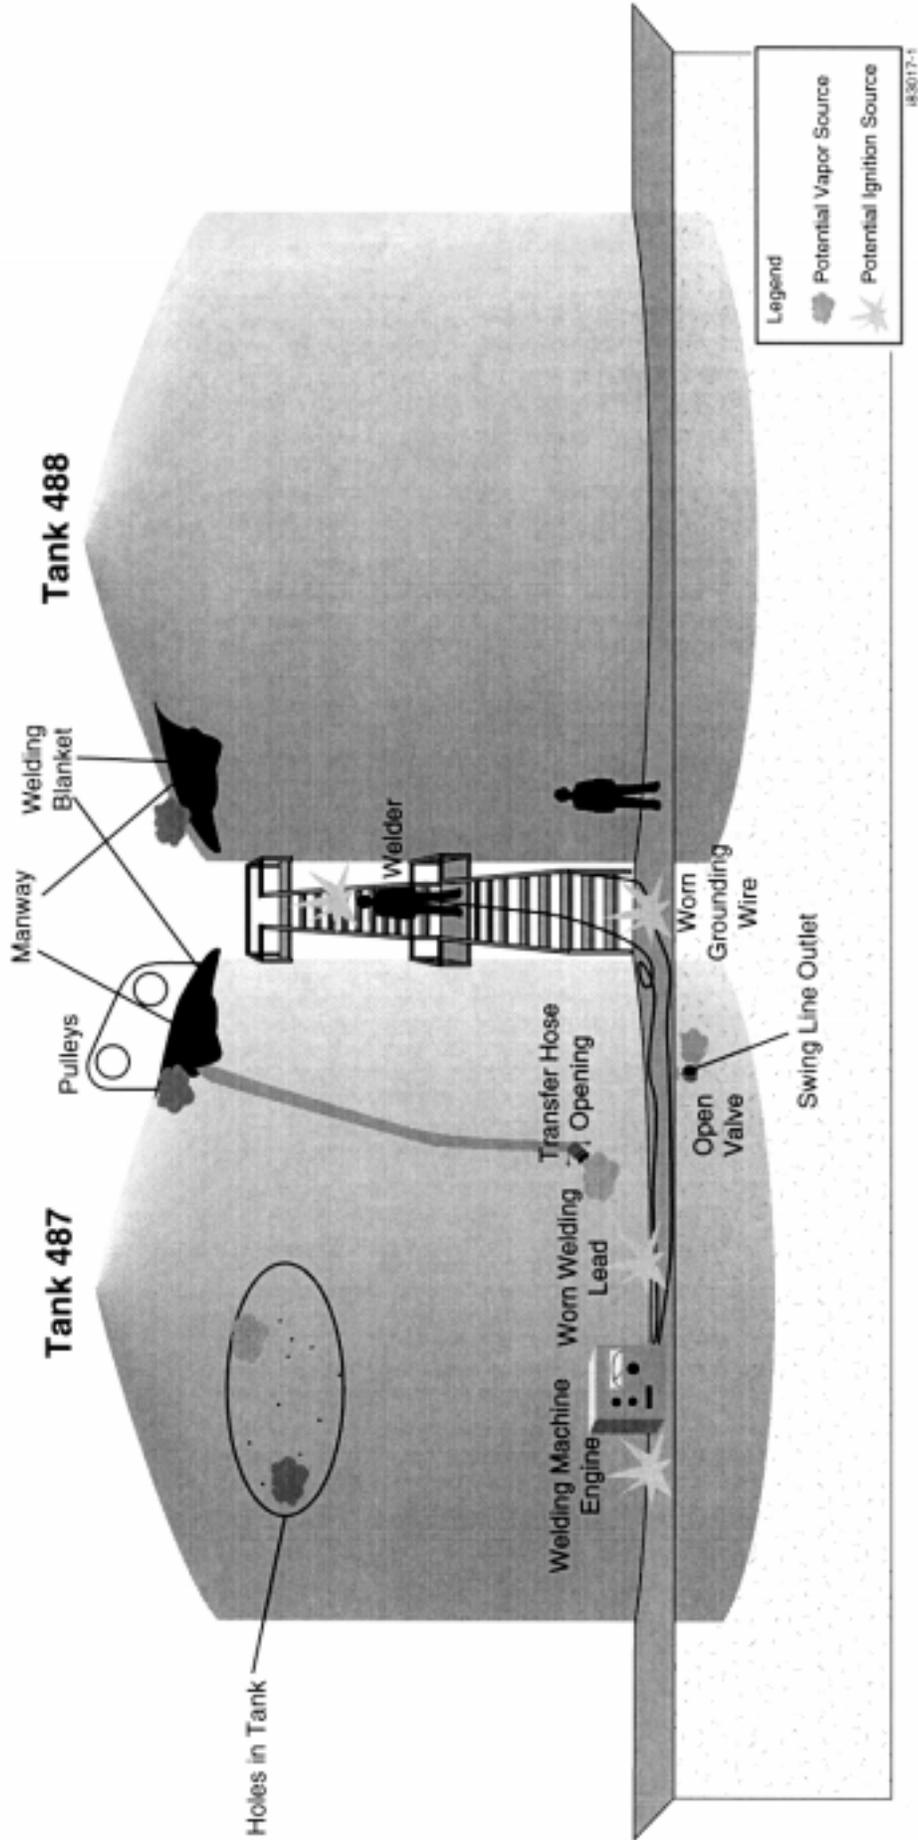
Exhibit 7  
Pennzoil Tank Explosion:  
Potential Vapor and Ignition Sources at Tanks 487 & 488

**Vapor Escaping from Swingline.** The swingline could have provided a route for vapor release (see Exhibit 7). The swingline portion inside the tank was raised above the liquid level in the tank vapor space. Investigators found after the accident that the outside valve near the base of the tank connected to the swingline inside the tank was open. As above, as the tank warmed, if sufficient driving force was present, undiluted heavier-than-air flammable vapors could have been pushed out through the swingline and open valve. If there was little or no wind, these dense vapors could have collected at grade level near ignition sources (see below). After ignition, the flame front could have flashed back through the swingline, igniting vapors in the tank. However, the end fitting on the swingline valve outside the tank was buried under the soil. Further, inspection of the inside of the swingline, after the accident, revealed no evidence of burn or scorch marks.

- The welding rod or sparks from hot slag or spatter possibly could have caused ignition of vapors present, if welding had been started (see Exhibit 7 for employee accounts of the position of the welder). During welding, flux coating the welding rod burns off. The welding rod being used by the welder was found after the accident and inspection revealed that flux on the tip was not burned off; however, there could have been an instantaneous arc, which could have caused ignition, but could have been of such short duration that the flux was not burned off. Or, the welding gun may have been dropped or kicked against the stairway causing an arc. However no evidence was discovered (e.g. arc marks) to support this scenario. Flammable and combustible materials are often ignited during hot work; generally, the material ignited is in the equipment being worked on. It is relatively rare for hot work to ignite a vapor cloud (Lees, 1996).
