Mobile Acetylene Trailer Accidents:  
Fire During Unloading in Dallas, Texas, July 25, 2007;  
Fire During Unloading in The Woodlands, Texas  
August 7, 2007; and  
Overturn and Fire in East New Orleans, Louisiana,  
October 20, 2007

NTSB/SIR-09/01  
PB2009-917002

# Special Investigation Report

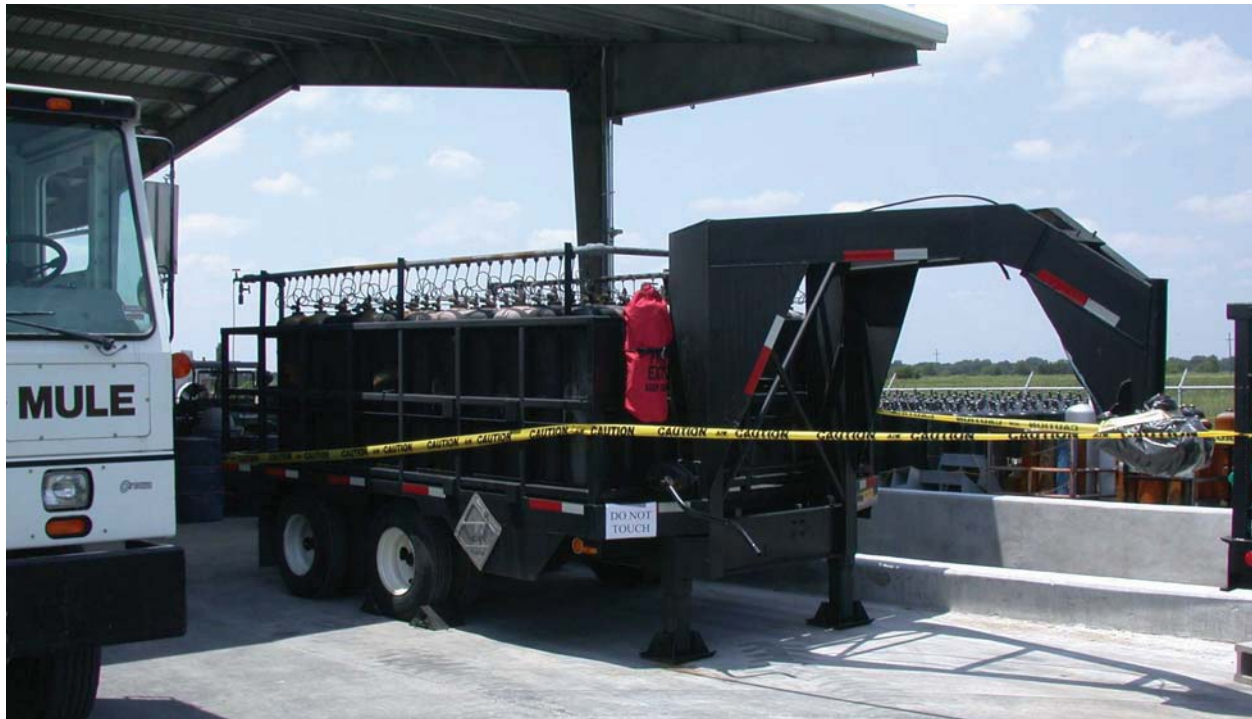
**Figure 1.** The Woodlands trailer (a small mobile acetylene trailer).

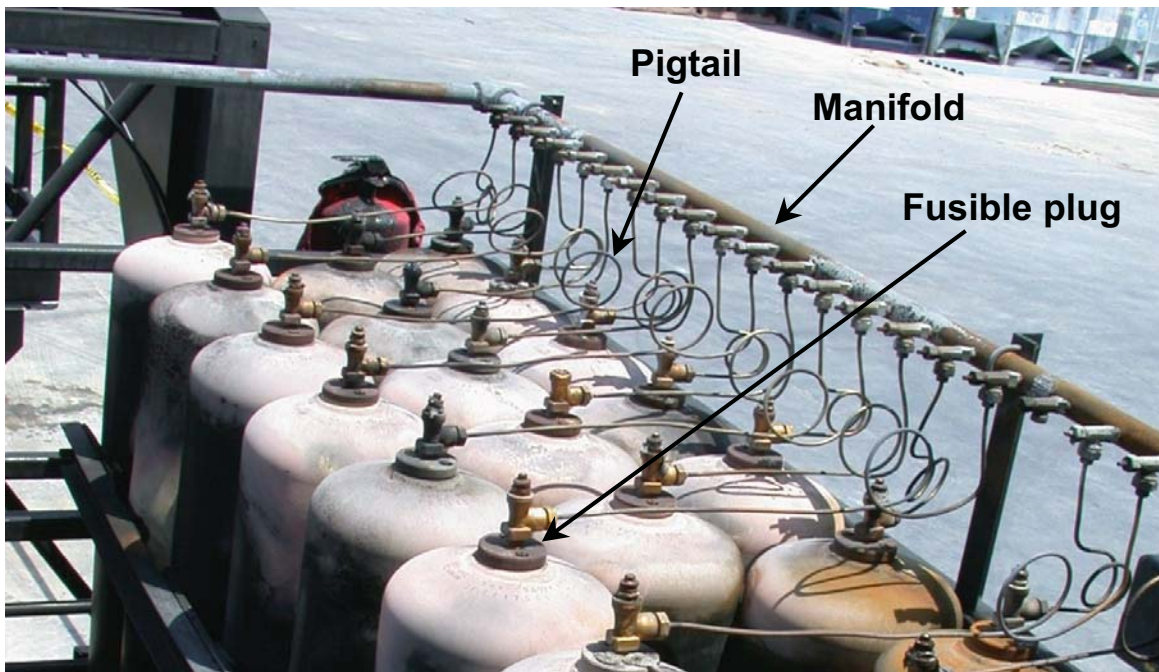
Although the trailer has strong outer railings and the manifold is mounted above the top of the cylinders, neither the railings nor the manifold protects the cylinder valves in case of a trailer overturn. The four accident mobile acetylene trailers had no rollover protection for the valves, nor were they required to.

**Figure 2.** The Woodlands cylinders on front right of accident trailer.

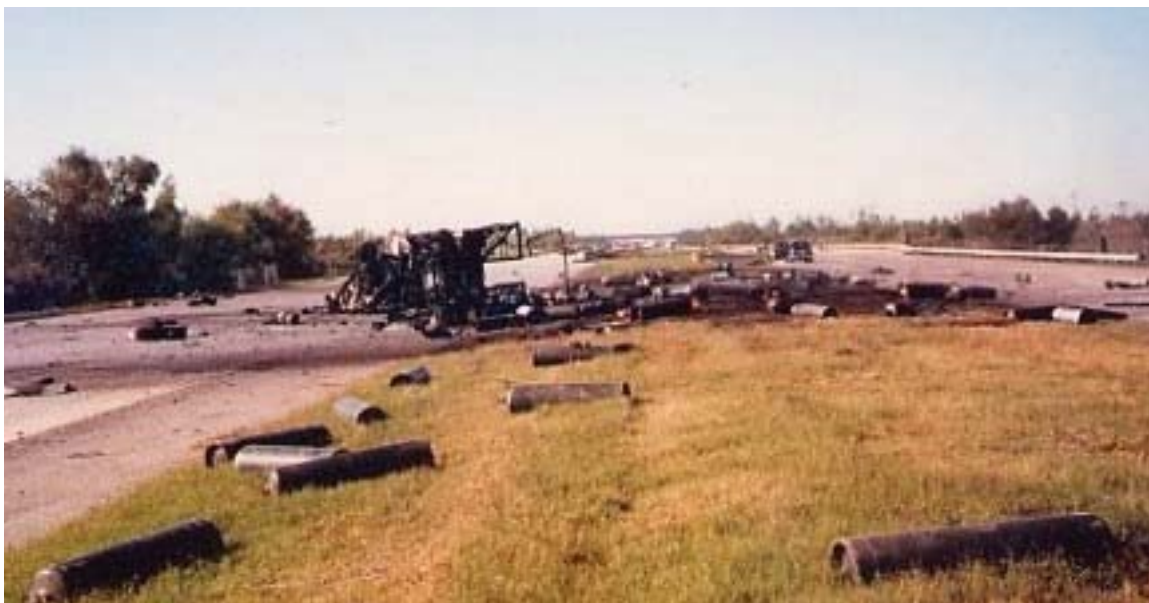
**Figure 4.** East New Orleans accident vehicle and cylinders.

In the East New Orleans, Louisiana, accident in which the tractor and mobile acetylene trailer overturned, the cylinders mounted on the trailer were thrown from the vehicle. The postaccident examination of the cylinders recovered from the scene revealed that 32 of the cylinders recovered had their valves broken off during the accident, releasing acetylene that ignited. Similarly, in the Lamar, Colorado, accident, about half of the 225 cylinders were thrown from the trailer. The postaccident examination of the cylinders recovered from the scene revealed that 86 of the cylinders had their valves broken off during the accident, resulting in the release and ignition of the residual acetylene. An examination of these cylinders showed that the fire from the cylinders with broken valves caused the fusible plugs of other cylinders to melt, releasing additional acetylene that ignited. Possible ignition sources include the generation of a static charge in the rapidly escaping acetylene and solvent and a spark caused by the steel cylinders striking concrete, rocks or stones, or the road surface.

The Safety Board concludes that the fires in the East New Orleans, Louisiana, and Lamar, Colorado, accidents occurred as a result of the ejection of unsecured cylinders during the rollovers of the mobile acetylene trailers, resulting in damage to many of the cylinder valves and the release of acetylene, which then ignited.

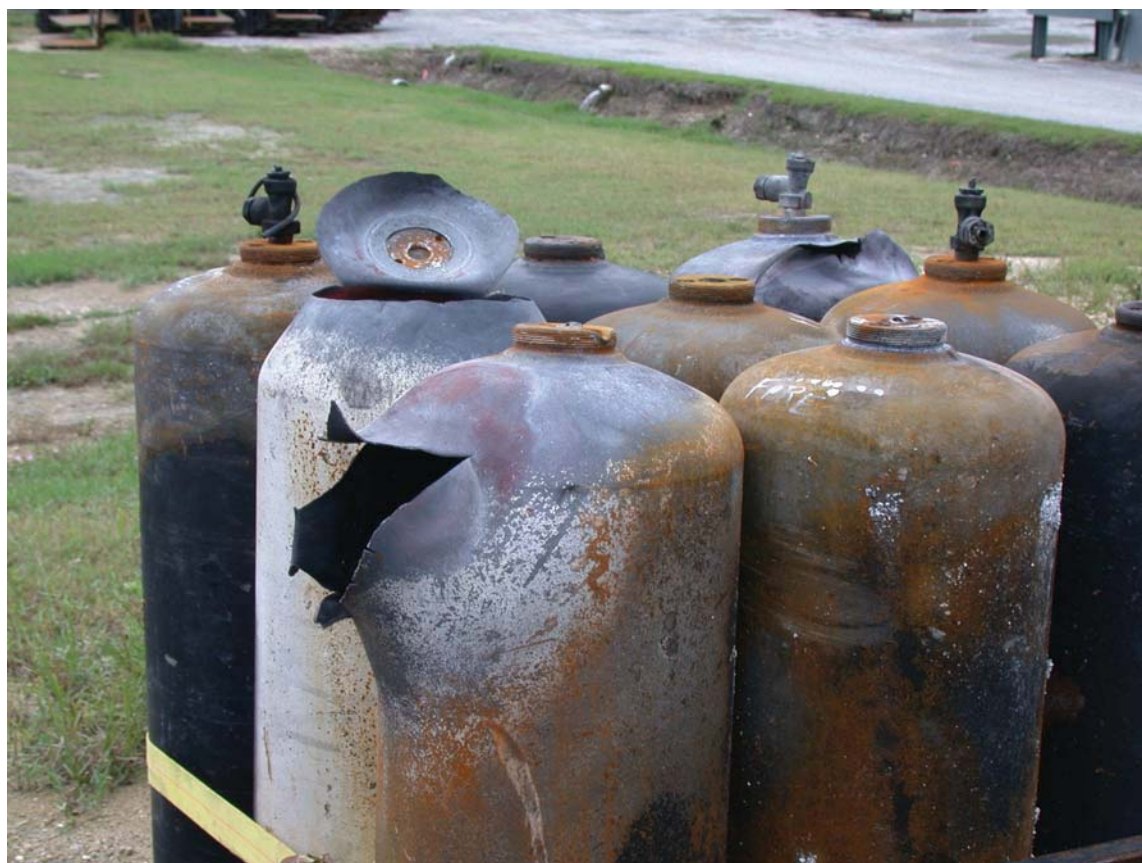
Of the 145 cylinders that released acetylene, 88 were so severely damaged that they were discarded. Of the remaining 57 cylinders that released acetylene, 32 had their valves broken off, and all 57 had evidence of heat exposure and melted fusible plugs. Significant damage to these cylinders included burst heads, a bulging and burst sidewall near the top head weld, extreme localized bulging of the heads and sidewalls, and denting. (See figure 5.)

**Figure 5.** East New Orleans cylinder showing burst near head.

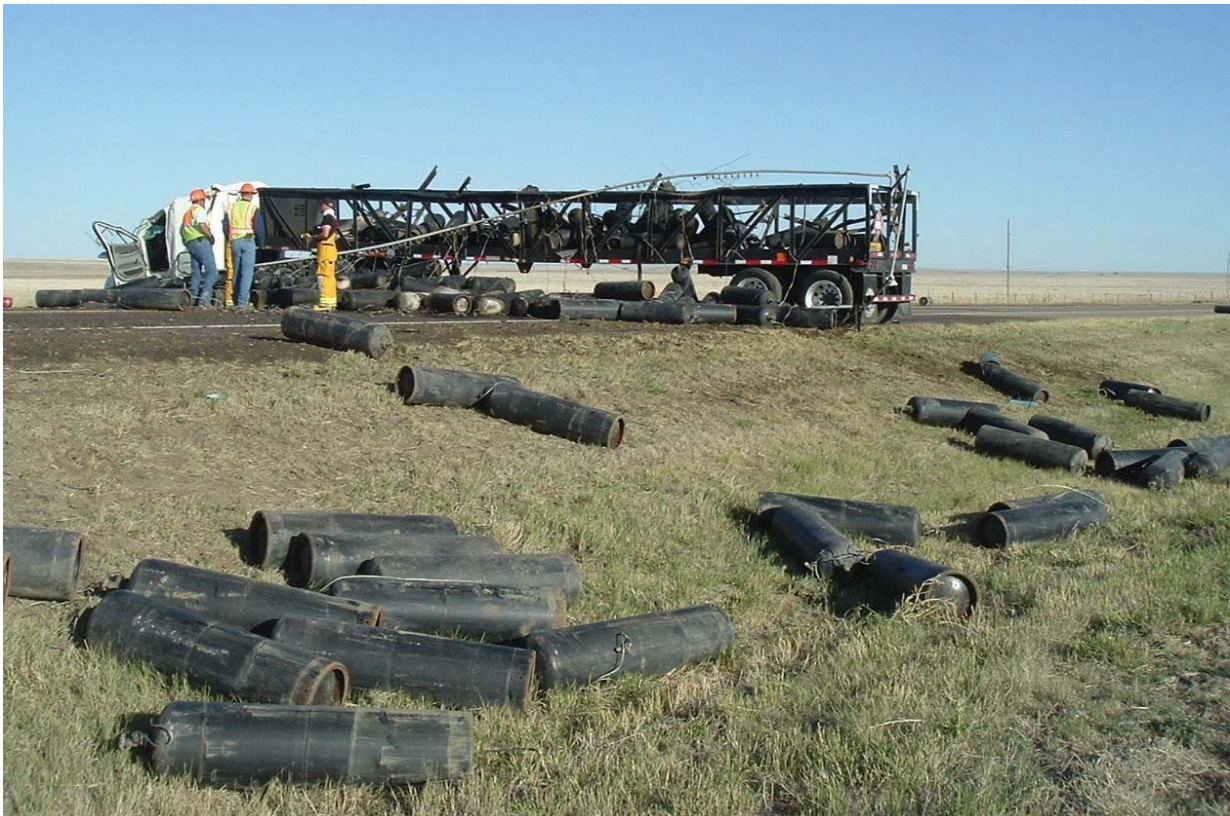
**Figure 6.** Lamar accident vehicle.

The trailer had been unloaded at a Western facility in Pueblo, Colorado, and was en route to Louisiana to be refilled. There was still a residue of acetylene in each cylinder. The valves of all the cylinders were closed during transportation. Before this trip, the operator had been off duty since June 6, 2008. The Colorado accident report indicated that the vehicle skidded for 106 feet, went off the right side of the roadway, and traveled an additional 250 feet before striking a delineator pole. The vehicle was then steered to the left onto the roadway, where it rolled over completely. The vehicle came to rest perpendicular to and completely across the two-lane road. At least half of the cylinders were thrown from the vehicle, and the remainder fell over. The valves were broken off of 52 cylinders, and acetylene was released and ignited. The fire caused

fusible plugs on other cylinders to melt, which released acetylene that also ignited. About 86 cylinders were damaged by the fire. The tractor and trailer had extensive collision damage; the trailer had some fire damage.

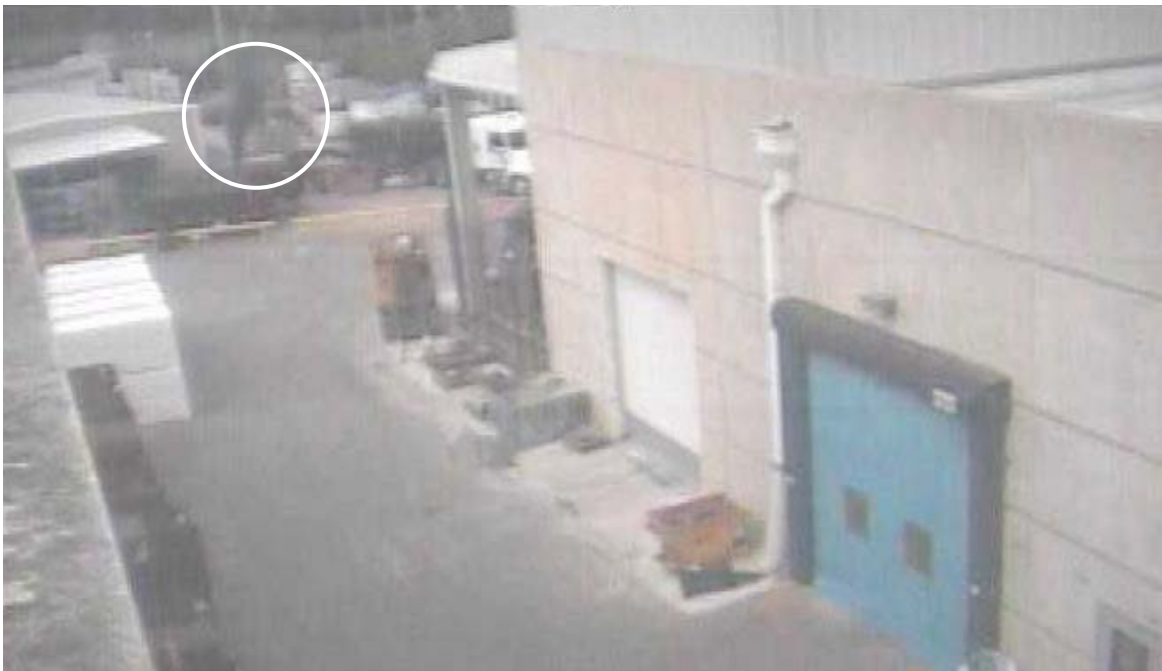
**Figure 8.** Security camera photograph of black plume coming from a cylinder on trailer in The Woodlands, Texas.

The postaccident examination of the trailer being prepared for unloading revealed that the trailer and manifold piping had some fire damage at and above the level of the top of the acetylene cylinders. There was little damage to the trailer below that level. The cylinders' fusible plugs were all melted, with some evidence of fusible material remaining on the top of some of the cylinders. At least three cylinders in one cluster had visible bulging on their sidewalls just below the circumferential head weld. The cylinder valves appeared to be intact; however, the hand wheels had been consumed in the fire. The pigtailed also had evidence of heat exposure but appeared to be intact. The connection fitting from the trailer to the plant piping had a large deposit of black powderlike material inside. A large deposit of the same black material was also in the plant discharge arm at the Hughes Christensen plant. There was no deposit of a similar material in the discharge arm for the second trailer.

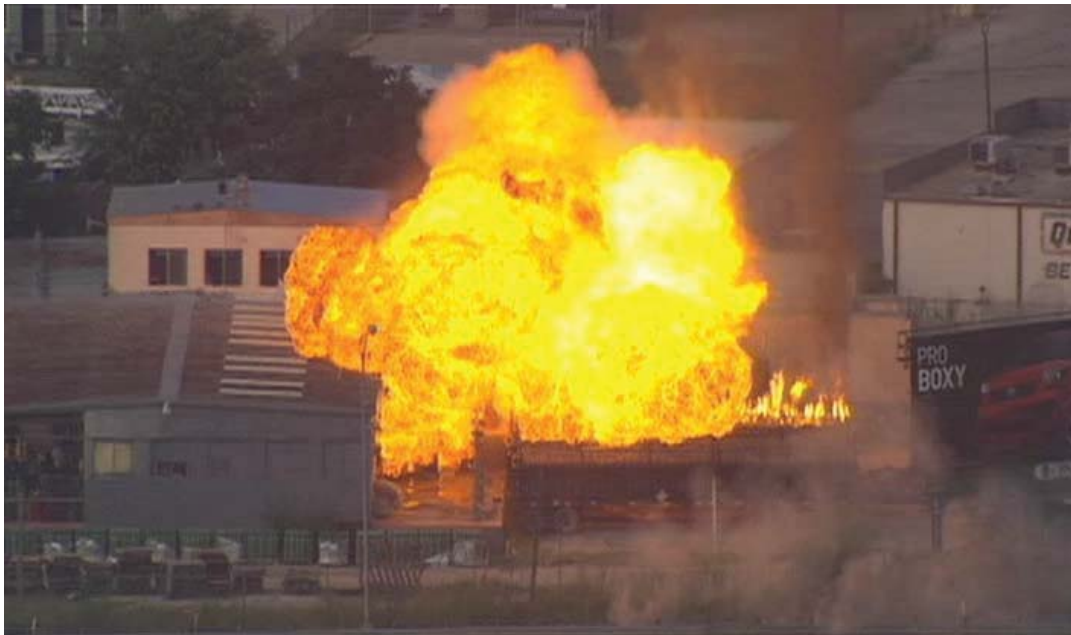
**Figure 9.** Acetylene gas fire at Southwest facility in Dallas.

4. The ignition of the acetylene in the Dallas, Texas, accident likely occurred because of the operator's failure to follow Western's standard operating procedures, which resulted in the reduction of the pressure in the manifold to 0 psig, allowing air to enter the manifold and initiating a decomposition reaction when pressurized acetylene was subsequently introduced into the manifold.

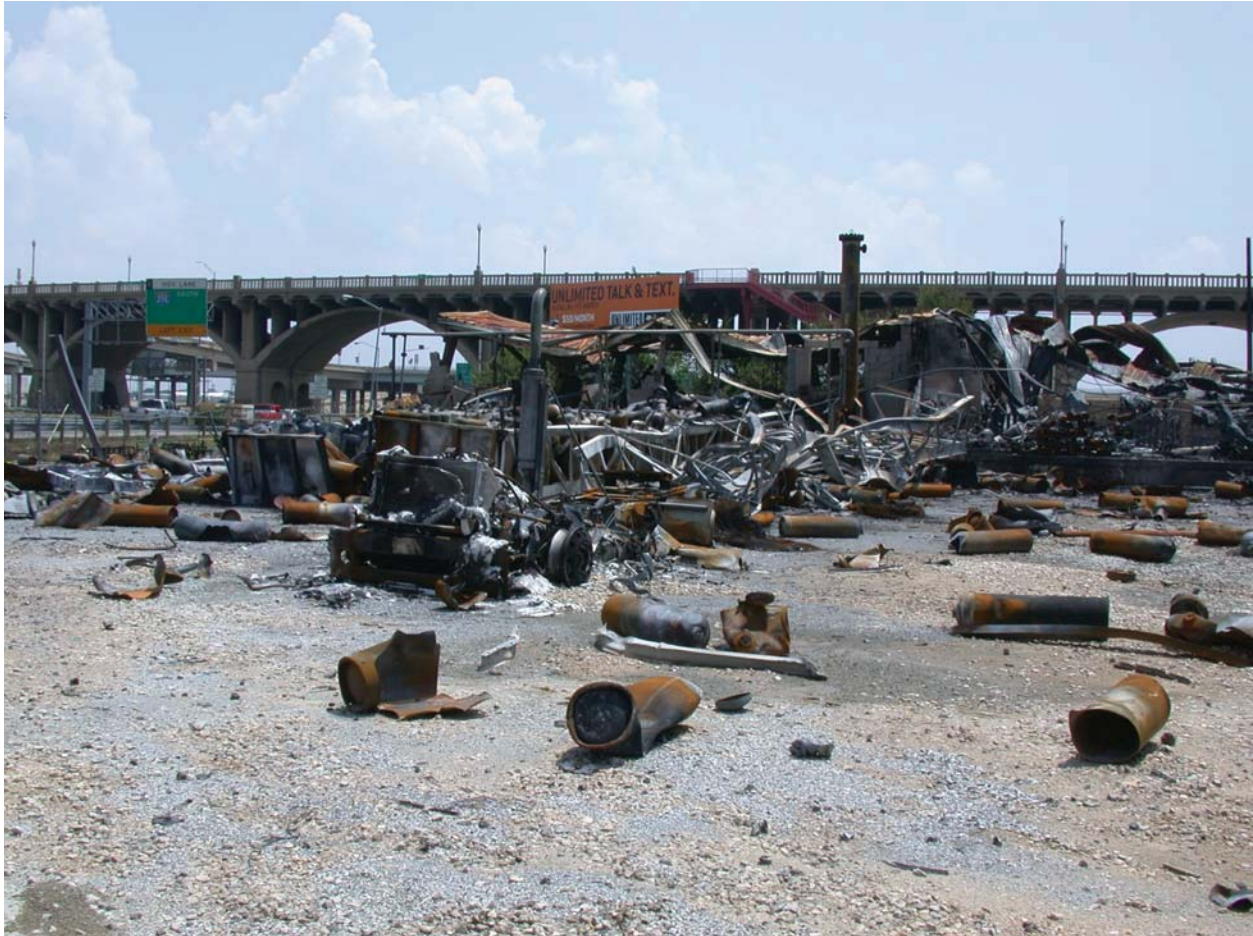
**Figure 10.** Dallas accident damage to Southwest facility and vehicles. (Accident trailer and cylinders in foreground.)

Postaccident examination of the accident site revealed that the discharge arm to the accident trailer had broken from the plant's piping and the trailer connection. The discharge arm valve was found in the closed position. No acetylene cylinders were found on the accident trailer. The three other Western mobile acetylene trailers that were attached to Southwest's unloading apparatus were destroyed, although some cylinders remained on two of these trailers. More than 1,000 cylinders from the trailers and from plant inventory were recovered from an area with a radius of about 1/4 mile. (See figure 12.) Although the cylinders from the Western trailers could be differentiated from Southwest's cylinders, Western's records did not identify the cylinders that were mounted on each trailer, so no detailed examinations were performed on the cylinders. A sampling of cylinders of the same size and construction as those from the trailers were visually examined. Damage ranged from a melted fusible plug to a longitudinal tear running the length of the cylinder. In some cases, the top or bottom cylinder head had torn off.

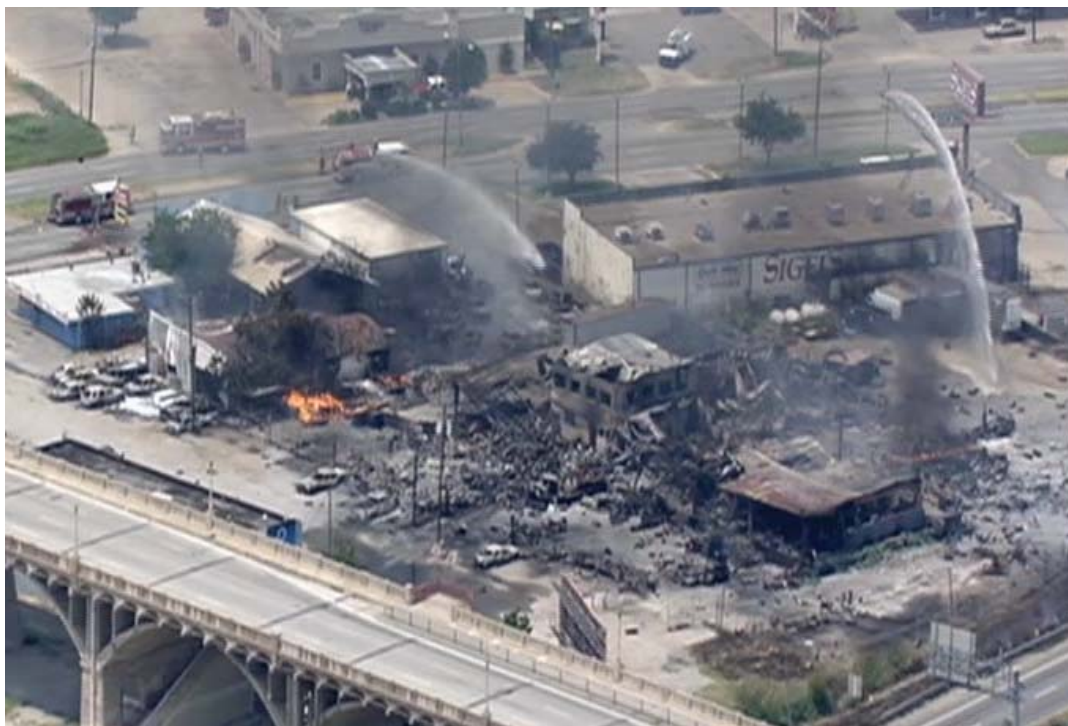
Both managers then helped operate the fire hose, and both saw cylinder explosions, were knocked down, and received second and/or third degree burns while they were operating the hose. Another employee turned on a permanently mounted water monitor and began spraying water onto the trailer. However, because supplying water to the monitor reduced the water pressure in the fire hose, the water monitor was shut off. The hose was not effective in suppressing the fire, which was extinguished about 9 hours later by the Dallas Fire Department. (See figure 11.) The only fire-fighting equipment available at the Dallas plant included fire extinguishers, one fire hose, and the manually operated water monitor on the roof. There was no automated water deluge system.

**Figure 11.** Final phase of fire suppression at Southwest facility in Dallas.

Revise the recommended practices in Compressed Gas Association standard G-1.6, section 7, *General Provisions*, to require automated water deluge systems at all mobile acetylene trailer loading and unloading locations to control the spread of fire to other cylinders on a trailer and to nearby mobile acetylene trailers. (H-09-03)

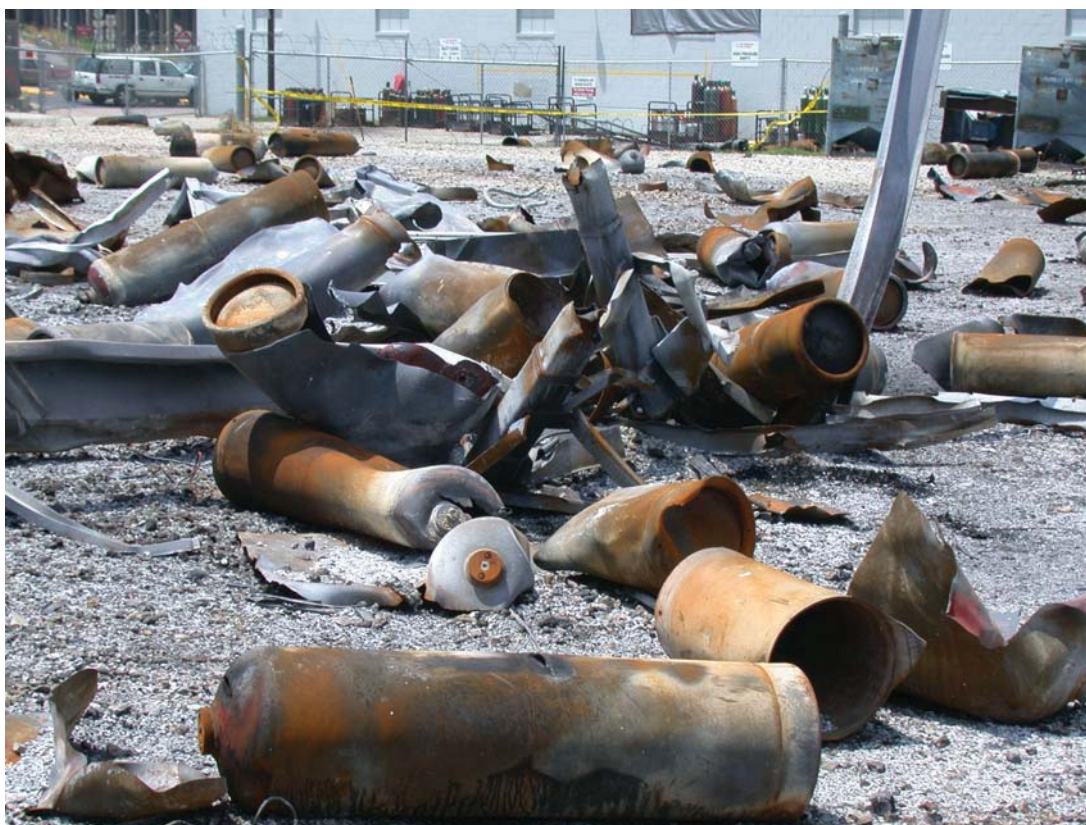
**Figure 12.** Dallas cylinder damage.
