# NATIONAL TRANSPORTATION SAFETY BOARD

## MARINE ACCIDENT REPORT

SINKING OF THE RECREATIONAL SAILING VESSEL  
*MORNING DEW* AT THE ENTRANCE TO THE HARBOR OF  
CHARLESTON, SOUTH CAROLINA  
DECEMBER 29, 1997

**National Transportation Safety Board. 1999. *Sinking of the Recreational Sailing Vessel Morning Dew at the Entrance to the Harbor of Charleston, South Carolina, December 29, 1997. Marine Accident Report NTSB/MAR-99/01. Washington, DC.***

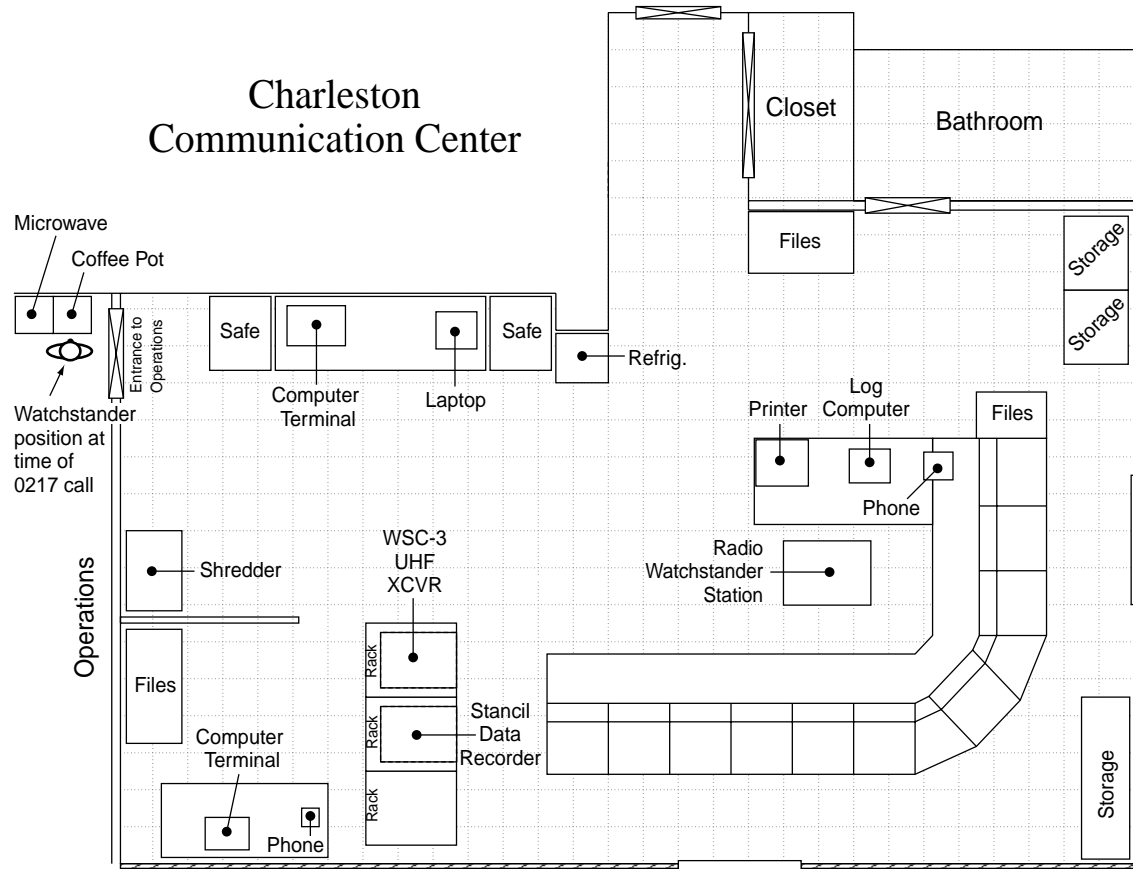
**Figure 6.** Layout of Group Charleston communications center

Furthermore, the NSWC-CD observed that, at Charleston, the DF unit was mounted such that it would be behind the watchstander when the watchstander is seated at the normal watchstanding station. Communications center watch personnel were aware of the limitations of the DF equipment and stated that the DF equipment installed at Charleston was not regularly used and, in fact, was not routinely turned on.

Stancil recording and playback device was not located conveniently to the watchstander. At both centers, watchstanders had to leave their normal work station and walk to the playback device to replay recorded transmissions. Since the accident, the Coast Guard has replaced the Stancil recorder at Charleston and 31 other group communications centers with a digital voice logger (recorder), or DVL. At Group Charleston, the DVL has been placed within reach of the communications watchstanders' station.

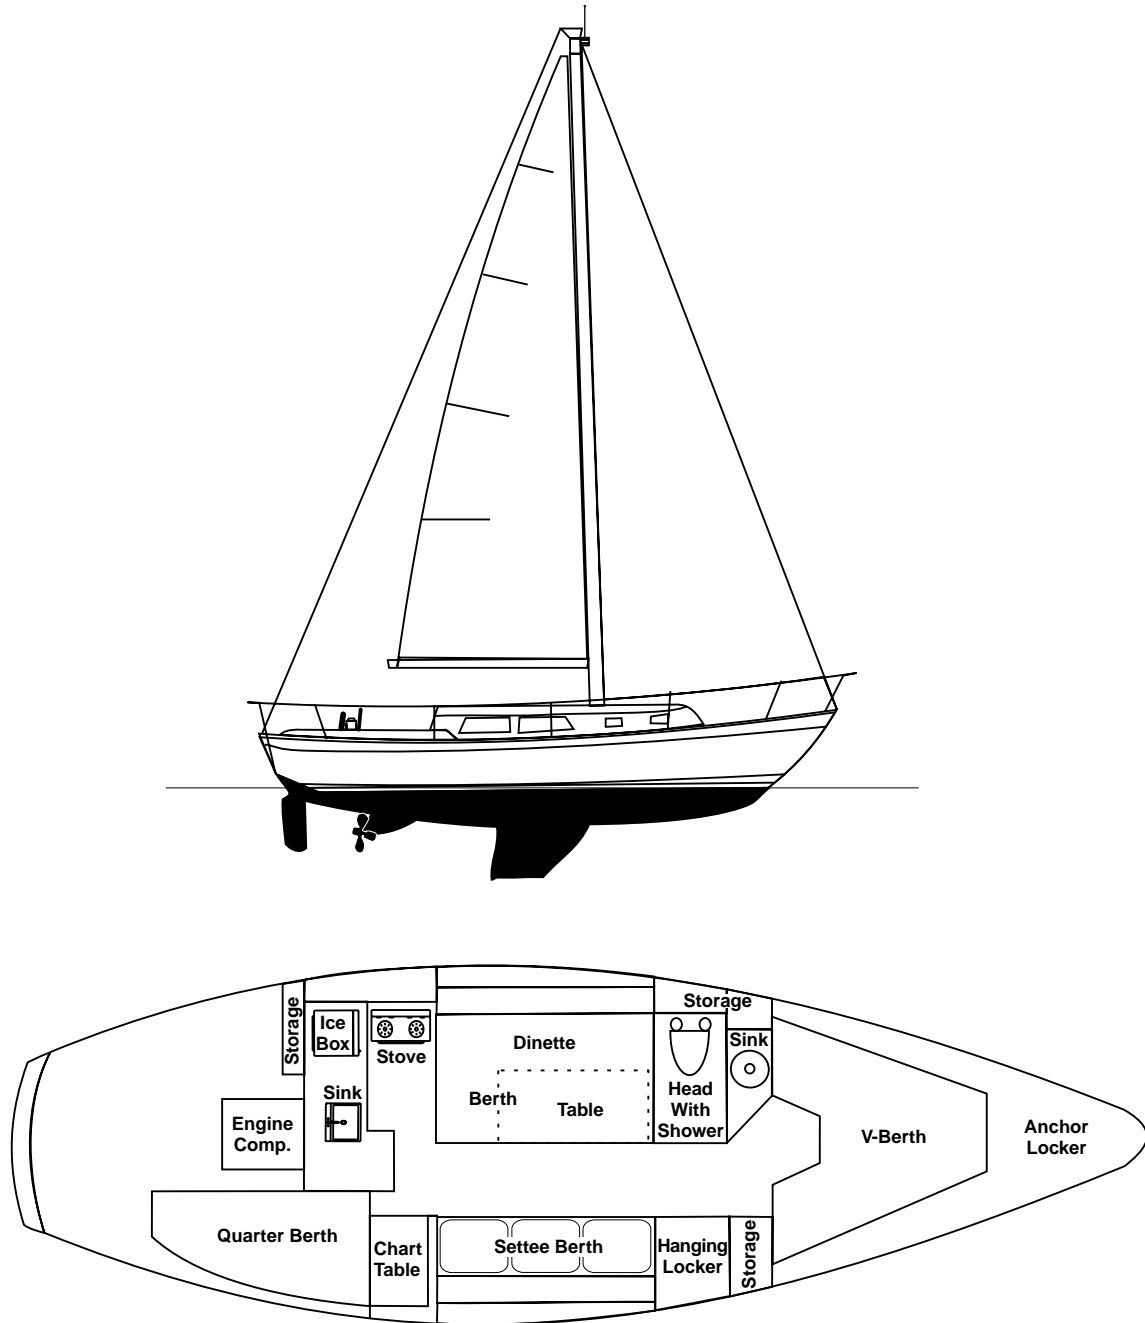
**Figure 8.** Profile and plan views of typical Cal 34 sailboat

The deck was constructed of hand-laid fiberglass over a plywood core. The self-bailing cockpit in the after end of the boat was fitted with a pedestal-type steering stand. Molded into the cockpit were seats for the helmsman and several passengers. The cockpit steering position was the only location from which the boat could be steered. The cockpit area had one under-seat storage hatch with a hinged cover.
