Driving Apparatus on Flooded Roadways Safely and Effectively

David Wade

Virginia Beach Fire & Rescue, Virginia Beach, Virginia

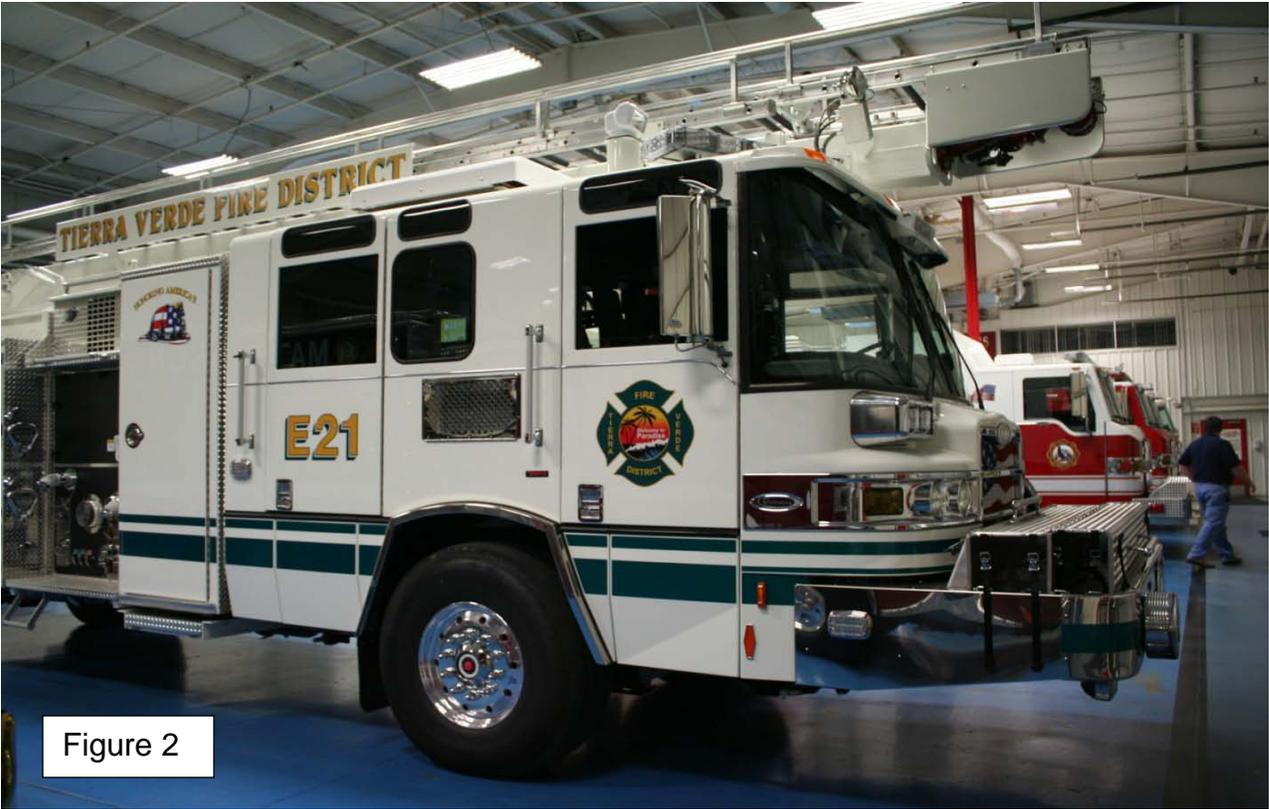
the unit and moves the air intake to the side of the truck over the passenger side front wheel (high side option). This option also includes the movement of the electrical junction box distribution nodes and the “can bus” nodes into a compartment of choice. The new nodes box is usually mounted in the top of a compartment to alleviate equipment banging into it and causing damage and provide easy access by mechanics. This option is not retro-capable to current units in the fleet. This option also takes up space in the cab that must be considered. This option is pictured in Figure 2 on the Tierra Verda Fire District apparatus.

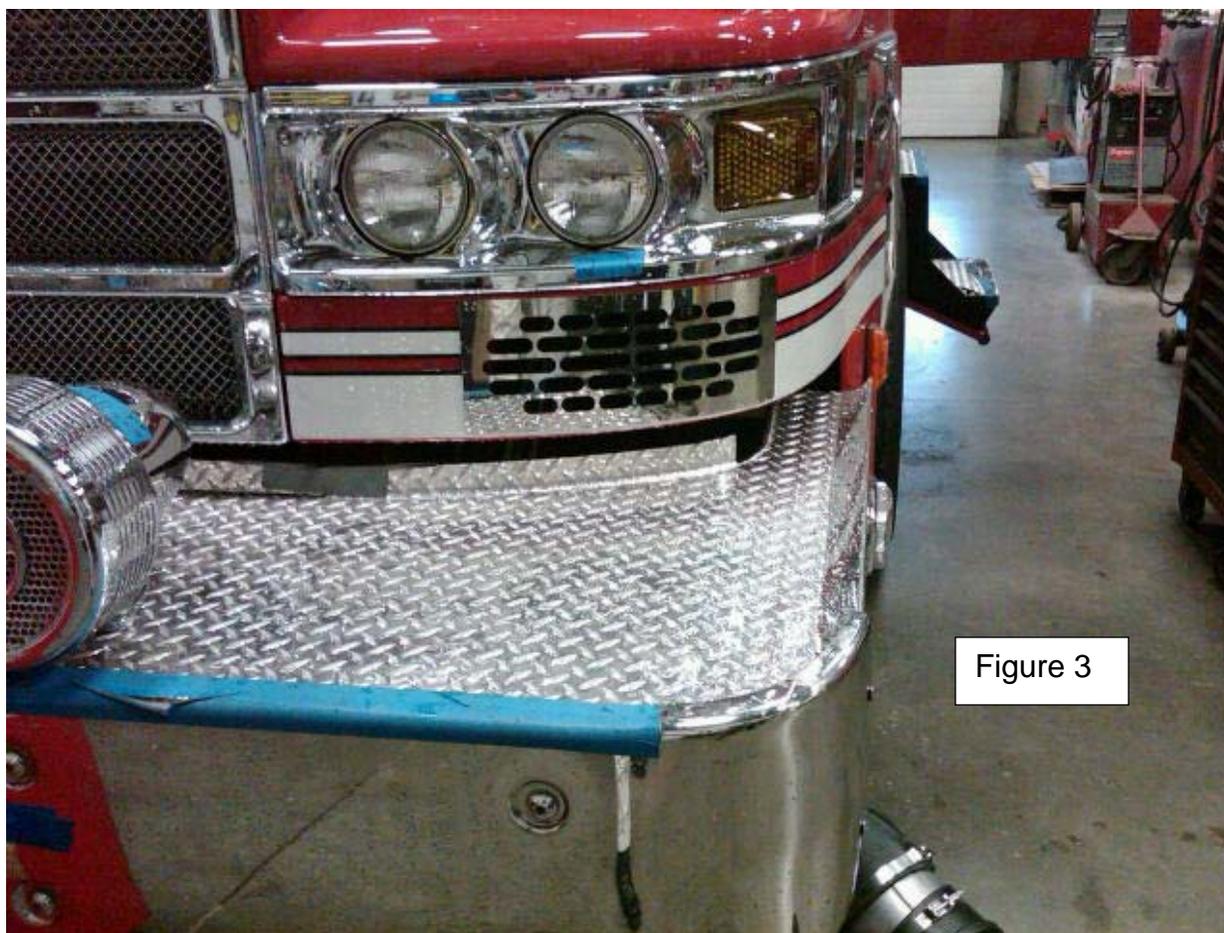
Figure 3

The second option that was established is a more cost effective, as long as it is done at the time of the purchase, method for those that have limited funding for apparatus purchases. This design when performed on the apparatus while it is being built only adds \$500 to the cost for the intake movement and an additional \$1,617 to the price if you choose to move the electrical components. This second option method is also advantageous in that it can be retro-fitted to existing apparatus that are already in the fleet. It is more expensive than having it built in at the factory originally. The kit to move the air intake can be ordered at a cost of \$1,623. Labor to perform the move and install the kit is extra and dependent on the dealer selected to perform the work. The electrical components cannot be moved during the retro-fit. The second option is featured in the picture Figure 3.
