Historic Home Retrofit

Full Mitigation Best Practice Story

Kitsap County, Washington

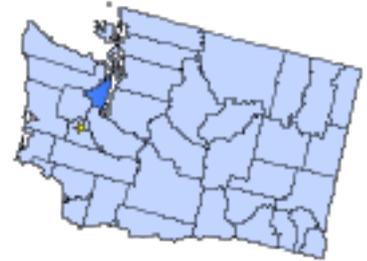
Poulsbo, WA - In late 1998, Doris Chapot purchased a two-story Cape Cod-style home built in 1902. For years it served as the First Lutheran Church parsonage. In 1940, the parsonage was moved to its present location. It was set on posts and concrete pier blocks, but nothing more was done to ensure its safety from earthquake damage.

At the time of purchase, a building inspector suggested that Chapot have an earthquake retrofit done to ensure positive connections among beams, posts, and pier blocks. Forty piers were braced with a gusset system that included a two-foot, triangle-shaped plywood tying the posts to the concrete pier. All of the posts around the perimeter were tied together in the front and the back with 2-foot by 6-foot posts, and nails were strategically placed. Because pier blocks were different shapes, bendable metal connections were used for attaching the posts.

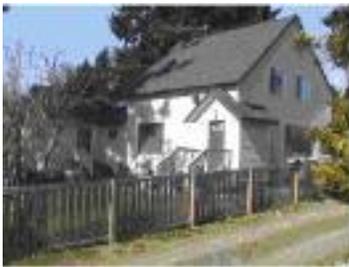
Extensive retrofitting of this historic home protected it from damages during the Nisqually earthquake.
