PB90-916405
NTSB/MAR-90/04

NATIONAL TRANSPORTATION SAFETY BOARD

MARINE ACCIDENT REPORT

GROUNDING OF
THE U.S. TANKSHIP EXXON VALDEZ
ON BLIGH REEF, PRINCE WILLIAM SOUND
NEAR VALDEZ, ALASKA
MARCH 24, 1989

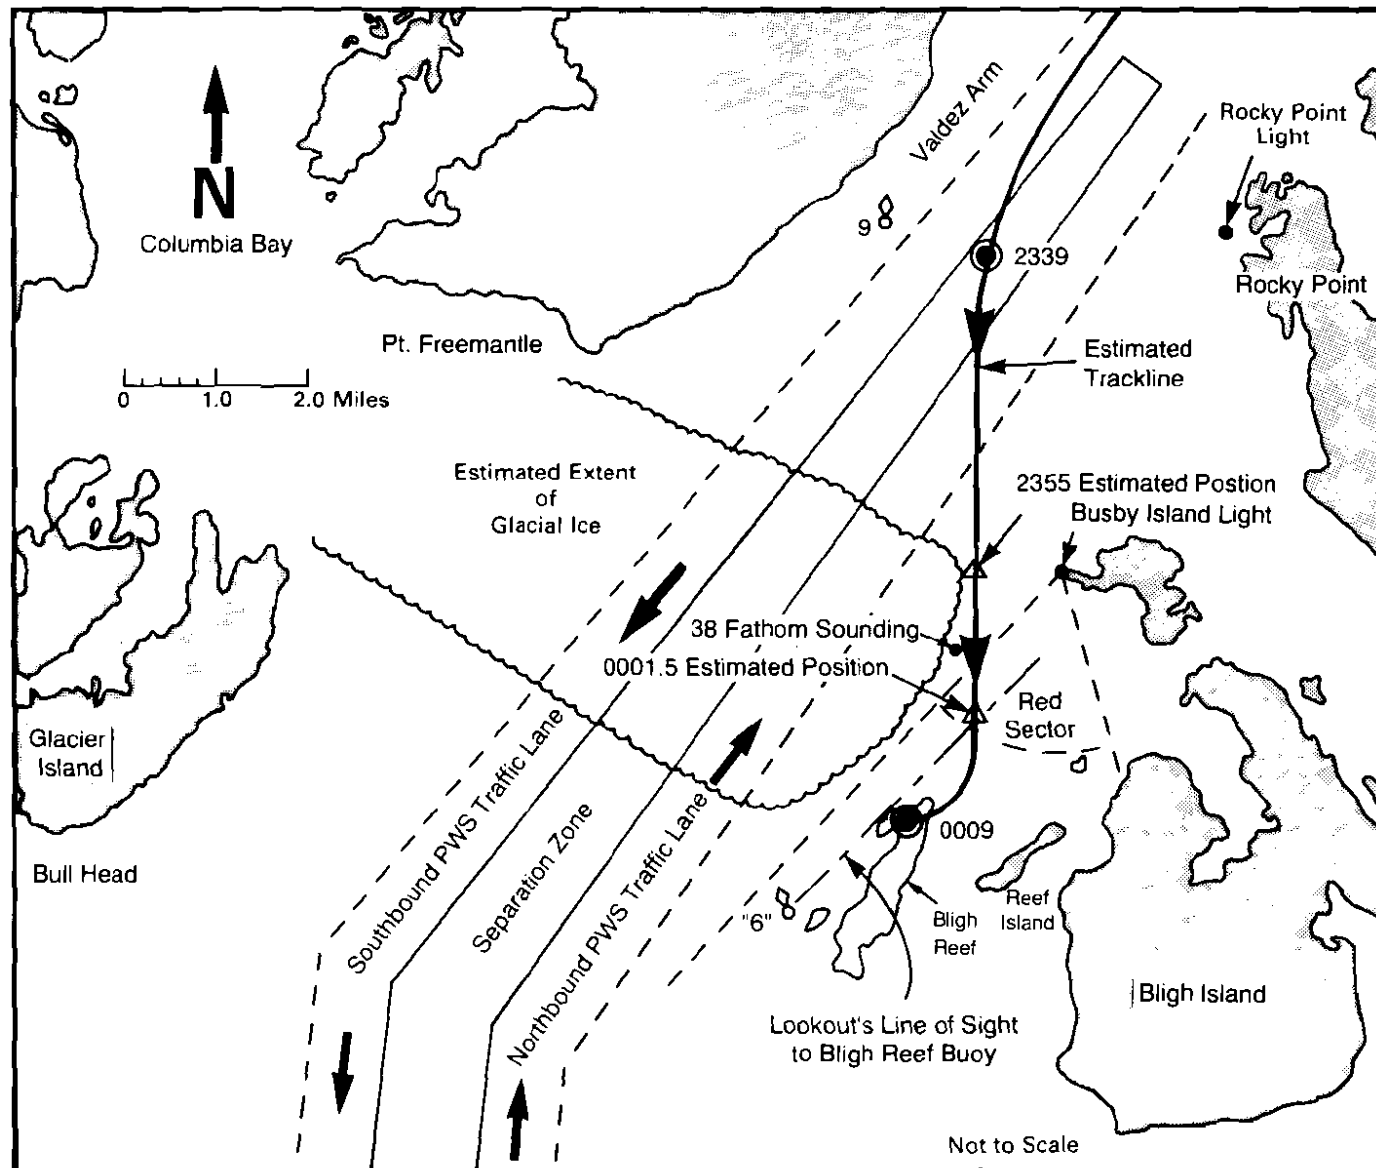
Figure 3.--Trackline of EXXON VALDEZ.

Light and Buoy No. 9 and a radar range to the land adjacent to Buoy No. 9. The third mate stated that the vessel was turning while he was taking the bearings. When plotted, his fix showed that the vessel's 2339 position was in the middle of the separation zone and approximately 2 miles west of Rocky Point Light. By about 2343, according to the course recorder, the vessel was steady on a course of 180°.

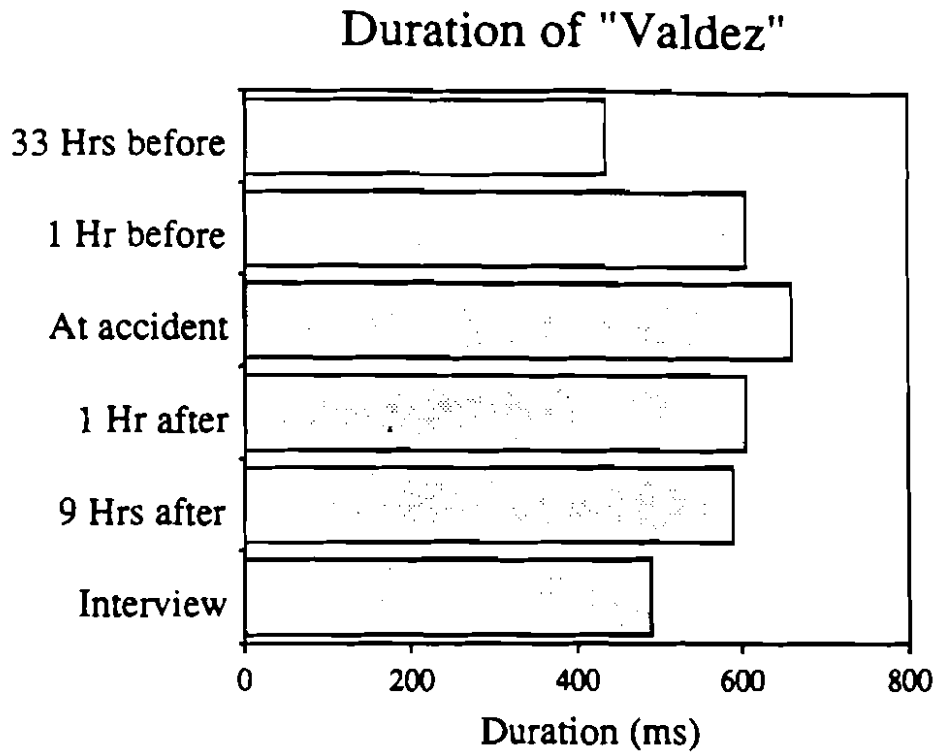
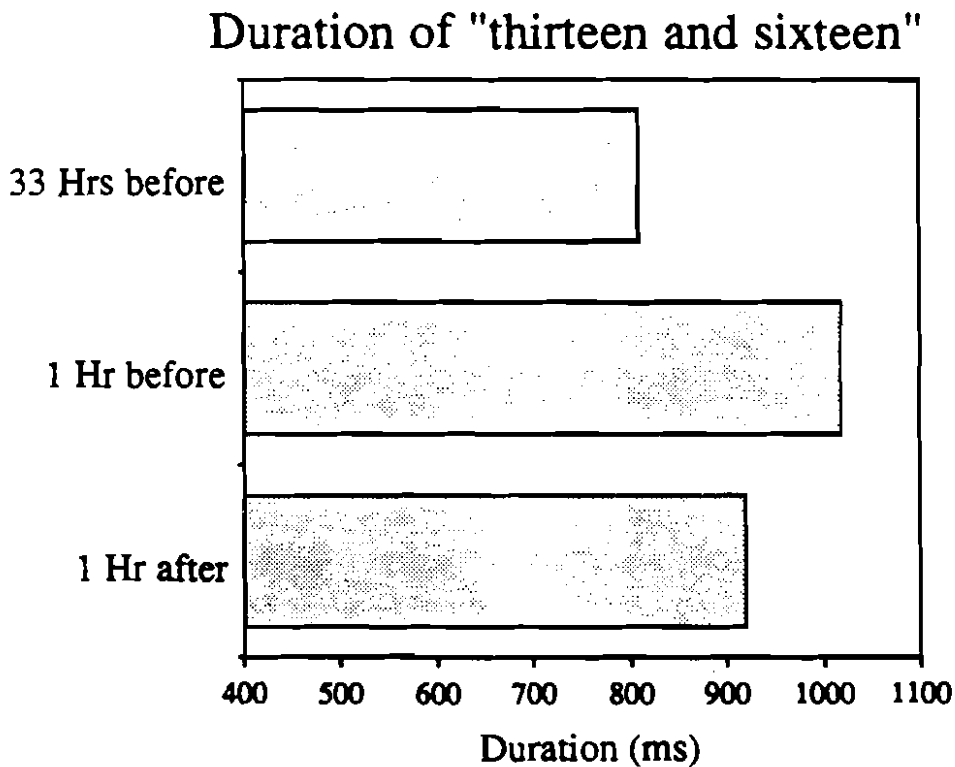
Figure 5. Top panel: Duration of the word *Valdez* from the NTSB tapes (data is the same as that in Figure 4) compared with the same word produced in a similar discourse position in the televised interview. Bottom panel: Duration of the phrase *thirteen and sixteen* from recordings made at three times around the time of the accident.

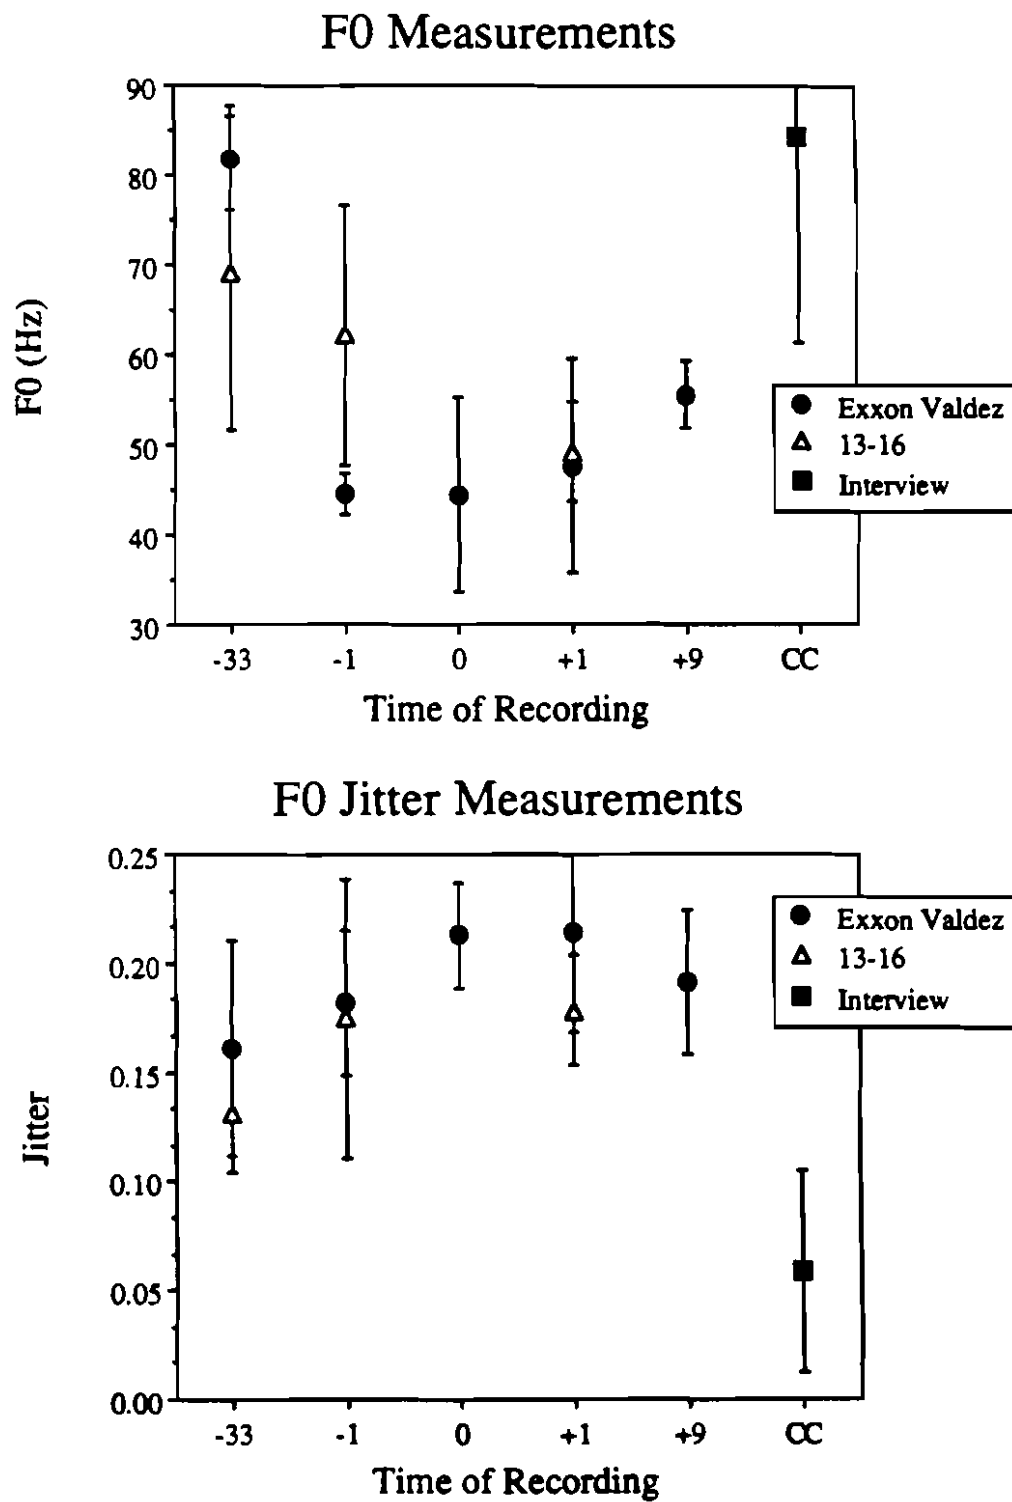
Figure 6. Top panel: Average fundamental frequency (pitch of voice) in *Exxon Valdez*: thirteen and sixteen and from one sentence in the televised interview as a function of time of recording. Bottom panel: F0 jitter measurements from the same speech samples.
