## Collaborating and Assisting in Turkey

### The 2011 Van Earthquake Sequence

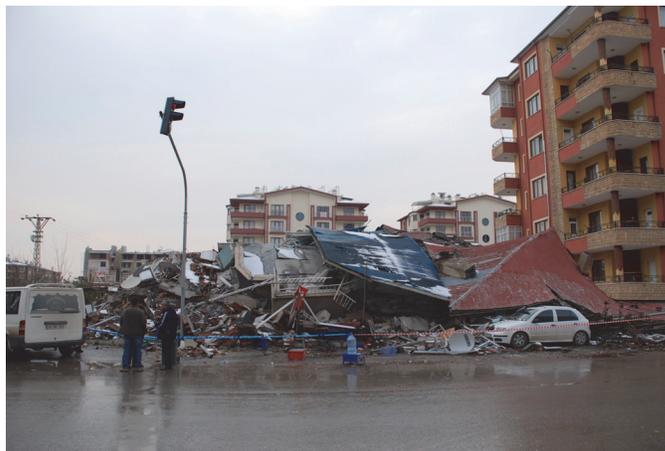
*Building collapse (38.49276N, 43.37539E) in Van, Turkey, caused by November 9, 2011, M5.6 earthquake. Structure was damaged by the October 23, 2011, M7.1 earthquake. Collapses caused by aftershocks created anxiety among the Van population and, combined with the wintry conditions, prompted a large migration of families from Van. Credit: T. Holzer, USGS.*
