**Landslides  
and  
Landslide  
Hazards in  
Washington  
State Due  
to February  
5-9, 1996  
Storm**

**U.S. Geological Survey Administrative Report**

# **Landslides and Landslide Hazards in Washington State Due to February 5-9, 1996 Storm**

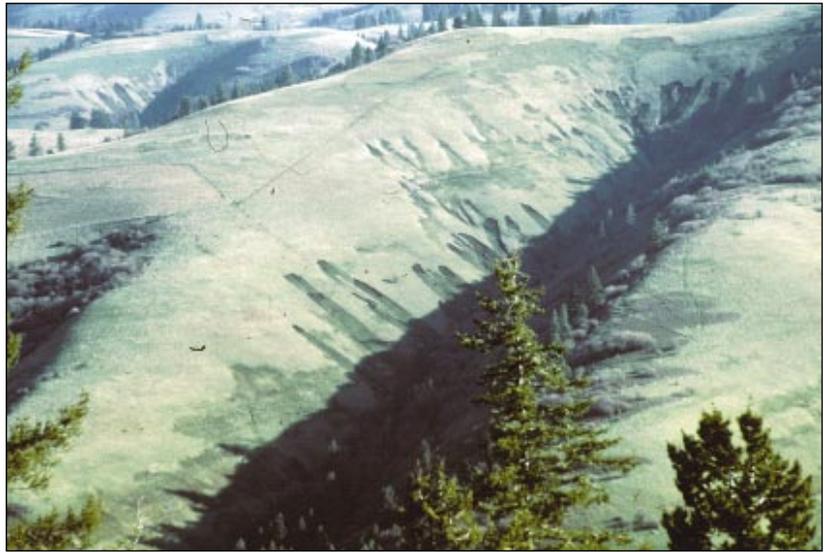
The main areas affected by the exceptional debris-flow occurrences were the Mill Creek, Blue Creek, Touchet, Tucannon, and Walla Walla drainages. Of these stream drainages, Mill Creek is the only one that has been extensively developed and populated. Some of the slopes adjacent to Mill Creek had such numerous debris flows that more than 100 individual failures could be counted within areas as small as 10 acres (Figure 1).

Figure 1. Grassy slopes in Blue Mountains of southeastern Washington showing extremely high concentrations of debris flows that occurred along the northwestern edges of this range.

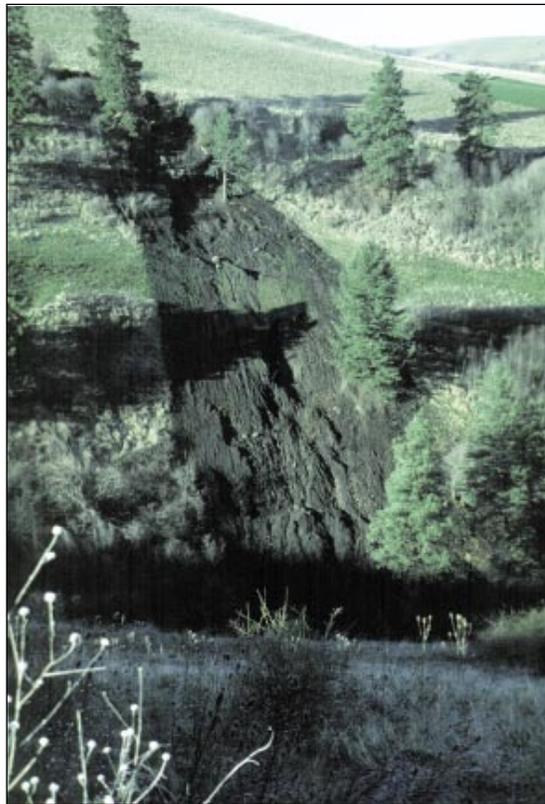
Figure 2. Large debris flow in Blue Creek drainage that, although shallow, has produced a large amount of debris. The road at the bottom of the gully was completely covered to a depth of about 4 ft.

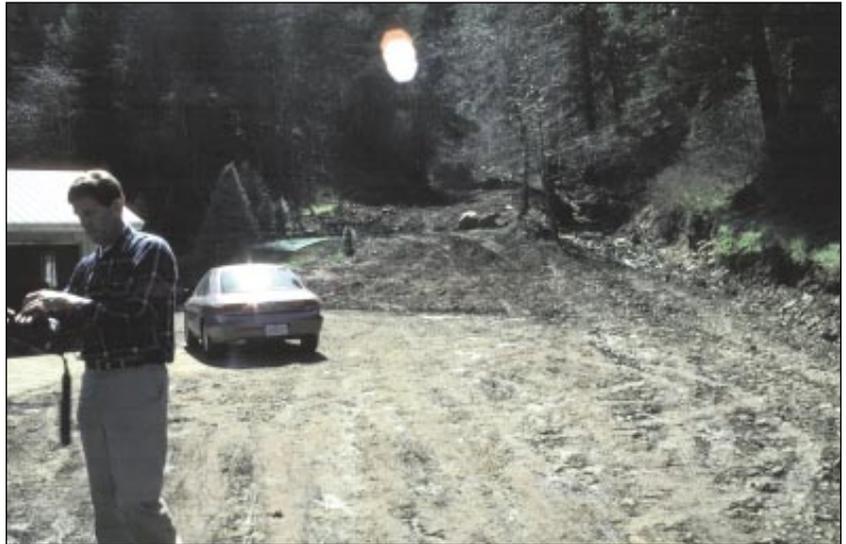
Considerable damage to houses and vehicles was done by debris flows in the Mill Creek area (Figure 3). Seven vehicles and five houses were damaged or destroyed by debris flows emanating from side canyons to Mill Creek itself (Figure 4). Debris flows ranged in size from shallow flows less than 50 ft in length to deeply incised flows along main side drainages exceeding 1 mi in length.

Figure 3. Residence in Mill Creek located near the mouth of a side canyon. Debris flows emanating from this side canyon hit the garage shown in left center of photo, damaged two cars, and partially covered a caterpillar tractor. Remnants of the debris flow deposit can be seen in photo center.

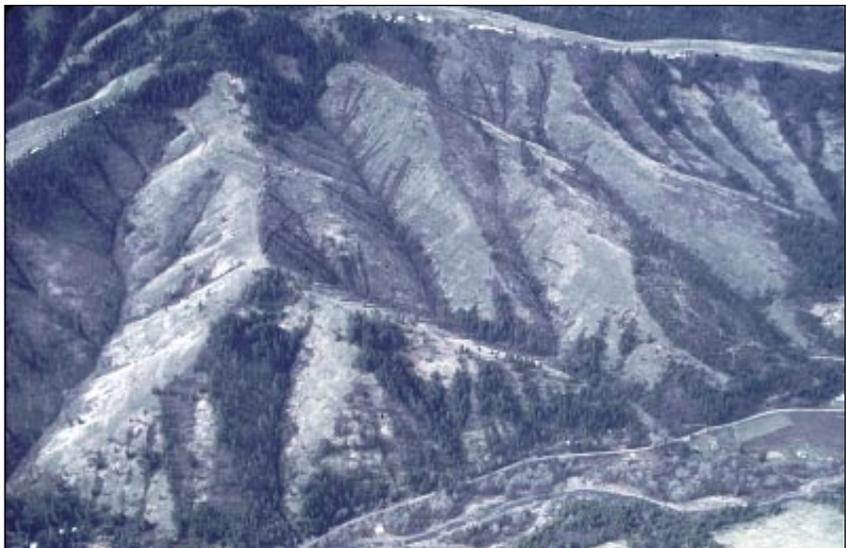
Figure 4. Aerial oblique view of Mill Creek showing debris flows in almost every tributary canyon. Debris flows extend the entire length of all of the tributary canyons to the intersection with Mill Creek.

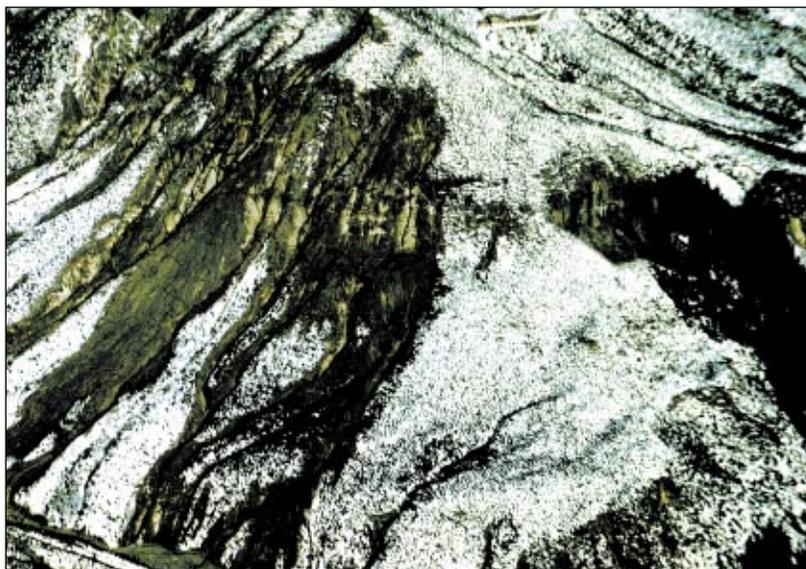
*Figure 5. Large debris flows in recent volcanic ash deposits southeast of Mount St. Helens.*

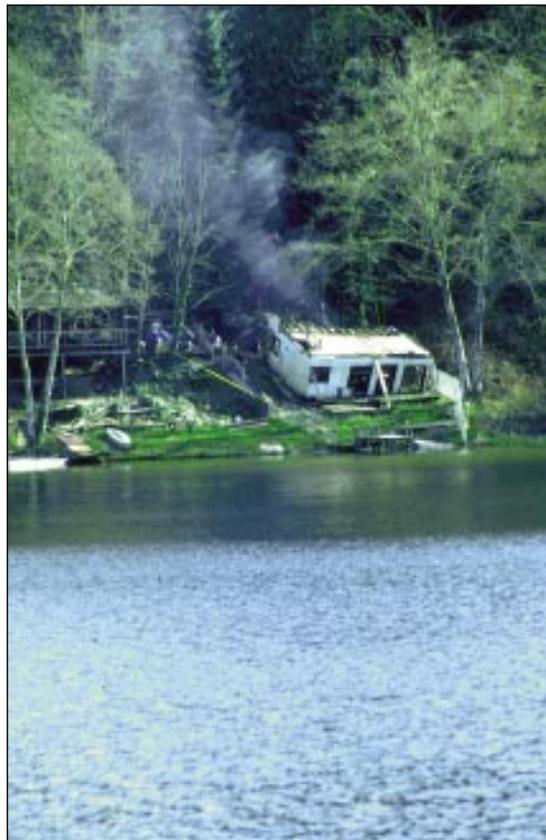
Figure 7. Cottage on east shore of Ohop Lake knocked off its footings by a small debris flow.

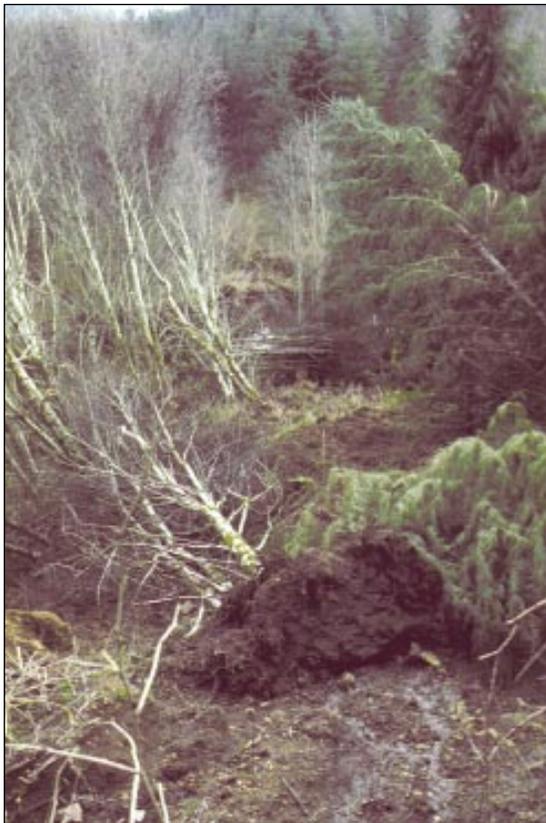
Figure 8. Headscarp area of deep-seated slump-earth slide west of Washington SH-4 near Skamokawa Creek.

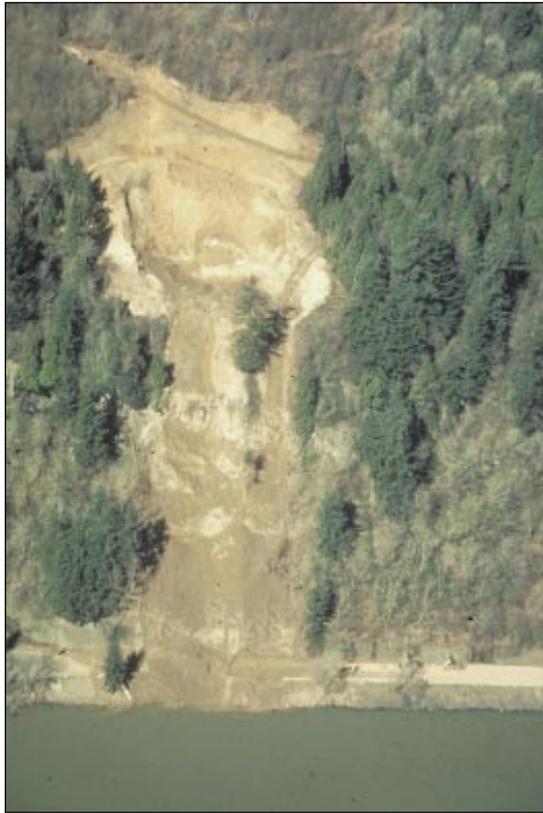
Numerous debris flows occurred in a narrow section, about 10 mi in length, of shoreline of the Columbia River just west of Stella along SH-4. The highway was closed during the February storms in many places by debris flows that occurred in marine deposits that overlie the basalt cliffs adjacent to the highway. These debris flows ranged from several thousand cubic yards to almost 100,000 yd<sup>3</sup>. The material from the debris flows cascaded over the basalt cliffs and buried the highway in several places. In most cases, the basalt cliffs were not involved in the failures except for a few pieces of loose basalt dislodged by the flow of the overlying material. The largest of these debris flows reached the Columbia River (Figure 9). By April 1996, all of the debris-flow material had been removed except for debris from the largest of these failures. At that time extensive excavation and slope reconstruction was still ongoing in the headscarp area (Figure 10) of this failure (#59, Plate 1).

*Figure 9. Large slump-debris flow located about 5 mi west of Stella, Washington on SH-4.*

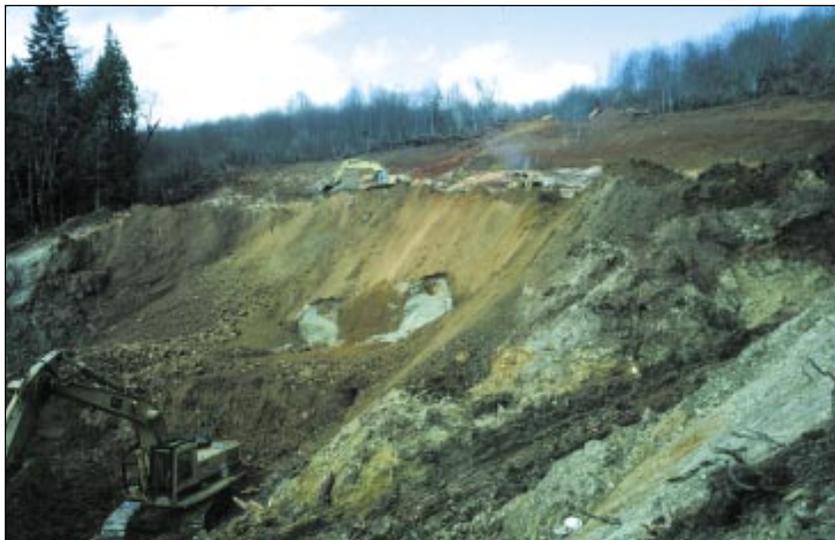
*Figure 10. Head-scarp area of slump-debris flow shown in figure 9.*

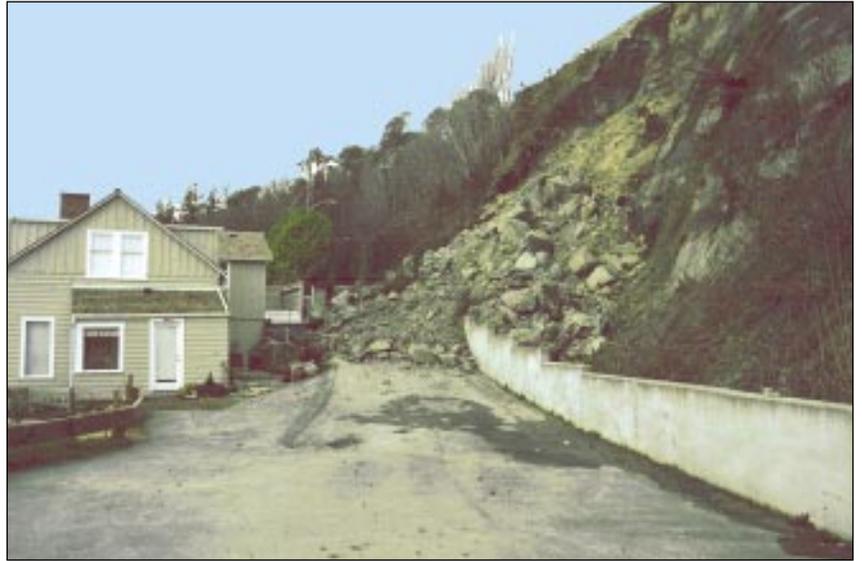
The rock fall took place along a well developed fracture that presently forms the headscarp of the larger rotational slump at the site. To the south of the recent failure, this fracture surface forms the cliff; all rock west of the fracture having been previously removed by past episodes of failure. To the north of the

*Figure 11. Rock fall next to a house on Perkins Way in northern Seattle. Rock fall is a secondary failure on a larger rotational slump whose failure surface projects beneath the house and Perkins Way.*

present scarp, the fracture disappears behind 3-5 ft of sandy conglomerate. Additional rock may peel away from the fracture surface in future storms. Drilling done by Shannon and Wilson consultants (T.E. Kirkeland, personal commun., 1996) indicates that the failure surface of the rotational slump continues underneath the house site. The rotational slump and rockfall did not occur during the February storms. Instead its movement lagged behind the February rainfall and occurred on March 9 (T.E. Kirkeland, personal commun., 1996).

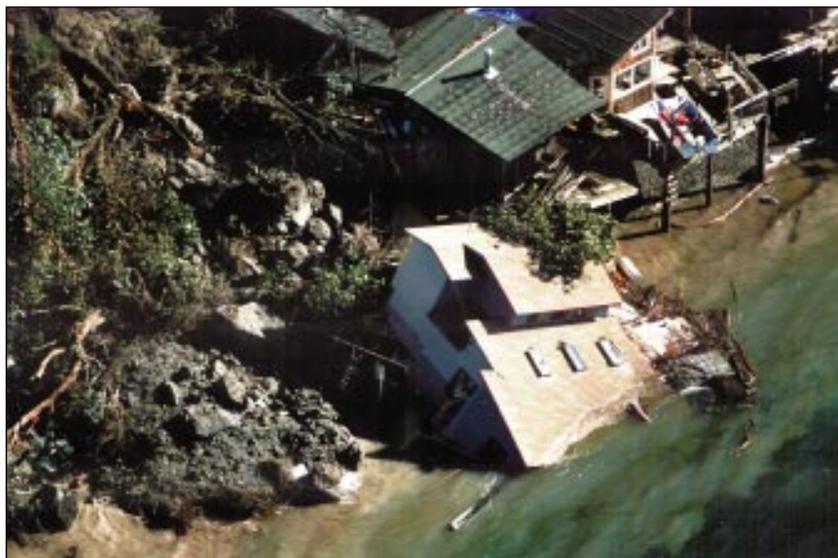
A number of landslides originating in unconsolidated glacial deposits that form the steep coastal bluffs on Puget Sound destroyed two homes in Salmon Beach and damaged another (#'s 4, 5, 6; Table 1). The failures were about 1,000-5,000 yd<sup>3</sup> each and started as translational slides, subsequently mobilizing into debris flows that slammed into the houses, pushing them out into the Sound (Figure 12). Utility lines coming into the area were also damaged by the debris flows.

Figure 12. Debris flow from steep coastal bluffs along Puget Sound in the community of Salmon Beach which destroyed a residence (Reprinted courtesy of the Seattle Post-Intelligencer).

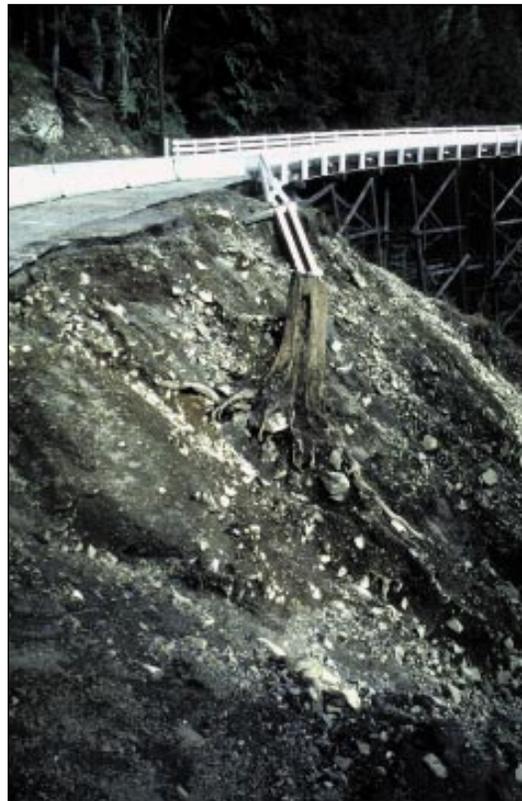
Numerous debris flows damaged SH-165 south of Carbonado. Volumes ranged from about 500 to 3,000 yd<sup>3</sup> and produced significant damage to SH-165 and to a bridge abutment across the Carbon River.

Figure 13. Debris flow undermining abutment of bridge across the Carbon River on Washington SH-165 south of Carbonado, Washington.

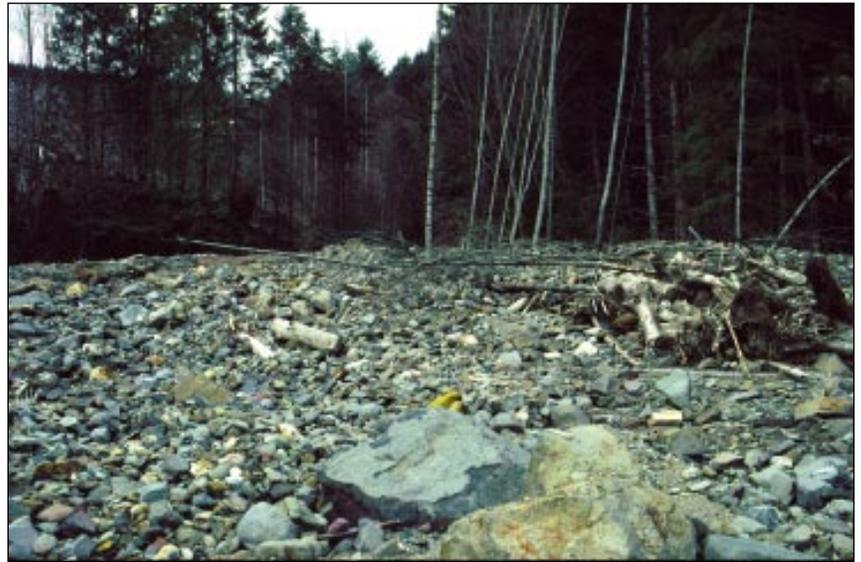
Figure 14. Lower portion of debris-flow path that closed Washington SH-410 east of Enumclaw. Debris flow originated in berm of logging road. Note preponderance of coarse material in debris.

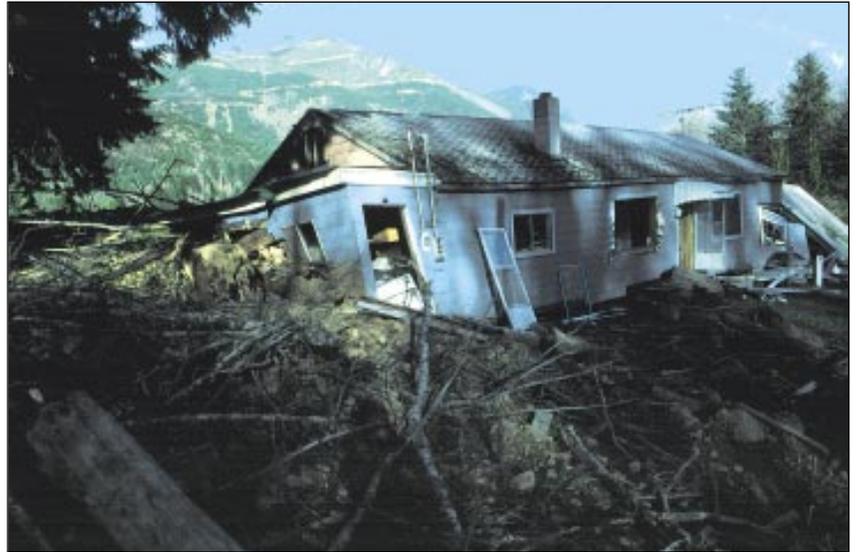
At approximately 3:00 a.m., Thursday, February 8 (Elmer Day, oral commun., 1996), a block slide of about 1.5 million  $\text{yd}^3$  was triggered from the shoulder of a partially clear-cut ridge in volcanoclastic sediments about 1 mi north of U.S. 12, 5 mi east of Glenoma and about 13 mi east of Morton (#77, Table 1). It appears that the slide moved southeast into a narrow V-shaped gully where it may have remained until overtopped by impounded water. Regardless of whether the slide mass mobilized immediately or sometime after initial failure into the gully, the slide mass eventually became extremely fluid as it traveled as a debris flow. It traveled southeast from this gully where it collided with a house and a garage (Figure 15 and 16) before stopping about 150 yd short of U.S. 12.

Although the house was occupied at the time it was hit by the debris flow, no fatalities resulted, because the slide mass had nearly traveled its full extent before hitting the house. The house was cracked beyond repair but was not overrun or crushed by the debris. Elmer Day, who owns the house and lives in a trailer beyond the slide margins, stated that he heard and felt the debris-flow movement and could see the movement of trees as the debris flow spread out across the relatively flat field next to the dwellings.

*Figure 15. House crumpled by block slide-debris flow shown in figure 16 near U.S.-12 east of Glenoma, Washington.*

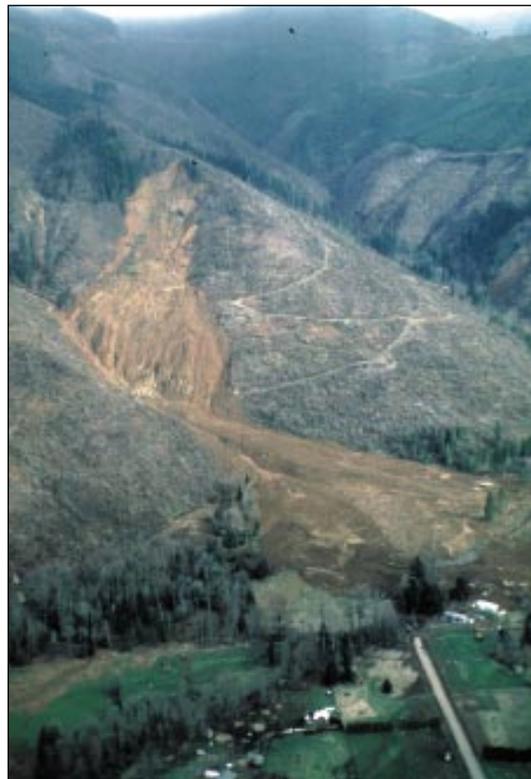
The slide headscarp, shown in figure 16 is approximately 150 ft high, with a nearly vertical headwall and a nearly  $90^\circ$  intersection of this wall with the exposed basal shear surface. The shape of the scarp suggests that the landslide's initial movement was mainly translational as a relatively coherent mass. After reaching the narrow gully, its direction of movement changed by almost  $90^\circ$  from southwest to southeast. In the first few days after the landslide, numerous small pieces of the cliff forming the headscarp

*Figure 16. Block slide-debris flow that destroyed house shown in figure 15. House is at bottom right of photo. Near-vertical cliff in headscarp is about 150 ft high.*

fell leaving a fairly planar scarp with few remaining fractures above the present headscarp (Elmer Day, landowner, oral commun.).

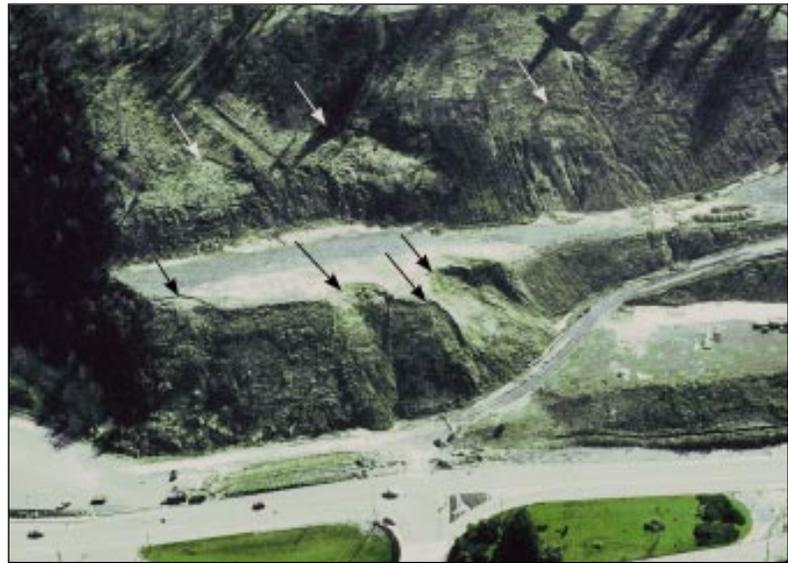
Immediately east of the I-5 exit for north Chehalis is a hillside that has been cleared of trees and prepared for residential development. The devegetation and road emplacement for the development destabilized a large area of the hillside and subsequently produced several slow-moving slump-earthflow type landslides that have been active in past years (#53, Table 1). The February storms reactivated movement on these earthflows as well as triggering several debris flows from the same area (Figure 17).

*Figure 17. Numerous slumps (arrows) near Chehalis, Washington, reactivated by February storm.*

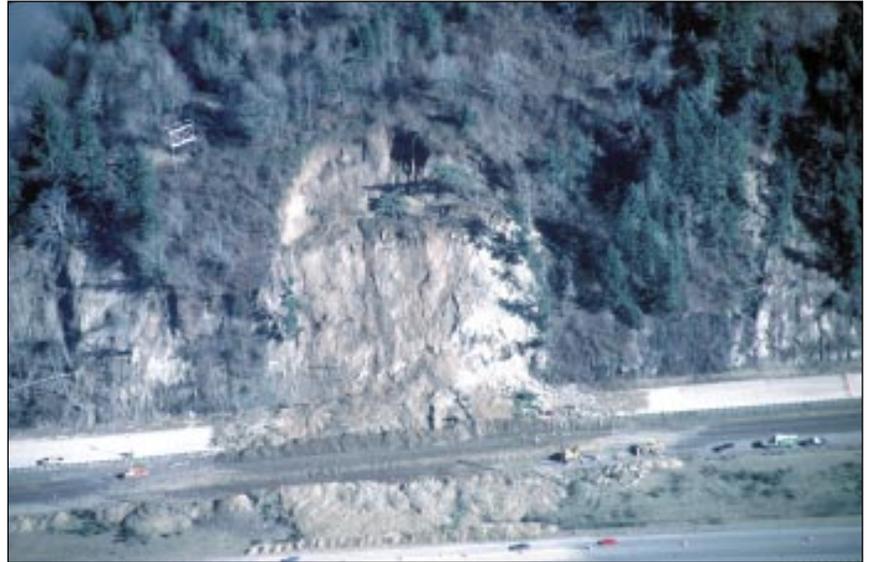
ure of the 32,000 yd<sup>3</sup> landslide that blocked I-5 and the Burlington Northern-Santa Fe railroad tracks 3 mi north of Woodland (#80, Table 1). The initial landslide of about 12,000 yd<sup>3</sup> occurred shortly after 2:00 p.m., February 8. Its initial movement blocked only the northbound lanes of the interstate. By Friday, February 9, Washington Department of Transportation was planning to open the northbound lanes at 6:30 p.m., when, shortly after 6:00 p.m., a larger landslide mass of 20,000 yd<sup>3</sup> failed from the same source area and covered all lanes of I-5 as well as the rail lines adjacent to I-5 (Figure 18).

*Figure 18. Slump north of Woodland, Washington that covered I-5 and the Burlington Northern-Santa Fe rail line.*

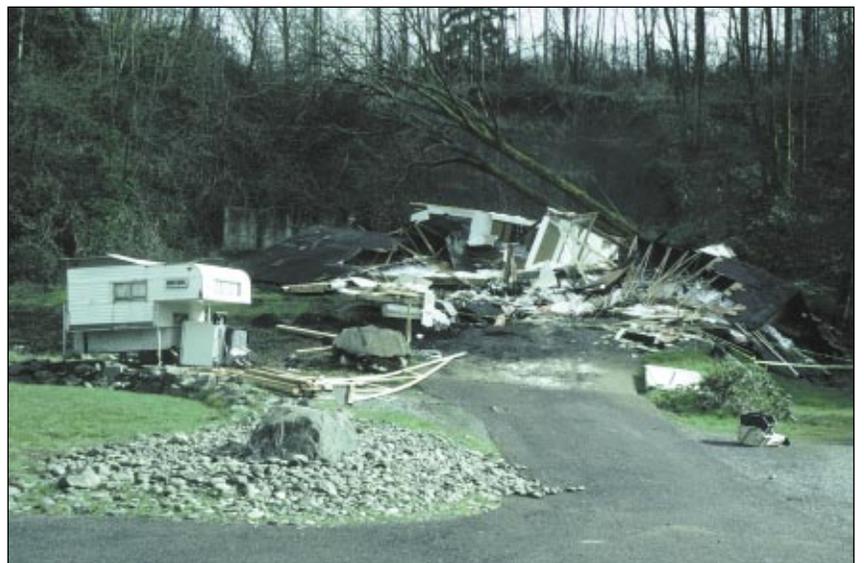
*Figure 19. Small slump in northwest Vancouver that destroyed a residence located next to a steep slope bordering an old river terrace.*

In the Hazel Dell area of north Vancouver at 11612 N. E. Ninth Ct., a house was broken in two when a debris flow of about 1,000 yd<sup>3</sup> carrying two large trees failed from a 30-foot-bluff just behind the home (Figure 19; #43, Table 1). The bluff is at the edge of an old river terrace. Most of the homes in this area are built on the terrace next to and below the low bluff that

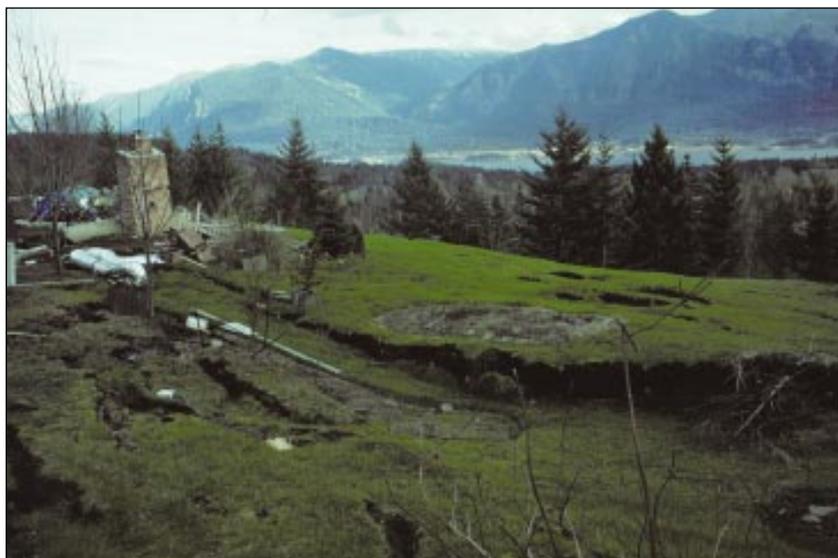
In the northern part of Stevenson, west of the junction of Loop Road and Maple Hill Road, a large complex rotational slump-earthflow was reactivated in the February storms (#81, Table 1). Most of the area here is comprised of old landslide deposits with many visible old scarps and hummocky topography. Below Maple Hill Road, a zone of prominent scarps developed following the February 1996 storm with cumulative downslope displacements of 4 ft or more (Figure 20). Three houses in this area had to be removed

Figure 20. Headscarp area of deep-seated, complex rotational slump-earthflow in subdivision in Stevenson, Washington. Landslide has resulted in removal of three houses and has threatened six or seven additional residences.

The fractures shown in figures 20 and 21 constitute the headscarp area of the landslide. Below this, the topography steepens due to the presence of what appears to be an old landslide scarp that produced many coalescing debris flows from its face during the February rainfall. These debris flows covered a section of Loop Road just below this old scarp and flowed across the road, plugged a culvert in the road, and filled a small basin above the road culvert.

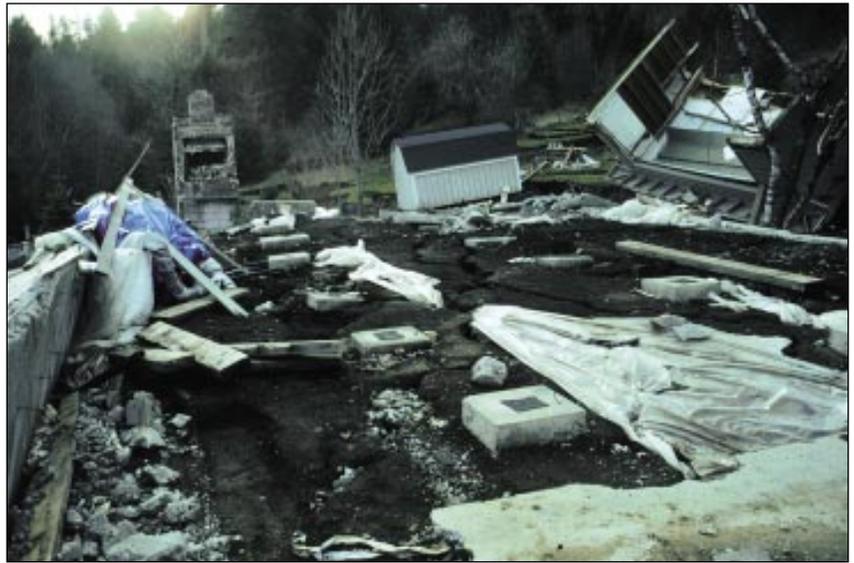
from their foundations. The foundation shown in figure 21 illustrates the damage done to houses by deformation across this zone of fractures.

Figure 21. Effects of headscarp fractures on foundation of residence on Stevenson landslide.

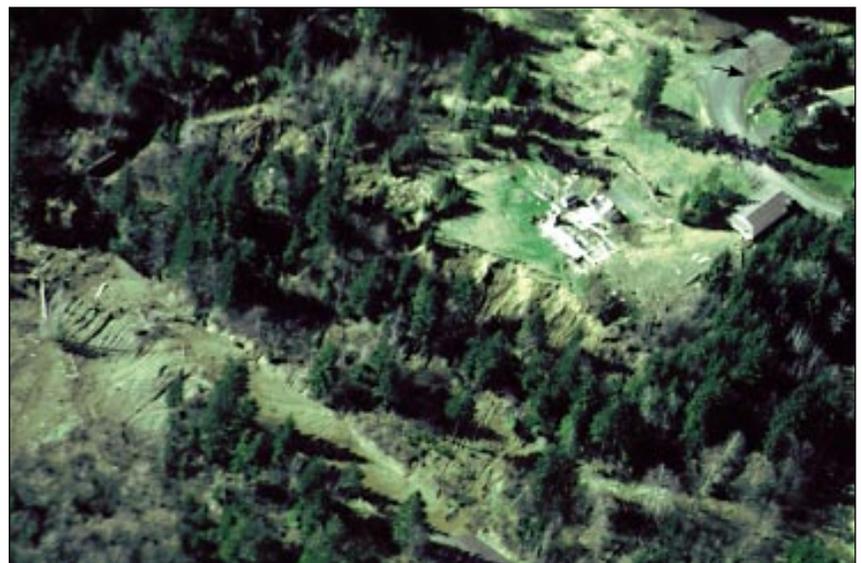
Above the headscarp shown in figures 20 and 21, are other tension fractures formed by the retrogression of deformation upslope (Figure 22). These mark the spreading of displacement of the slope beyond the initial landslide boundaries. Using a crude estimate of the average landslide depth of about 50 ft, the landslide volume totals about 500,000-1,000,000 yd<sup>3</sup>. According to residents of the area, movement continues (as of May 1996), and it is unclear how great the final extent of the landslide mass will eventually be and

Figure 22. Aerial oblique view of Stevenson landslide. At center right is foundation shown in figure 21. Arrows denote additional extension fractures upslope from fractures shown in figures 20 and 21.

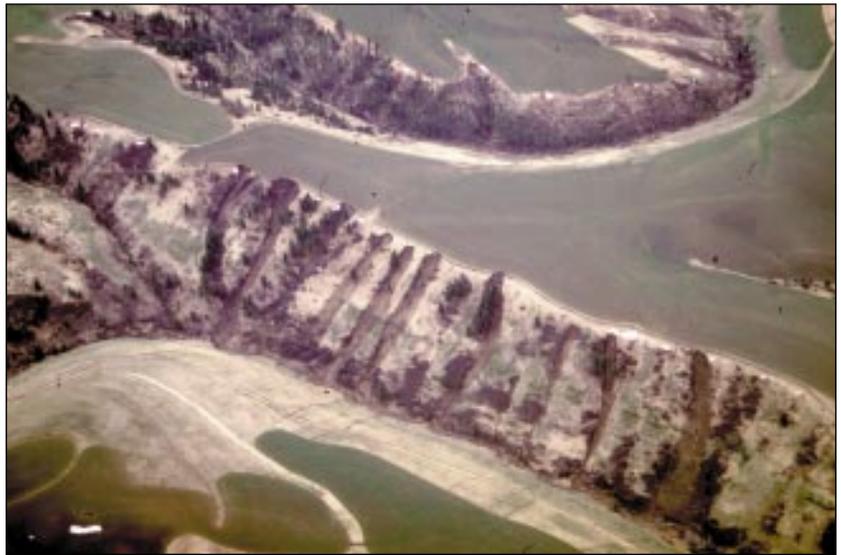
Figure 23. High concentration of debris flows in glacial-loess deposits on northwestern flank of Blue Mountains.
