Nine-Fatality Apartment House Fire Ludington, Michigan

Nine-Fatality Apartment House Fire Ludington, Michigan (February 28, 1993)

This is Report 072 of the Major Fires Investigation Project conducted by TriData Corporation under contract EMW-90-C-3338 to the United States Fire Administration, Federal Emergency Management Agency.

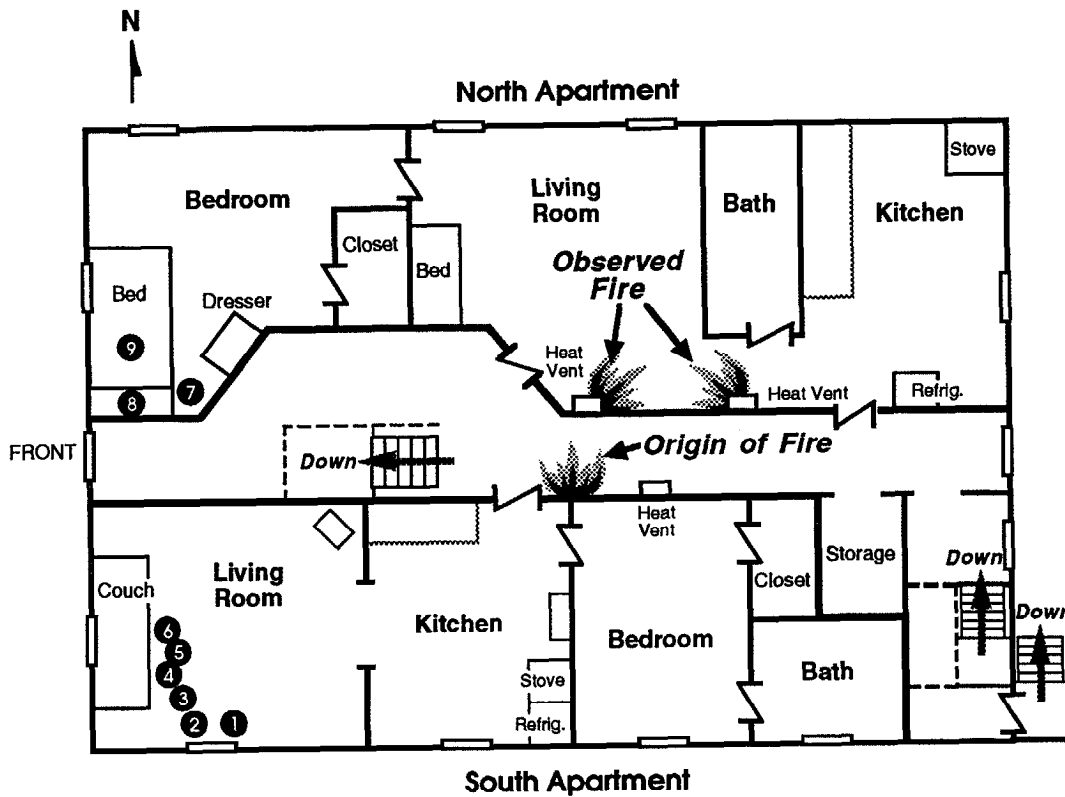
SECOND FLOOR PLAN

Fire damage revealed that the fire originated in the corridor at or below the ceiling level in the vicinity of a light fixture on the south wall. Fire progressed rapidly because of the highly combustible wood paneling and wood fiber ceiling tiles. It was aided by an additional supply of oxygen as a result of the occupant leaving both his apartment door and the front door open when exiting the building. It was allowed to penetrate the north and south apartments at an early stage, burning through wooden doors and through air-transfer grills that were installed in the corridor walls that separated the living units.

FATALITIES	
①	3-year-old girl
②	2-year-old boy
③	3-year-old boy
④	1-year-old boy
⑤	6-year-old boy
⑥	13-year-old girl (babysitter)
⑦	1-year-old
⑧	18-year-old woman
⑨	2-year-old boy

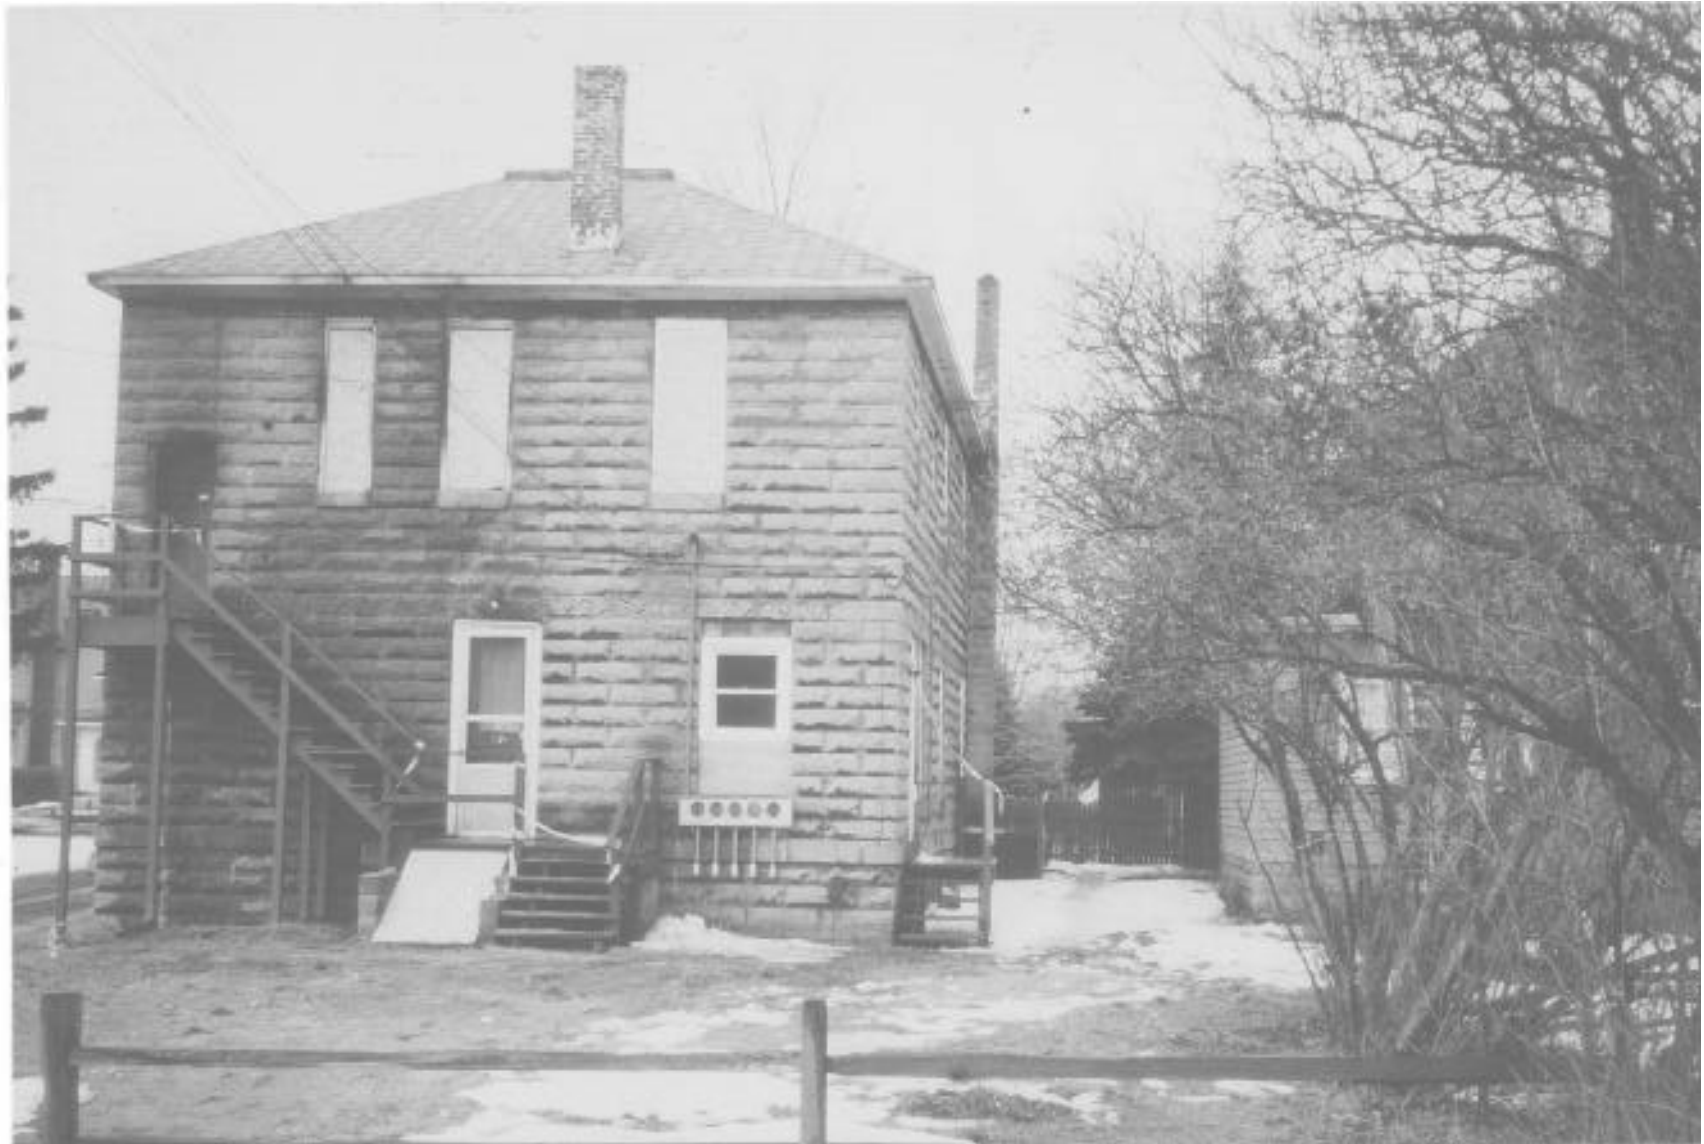
Separate entrance to first floor rear apartment and wooden fire escape to second floor.

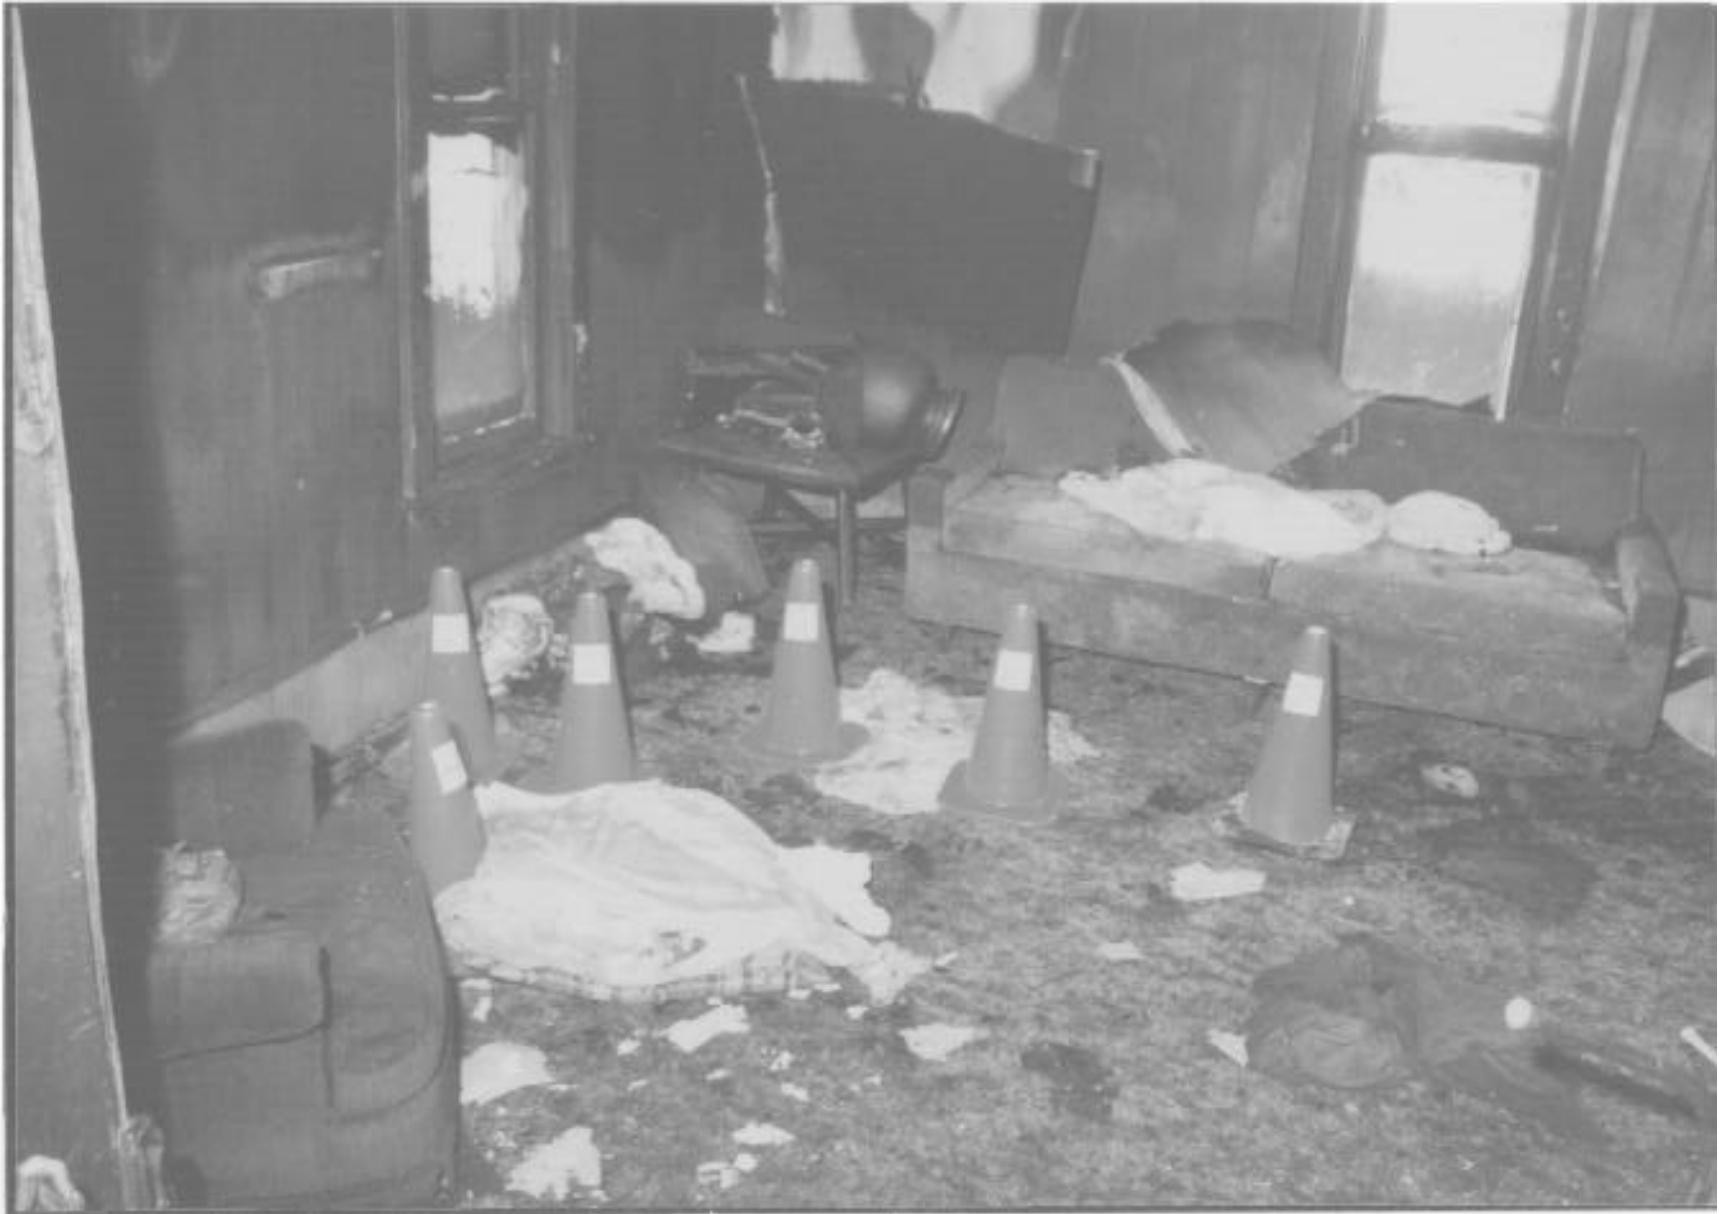
The positions of the victims located in the south apartment indicate, with one exception, that all were asleep on the living room floor and never woke up. Some were still clutching stuffed animals or other objects children normally sleep with.

Area on second floor south apartment living room where six fatalities were found. Notice little or no actual fire damage.

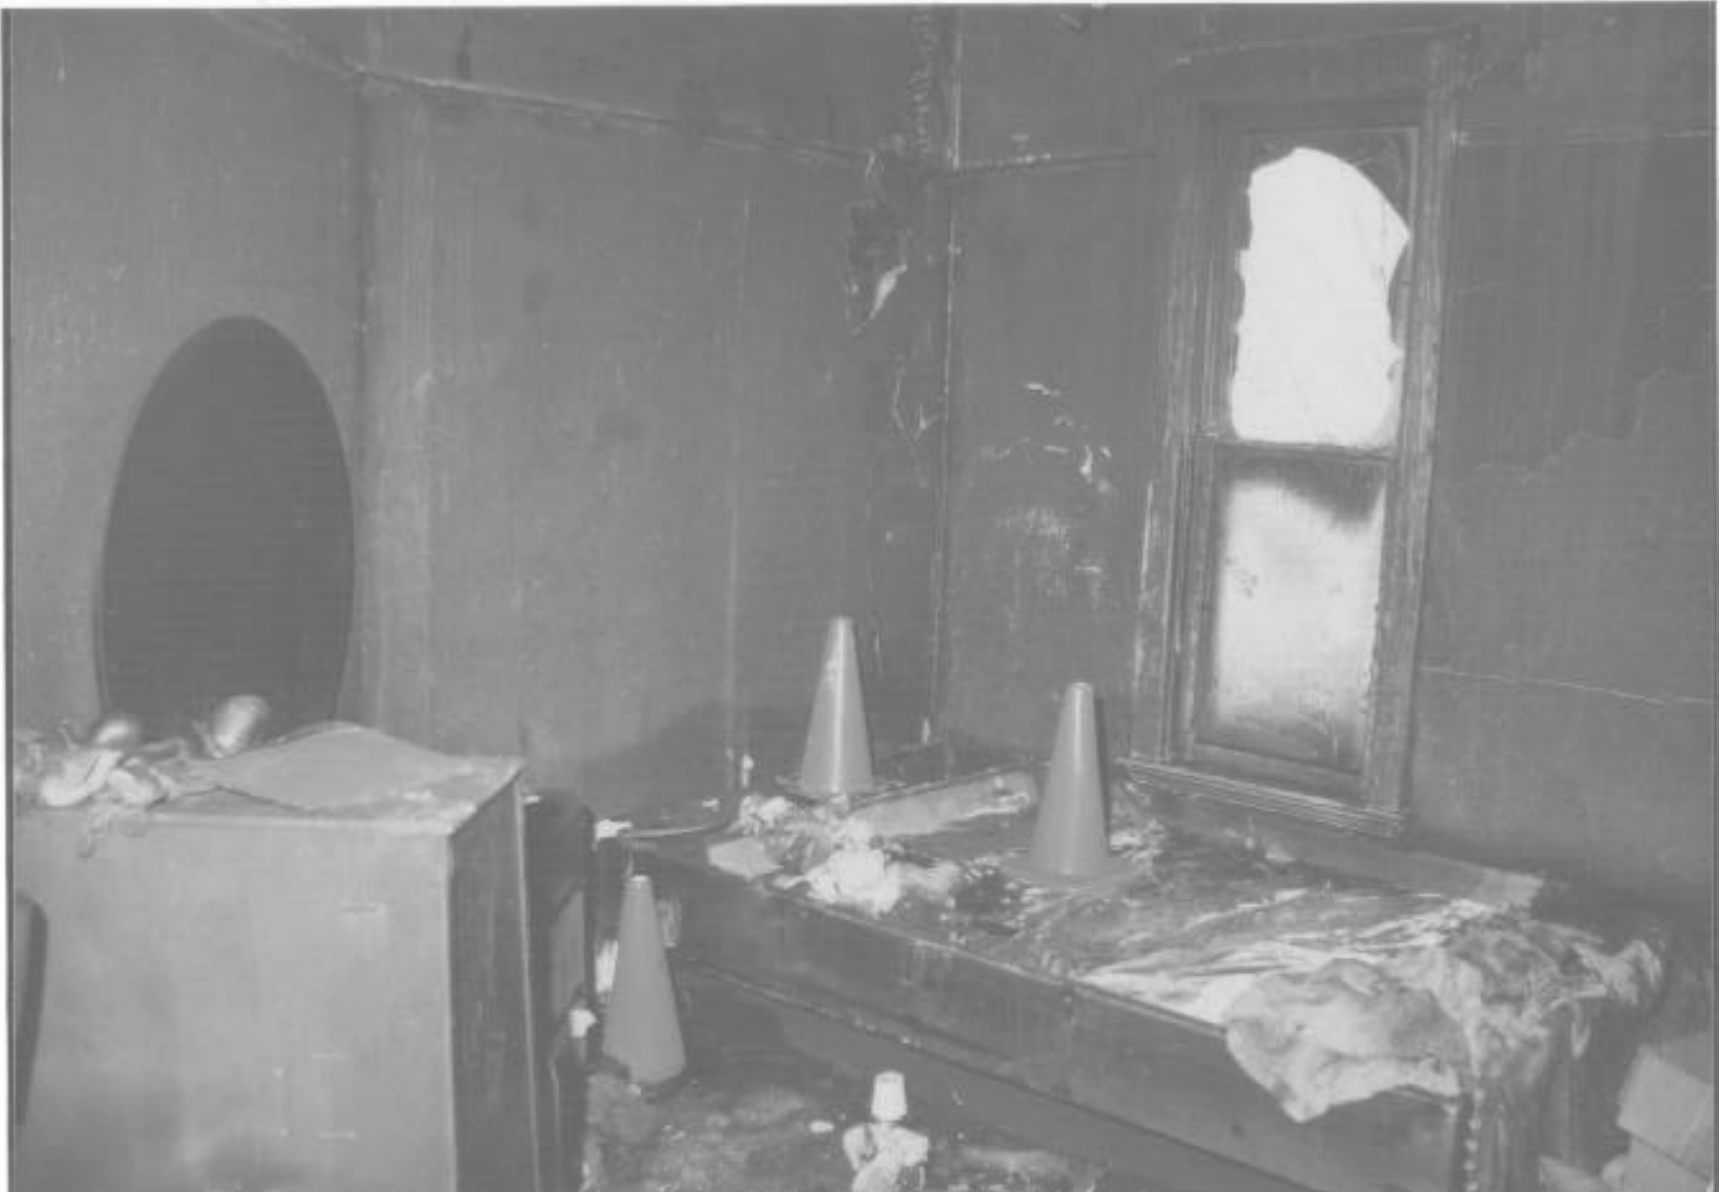
Bed in living room of second floor north apartment; area where three fatalities were discovered. Notice heat and smoke damage only.

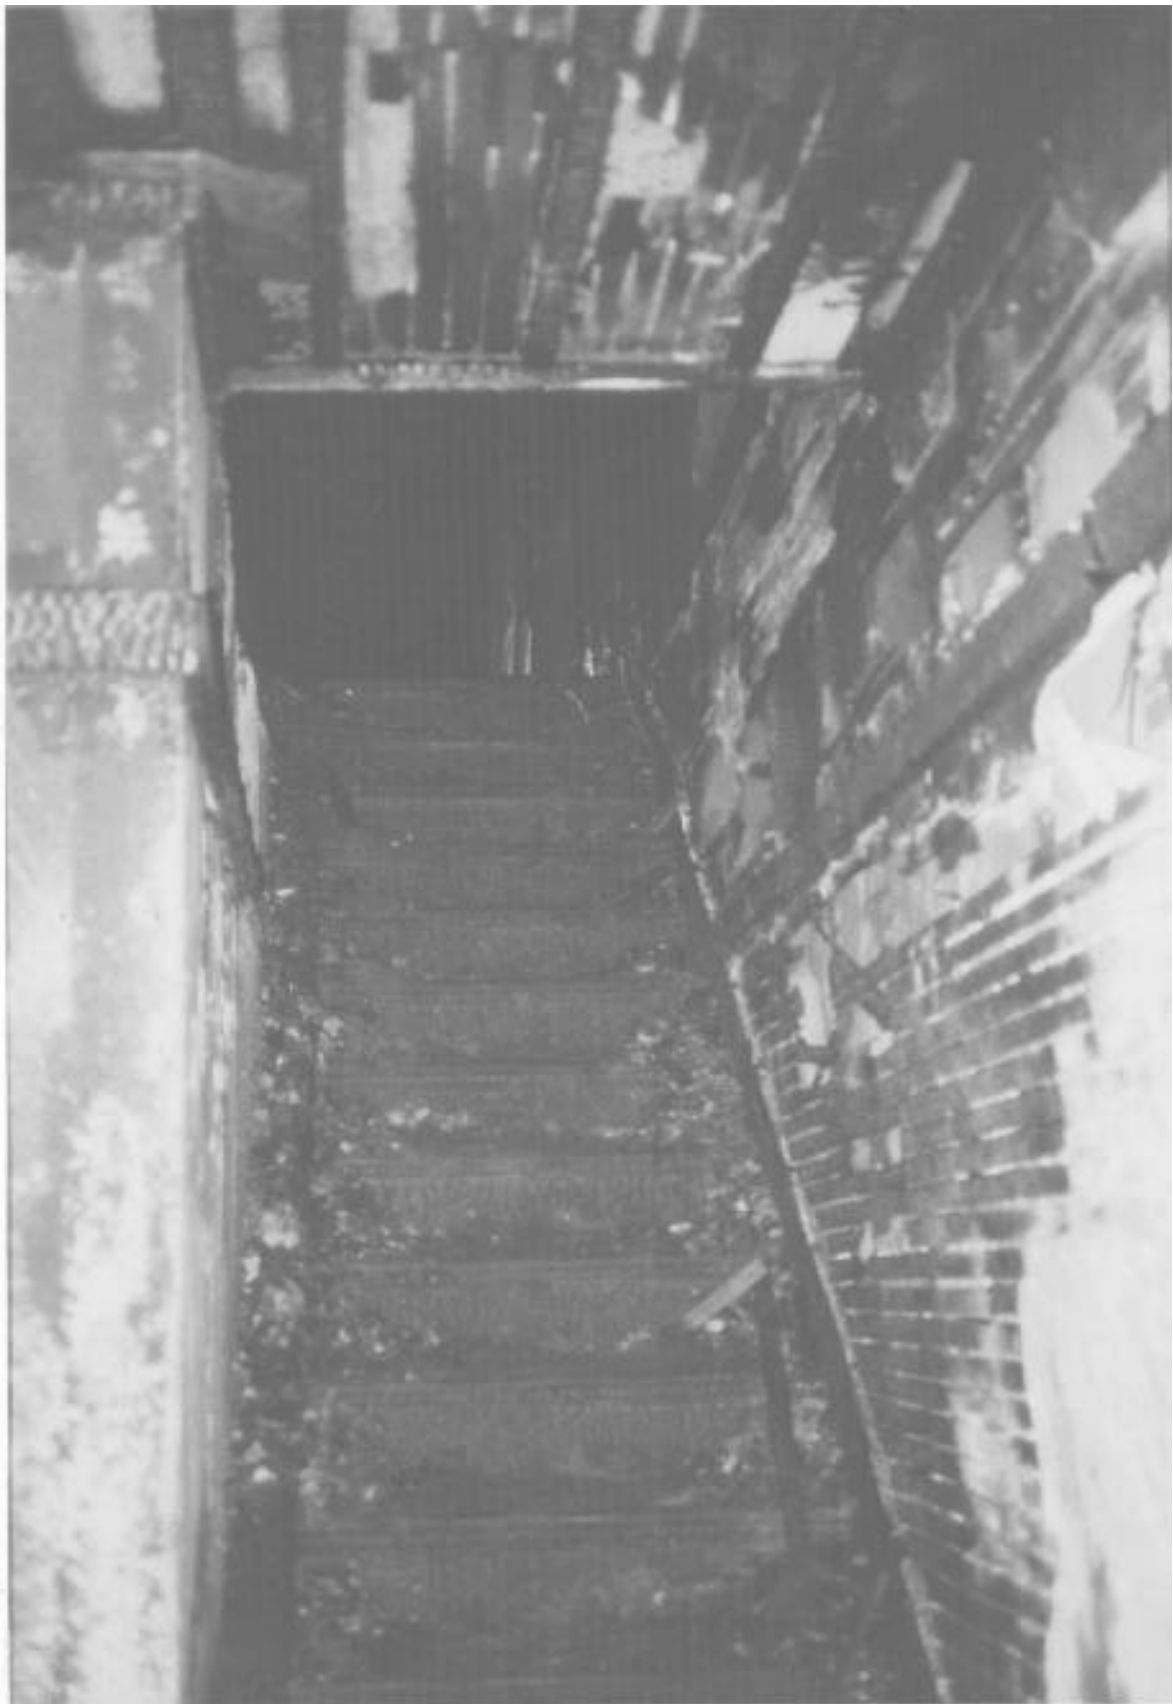
Stairway from first to second floor showing burn damage to staircase, wall, and ceiling.

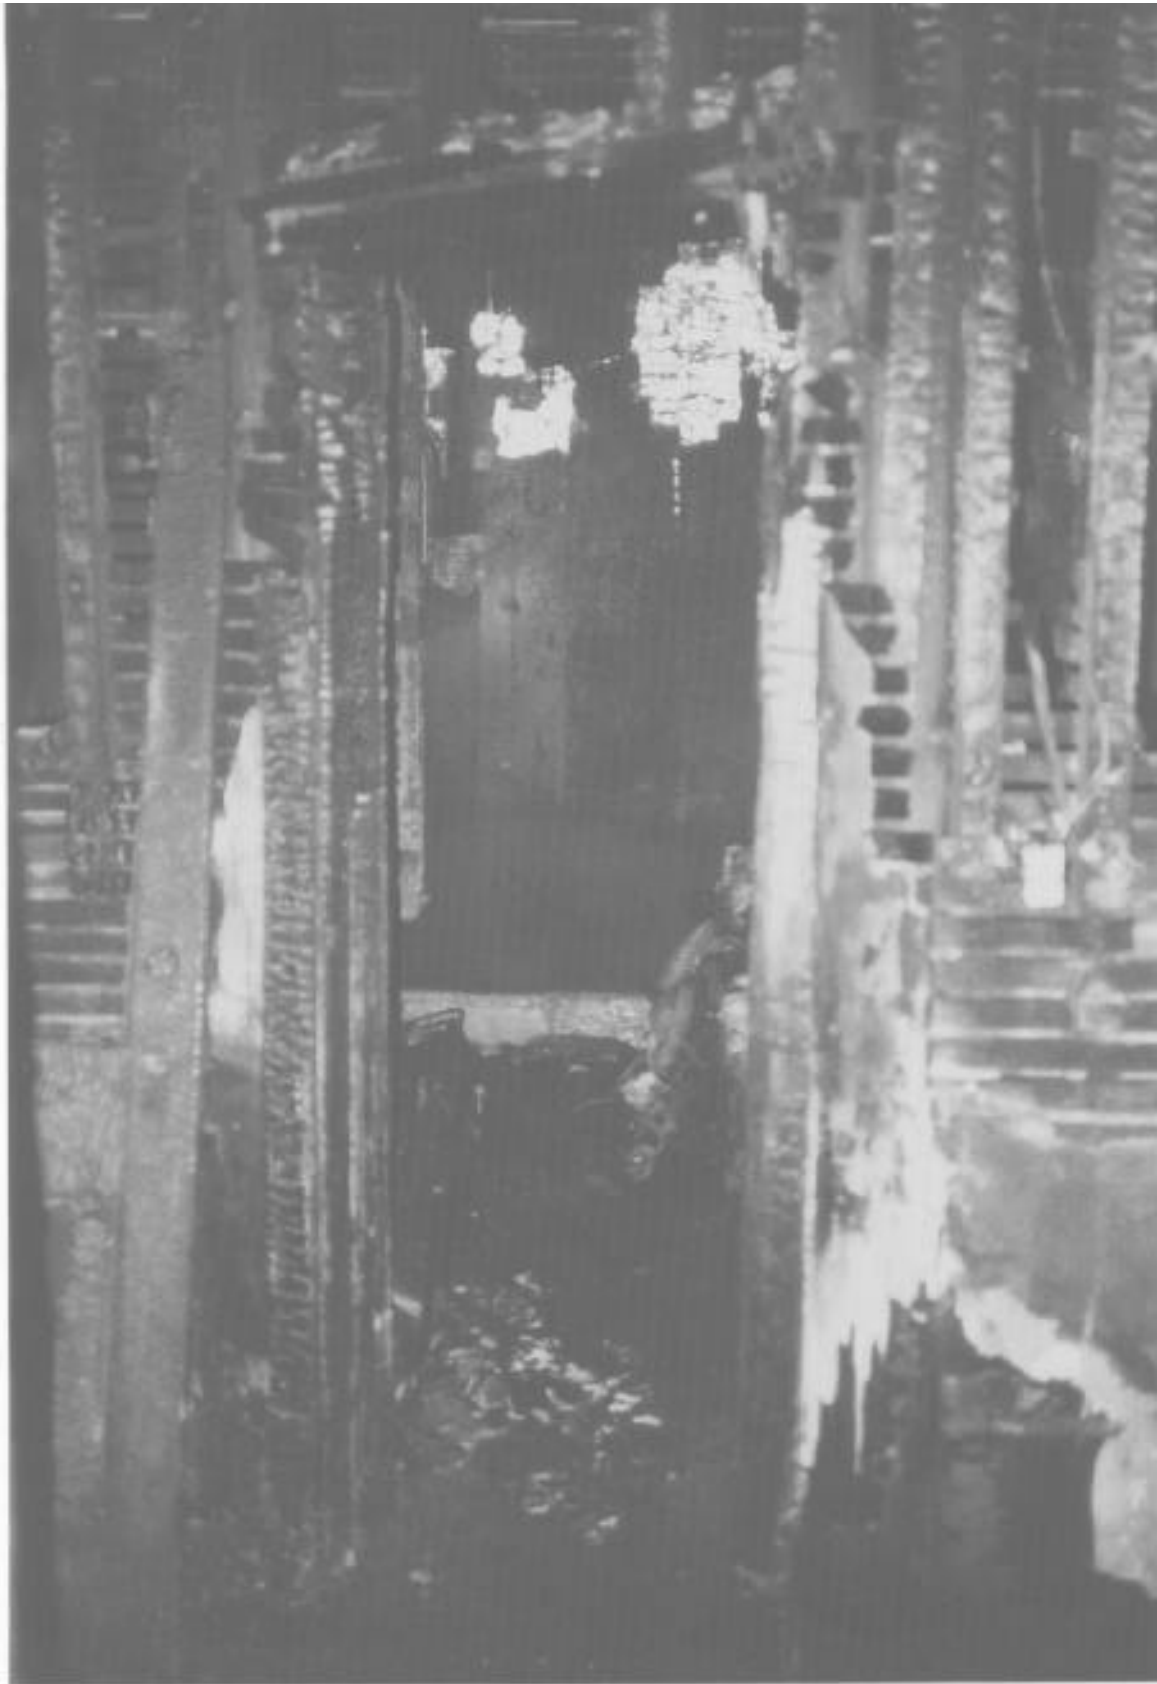
Fire damage to entrance doorway and walls of the second floor north apartment living room. Notice height of burn patterns and suspected area of origin.

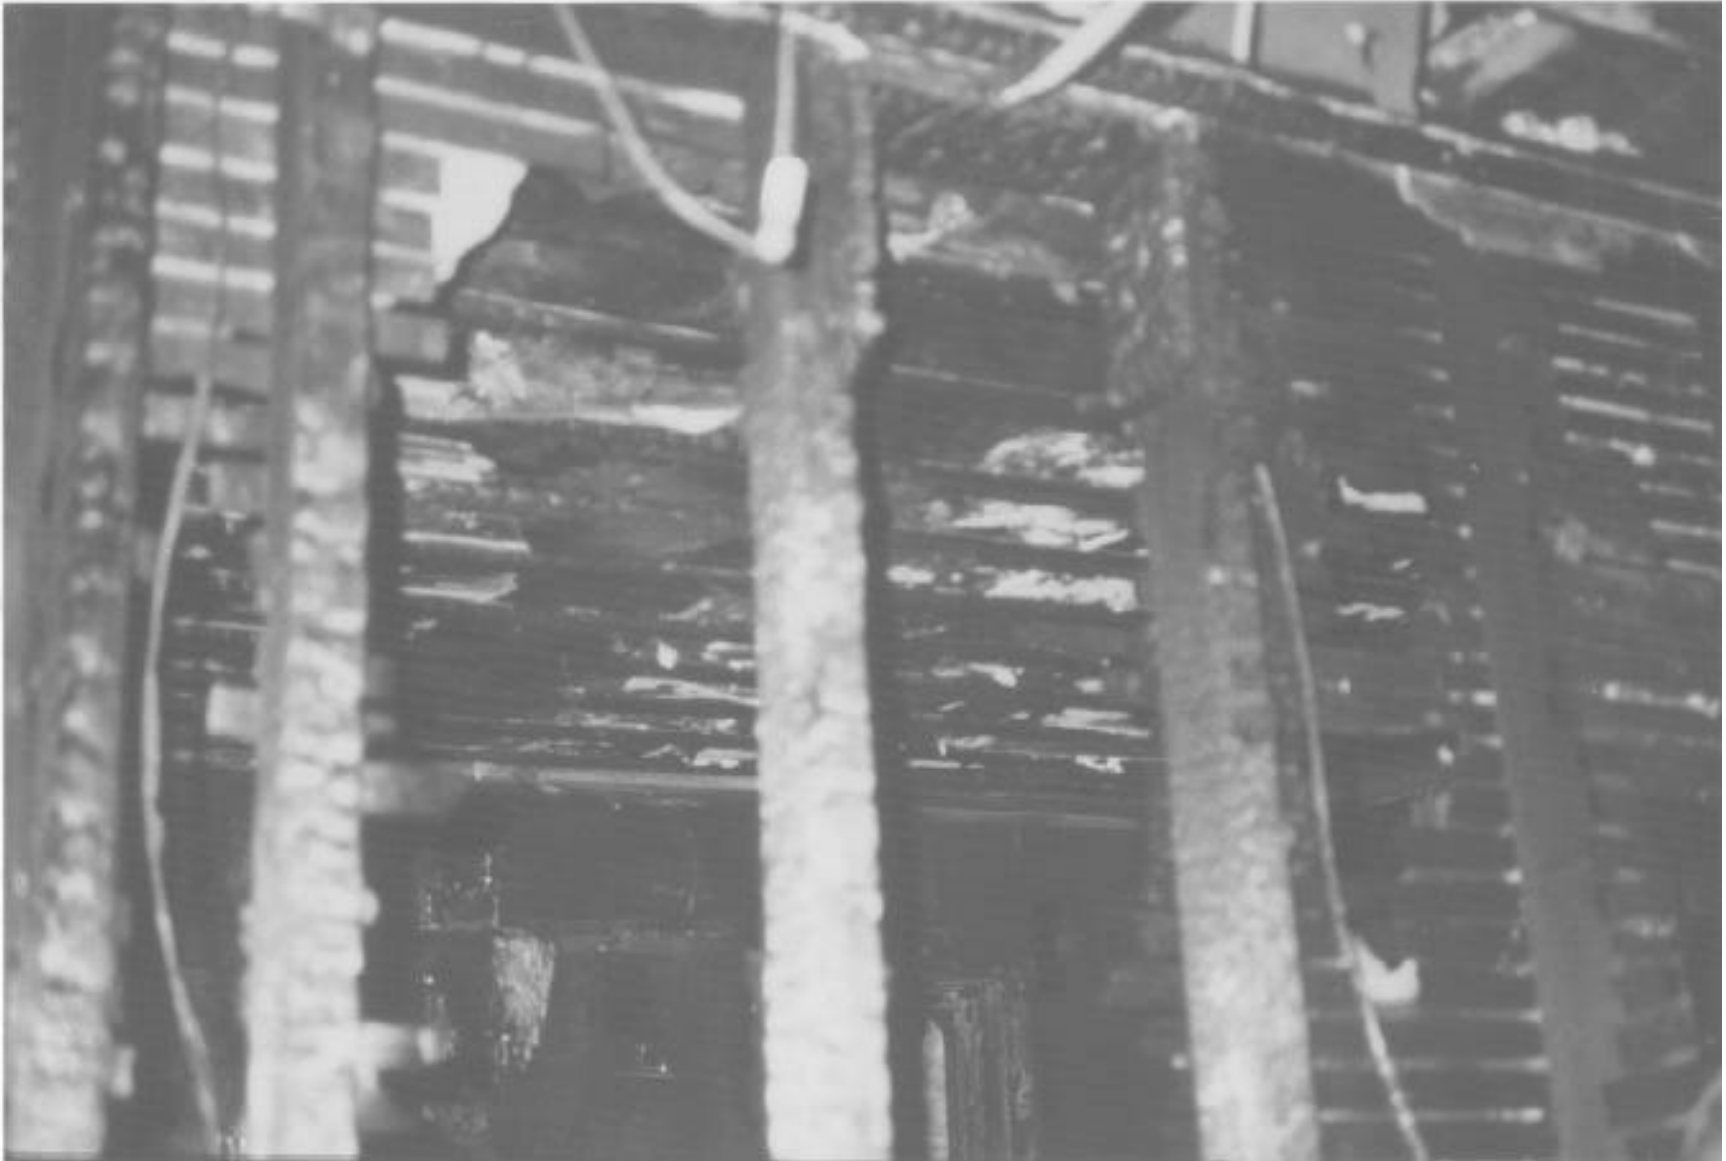
Fire traveled through air vent from suspected area of origin into second floor north apartment living room. Again, notice high burn pattern.

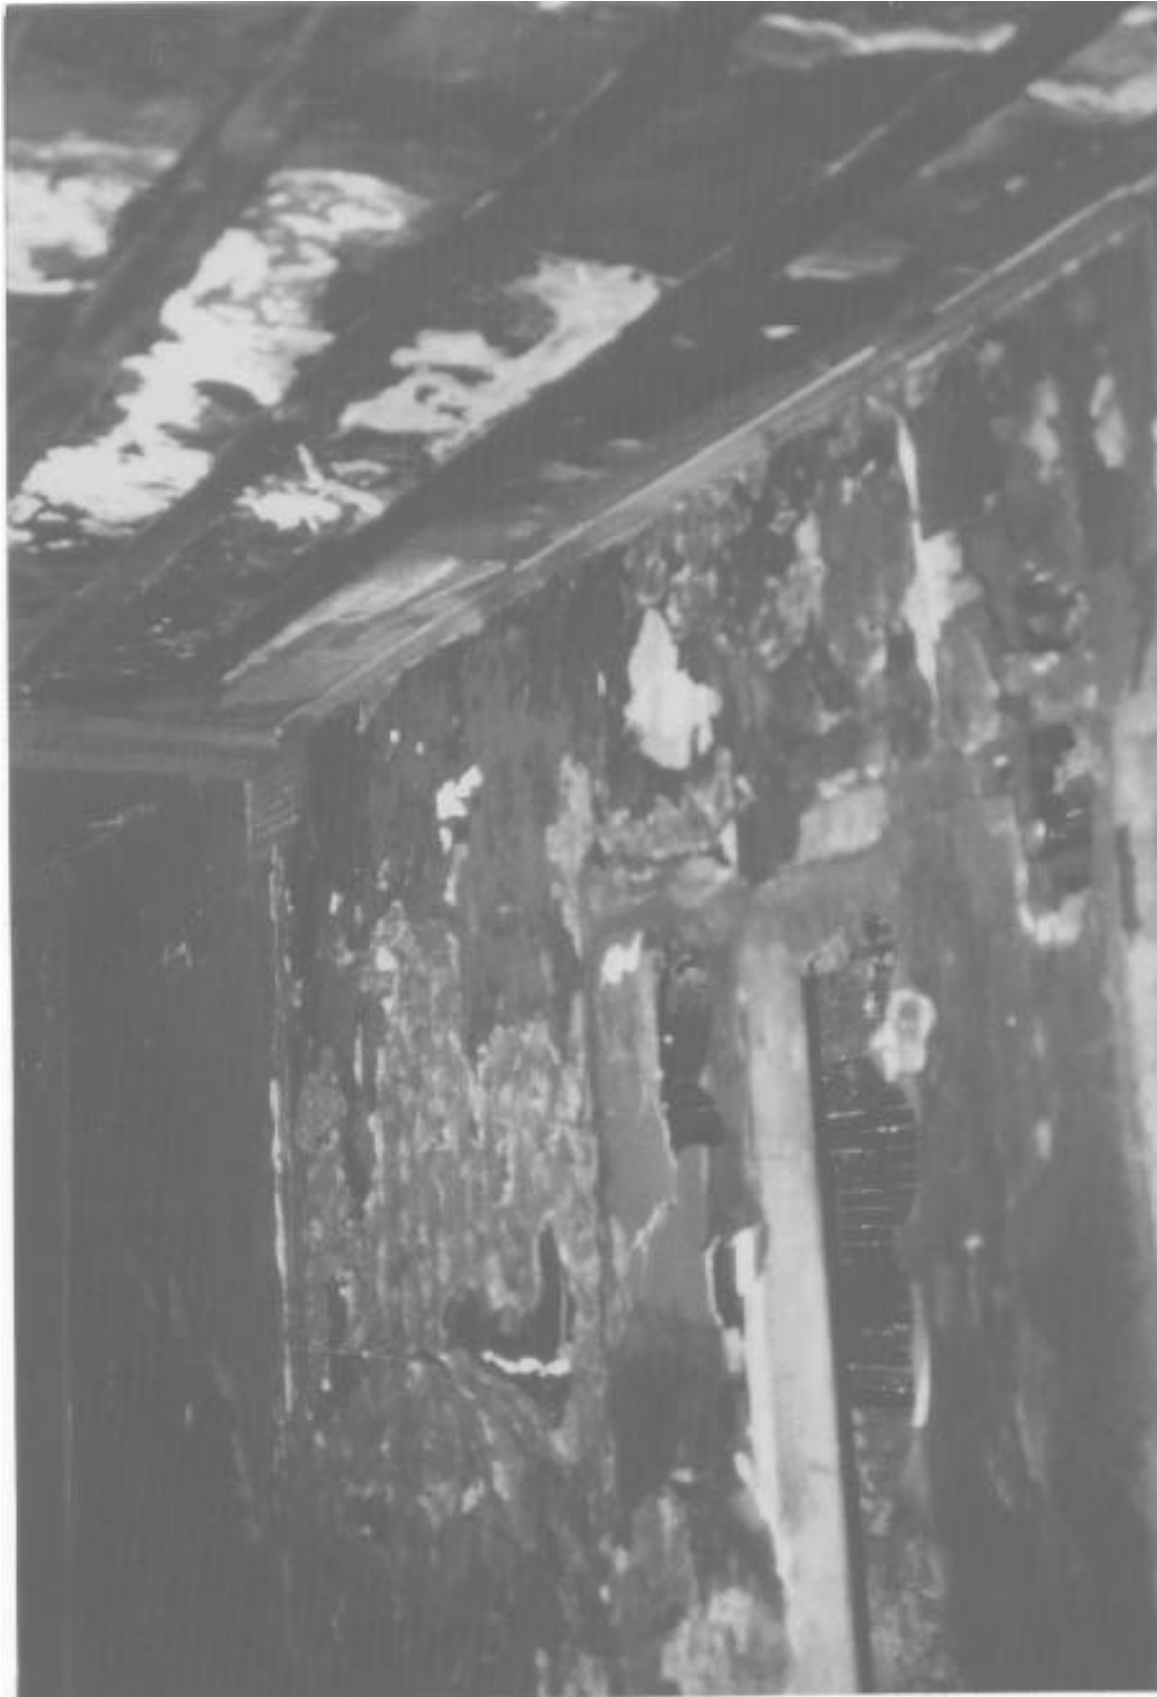
Fire was primarily confined to the 1st floor entrance foyer, the stairway, and the 2nd floor corridor and apartments. There was heavy fire damage to the corridor ceiling joists in the attic area above the suspected area of origin and to the two apartments on the 2nd floor where fire gained entry through doors and above the ceiling where fire penetrated the attic area.

Fire damage to second floor corridor walls and ceiling.
Notice fire penetration through wall into north apartment.
