St. George Hotel Complex 16 Alarm Fire

Brooklyn, New York

This is Report 108 of the Major Fires Investigation Project conducted by Varley-Campbell & Associates, Inc. under contract EMW-94-C-4423 to the United States Fire Administration, Federal Emergency Management Agency.

August 26, 1995

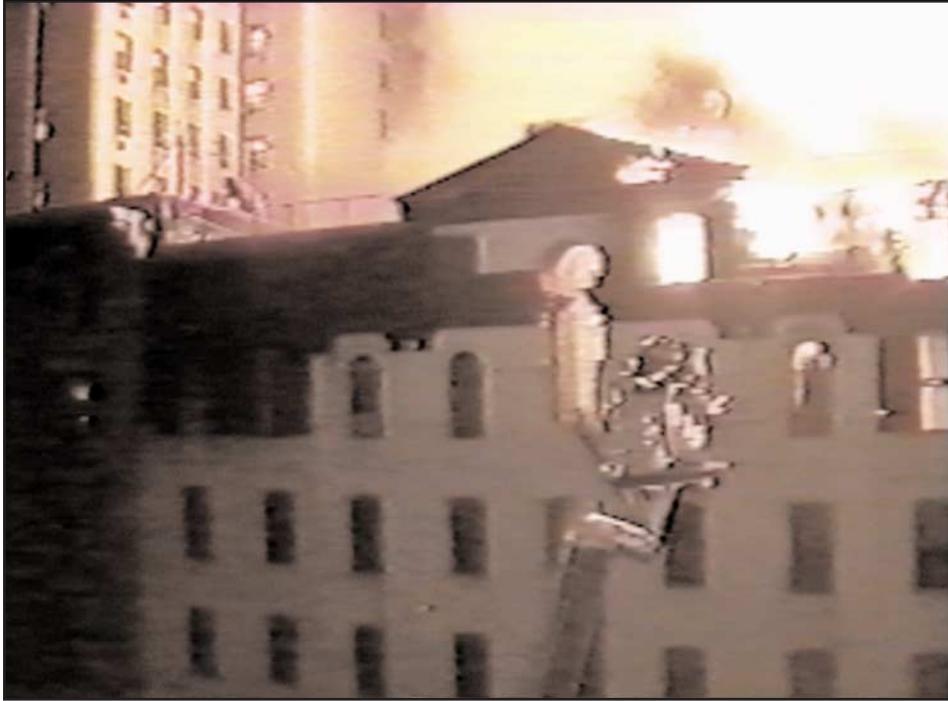
1. Early conditions on the Clark Street (front) side of the Clark building with Truck 119 in position to operate its elevated master stream.

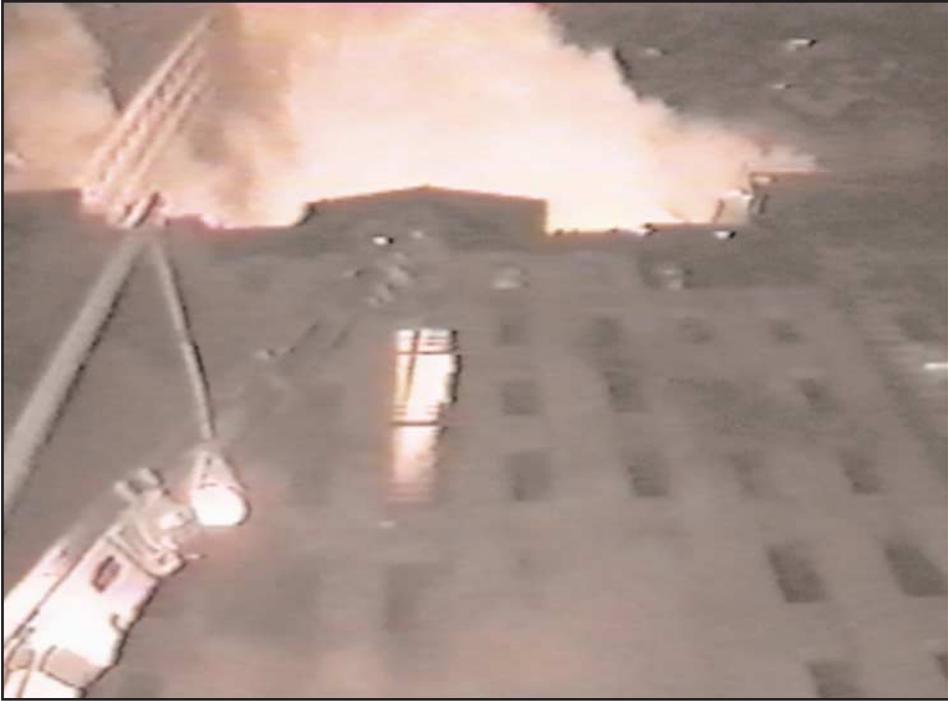
2. Later conditions on the front of the Clark building from street level.

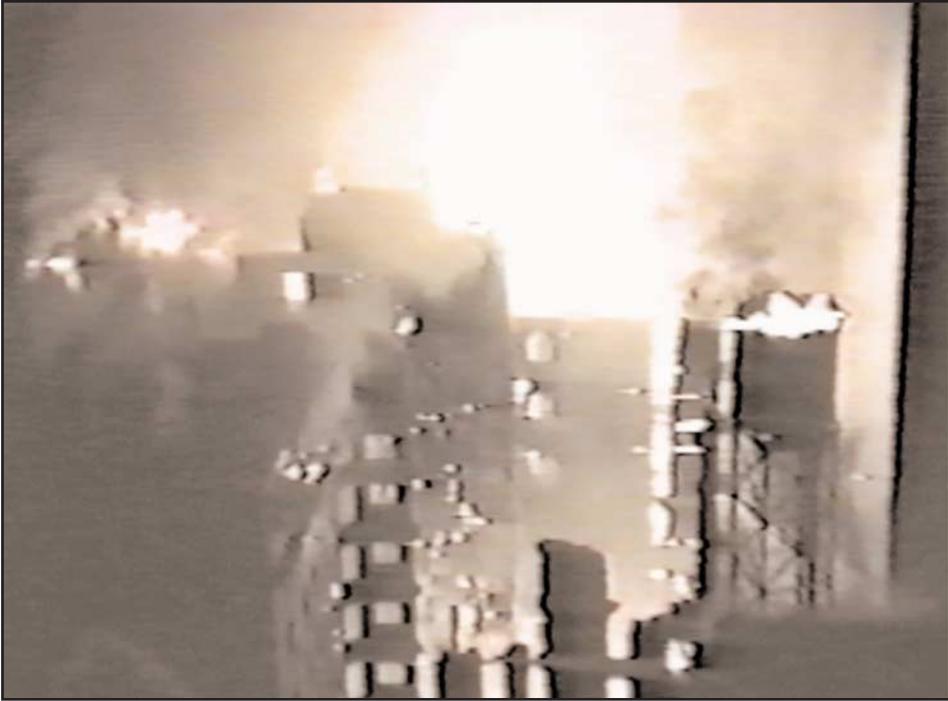
6. Fire conditions at the center of the block behind the Clark Building. The Tower building is in the background.

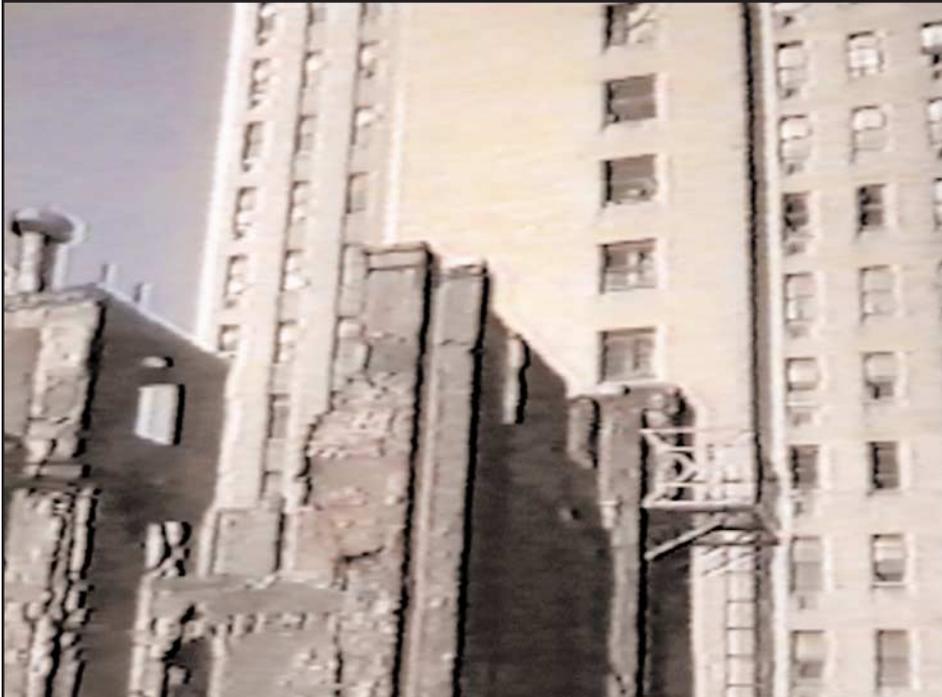
8. The Tower building and Grill Building with the 31 story Tower building in the background.

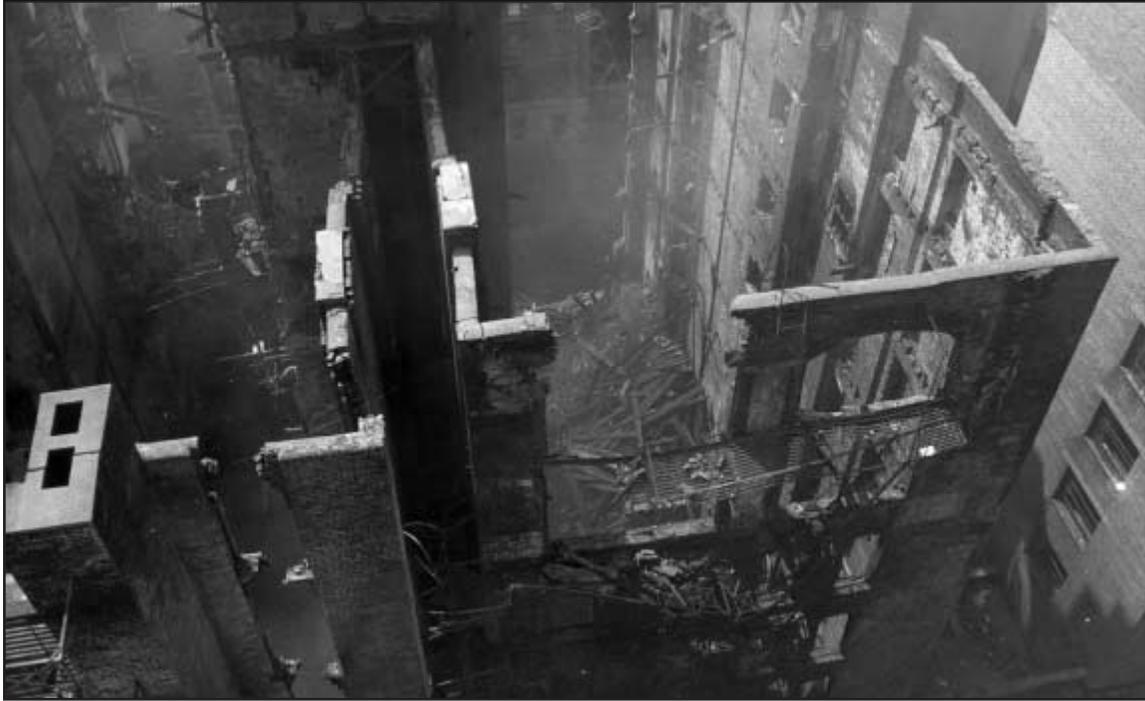
9. The Clark building during demolition as viewed from the rear to the front.

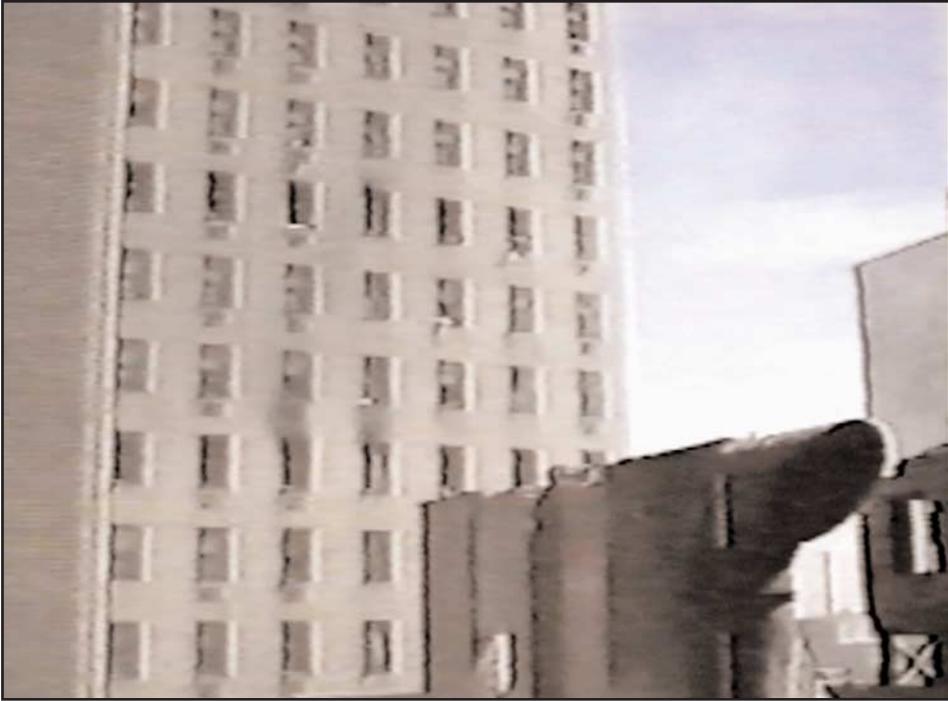
10. Damage to exposures across Clark Street from the fire building.
