## Hospital Fire Kills Four Patients Southside Regional Medical Center Petersburg, Virginia

**Hospital Fire Kills Four Patients  
Southside Regional Medical Center  
Petersburg, Virginia  
(December 31, 1994)**

This is Report 080 of the Major Fires Investigation Project conducted by Varley-Campbell and Associates, Inc./TriData Corporation under contract EMW-94-C-4423 to the United States Fire Administration, Federal Emergency Management Agency.

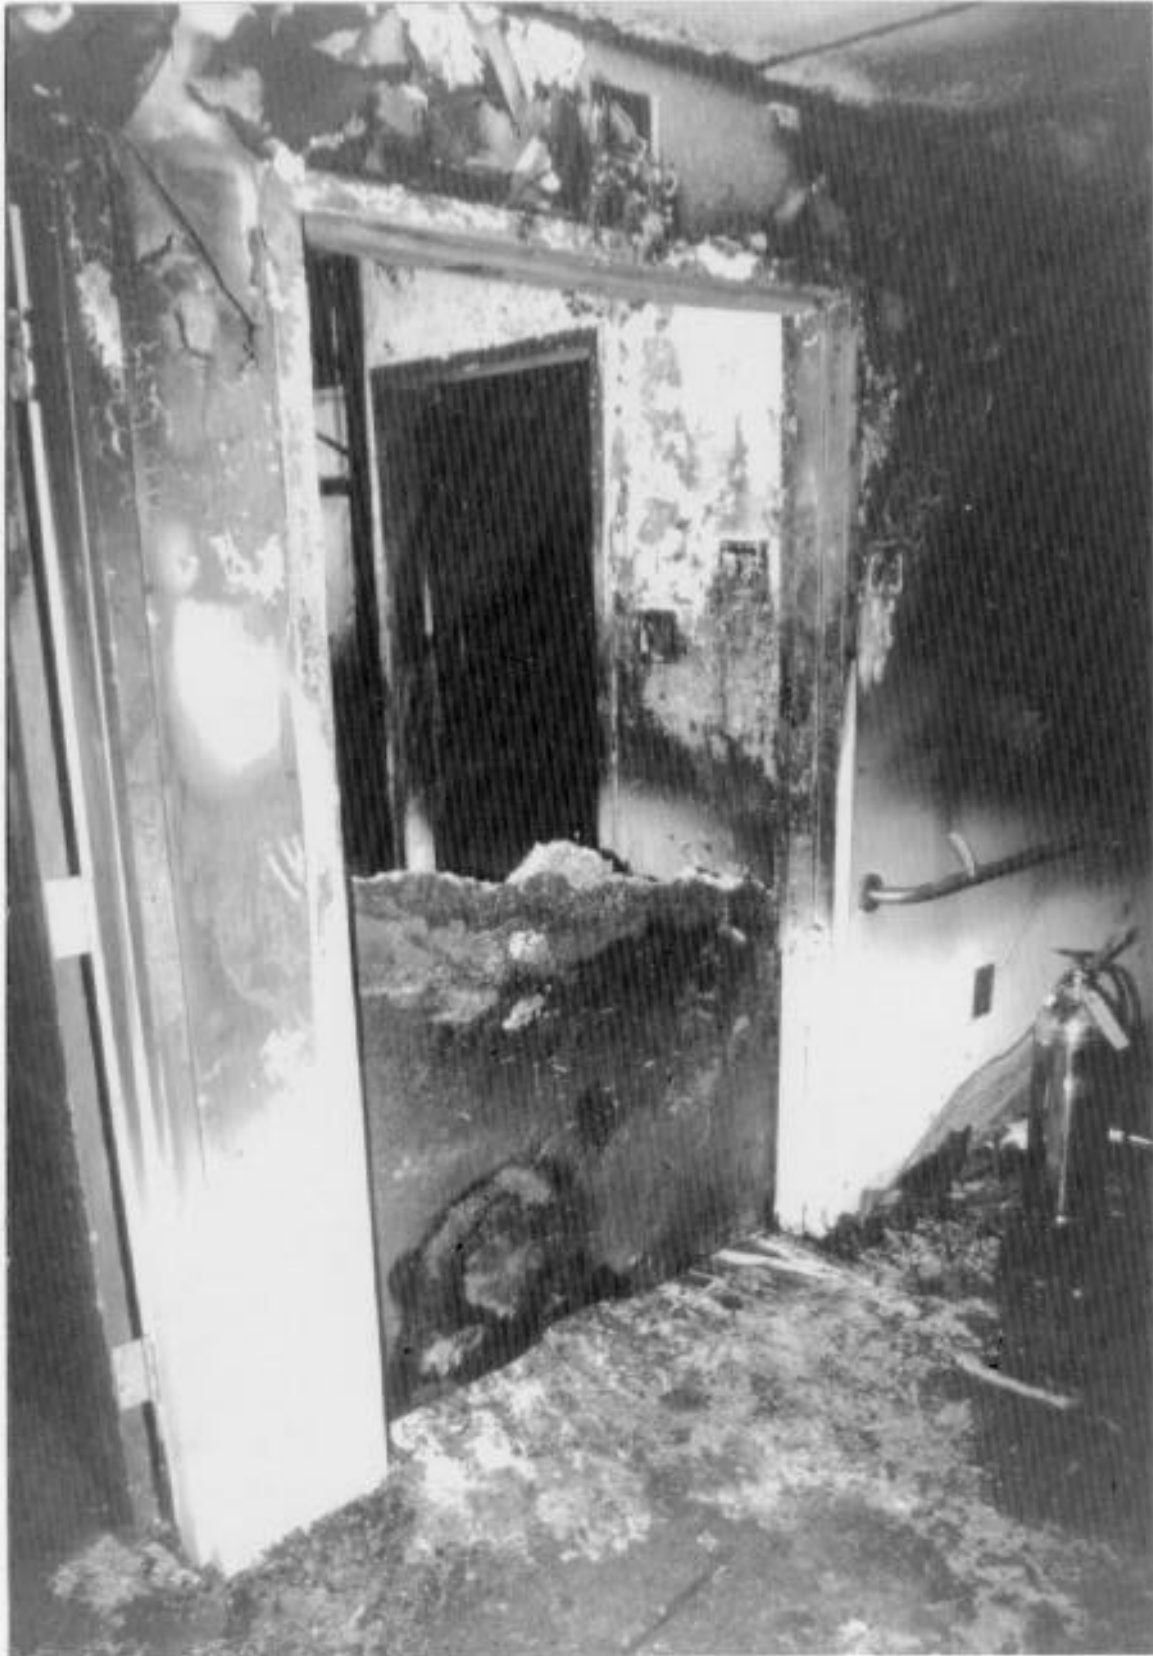
There was heavy smoke and heat damage around the door to the room of origin. The top portion of the door burned away in the fire.

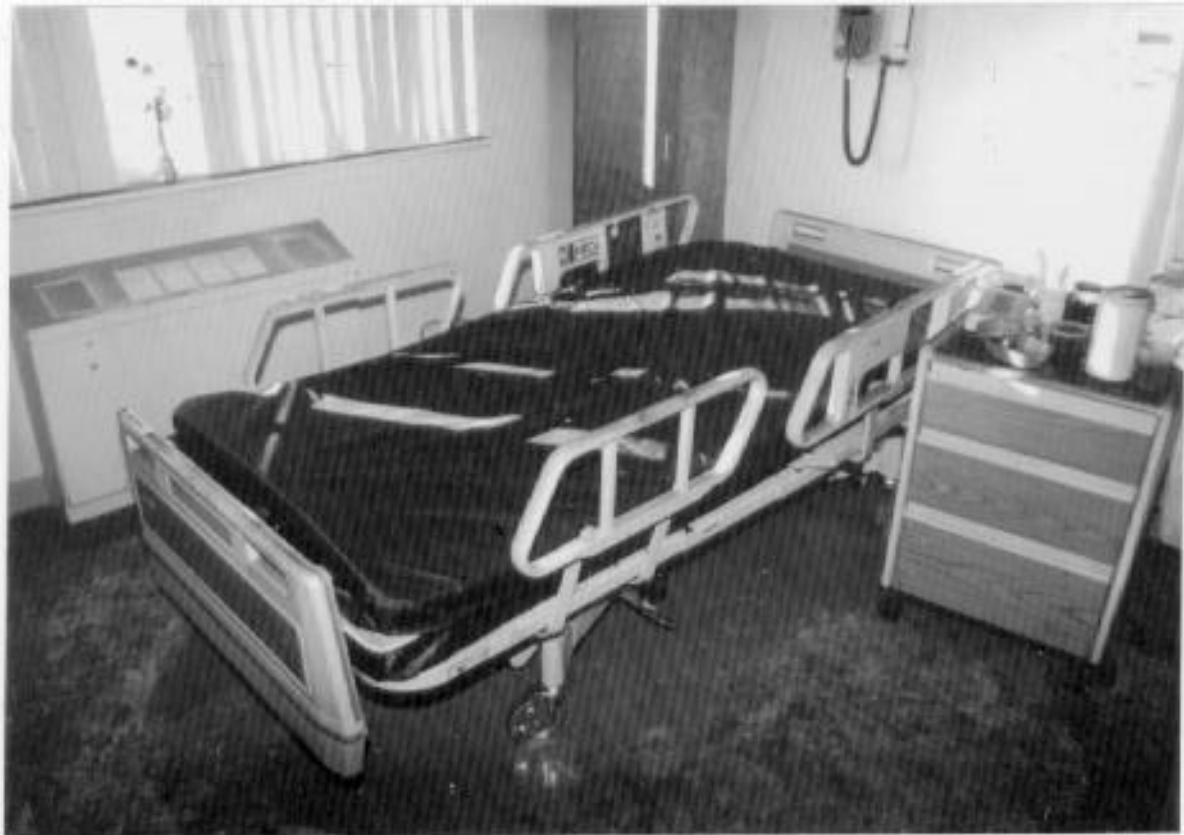
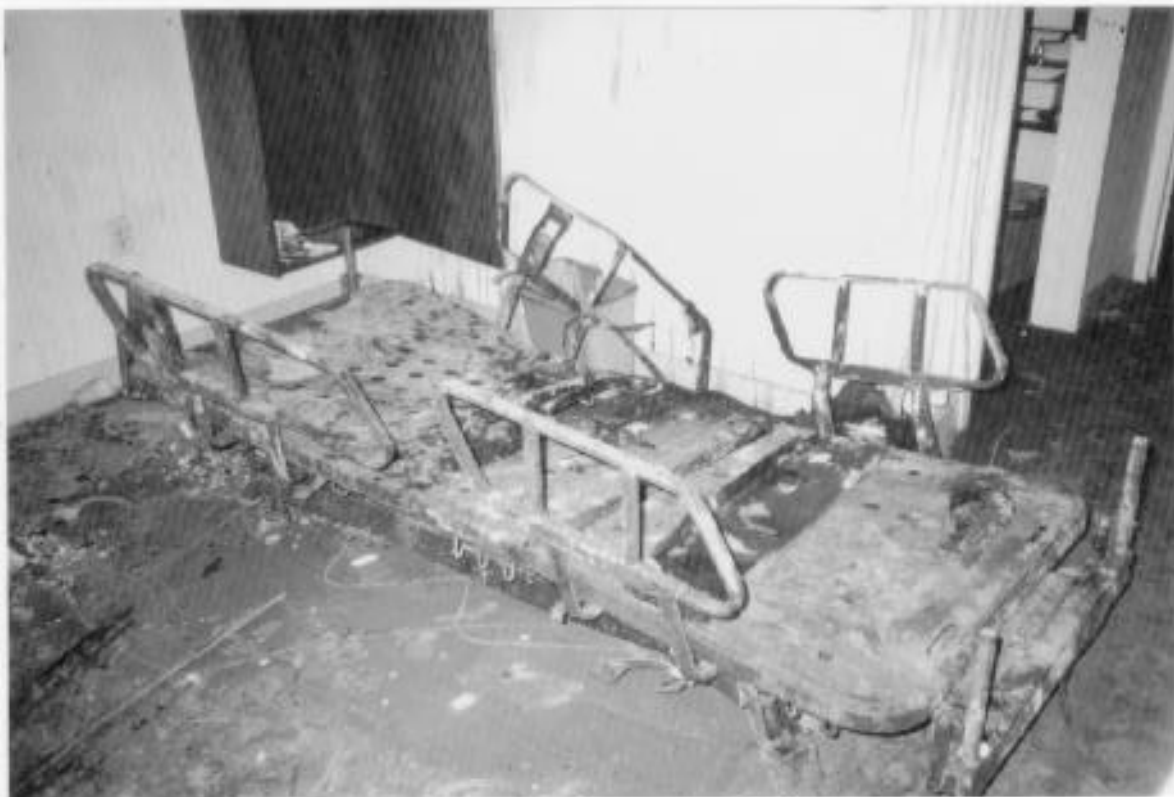
The beds in the hospital contained heavy amounts of plastic and foam parts. Only the metal frame of the patient's bed was recognizable in the room of origin.

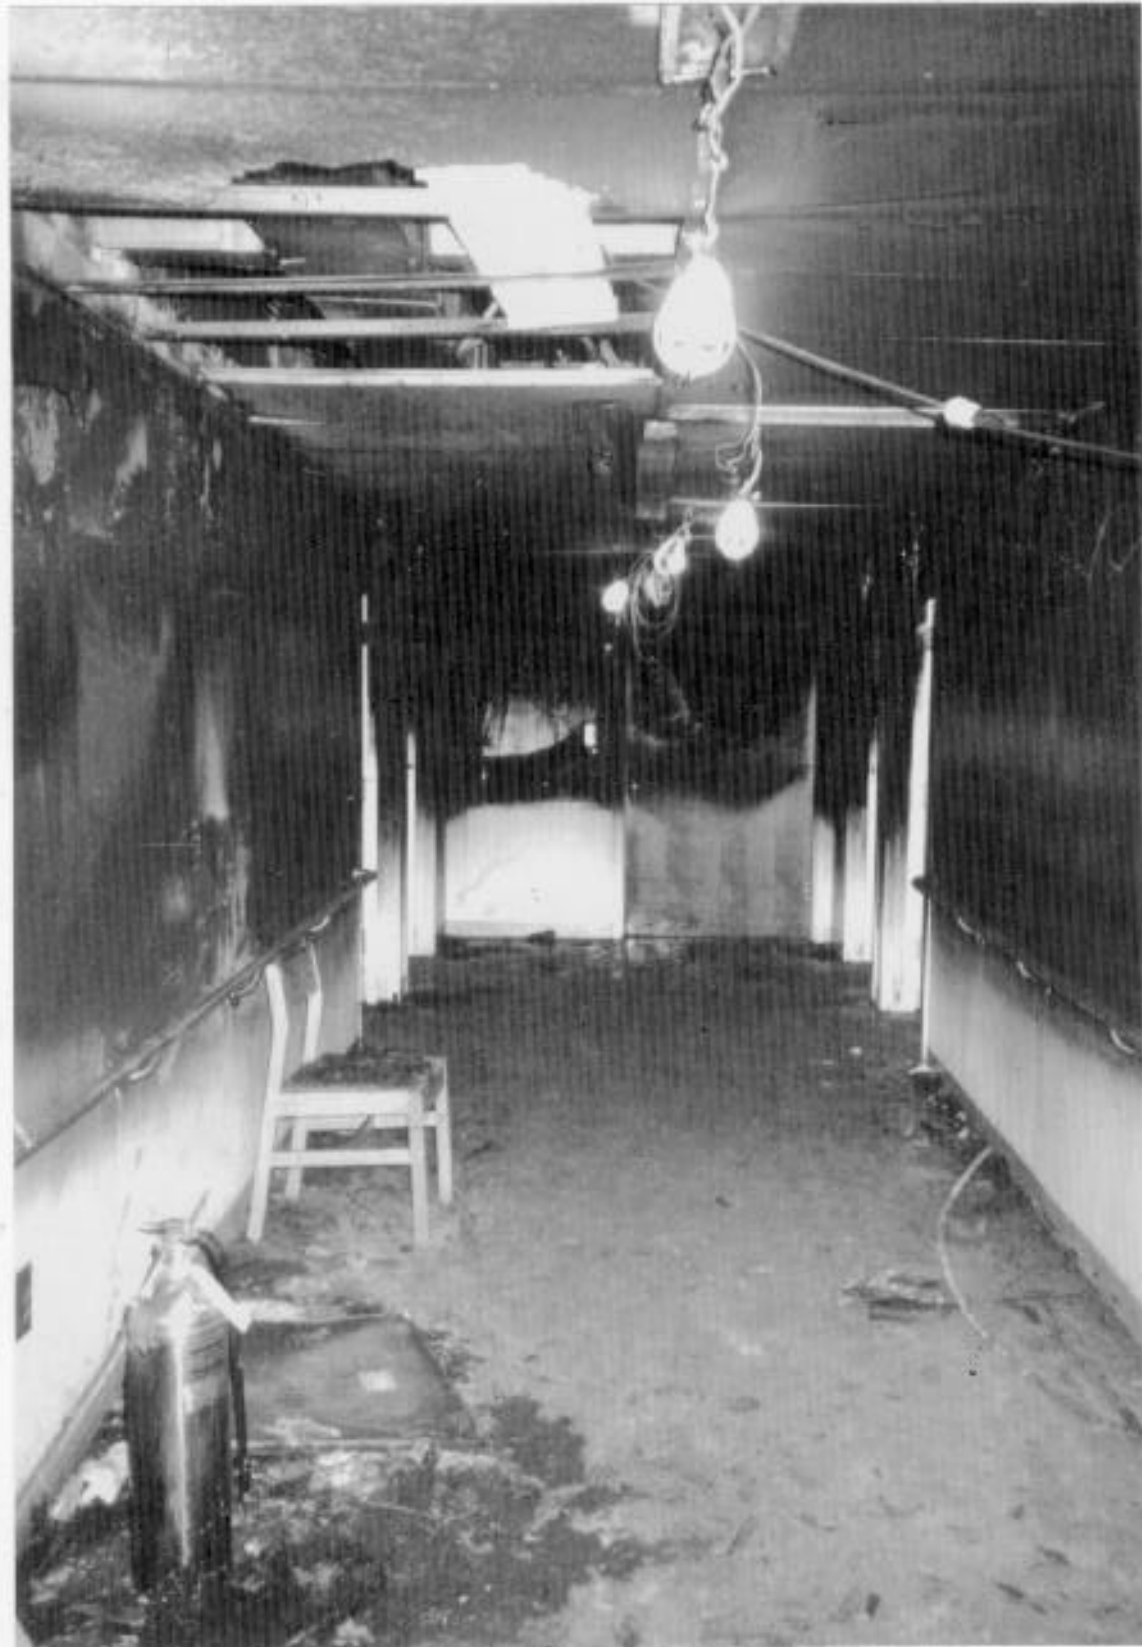
This photo shows the extent of smoke spread in the south corridor, looking down from the room of origin. At the end of the corridor is an exit, a hose cabinet containing a Class 3 standpipe connection and occupant use-hose, and a fire extinguisher, as well as the manual pull station that was activated by a nurse.

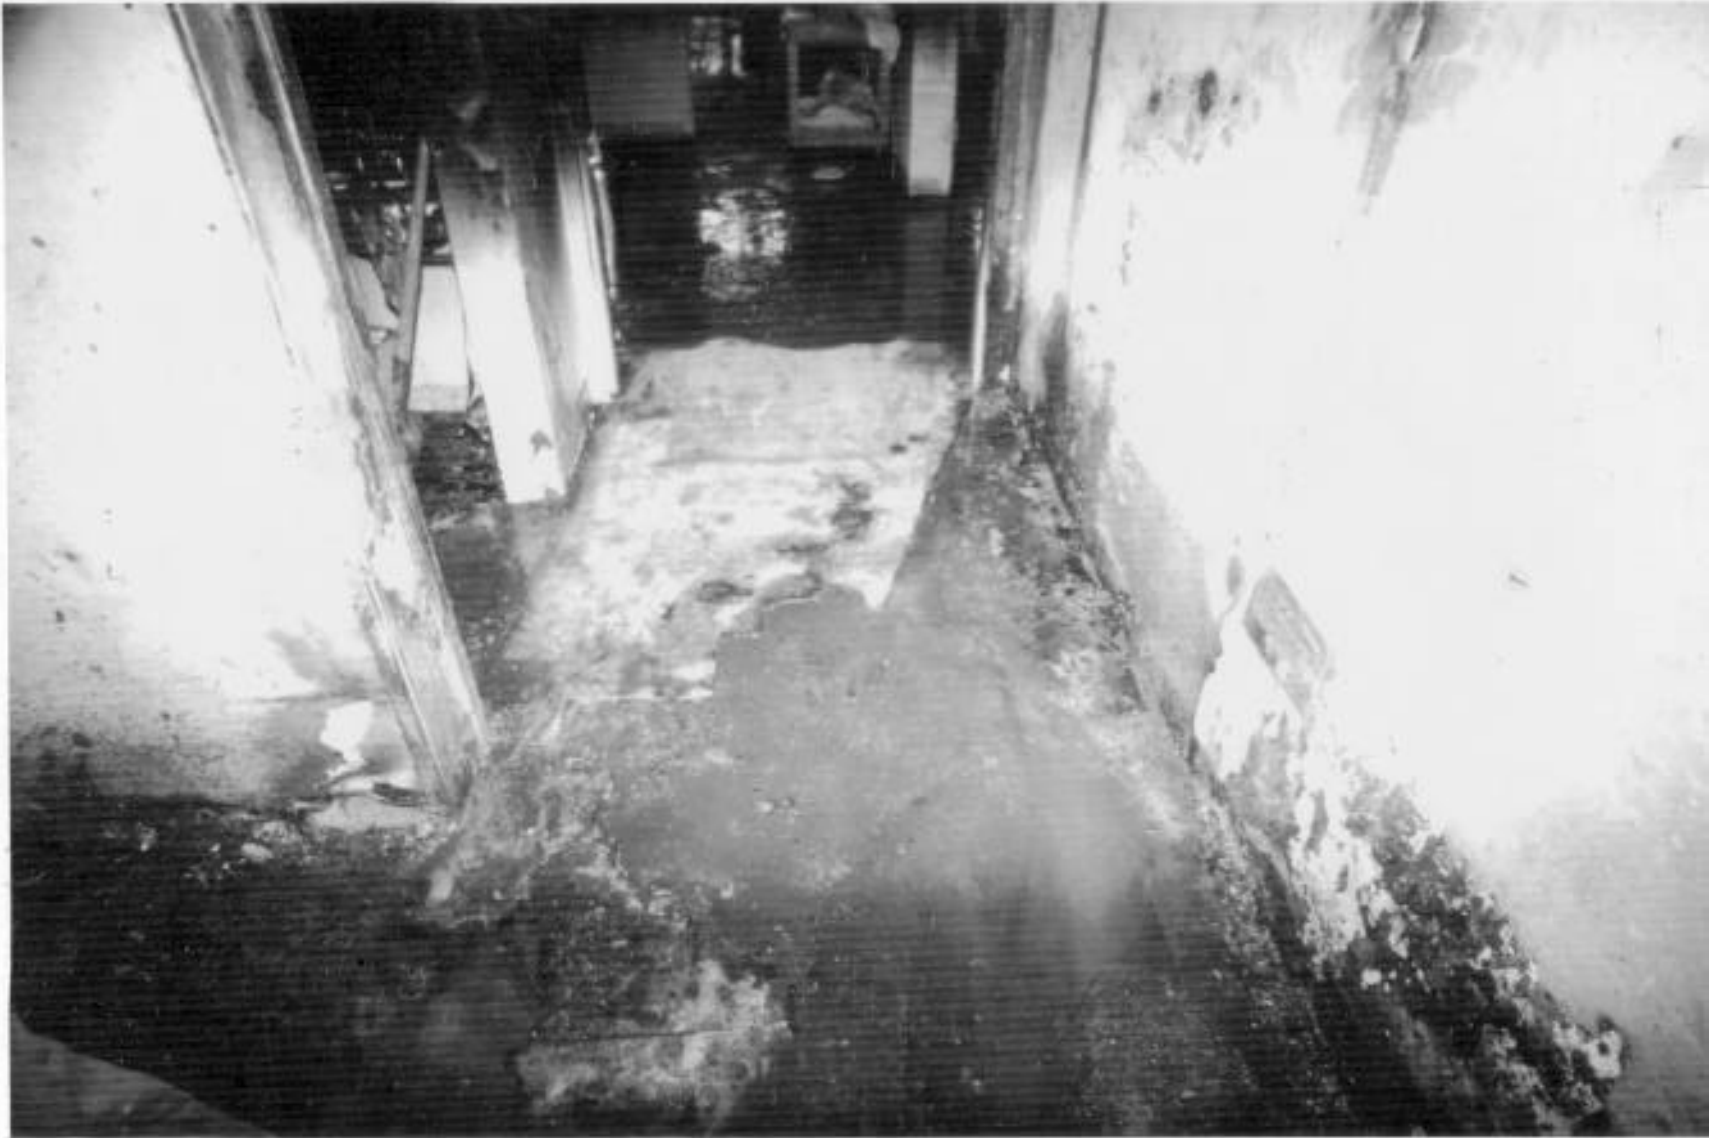
All but a small portion of the floor tile in the room of origin was consumed by the fire. This portion was partially shielded by the door to the room, which was open during the fire. The straight line pattern of burned away tile next to the right side of the doorway indicates the position of the door during the fire.

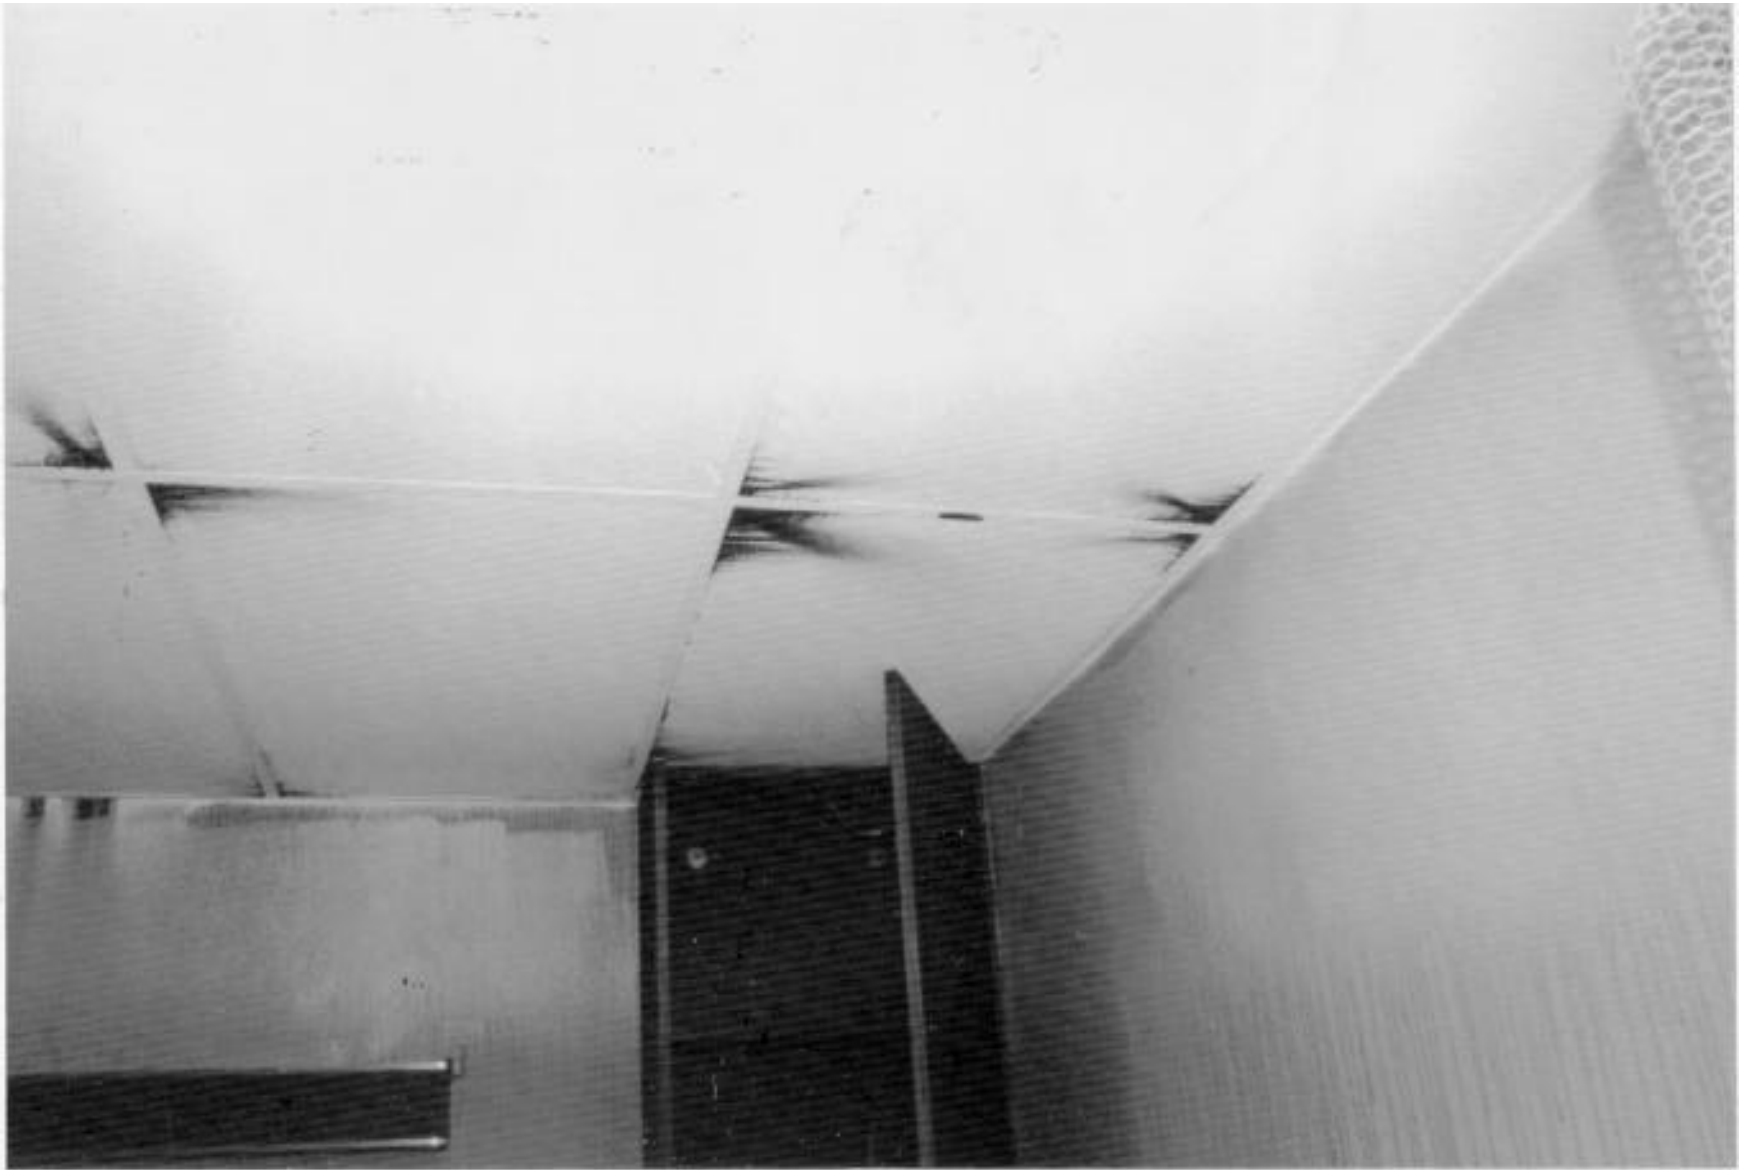
There was evidence of significant smoke spread into Rooms 416 to 421 via the common plenum space above the rooms. This was indicated by soot streaks on many of the ceiling panels, indicating that heavy smoke was leaking into the rooms via gaps between the ceiling panels and the suspension system. The ceiling above the fire failed, allowing smoke and heat to enter the plenum area. The smoke then leaked down through the ceilings, under pressure, into the adjacent rooms. The heat damaged some of the lightweight steel members in the floor assembly immediately above Room 418.

Smoke spread very rapidly, through the common plenum space above six rooms on the corridor due to rapid failure of the ceiling in the room of origin. This allowed smoke to fill the plenum space and to spread into adjacent rooms. Common plenum spaces allow for rapid smoke spread. Suspended ceilings should not be expected to contain smoke due to leakage between tiles and the ceiling frame.

Smoke streaks on the ceiling indicate that smoke was entering the rooms adjacent to the fire room through the ceiling suspension system.

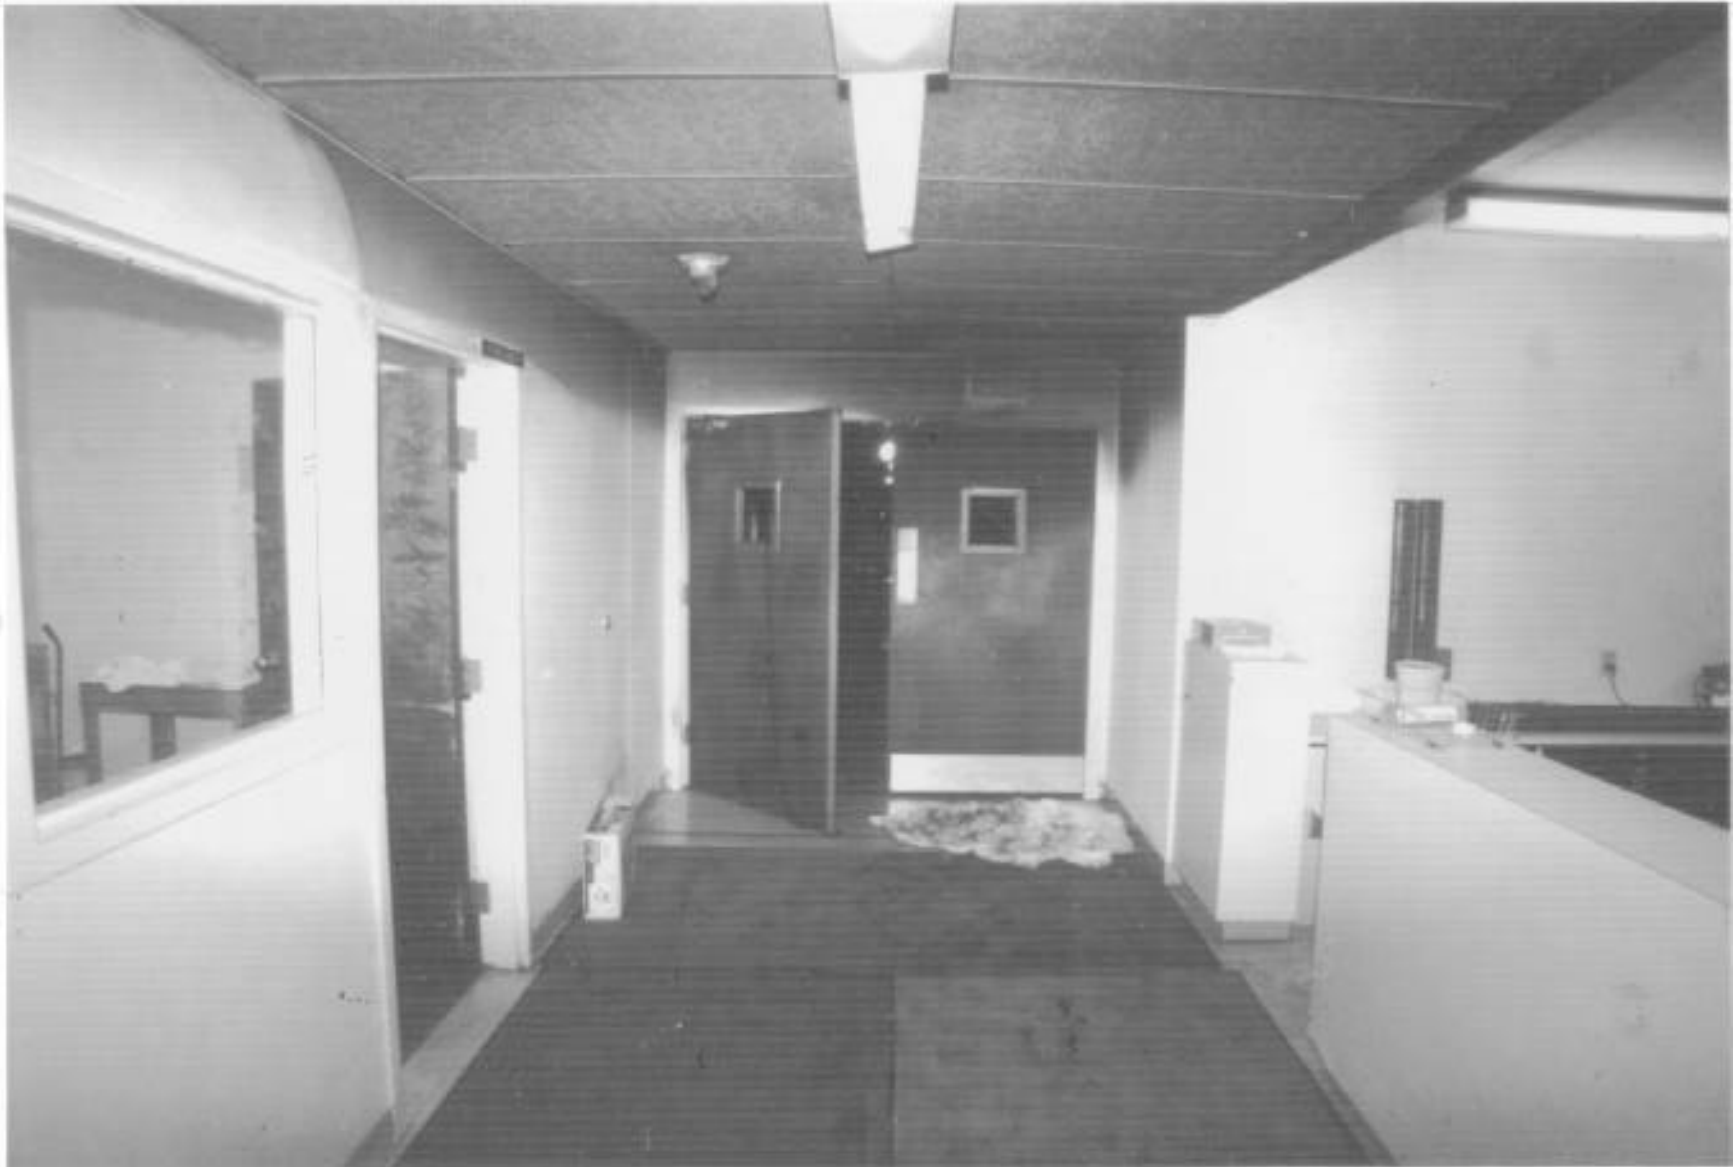
This fire demonstrated that smoke spread can be effectively controlled by smoke control doors and closed doors. Smoke spread via the corridor into other rooms on the corridor was controlled effectively by hospital personnel closing doors to patient rooms. The self-closing smoke control doors at one end of the corridor contained the heavy smoke damage to only one corridor on 4-South wing.

This photo looks down toward the south corridor with the nurses station on the right. The self-closing smoke control doors contained the bulk of the smoke and heat conditions to the corridor of origin, but some smoke escaped into the nurses station area as victims were evacuated through the doors.

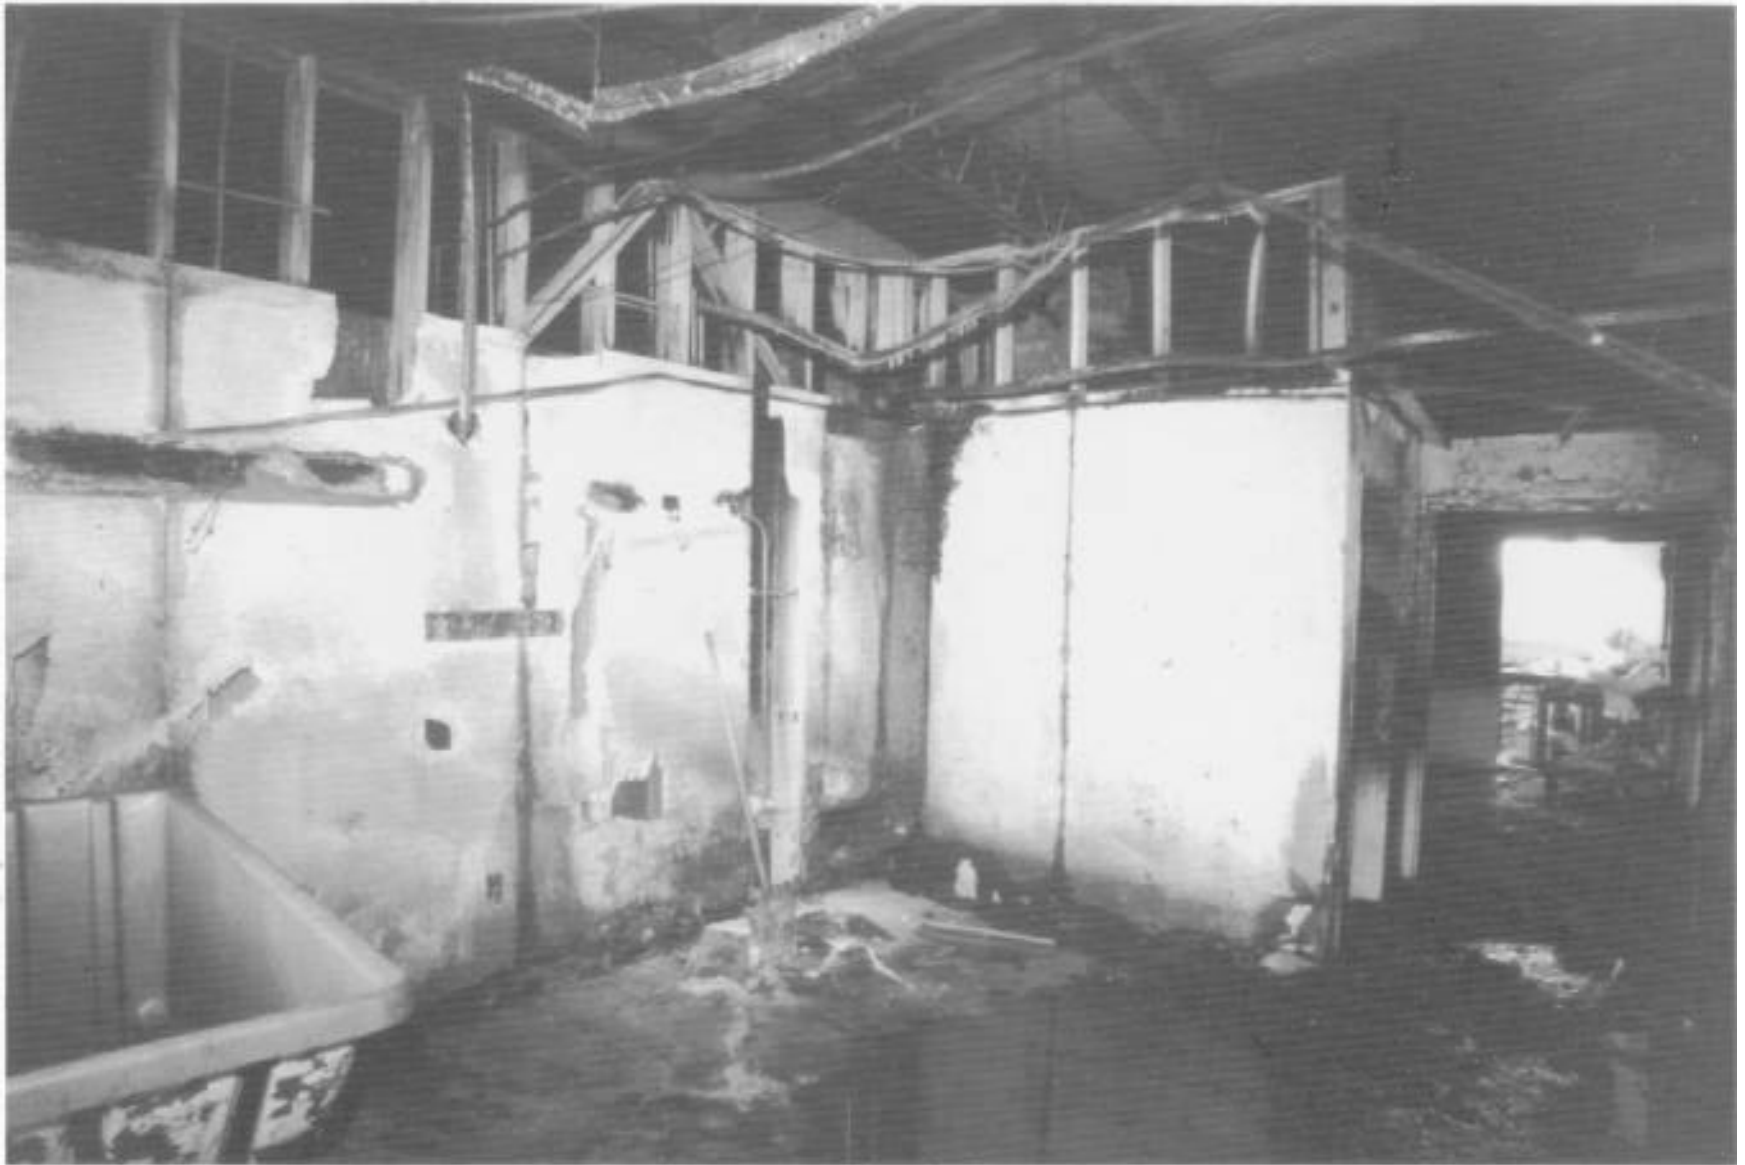
Room 418 and all of its contents were completely consumed. Only the metal frames of the beds and chairs remained. The suspended ceiling in the fire room collapsed during the fire. The unprotected steel trusses and the floor decking immediately above the suspended ceiling sagged slightly. The top half of the door to Room 418 was burned away. With the exception of a small area near the doorway, all of the floor tiles in Room 418 were consumed.

It is unclear why the ceiling assembly failed during the fire. The ceiling was part of a fire resistive floor ceiling system. One or more of the ceiling tiles, which must be secured in place with pins to function properly, may have not been secured, allowing them to be drawn up and out of the frame of the suspended ceiling by air drafts created by the fire. Due to the amount of damage to the ceiling, however, it was impossible to determine whether each ceiling tile was secured in place with clips.

There was very heavy damage to the room of origin. Some structural members were warped by heat after the suspended ceiling collapsed.

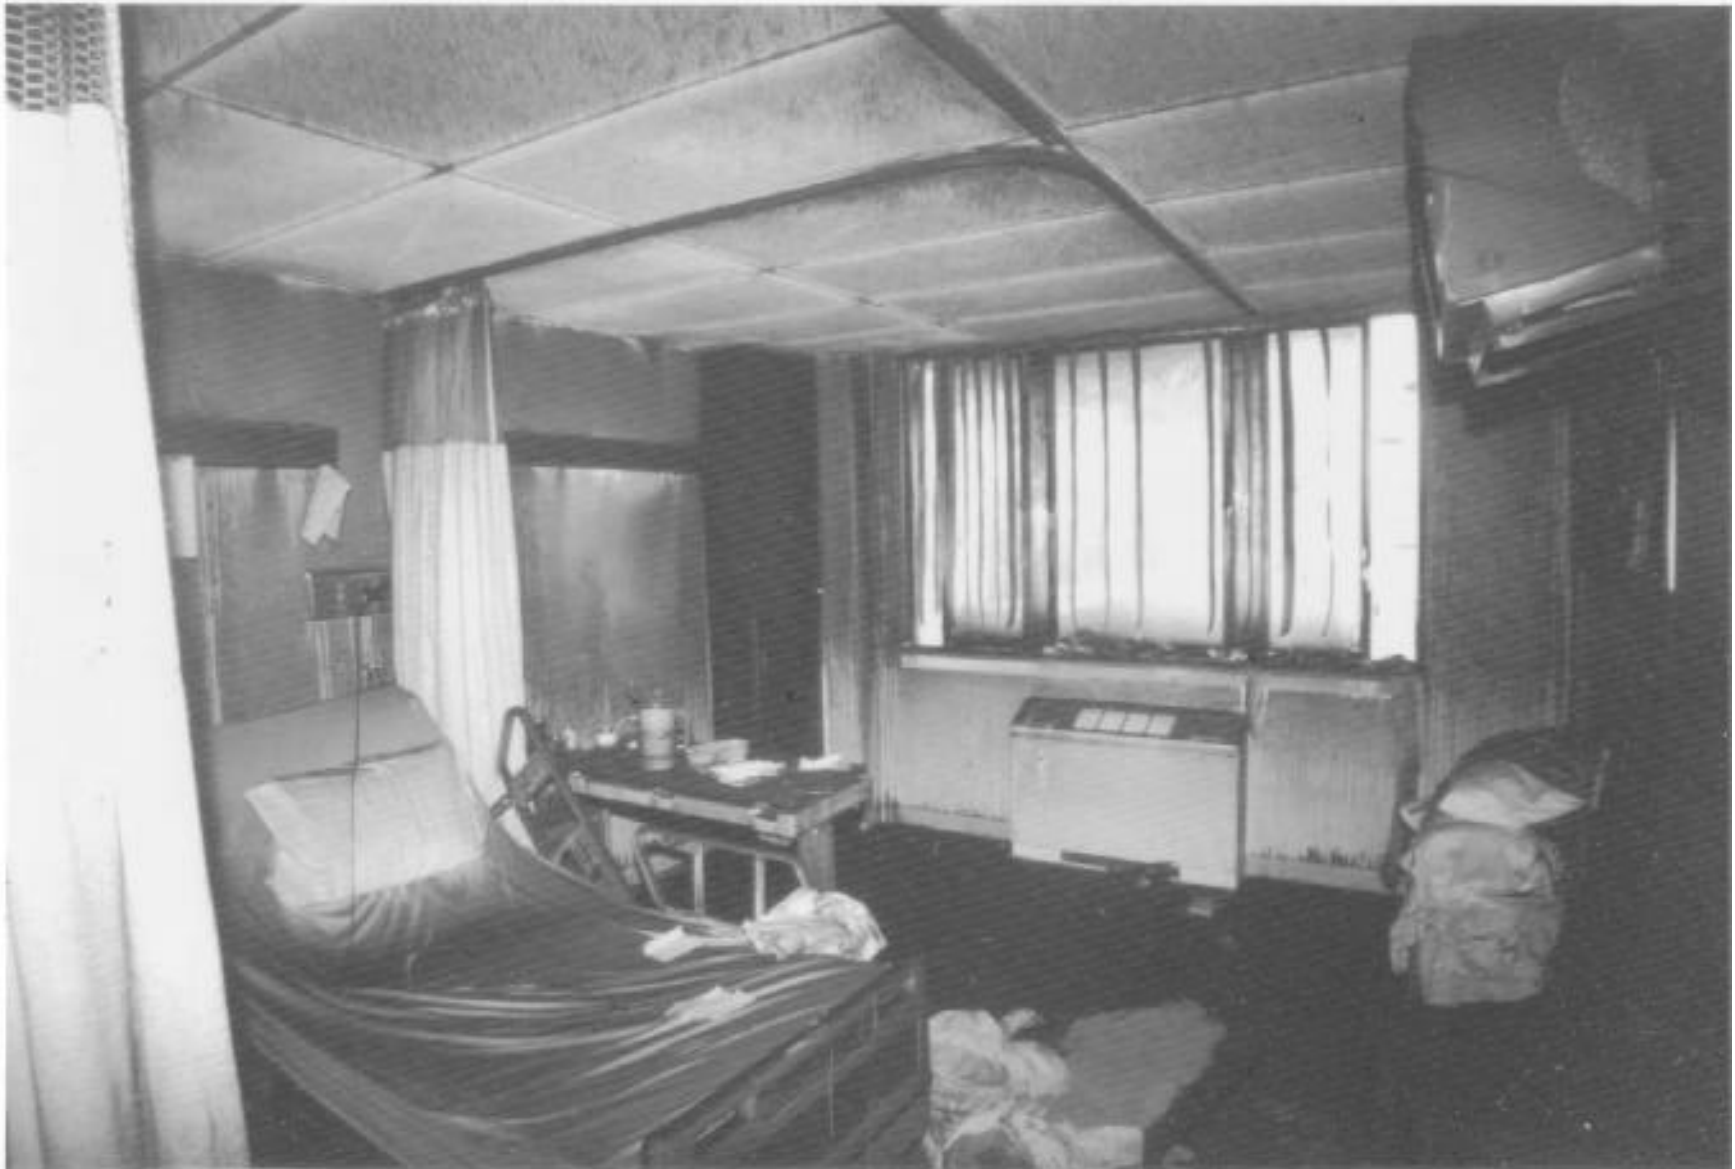
Smoke and heat damage to patient rooms on the south corridor varied significantly. Rooms 411 and 421 suffered heavy smoke damage, indicated by major soot stains on the walls and windows, because the doors to these rooms were open during the fire. The door to Room 411 was not closed by nurses because they had rescued the patient from this room and knew it was empty. The door to Room 421 was closed by nurses, but the patient apparently opened it while trying to escape and collapsed in the doorway.

Room 421 which was located on the south corridor suffered heavy smoke damage. Nurses closed the door to this room, however, investigators believe the patient opened the door while attempting to escape. The patient was found lying in the doorway by firefighters.

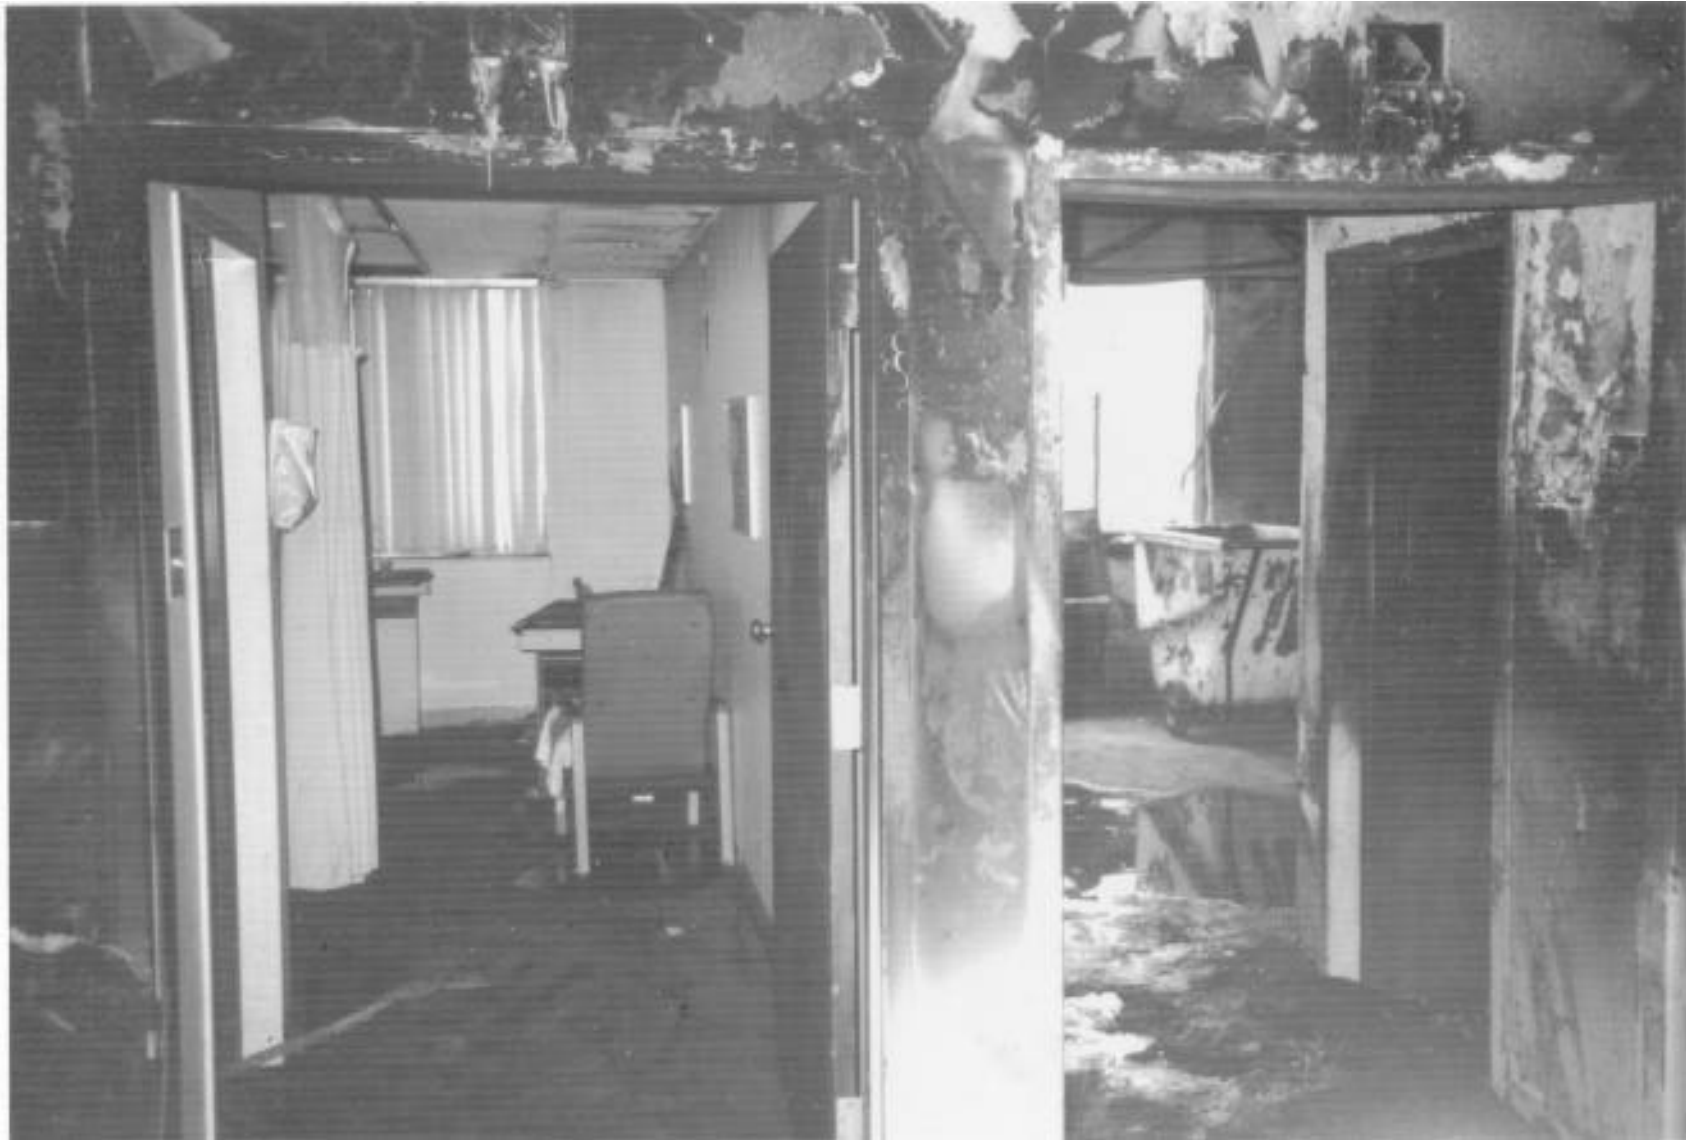
This photo shows the heavy damage to the fire room, Room 418 (on the right), and the adjacent room, Room 419 (on the left). Nurses closed the door to Room 419, but heavy smoke infiltrated the room through the suspended ceiling and cracks around the edges of the door. The patients in both of these rooms died.

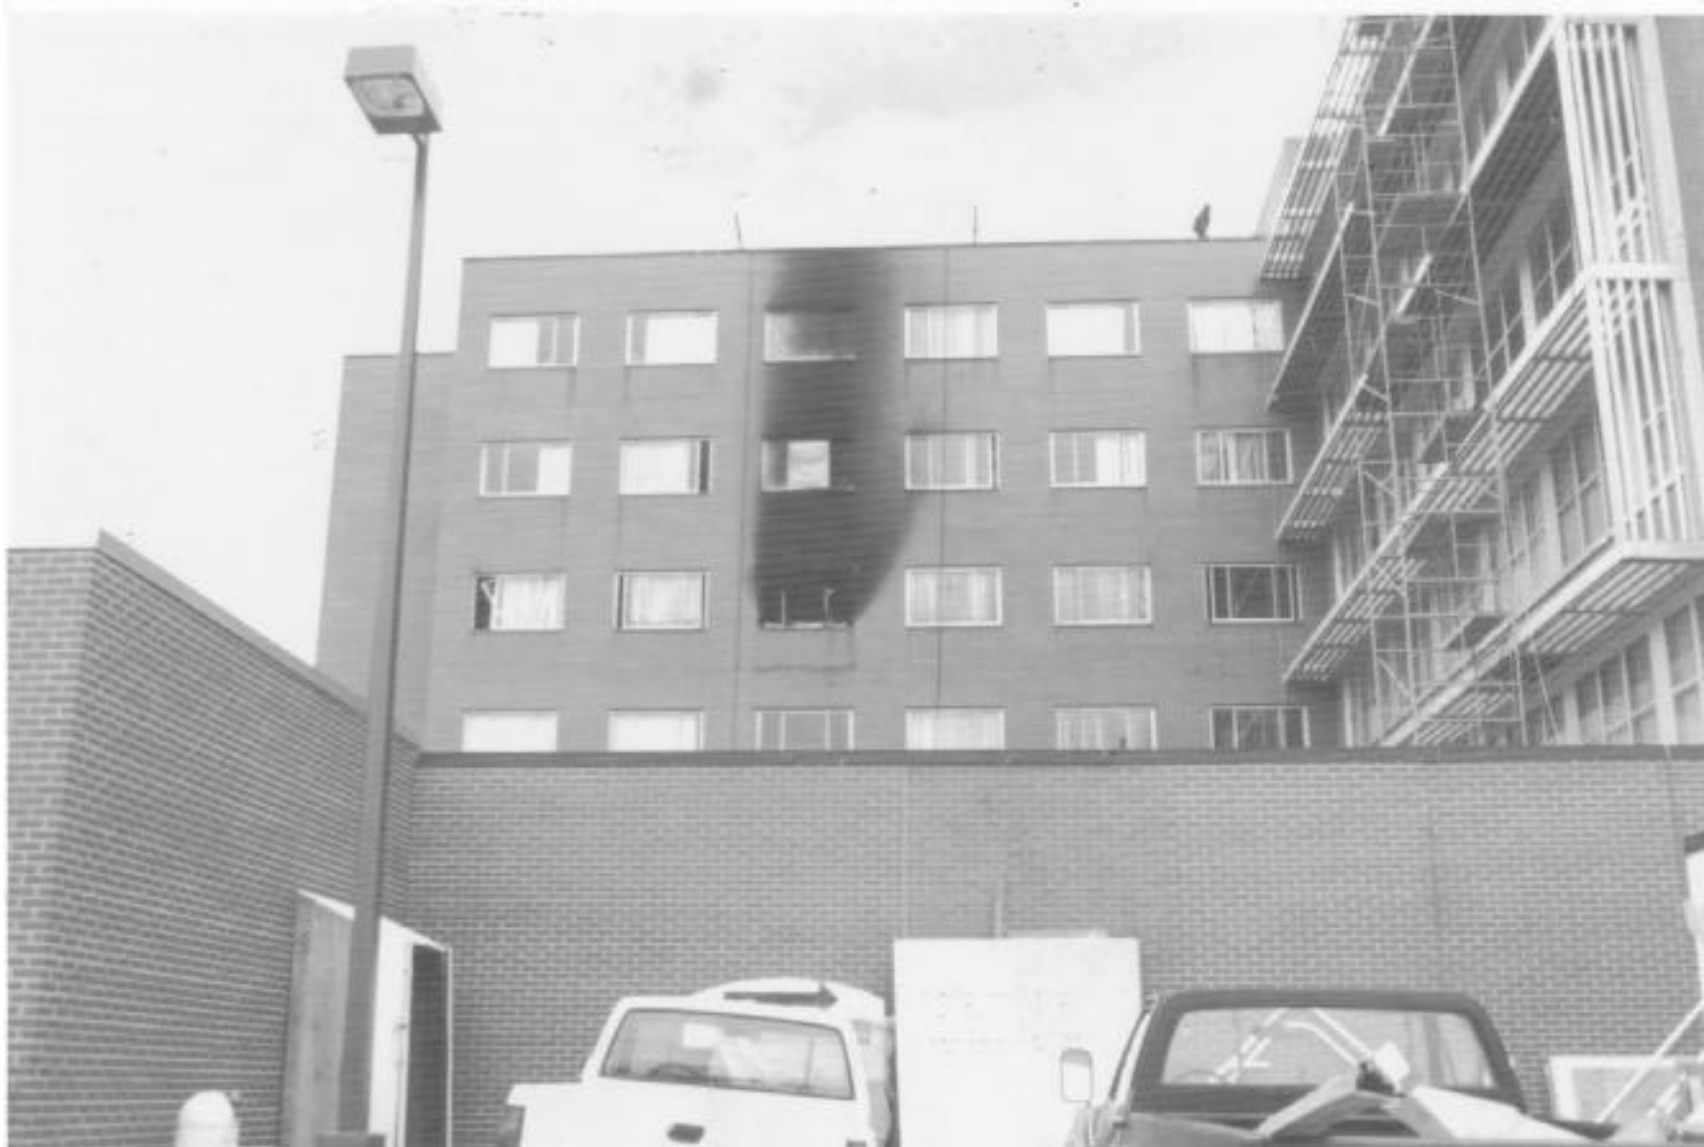
The first floor of the hospital extended out from the upper floors of the building, which blocked access to the fourth floor windows by an aerial ladder. Firefighters used a ground ladder from the roof of the single story wing to rescue a patient from a window located two rooms to the left of the room of origin.
