# **Aerial Ladder Collapse Incidents (April 1996)**

**This is Report 081 of the Major Fires Investigation Project conducted by Varley-Campbell and Associates, Inc./TriData Corporation under contract EMW-94-C-4423 to the United States Fire Administration, Federal Emergency Management Agency.**

## **Aerial Ladder Collapse Incidents**

Failure Analysis of a  
100 ft Aerial Ladder

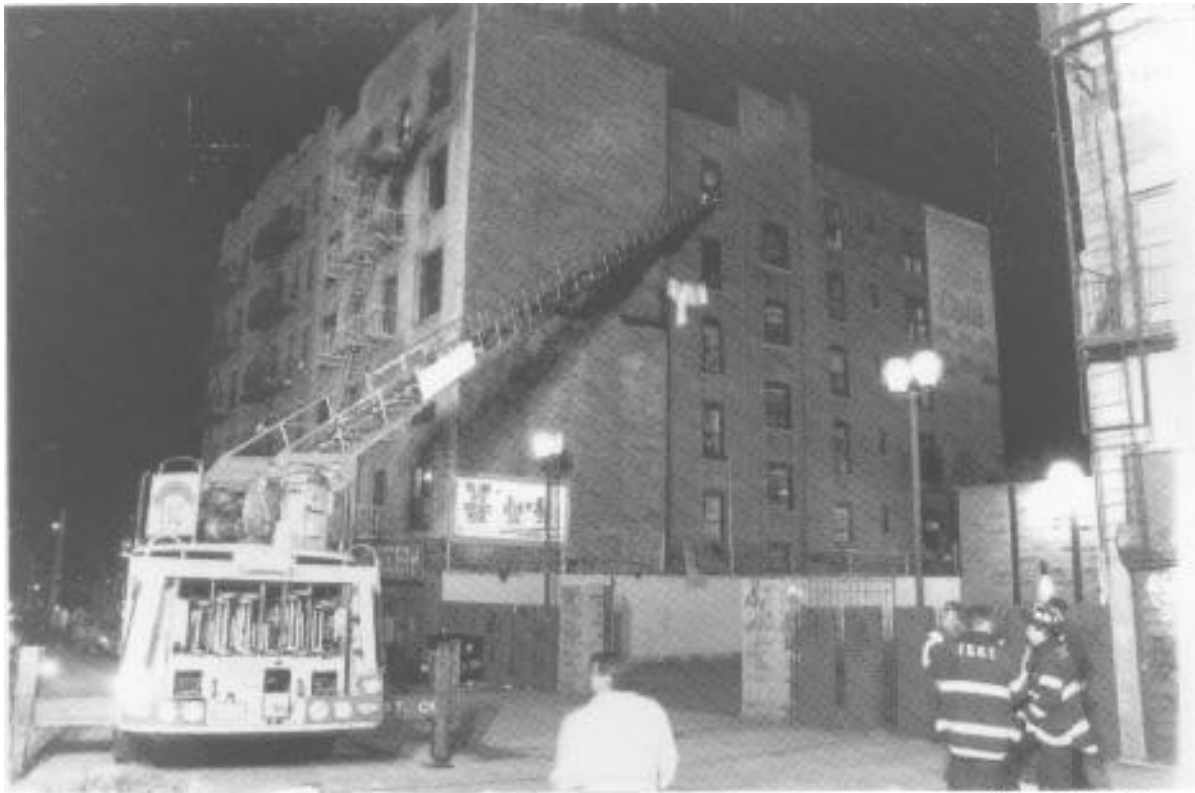
In a recreation of the FDNY Ladder 104 collapse scene, Ladder 112 is positioned with its ladder extended to the window where the occupants were trapped. The ladder is extended 91 feet at a 31 degree elevation angle.

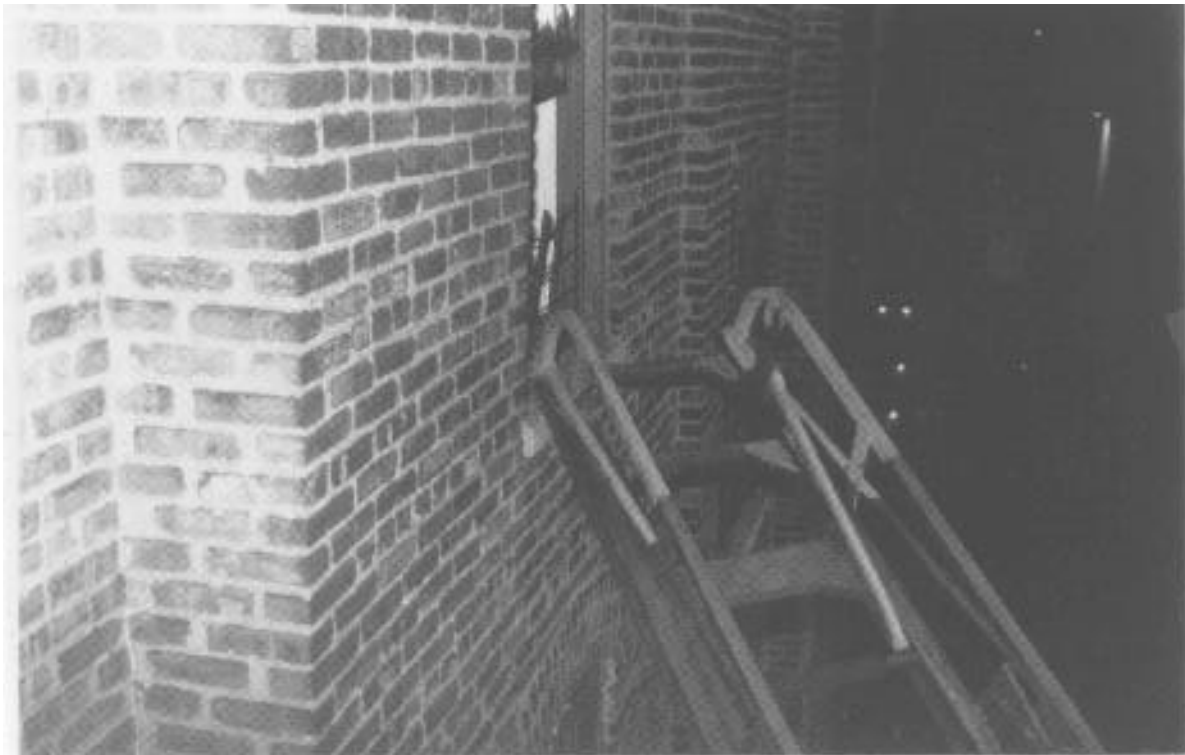
Prior to the collapse, the tip of the left rail rested on the window sill. The weight of the occupants caused a twisting force to the unsupported right side.

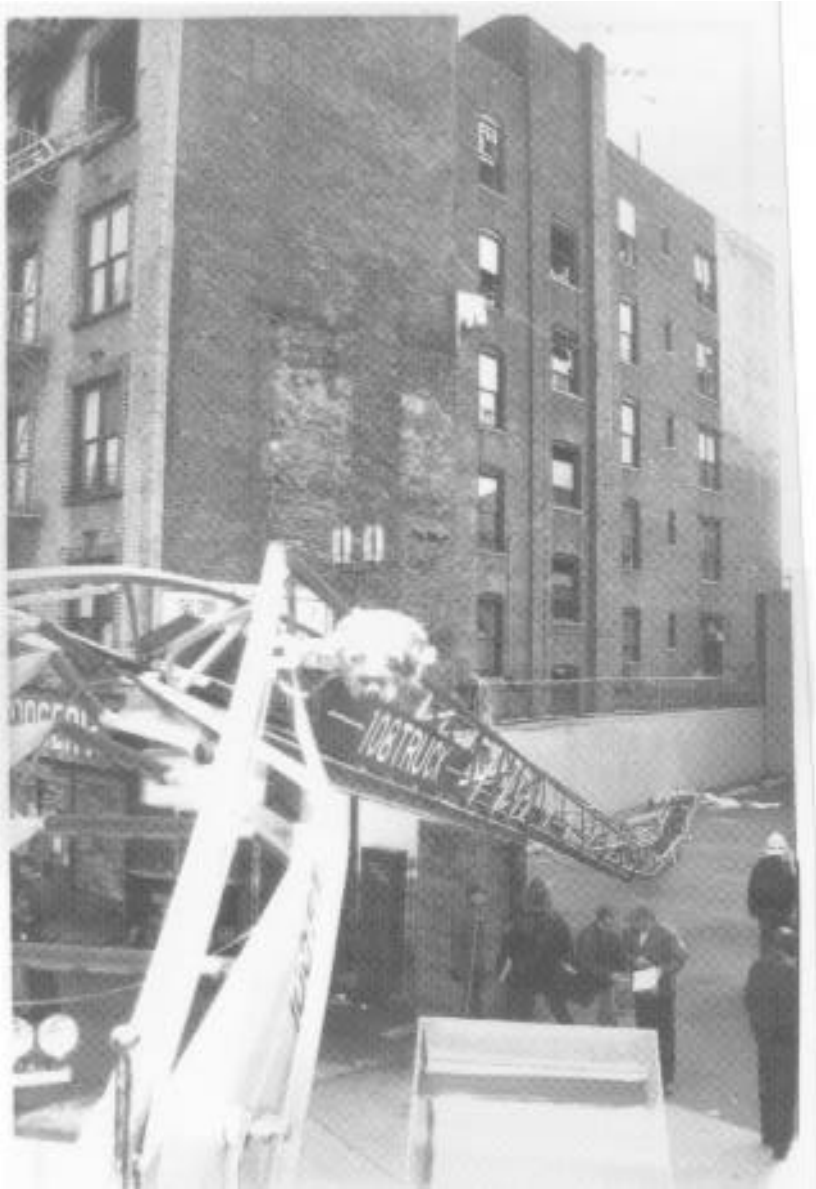
The twisting failure occurred in the lower right bed section, collapsing the ladder to the right side.

The primary structural failure occurred when the main beam on the lower right side of the bed section buckled inward, slightly above the point where it is supported by the ladder raising mechanism. This part of the ladder would be subjected to the maximum bending stress when the ladder is in a cantilever (unsupported) position. The buckling of the lower beam also crushed two of the rungs and caused a secondary buckling of the left main beam in the same area. The buckling indicates that the failure resulted from compression forces in the beam, which are caused by the bending stress in the ladder.

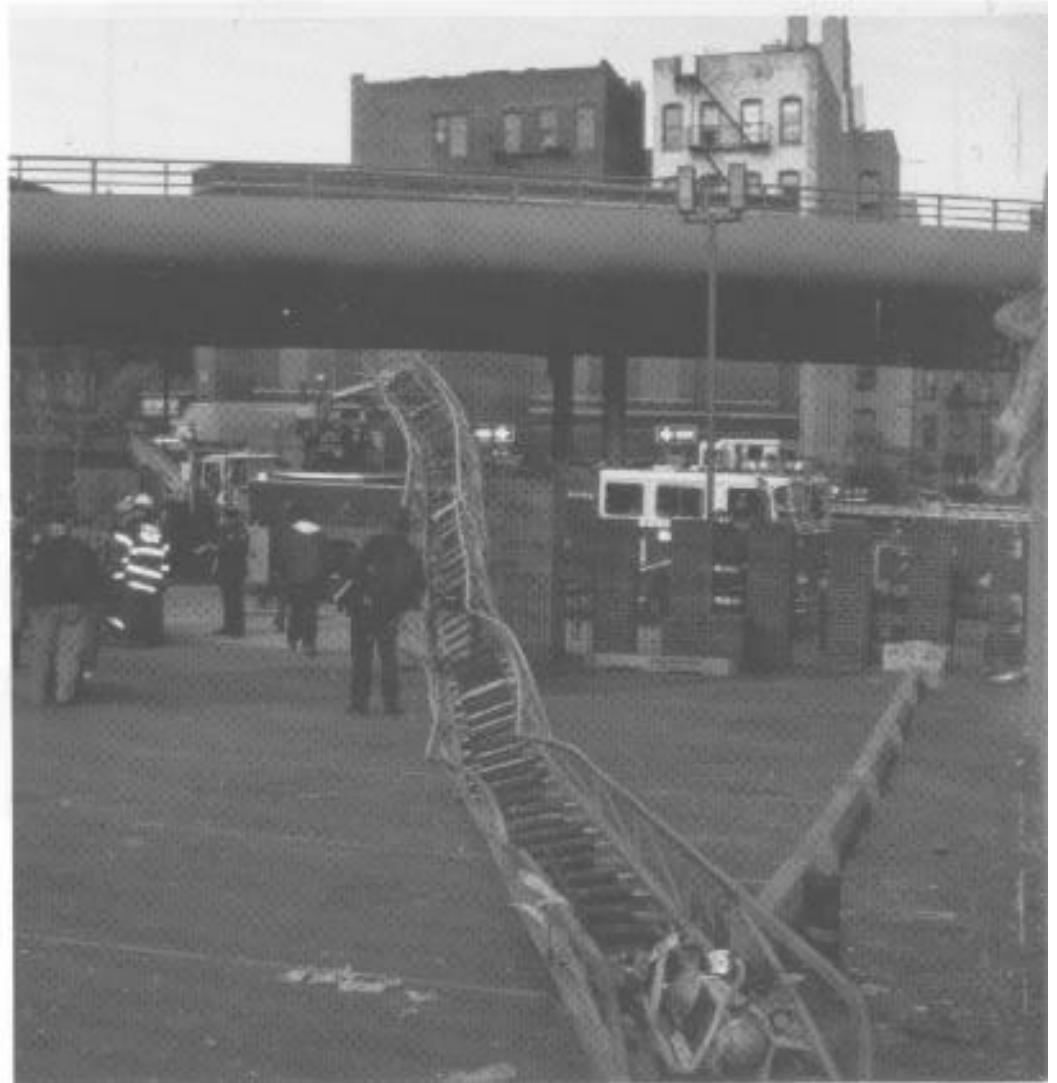
The primary failure in the bed section caused secondary failures in the fly sections.

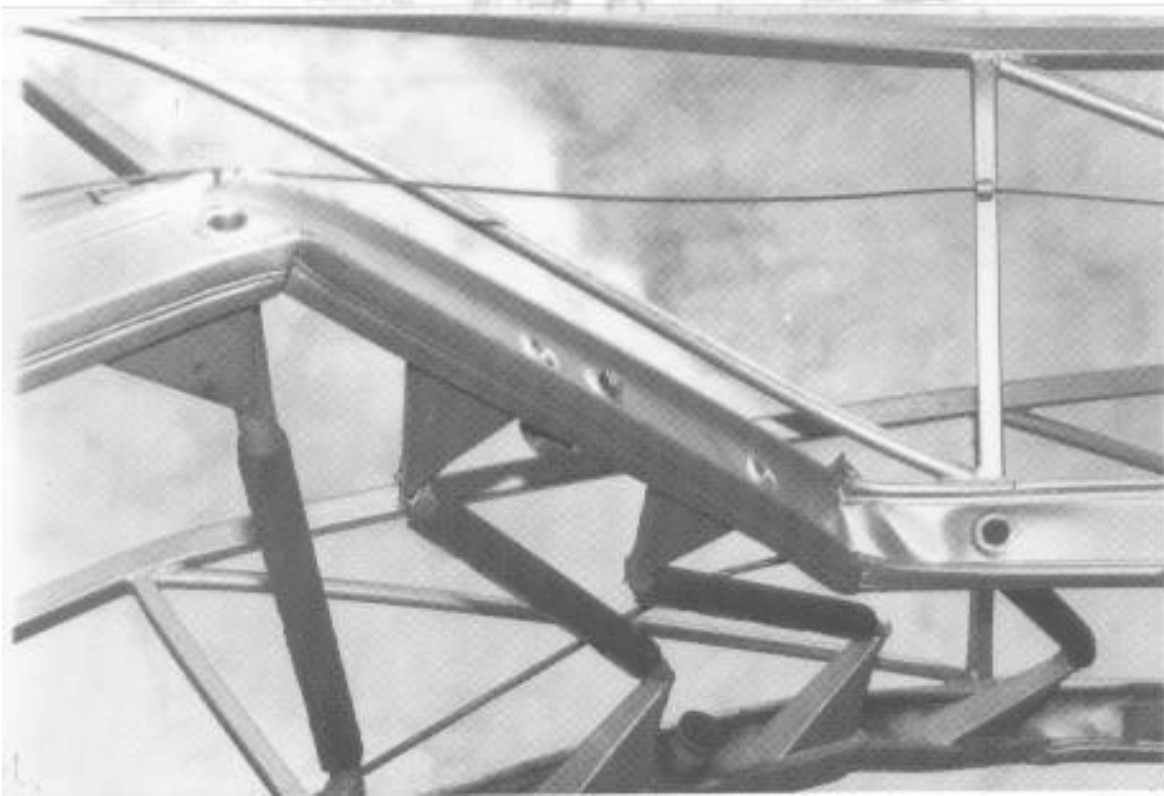
This close-up view shows the damage sustained by beams and rungs in the area of the primary failure.

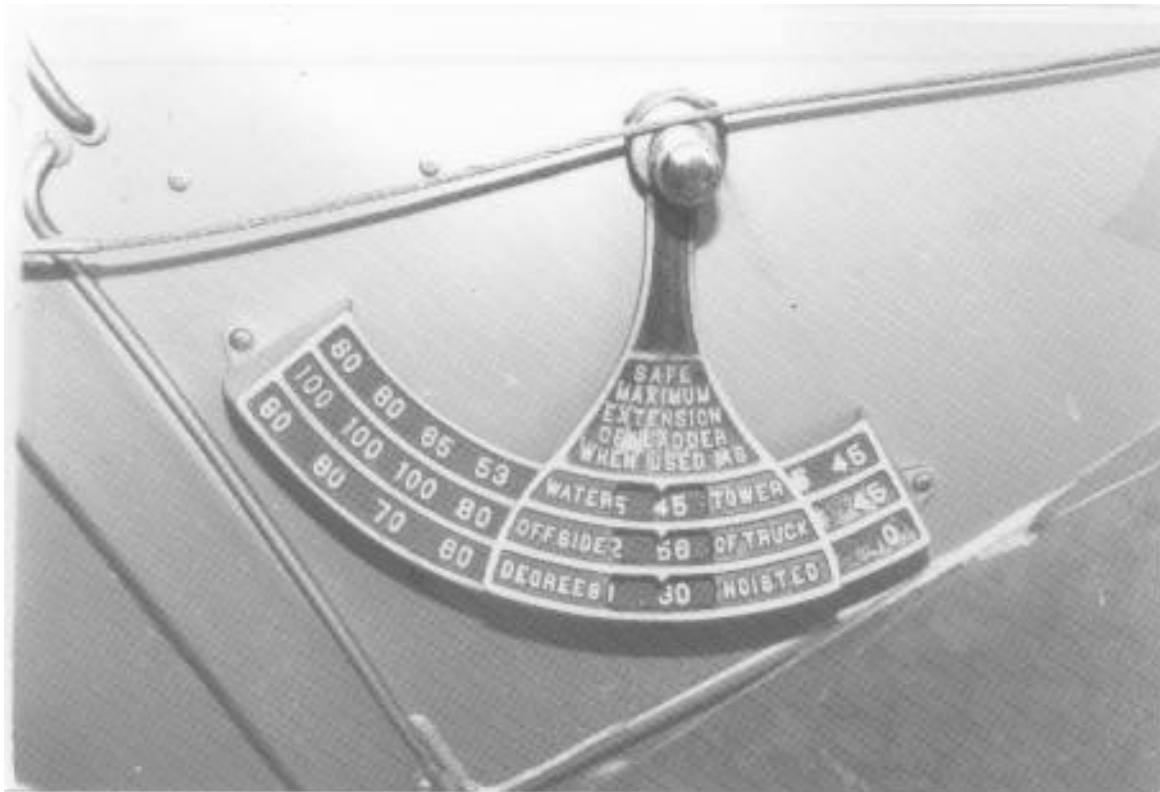
The inclinometer shows that the maximum safe distance of extension for the 31 degree angle is approximately 56 feet.

The inclinometer, which is mounted on the ladder, indicates the maximum allowable extension of the ladder at different angles of elevation. When raised to the position of Ladder 108 prior to its collapse, the inclinometer reading would allow 45 feet of extension for ladder pipe operations and 56 feet for use as a ladder only. The instructions state that these figures are based on an adequate margin of safety assuming that a person and/or ladder pipe is at the top of the ladder, which suggests that the ladder would be in an unsupported condition.

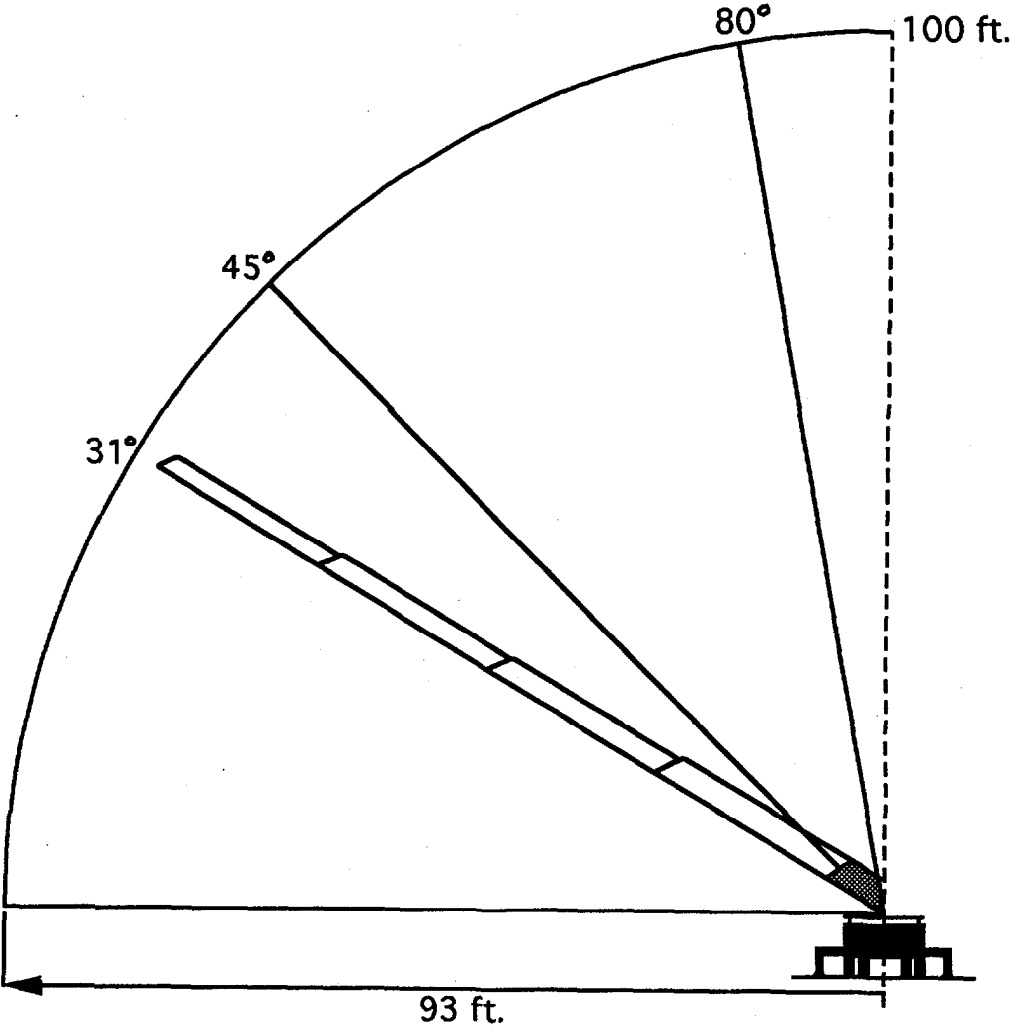
Figure 3. Ladder Position and Angle: New York Ladder Collapse

*Load Conditions* - To establish the elevation and extension of the ladder at time of failure, a similar vehicle was parked in the same location and the ladder was raised to the same window. To reach the window, the ladder was placed at an elevation angle of 31 degrees and approximately 91 feet, which is three feet short of its maximum extension (see Figure 3). It was rotated approximately 45 degrees to the right of the centerline of the vehicle.

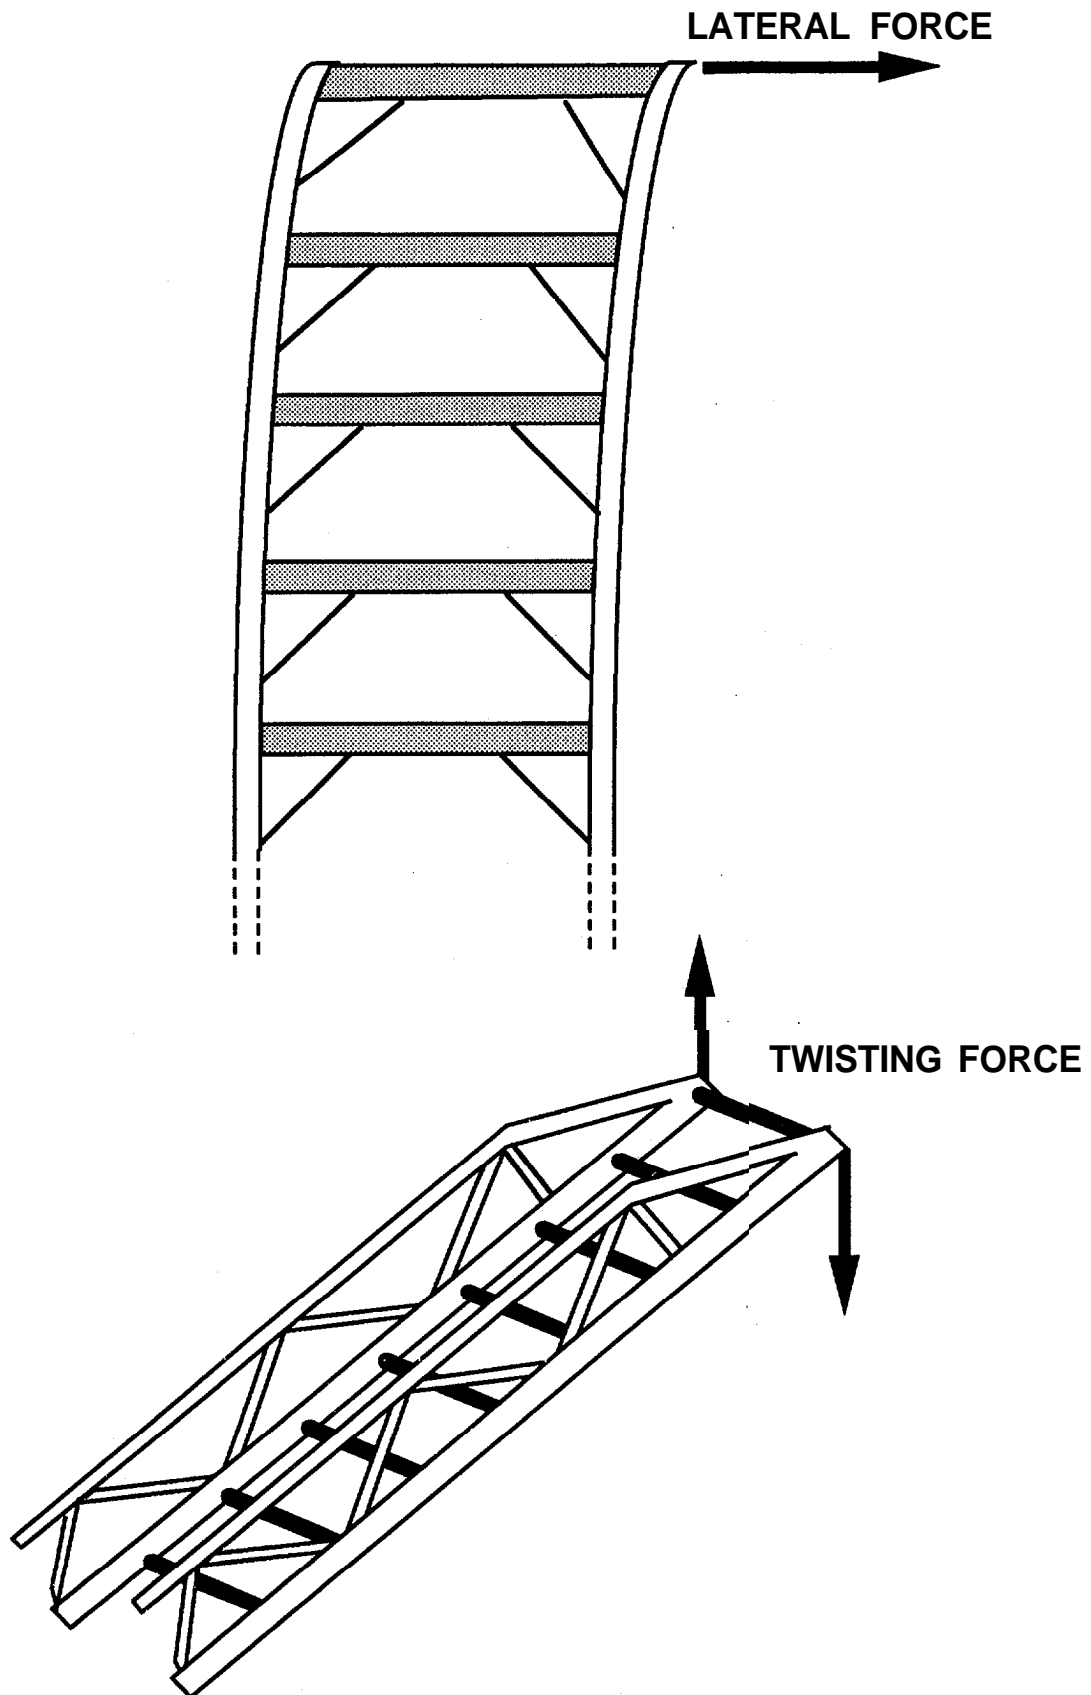
**Figure 4. Lateral Forces and Twisting Forces in Aerial Ladders**

The New York City collapse occurred when the capacity of the lower beam to support the compression forces was exceeded. The ladder was subjected to twisting forces caused by the contact between the building and the tip of the left beam (see Figures 2 and 5). In this situation the twisting increased the compressive load on the bed ladder at the location where the maximum bending stress is applied to the ladder, just above the area where the load is transferred to the vehicle. The inward buckling of the beam caused the right side of the ladder to fail first, which caused the ladder to twist to the right as it fell.

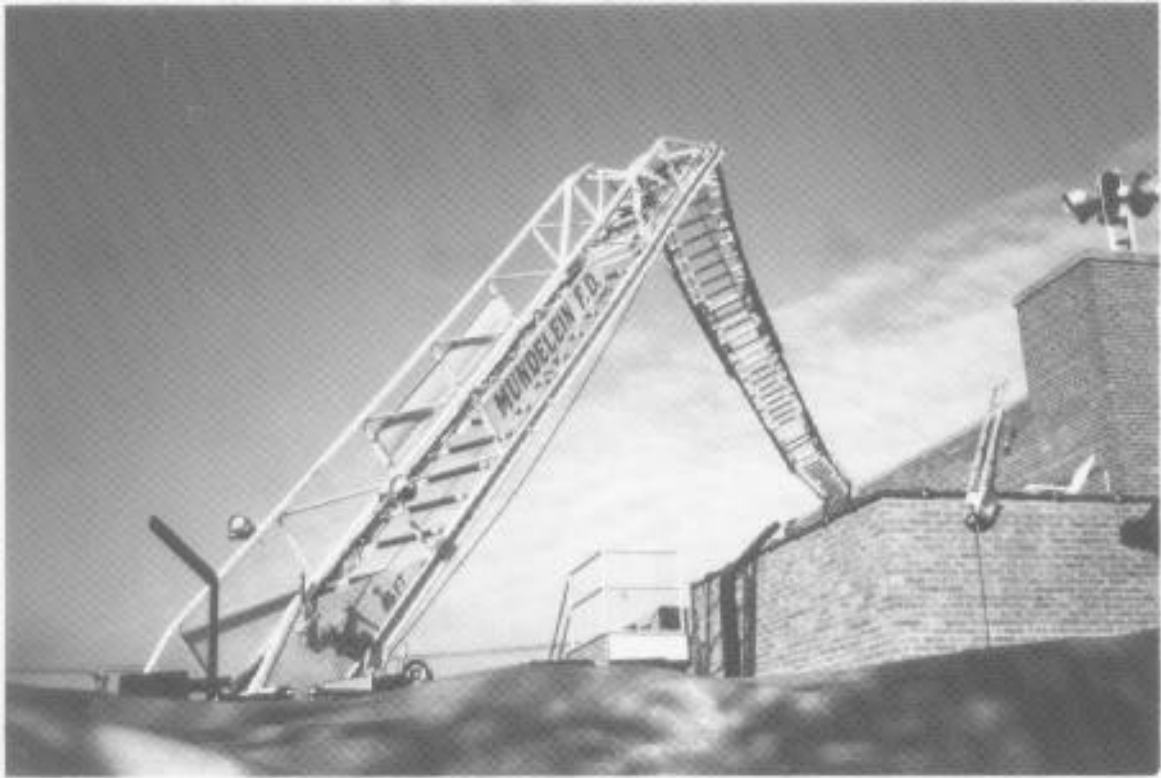
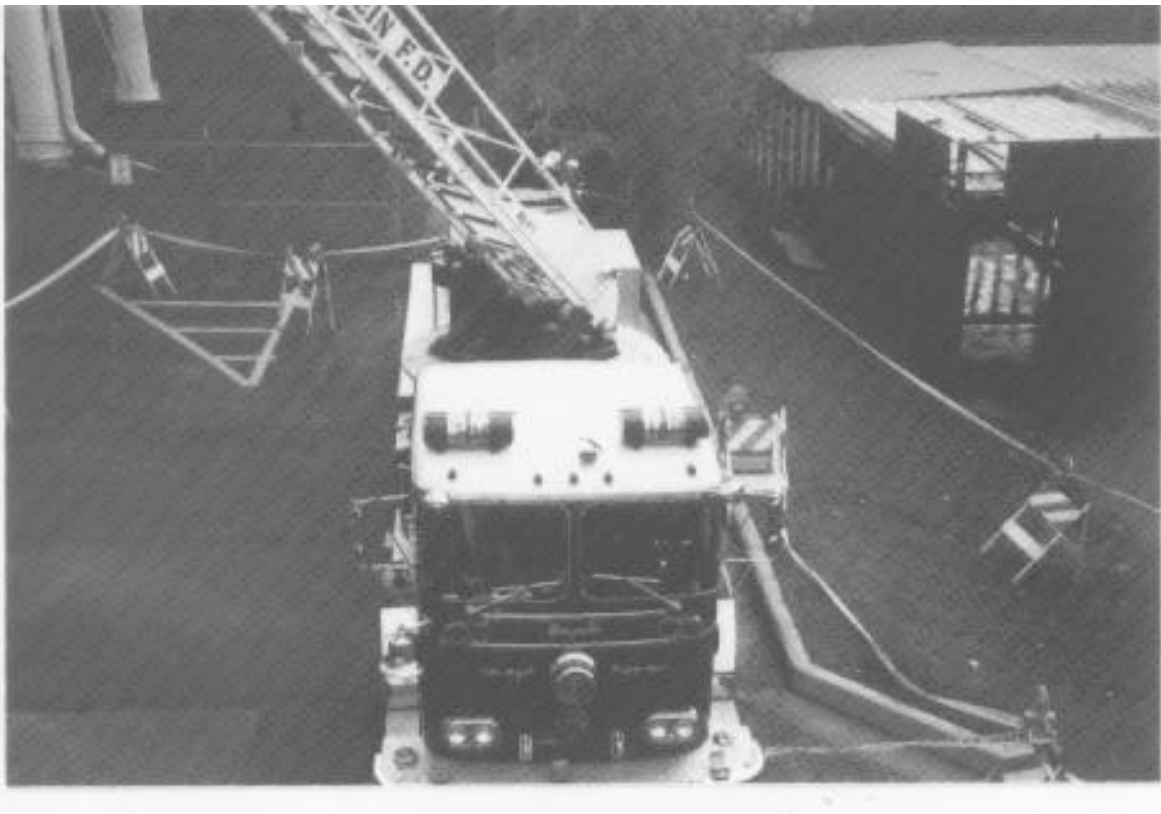
Firefighters in Mundelein, Illinois were practicing a stokes basket evolution when their aerial ladder failed just above the bed section. The firefighters had run a rope through pulleys attached to the tip and the front tow hook (seen below), and were attempting to raise the basket when the collapse occurred.

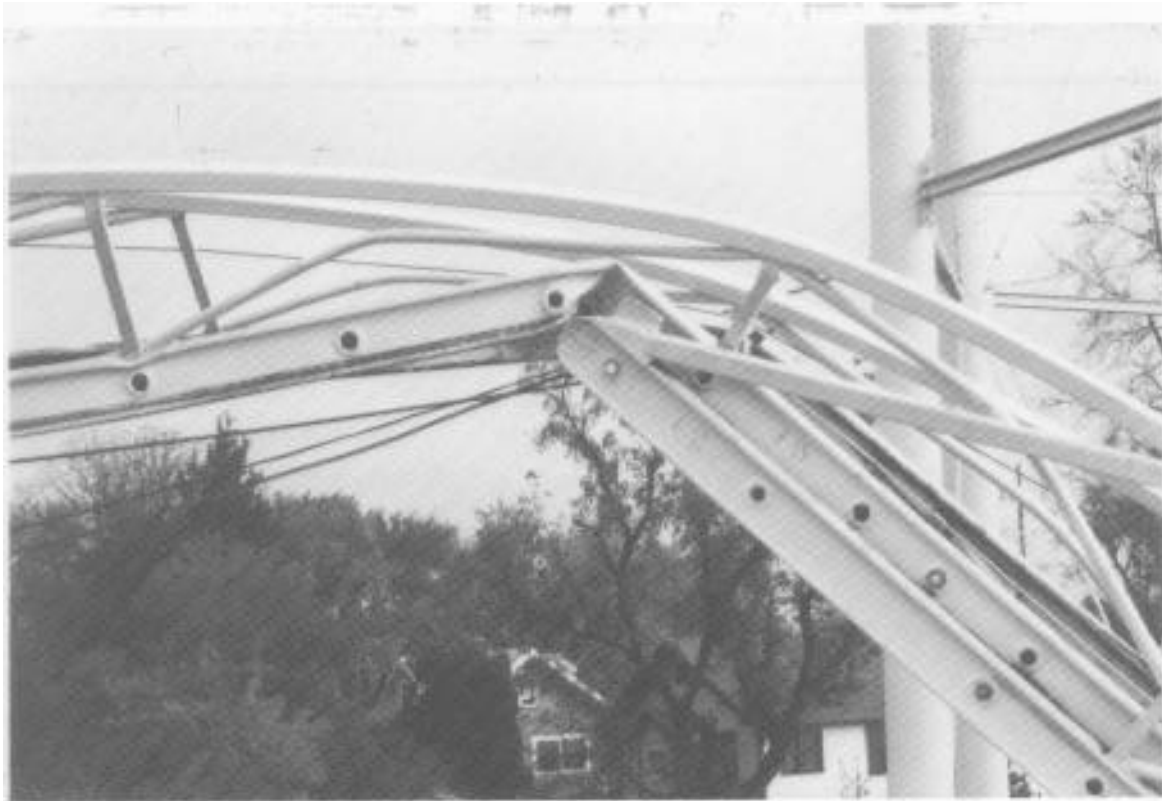
This photo shows a close-up view of the point of failure just above the bed section in the Mundelein incident. Ladder failures often occur at this point in the ladder.

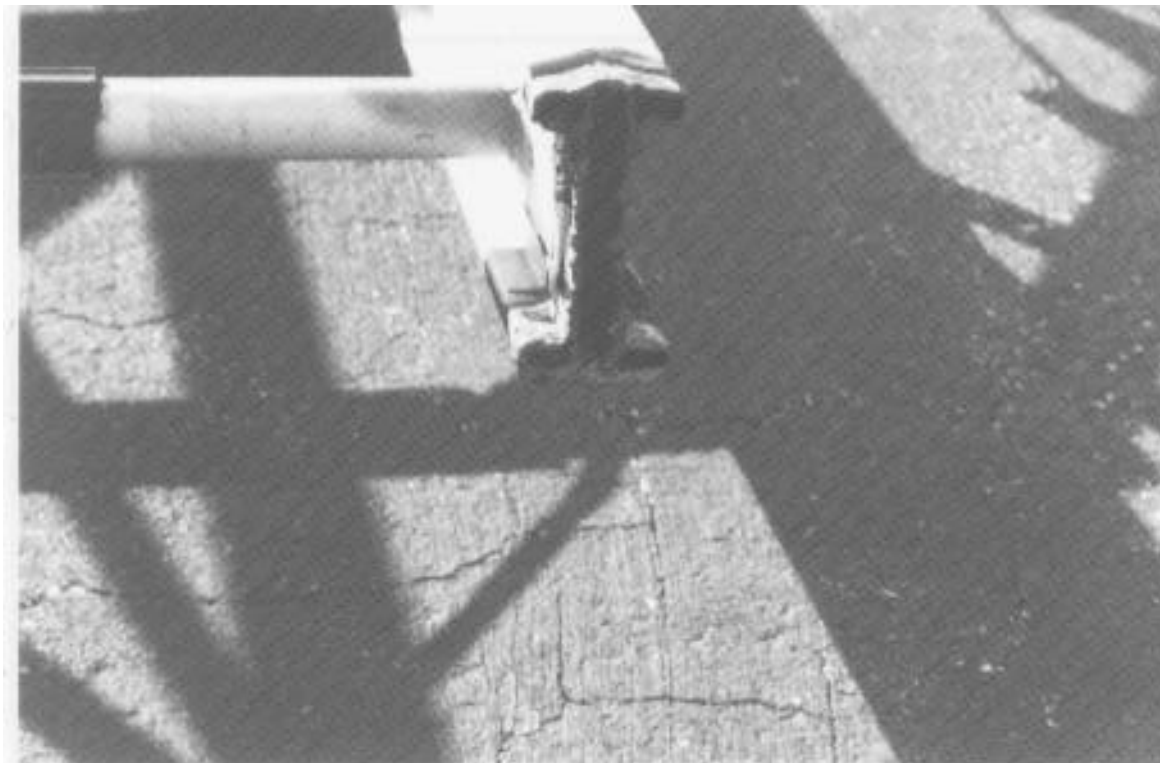
Cross section of the main beam of the Mundelein ladder after it was cut to remove the damaged sections. The beam is assembled from several section of flat steel strips which are bent to form the flanges and then welded together to create the I-beam shape. The interior of the beam is hollow.

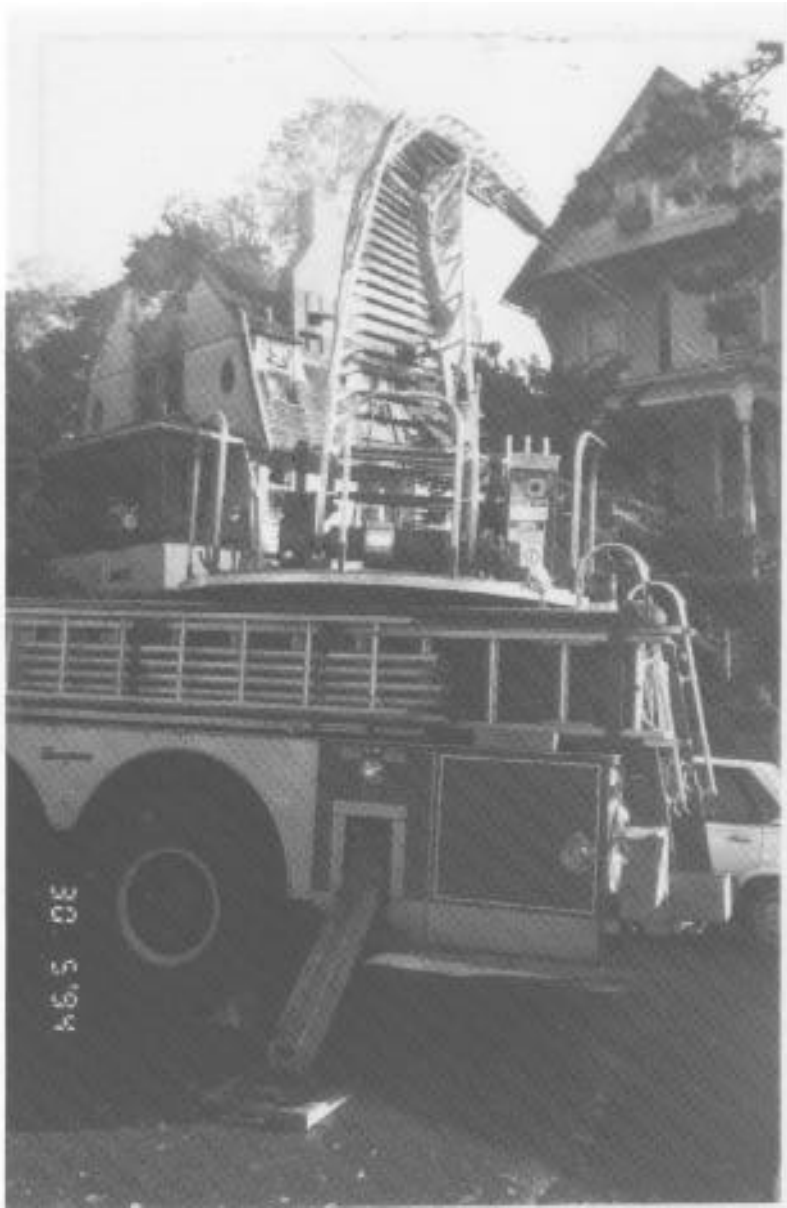
A Yonkers, New York aerial ladder failed during ladder pipe operations.

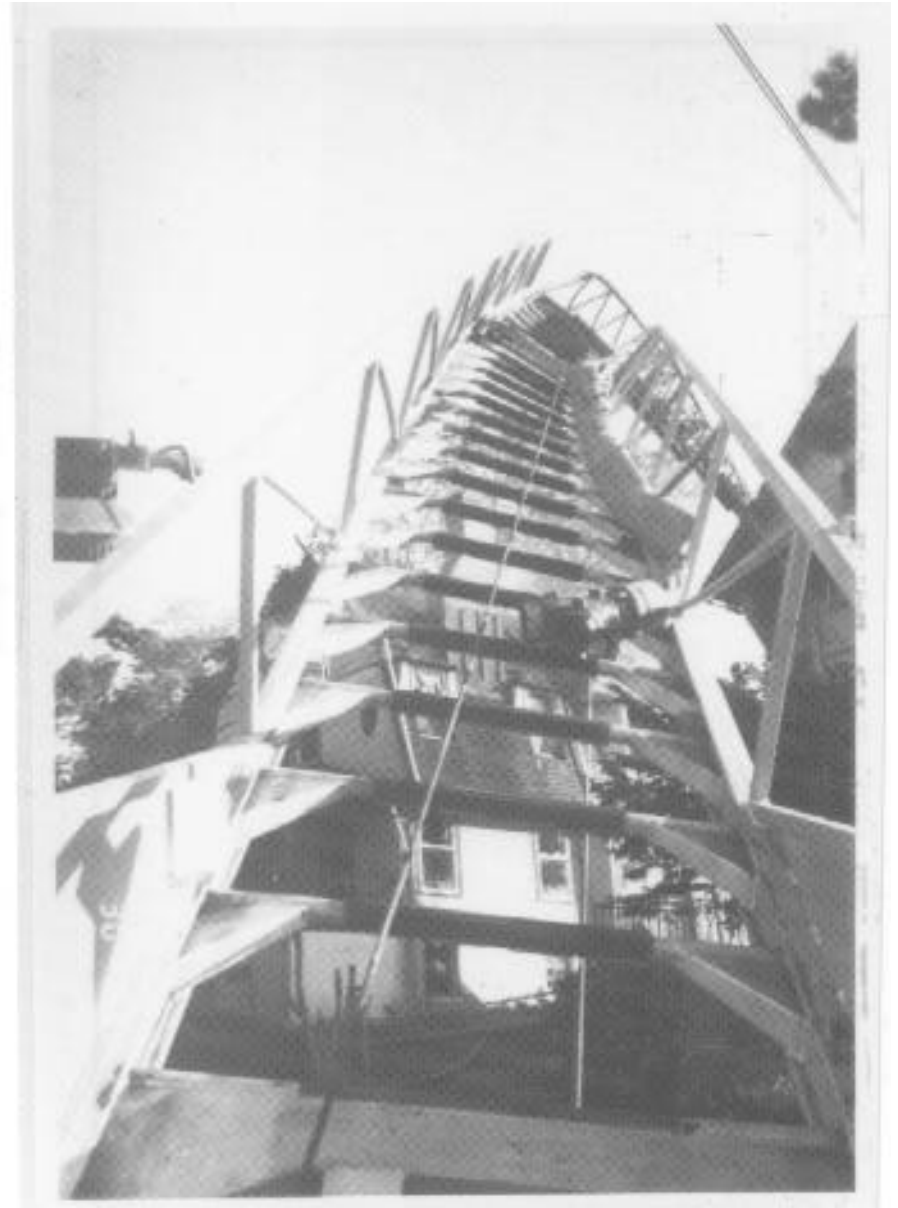
The ladder failed in the first fly section just above the bed section.

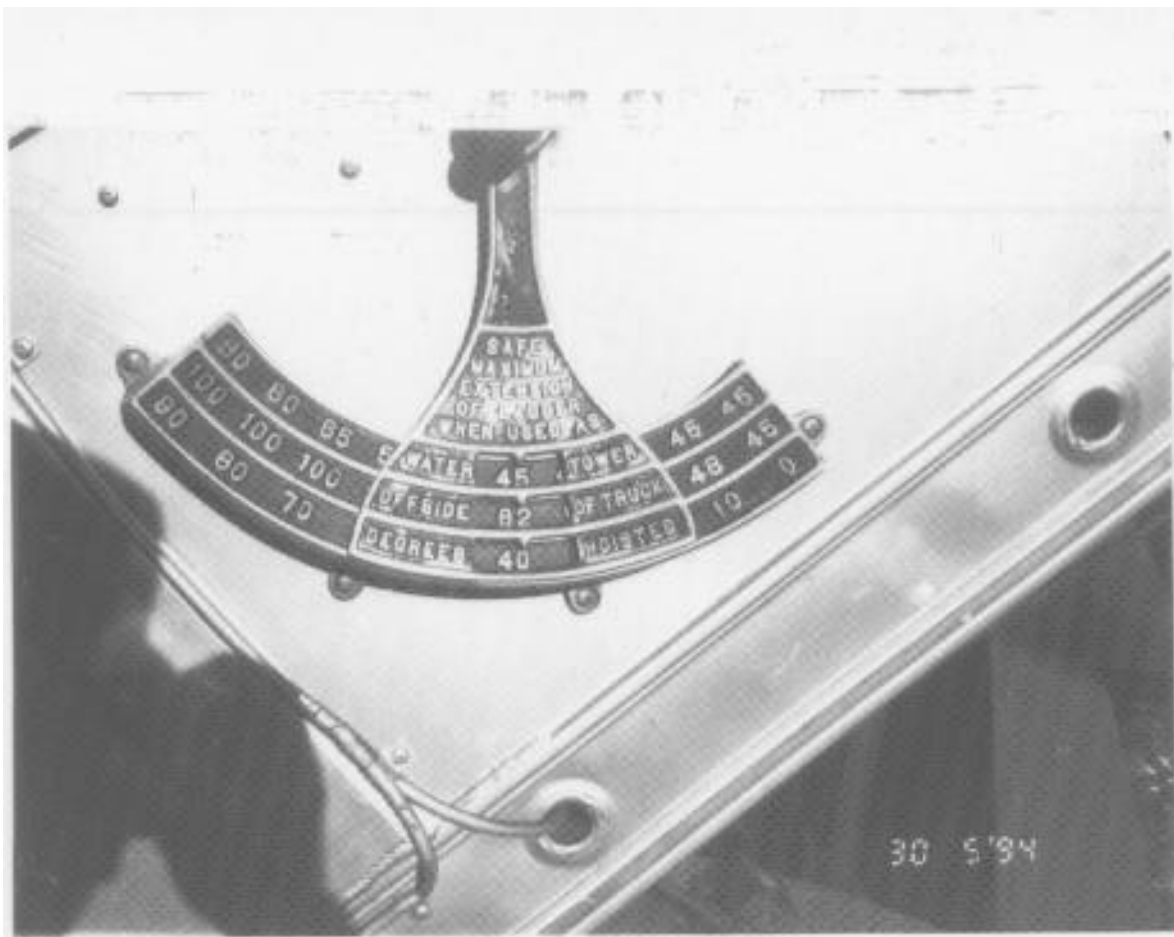
Although the exact angle of elevation at the time of the Yonkers collapse is unknown, the ladder was fully extended at an angle estimated at less than 50 degrees. The inclinometer shows that the maximum safe extension at 40 degrees elevation for a water tower operation is 45 feet.

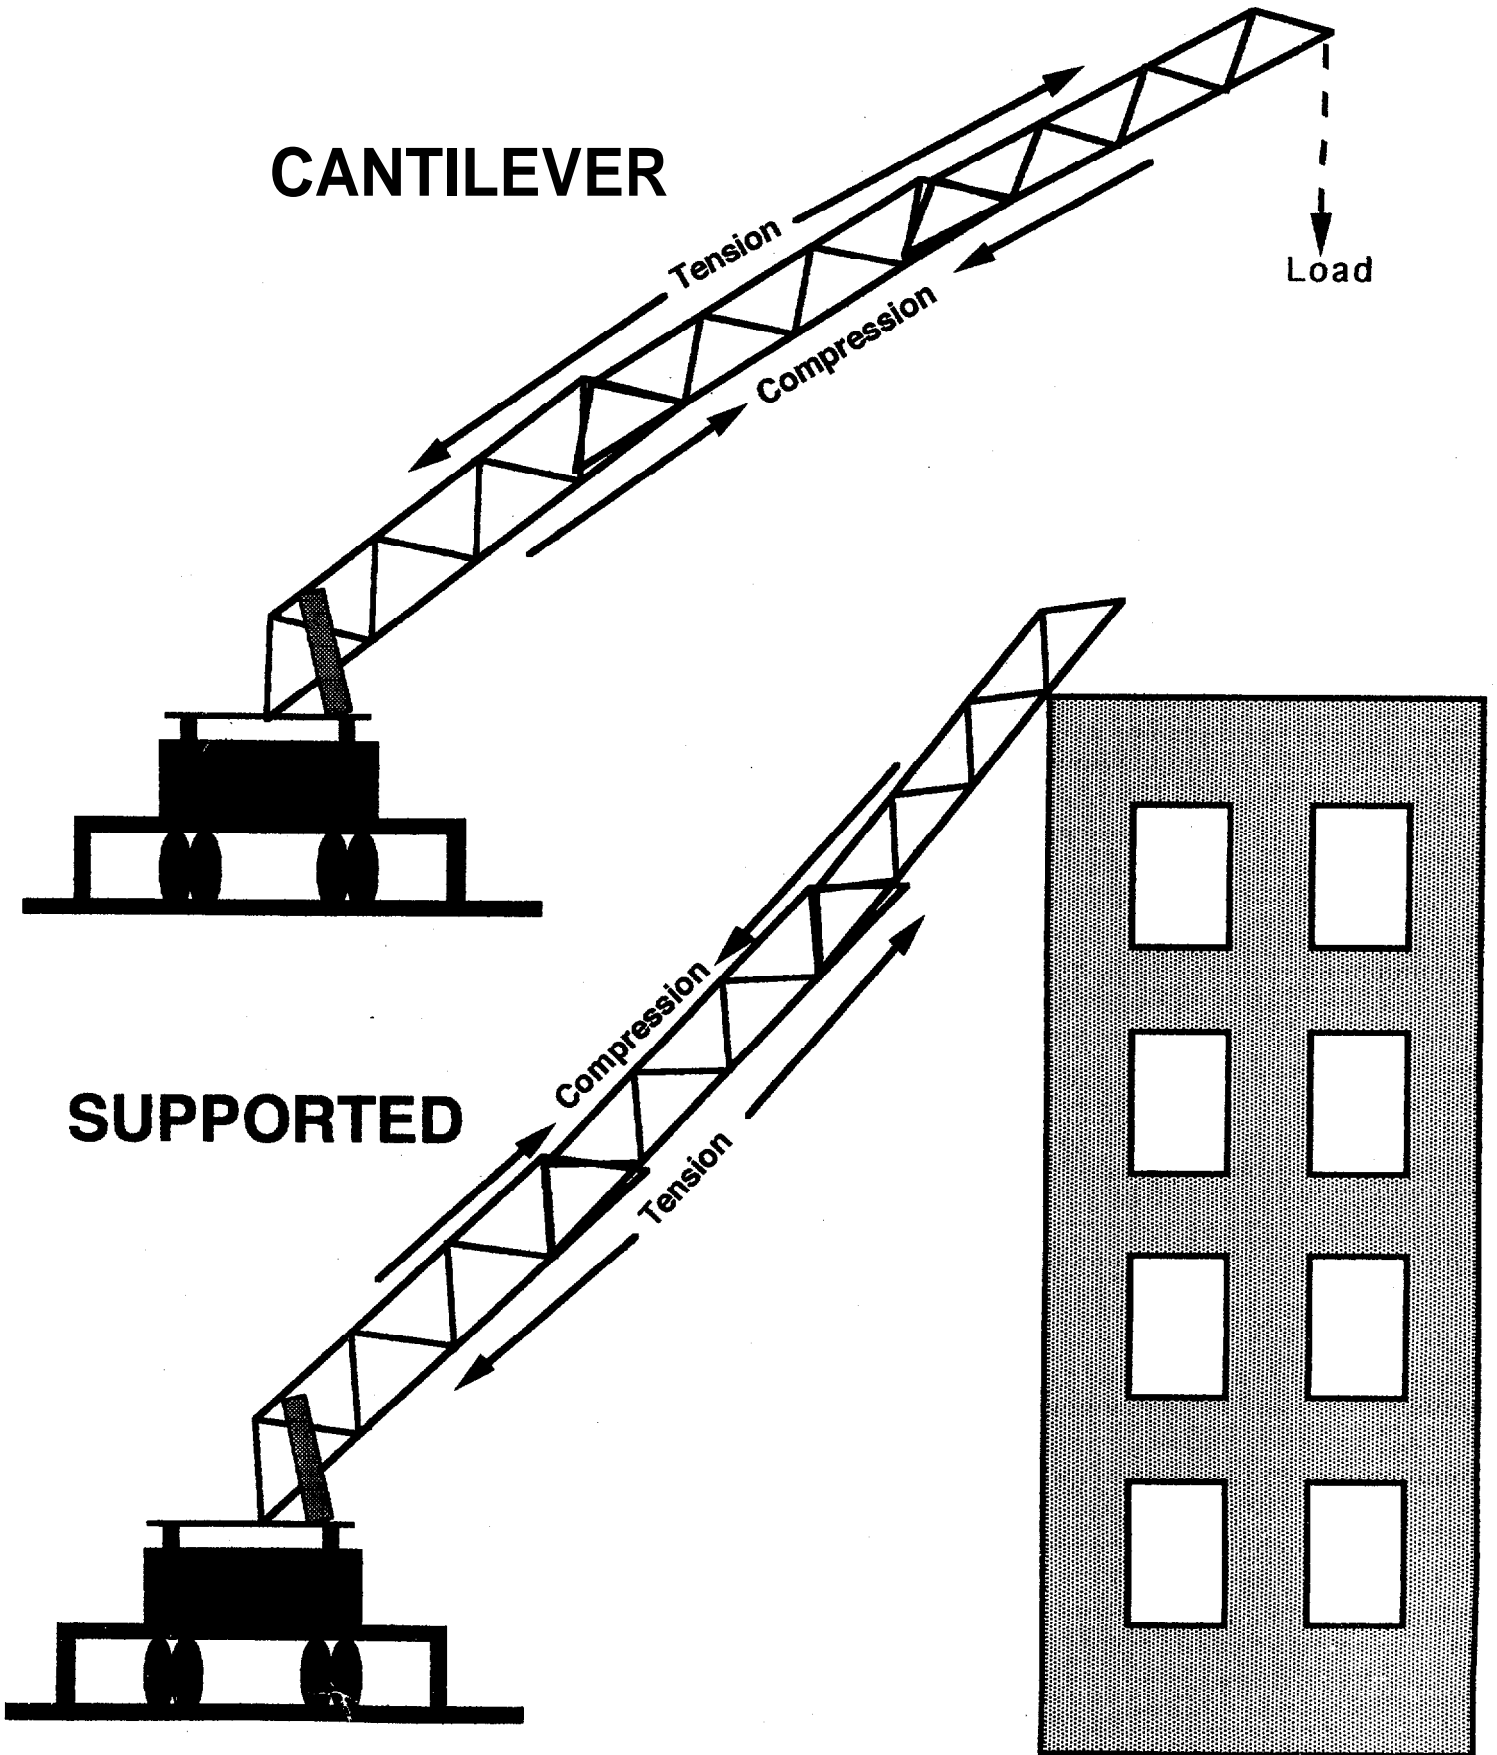
Figure 5. Forces in Ladder in Cantilever and Supported Operating Modes

Failure Analysis - An aerial ladder is a complicated assembly of trusses which telescope together. Each larger section of the ladder is significantly stronger than the individual sections that telescope into it, and the assembly is particularly strong where the sections overlap. In a cantilever configuration, bending stress creates tension forces in the top chord (the handrails) and compression forces in the bottom chord (lower beams), which increase in magnitude from top to bottom. When the tip of the ladder is supported the top chord is in compression and the bottom chord is in tension. A cantilever configuration creates greater bending stresses in a ladder than a supported configuration.

Simple bending failures often occur at the point where the first section extends out of the bed ladder, as shown in several of the incidents discussed in this report. At this location the ladder is subjected to the greatest bending forces in any of the telescoping sections, just prior to the point where the load is transferred to the bed ladder. The bending forces continue to increase in magnitude down to the bottom of the ladder; however, the bed ladder has a much greater capacity to resist bending stresses than the telescoping sections. Failures that occur at this location often involve elongation of the handrails when their tensile capacity is exceeded, or buckling of the lower beams due to compression forces, allowing the upper portion of the ladder to droop.

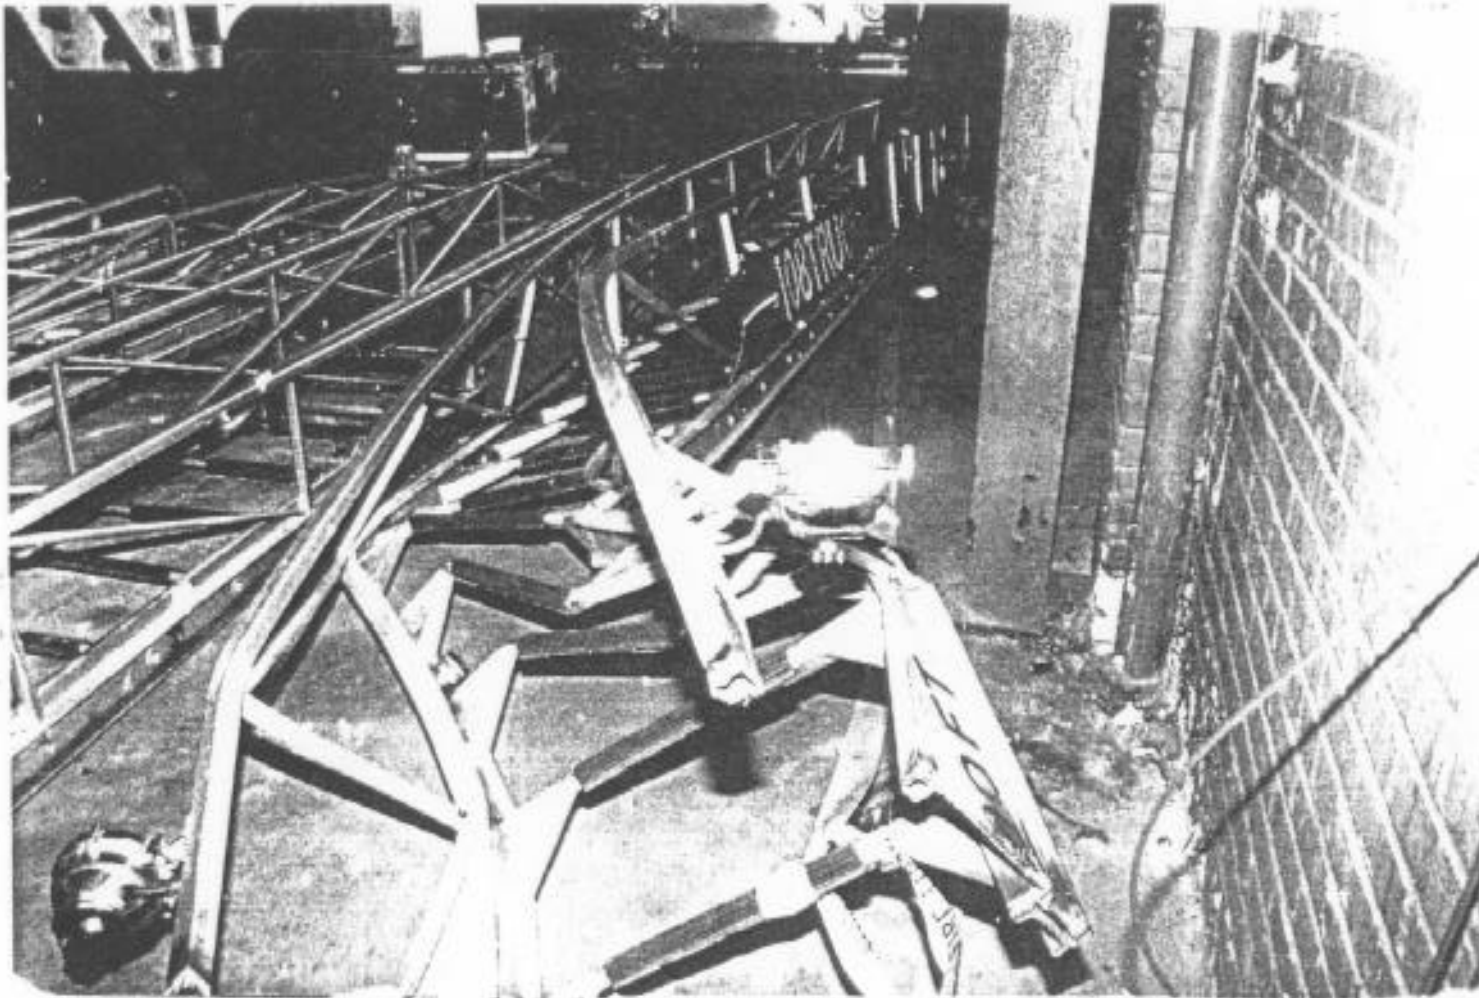
The bottom chord of the truss sides appears to be custom made and has the shape of a hollow I-beam section, Figure 2. Approximate dimensions of this cross section as well as the overall dimensions of the four ladder sections were made during examination of the ladder. For example, the I-beam chord has a flange width of a little over 2 inches and a height of between 4 and 4.25 inches. The railing, which forms the top chord of the truss, is a square tube section, 1.5 inches on a side at the bed section.

Figure 2. Photograph of Sections of the Failed Ladder after Disassembly and Storage. Bottom Chord Cross Section is Shown in the Lower Right Corner.

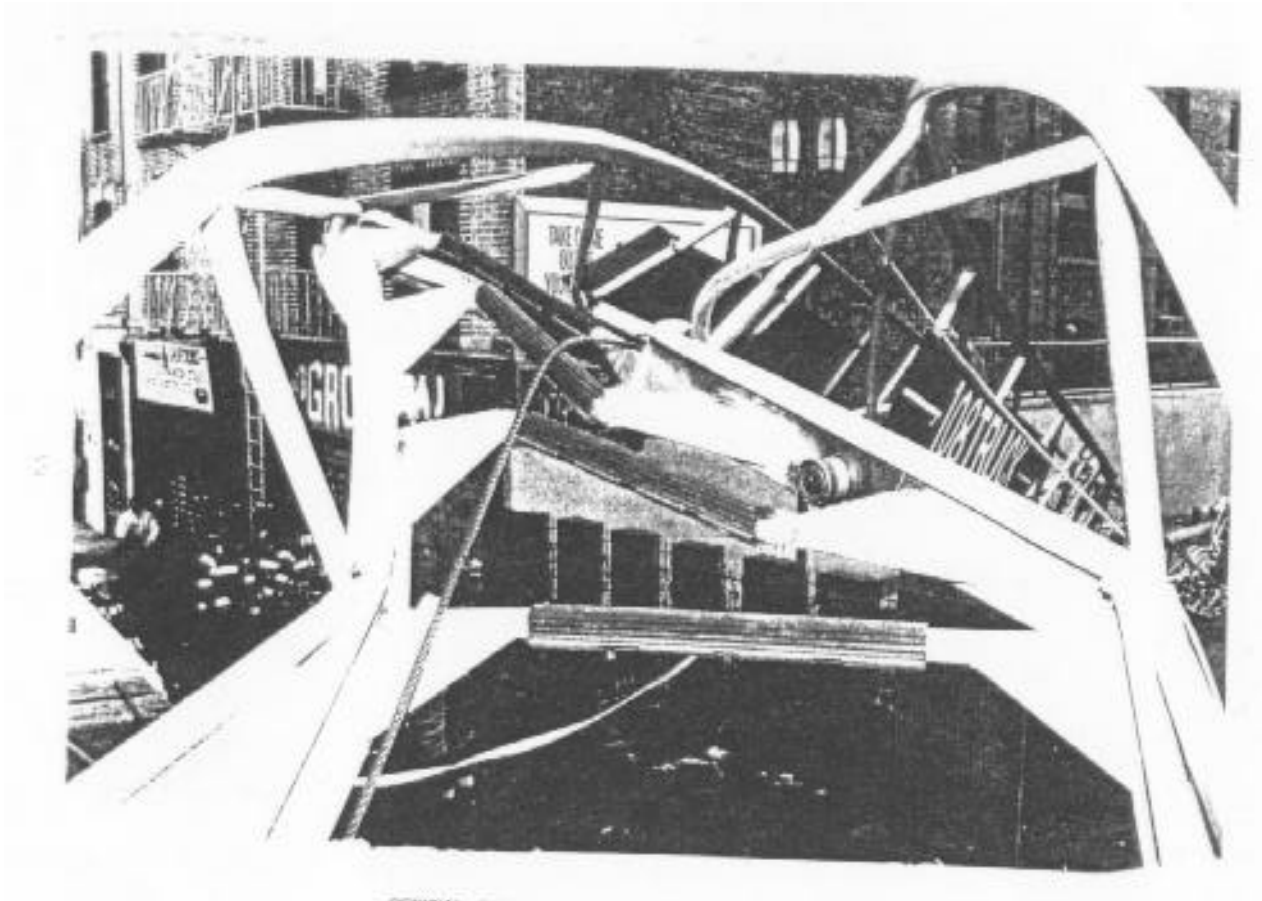
Figure 3. Photograph of the Buckled Bed Section in the Failed Ladder at the Site of the Accident.
