# **Aerial Ladder Collapse Incidents (April 1996)**

**This is Report 081 of the Major Fires Investigation Project conducted by Varley-Campbell and Associates, Inc./TriData Corporation under contract EMW-94-C-4423 to the United States Fire Administration, Federal Emergency Management Agency.**

## **Aerial Ladder Collapse Incidents**

Failure Analysis of a  
100 ft Aerial Ladder

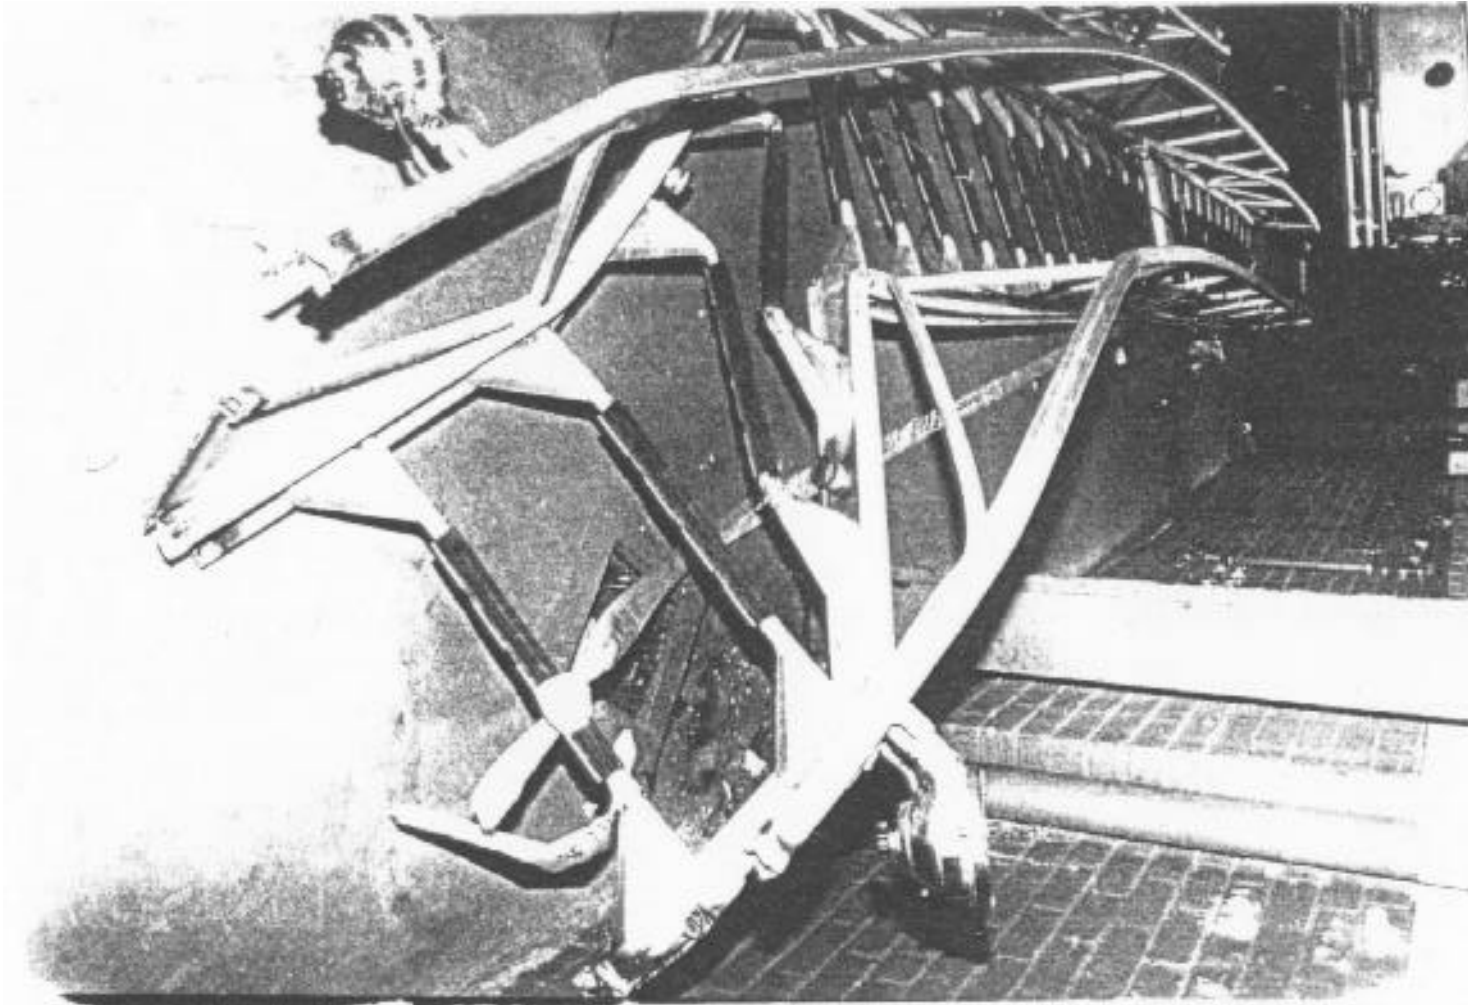
The primary structural failure occurred when the main beam on the lower right side of the bed section buckled inward, slightly above the point where it is supported by the ladder raising mechanism. This part of the ladder would be subjected to the maximum bending stress when the ladder is in a cantilever (unsupported) position. The buckling of the lower beam also crushed two of the rungs and caused a secondary buckling of the left main beam in the same area. The buckling indicates that the failure resulted from compression forces in the beam, which are caused by the bending stress in the ladder.

Figure 4. Photograph of the Bed Section of the Failed Ladder Showing the Buckled "Hinges" in the Right Bottom Chord.
