**Logan Valley Mall Fire  
Altoona, Pennsylvania**

**Logan Valley Mall  
Altoona, Pennsylvania  
December 16, 1994**

**Investigated by: Thomas H. Miller, P. E.**

This is Report 085 of the Major Fires Investigation Project conducted by Varley-Campbell and Associates, Inc./JTriData Corporation under contract EMW-94-4423 to the United States Fire Administration, Federal Emergency Management Agency.

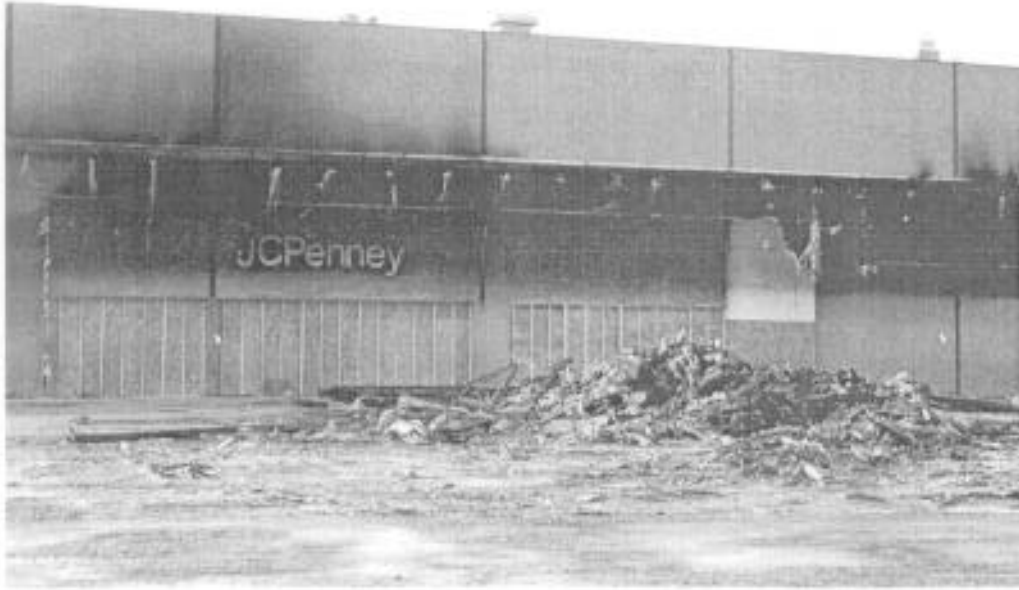
**Photograph 1.**

The J. C. Penney Store's separation from the covered mall consisted of a brick-faced 8-inch HCB wall and three large unprotected glass covered openings. Two of these were for show window openings and the third was for the store entrance which was closed at the time of the fire. Due to aggressive fire department actions, the tempered glass covering these openings did not fail during the fire. While not a rated fire wall due to the three openings, this wall was a significant factor in stopping the westward fire travel. The J. C. Penney side of the wall had automatic sprinklers spaced along the openings and the wall. All head spacings were on an ordinary hazard basis. The fire did not cause any heads to operate. No sprinkler heads protected the mall side of the wall and wall openings.

East wall of the J.C Penney Store where the westerly fire travel was stopped. Roof line of covered mall is identified by the dark black horizontal line. Glass entrance and show windows are behind the chipboard and wood studs.

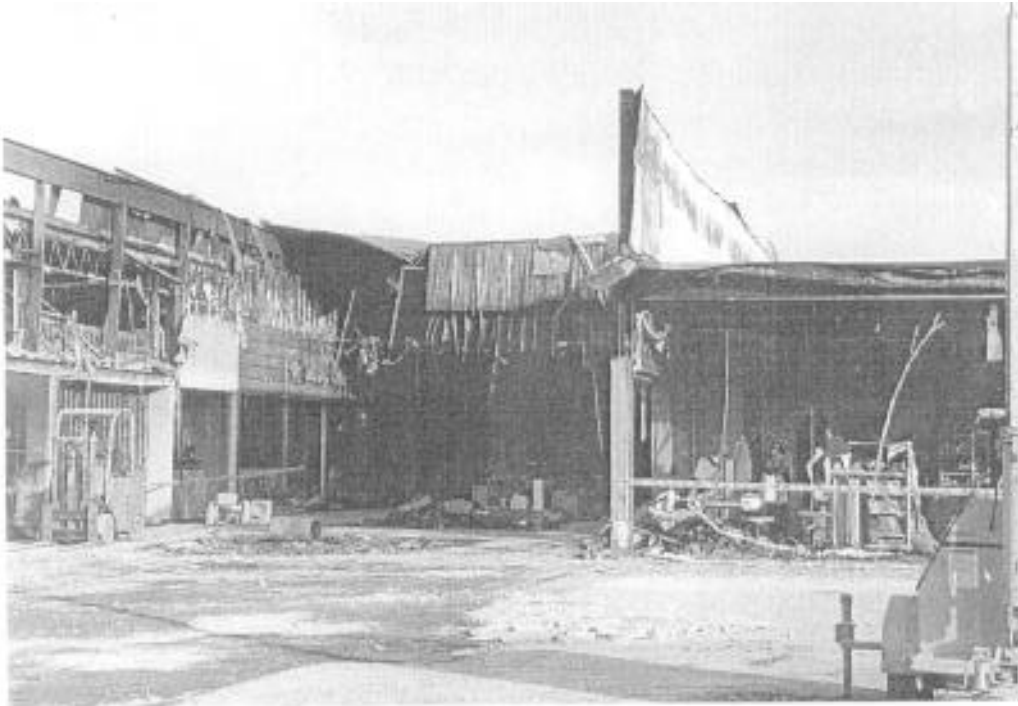
**Photograph 2.**

Covered mall to the east of the Murphy store and some of the stores adjacent to the covered mall. The three different roof heights and construction features are illustrated. The tenant separation wall for the right hand store has been removed.

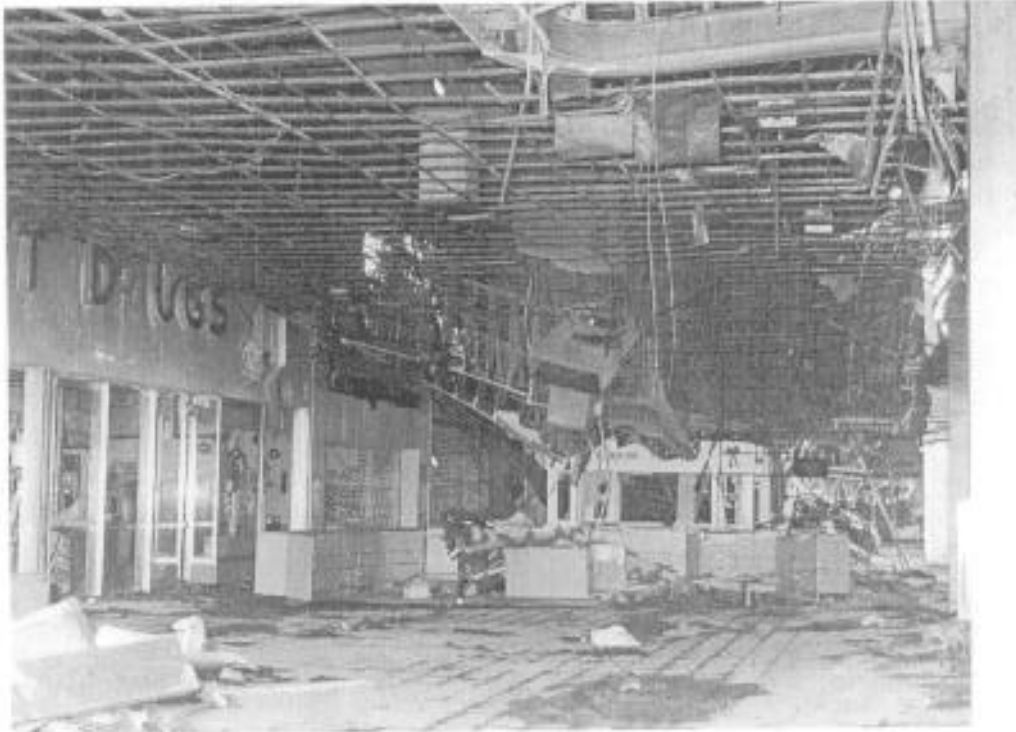
**Photograph 3.**

Looking east into the covered mall from about where the forklift is located in Photograph 2. The ceiling tiles were removed during the fire and the floor debris was removed before the photograph was taken. Note the partial roof collapse in the background

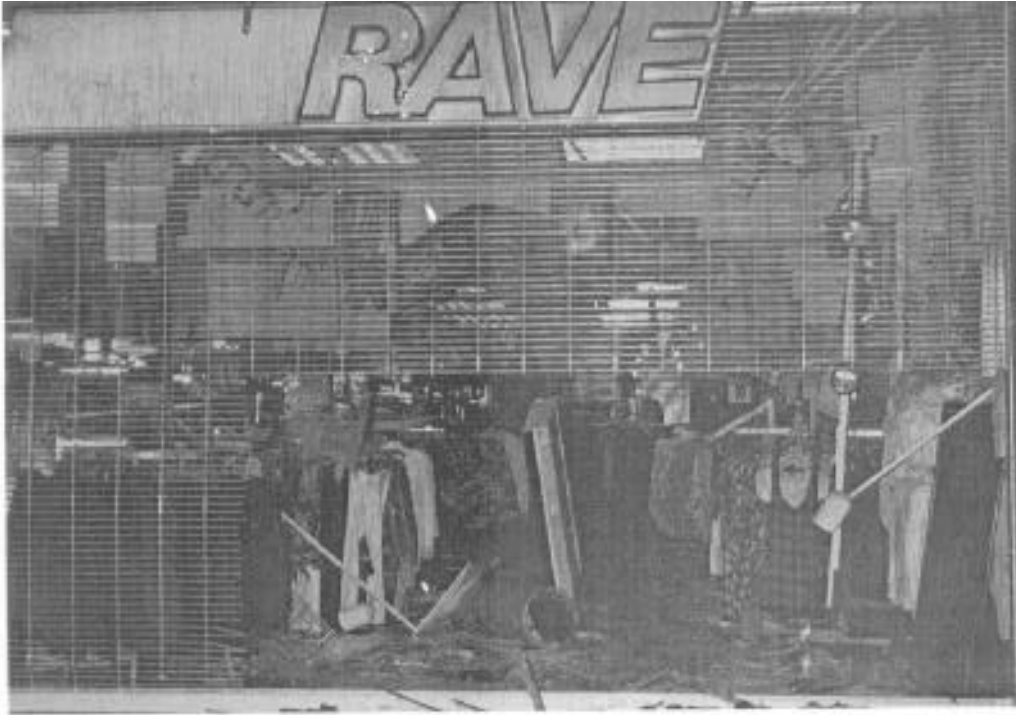
**Photograph 4.**

Open grill security separations allowed the free passage of smoke and heat into stores from the common, covered mall. This contributed to smoke and water damage to the stores' contents. Additionally, the forcible entry through these separations was more difficult and time consuming than for stores with solid separations. Smoke damage in a retail store is often as costly as direct fire damage. Controlling smoke travel is an important element in limiting damage. Rated fire resistance in the separation is not as important as a solid separation with minimal unprotected penetrations. NFPA 101, *Life Safety Code*, does not require separation between the covered mall and the tenant stores, but does require automatic sprinklers and a "smoke control system" within the covered mall. These systems were not present in this incident.

Store on the south side of the covered mall. Typical of the forcible entry work performed on the security grill and the damage to goods. This store had automatic sprinklers and the sprinkler heads at the front entrance operated.

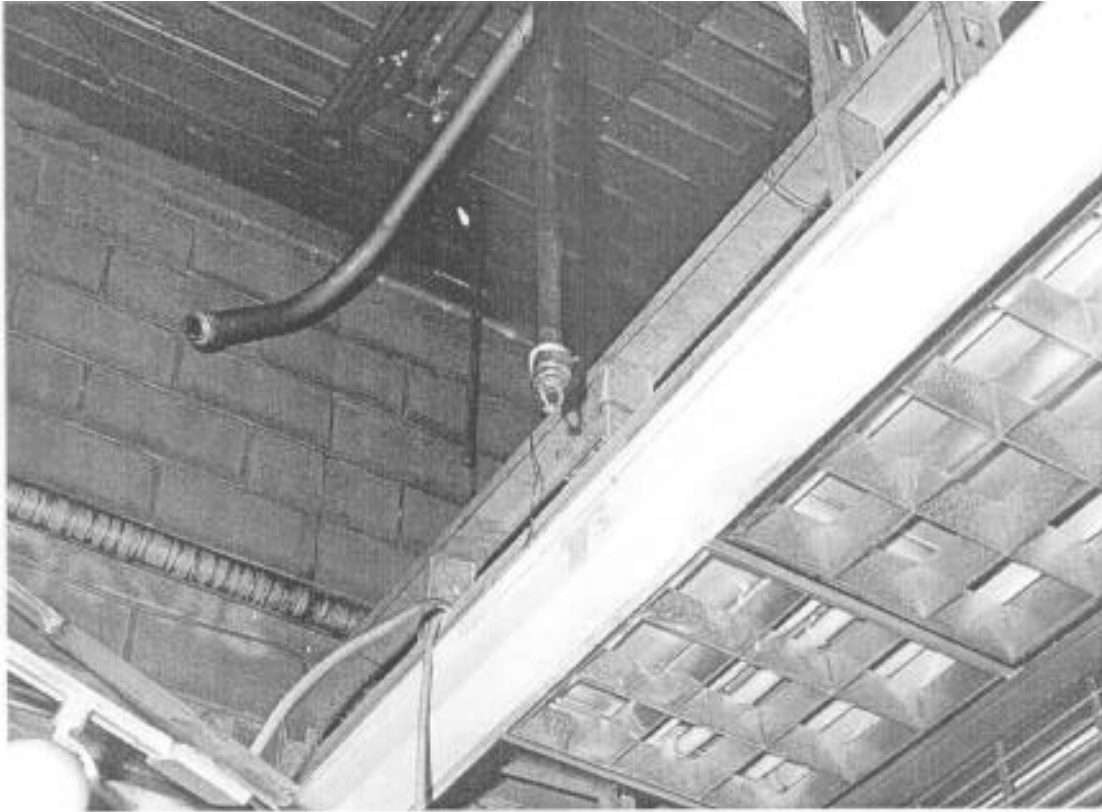
**Photograph 5.**

Open sprinkler head inside the store in Photograph 4. The ceiling tiles and grid around the head were removed before the picture. Typical concrete block tenant separation wall and metal deck roof construction in the older section. Interior tenant construction has used wood studs for the metal ones.

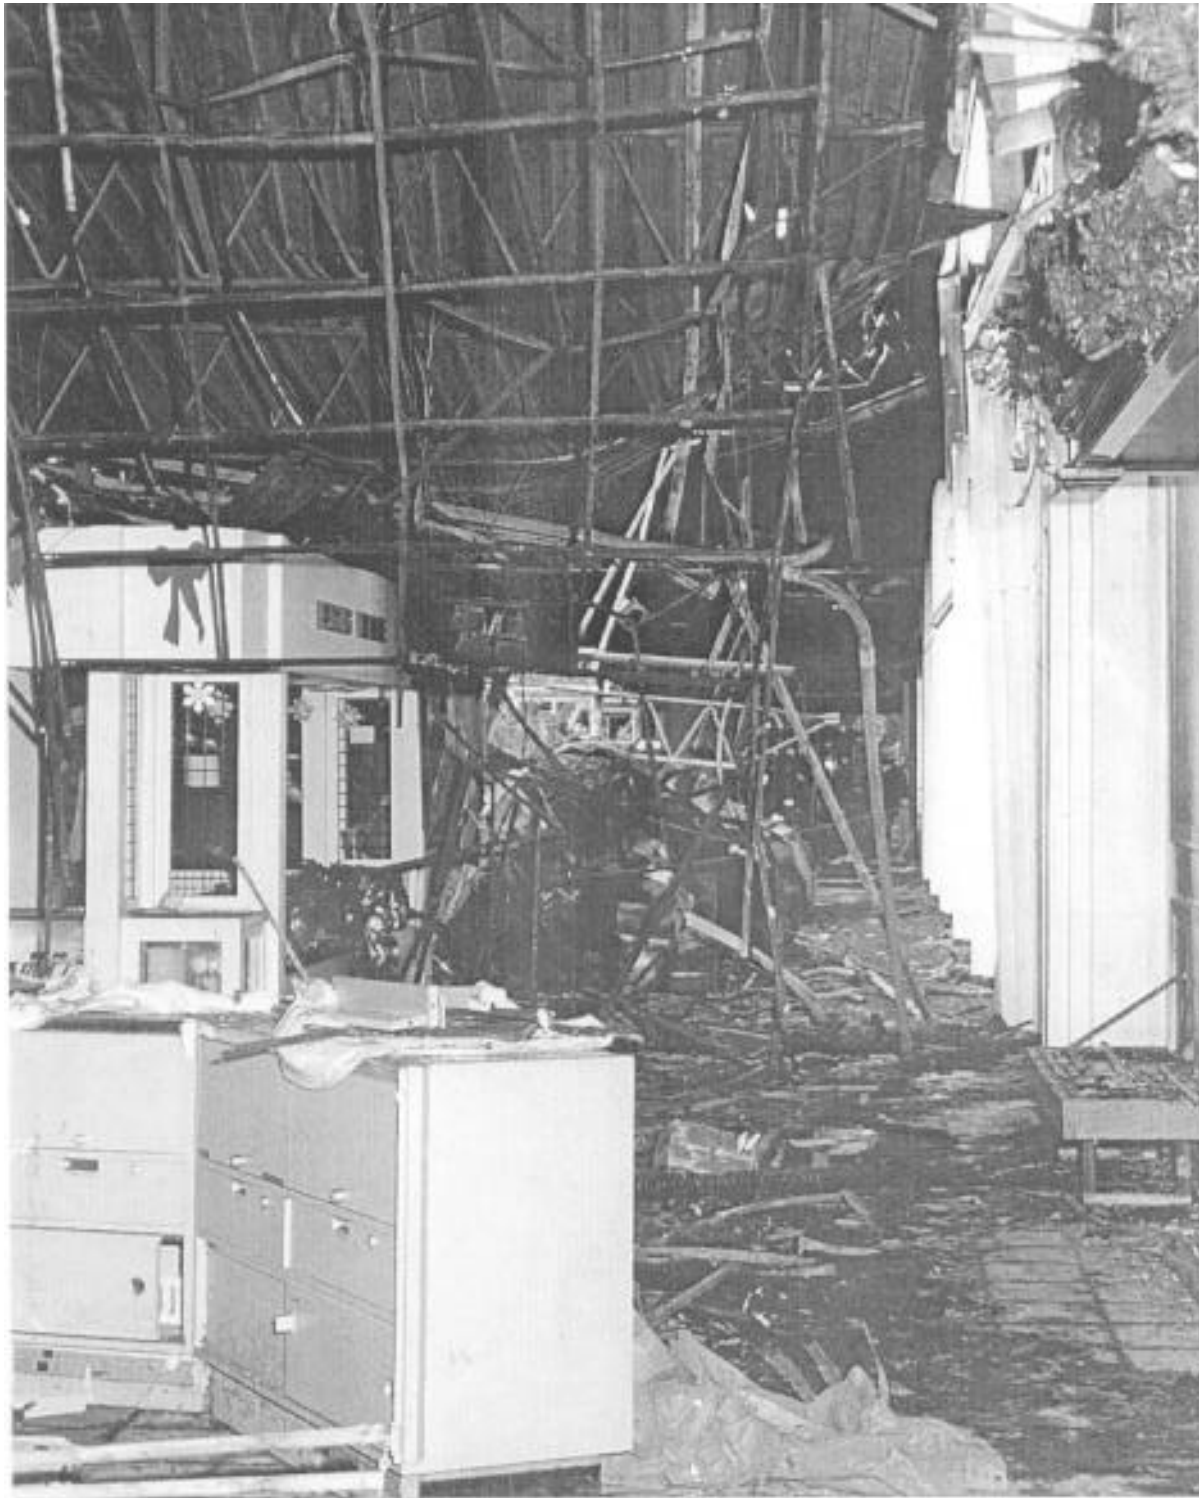
The fire and heat spread for a considerable distance in the covered mall area from in front of the G. C. Murphy store east to the food court. The covered mall's roof collapsed for about 60 feet to the east of the G. C. Murphy store. Further to the east, a roof section approximately 80 feet long was left standing but showed signs of burning on the underside of the deck. A kiosk below this section suffered only smoke and water damage. East of the standing section, another part of the roof collapsed in a lean-to fashion for a distance of approximately 60 feet. This collapse was due to the roof support beam on the south side rolling over. A candle kiosk under this collapse was not burned and the visible candles were not melted. One basket of candles was covered with melted tar, likely from the roof. (See Appendix F)

**Photograph 6.** Moving further east in the covered mall, the counters in the foreground are also in Photograph 3. This area is where the metal roof began a partial collapse. The goods in the kiosks were either stored before the fire or removed prior to the picture.

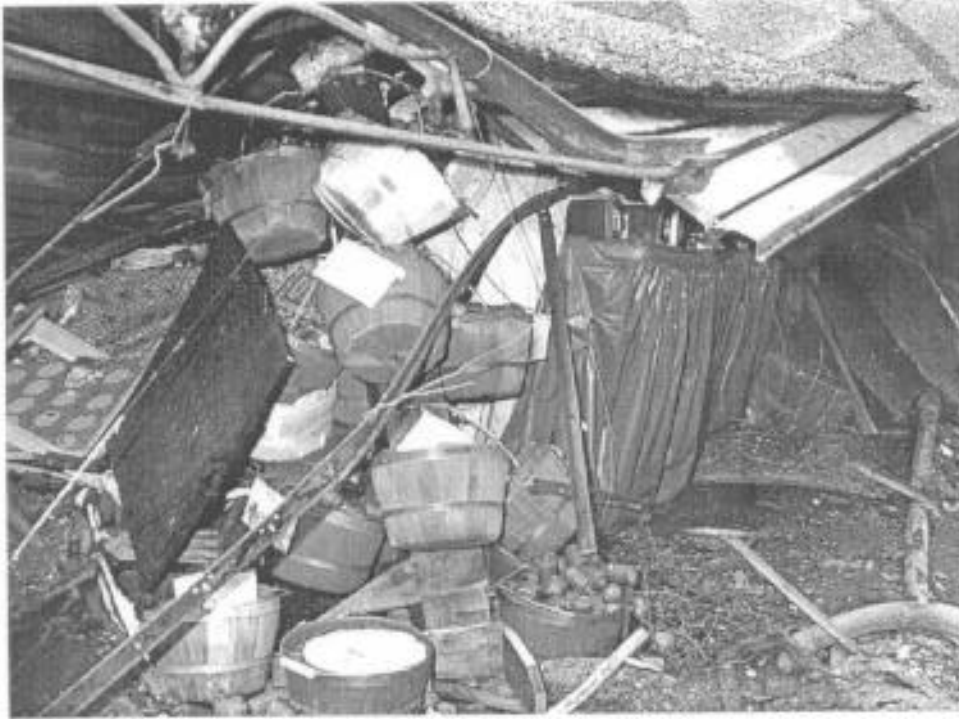
**Photograph 7.**

A candle kiosk under the roof collapse area shown in Photograph 6. Note that the candles, wicker baskets and table skirting are not melted or burned. Yet, the metal bar joist is severely deformed.

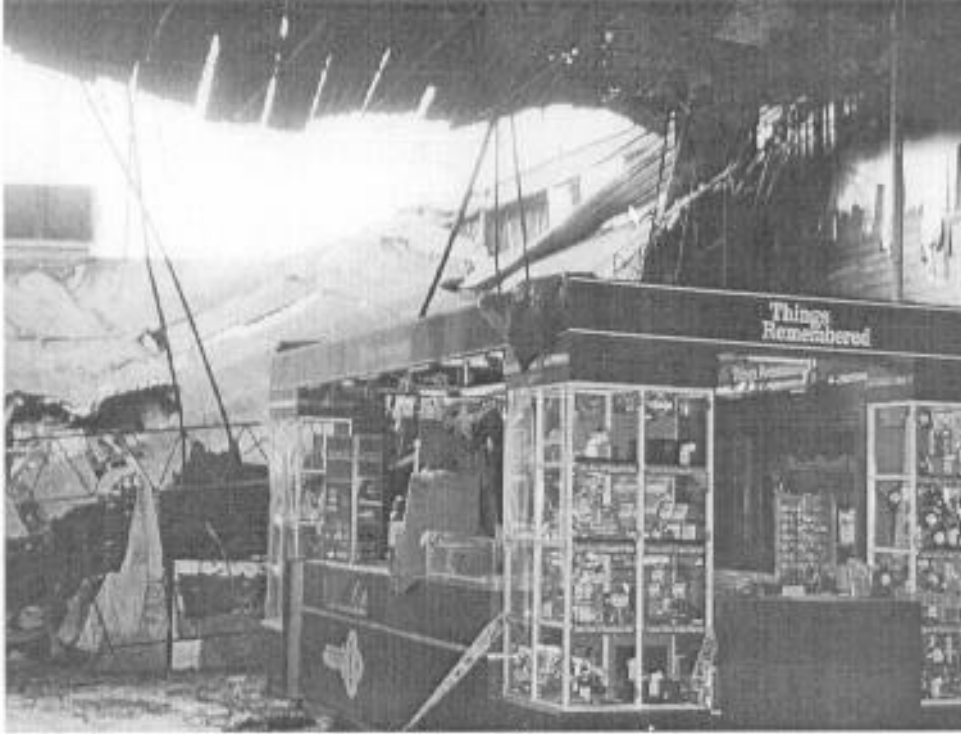
**Photograph 8.**

A front view of the partial roof collapse over the Things Remembered kiosk.

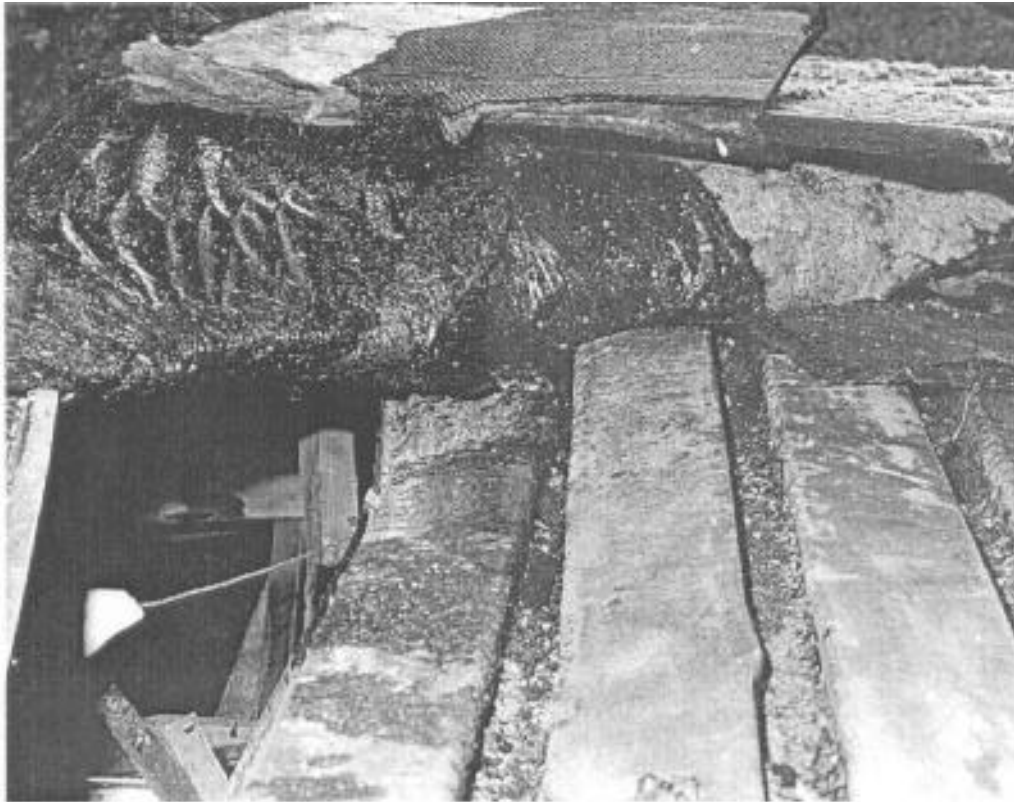
**Photograph 9.**

The fire damage and collapse of the covered mall roof was attributed to fire spreading under the metal deck roof. The fuel for this fire was the melted and vaporized asphalt from the adhesive and vapor barrier above the metal deck and under the roof insulation. This flammable vapor leaked into the building through the seams in the metal deck where it ignited. This combustion melted and vaporized more asphalt, creating a self-sustaining fire under the roof deck. The undamaged combustible kiosks at floor level further support this observation and also document the effectiveness of firefighter tactics and operations in this area.

The top of the metal deck roof illustrating the insulation board, the vapor barrier under the board, the seam in the deck and the deformed condition of the metal. This section is in the partial roof collapse area shown in previous photographs.

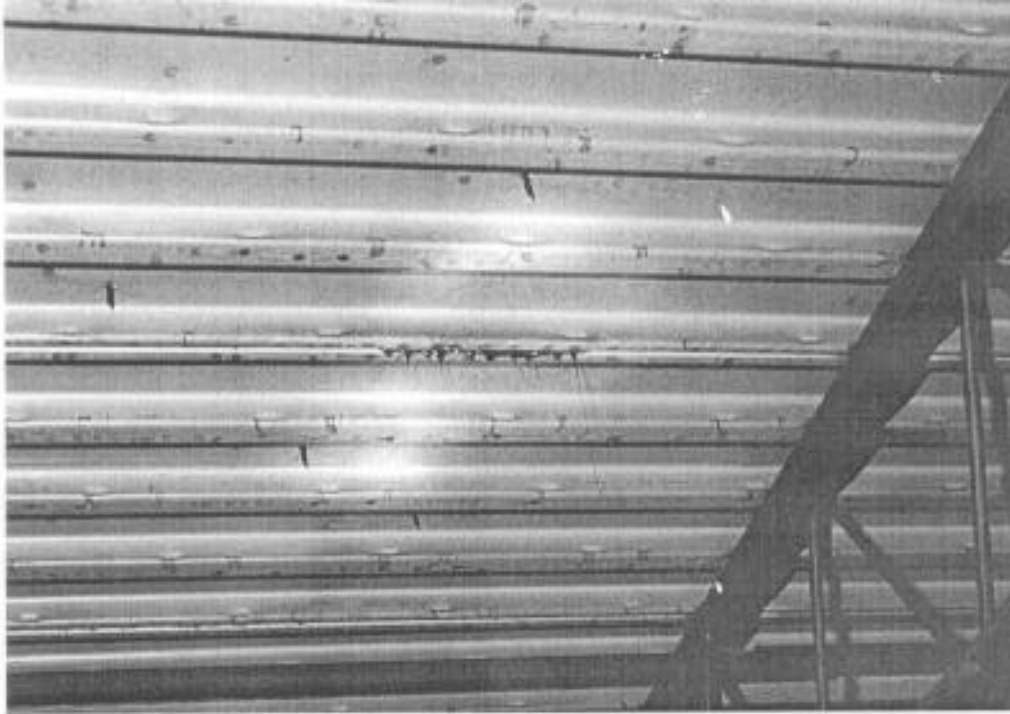
**Photograph 10.**

Parts of the complex had new roof coverings which were specified to meet Factory Mutual requirements for a Class I roof covering. Inspections by FM Engineering report that the roofing contractor was following proper procedure for installing a Class I covering. Mechanical fasteners, used with such roof installations, were found in some metal roof deck panels after the fire. The problem is that asphalt remains attached to the metal deck and in the corrugation valleys even when the old roof covering is tom off. This melts and vaporizes, providing the fuel for a fire under the deck. The age and history of the structure's roofing need to be included in pre-incident planning.

The underside of the metal deck roof above one of the stores adjacent to the covered mall. Note the tar dripping through the seam in the valley between metal deck sections. You can also see three mechanical fasteners poking through ridges in the deck. Such fasteners are usually found when less combustible roofing methods are employed.

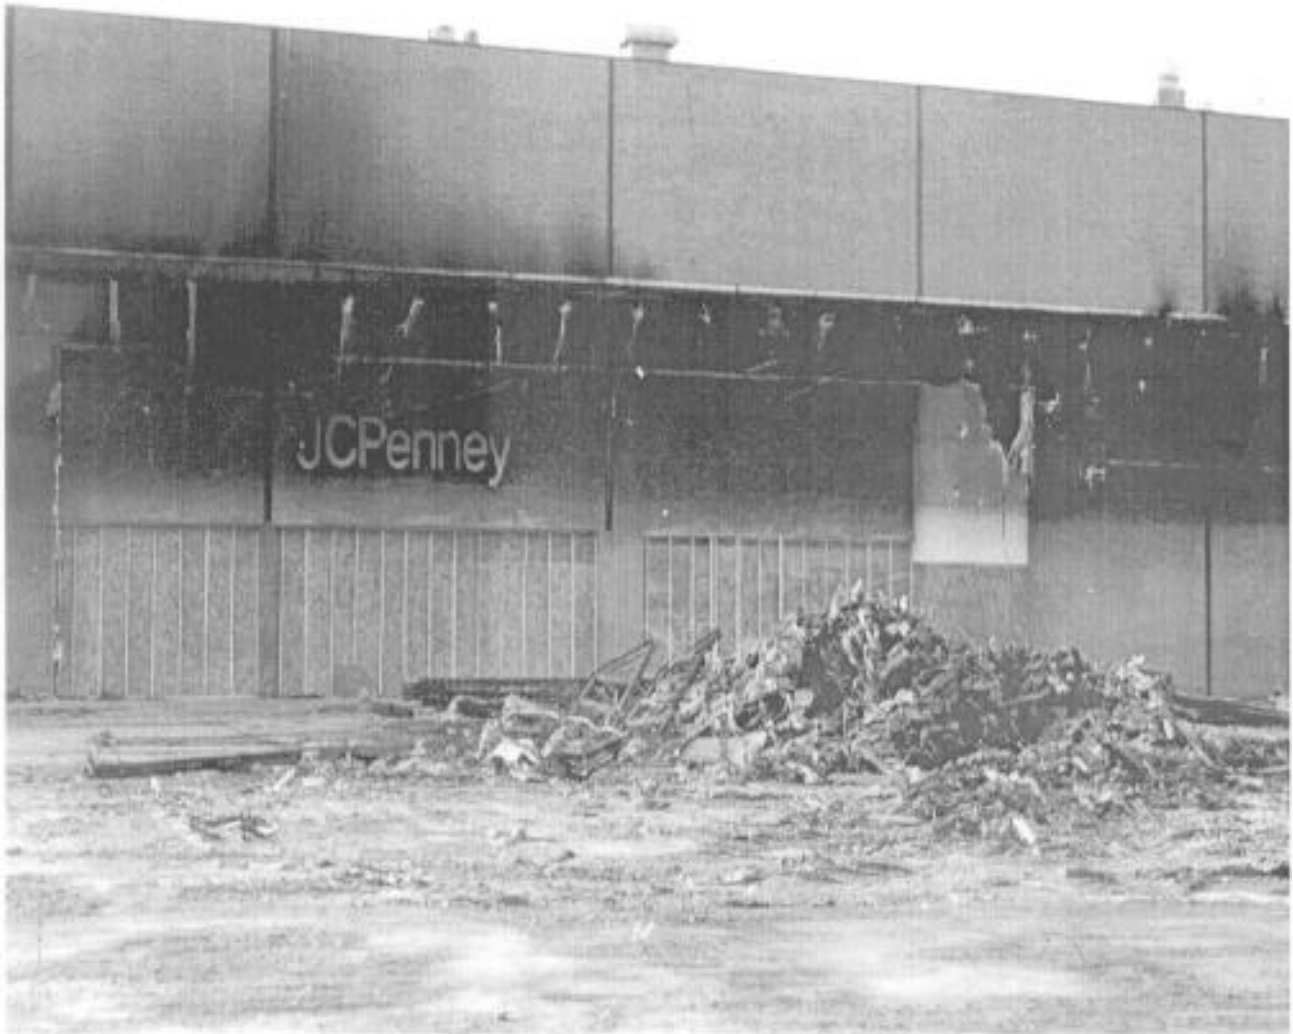
**Photograph 11.**

During the survey of the damage to the structure, a previously unidentified, concealed, potential hazard was discovered. Near the front of two stores damaged by the fire was a 50-foot long brick faced HCB wall supported by an unprotected steel beam lintel. The wall was 12 to 14-inches thick and 5 to 6 feet high in the ceiling space. This wall was above the suspended ceiling in these stores. Building additions and renovations can result in unexpected structural changes. Some may not present a hazard during normal building operations but can result in dangerous surprises during fires. Construction visits and inspections combined with pre-incident plans can assist in noting such hazards for the future.

Example of the hidden structural condition found above the suspended ceiling in one of the stores adjacent to the covered mall. This is a brick faced hollow concrete block wall supported on a 16-inch wide unprotected steel lintel that spanned the full width of the store.
