## INDUSTRIAL SILO FIRE AND EXPLOSION

# Industrial Silo Fire and Explosion

**Reported by: John Kimball**

This is Report 122 of the Major Fires Investigation Project conducted by Varley-Campbell and Associates, Inc./TriData Corporation under contract EME-97-CO-0506 to the United States Fire Administration, Federal Emergency Management Agency.

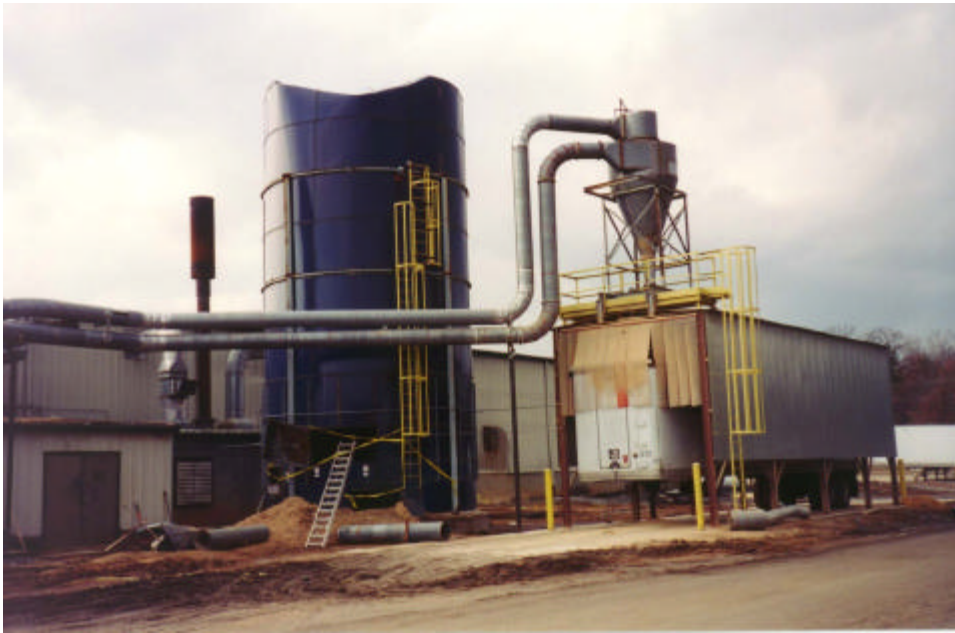
Photo #1 gives a perspective of the silo and its orientation to the building. The trailer shed to the right received wood waste via ducting and cyclone arrangement similar to that of the silo, for short-term storage in an open-box trailer and then disposal off site.

*Photo 1. Silo with trailer shed to right and manufacturing facility in background*

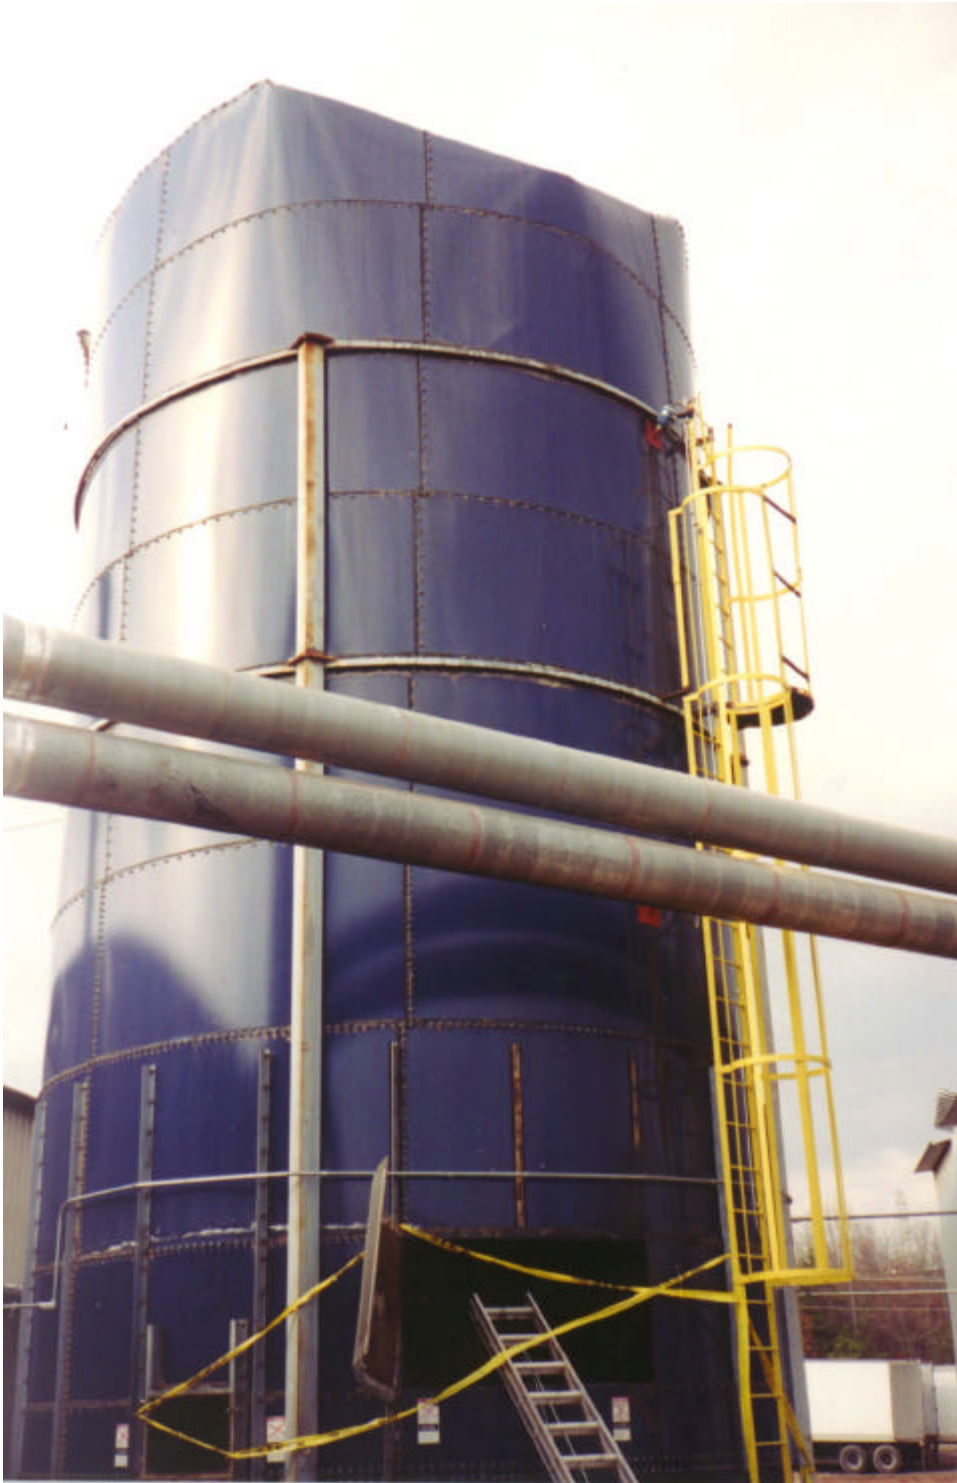
The Chief had moved all but essential personnel from around the base of the silo area as the crew commenced to remove the plates. As they worked on removing the last bolt of the 3 x 4 plate, one of the firefighters at the plate area noticed water flowing out along with burning ashes in the air space above. He then described a sucking and gurgling sound that was followed by a loud, low order explosion. The firefighters on the roof recalled the same type of inrush of air at their position followed by a dull thump and the roar of the main explosion. (Photo #2 shows access plate in relation to silo, photo #3 is a closer view of the access plate area).

*Photo 2. Access plate, origin of explosion*

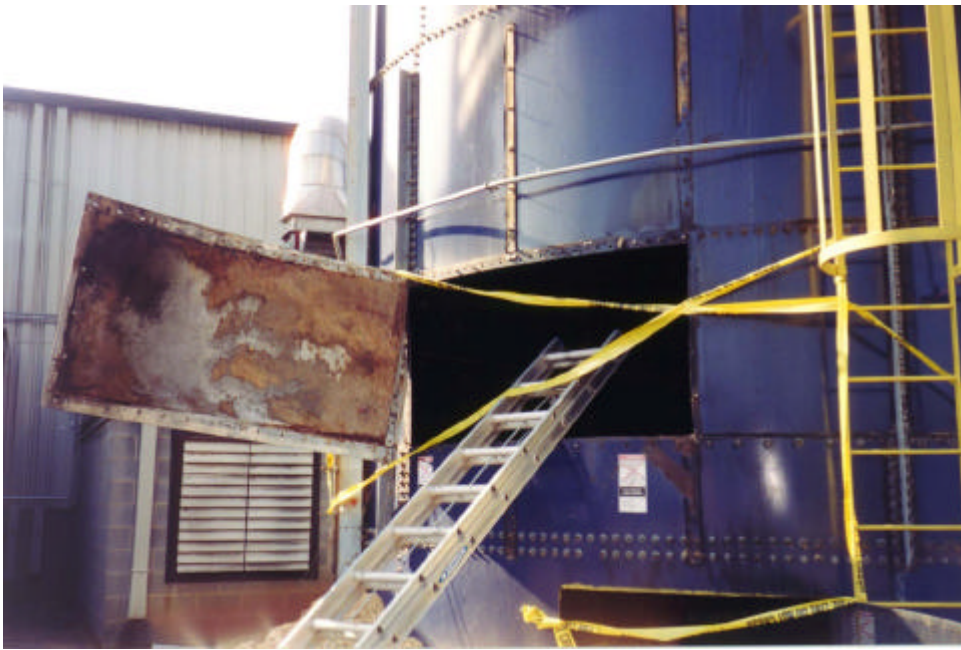
*Photo 3. Access plate; area of origin of explosion*

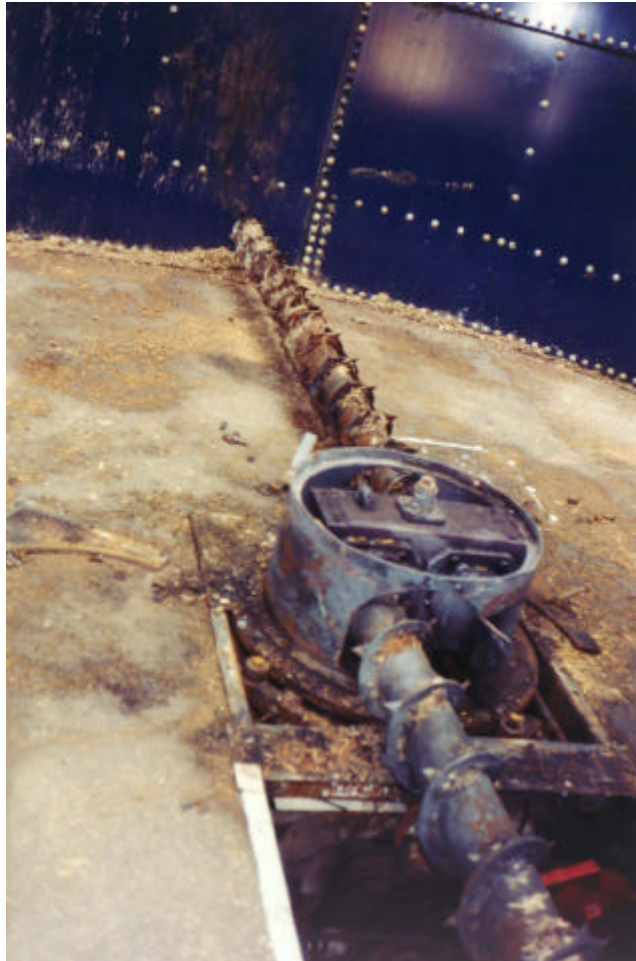
The observation indicated a large void area (approximately 12-foot x 16 foot x 10 foot) at the bottom of the silo radiating from the screw auger area. One of the "fingers" (Photo #4) of burned material ran to the direction of the access panel that was the focal point of the explosion. The direction of the burned void indicated fire travel in the direction of the screw auger to the compromised areas of the silo shell: the access panels. (Photos #5 and #6). Despite the application of several thousand gallons of water, **apparently no water penetrated to sufficient depth to reach the burning wood material.**

*Photo 4. View of auger inside silo; fire burned along the auger shafts to access panels*

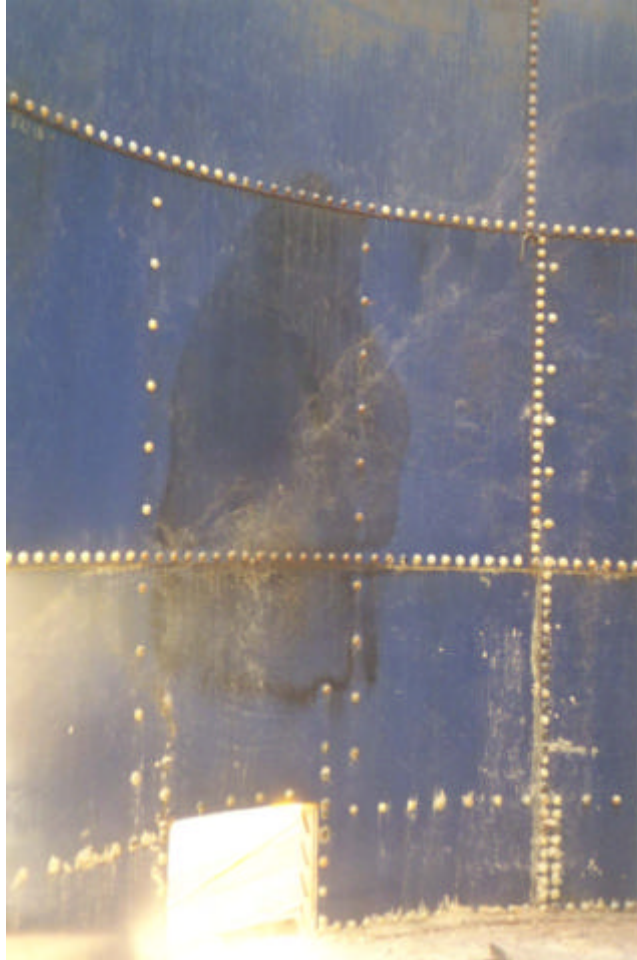
The fire marshal determined that the fire started when the gear box seized — burning the belt of the drive unit. The actual fire origin was deemed to have come from the plant side rather than from inside the silo. The day of fire origin was estimated to have been Tuesday or Wednesday. It was surmised that the fire burned void areas out of the sawdust over the auger. The fire also burned from the center toward the bolt holes in the access plates. (Photo #7).

*Photo 5. Smaller access panel indicating burning in stack above 2'x2' access panel  
(panel removed for post-fire investigation)*

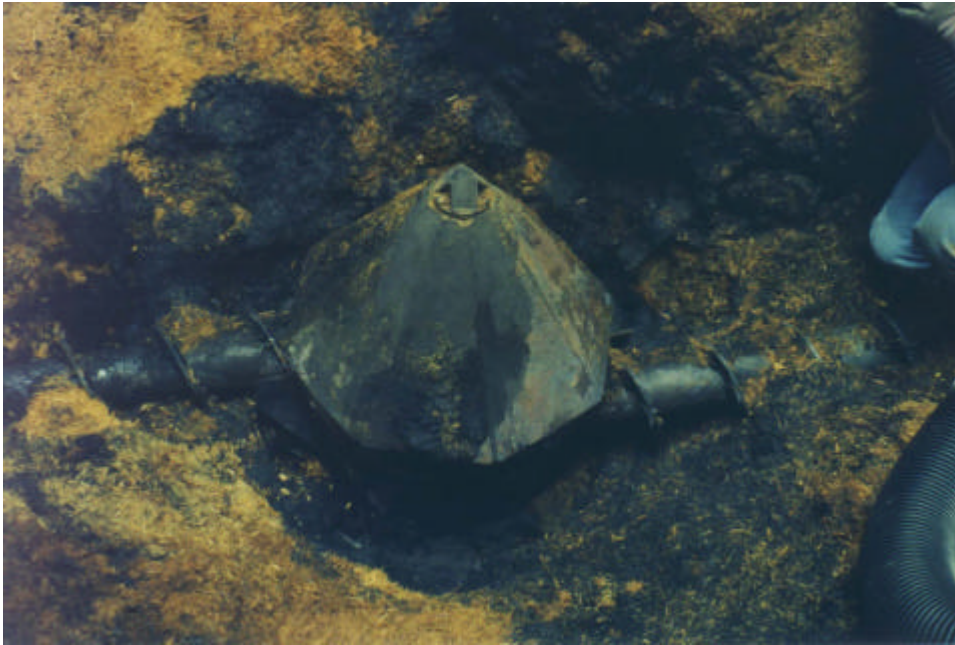
*Photo 6. Auger gear box, covered by a shield suspected origin of fire*

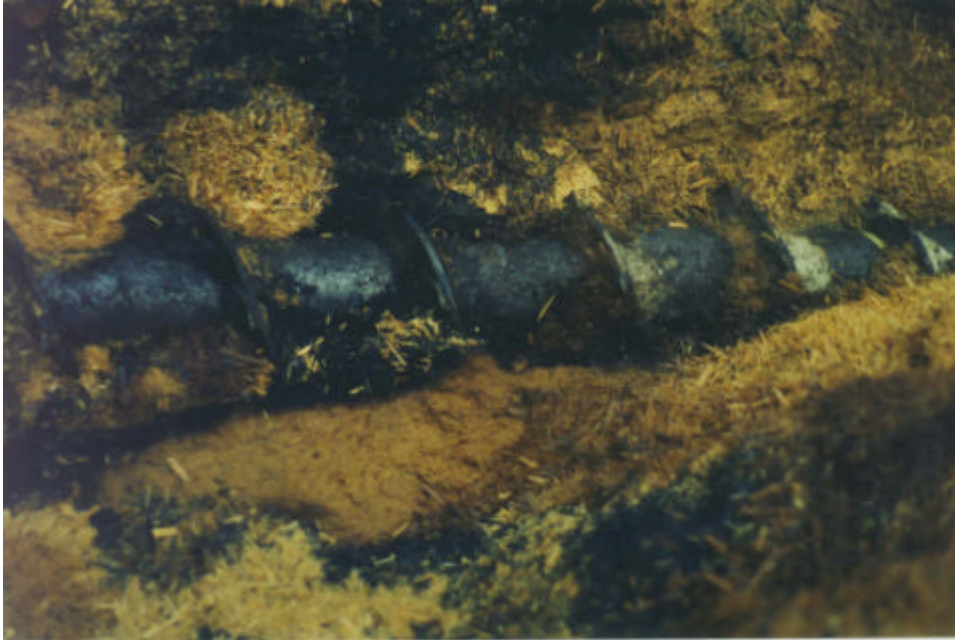
*Photo 7. Fire travel along auger shaft*

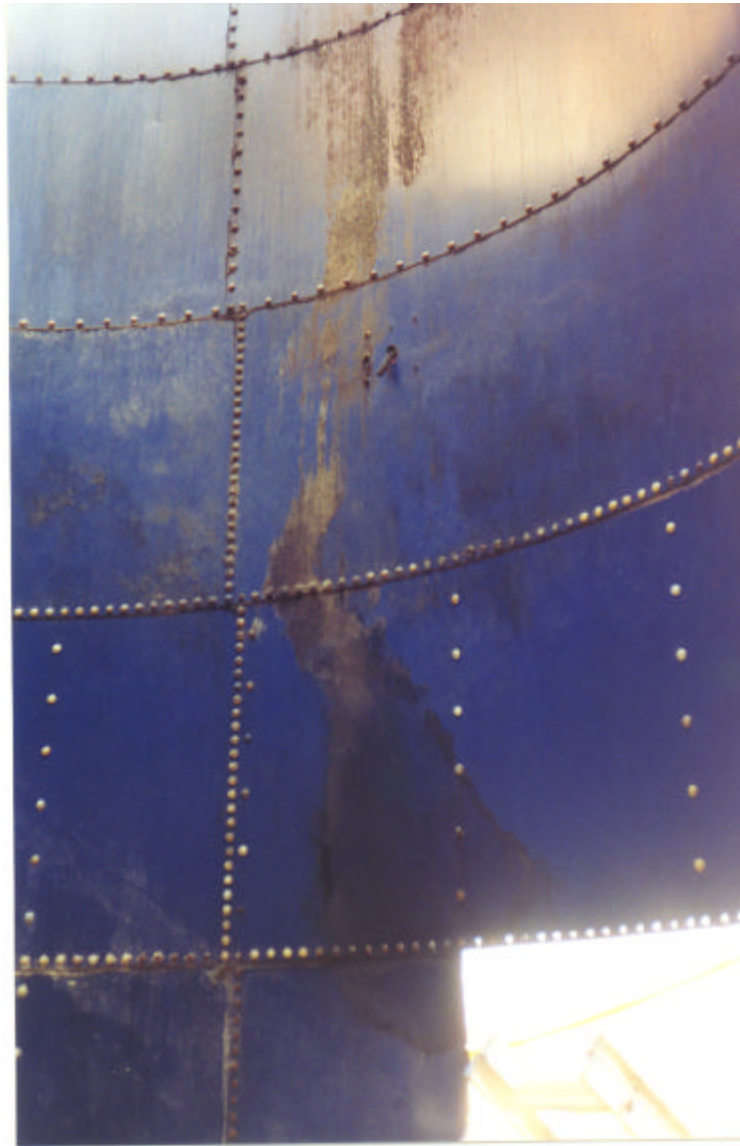
The explosion occurred when the 3'x4' side panel was removed, thus allowing oxygen to enter the burning area. (Photo #8). Because of the compromise of the integrity of the shell by the bolts and access plate, a minute source of oxygen-bearing air permitted the fire to burn in finger-like fashion from the source in the gearbox to the silo wall. This was an area of deep-seated, incomplete combustion, which needed only a source of oxygen to ignite explosively. This is consistent with backdraft-like explosions that have occurred in agricultural product silos. The sawdust also entrained dust to combine with the rapid oxidation of the backdraft to produce the energy sufficient to damage the silo and injure the firefighters. The water applied in the extinguishment attempts apparently either ran off the surface or was absorbed and acted as a tamper over the burned out voids in the wood waste.

*Photo 8. View from inside silo showing burned-out areas in relation to access panel (origin of explosion)*
