Eight Fire Fighters from a Combination Department Injured in a Natural Gas Explosion at a Strip Mall – Maryland

Fatality Assessment and Control Evaluation Investigation Report # F2009-13

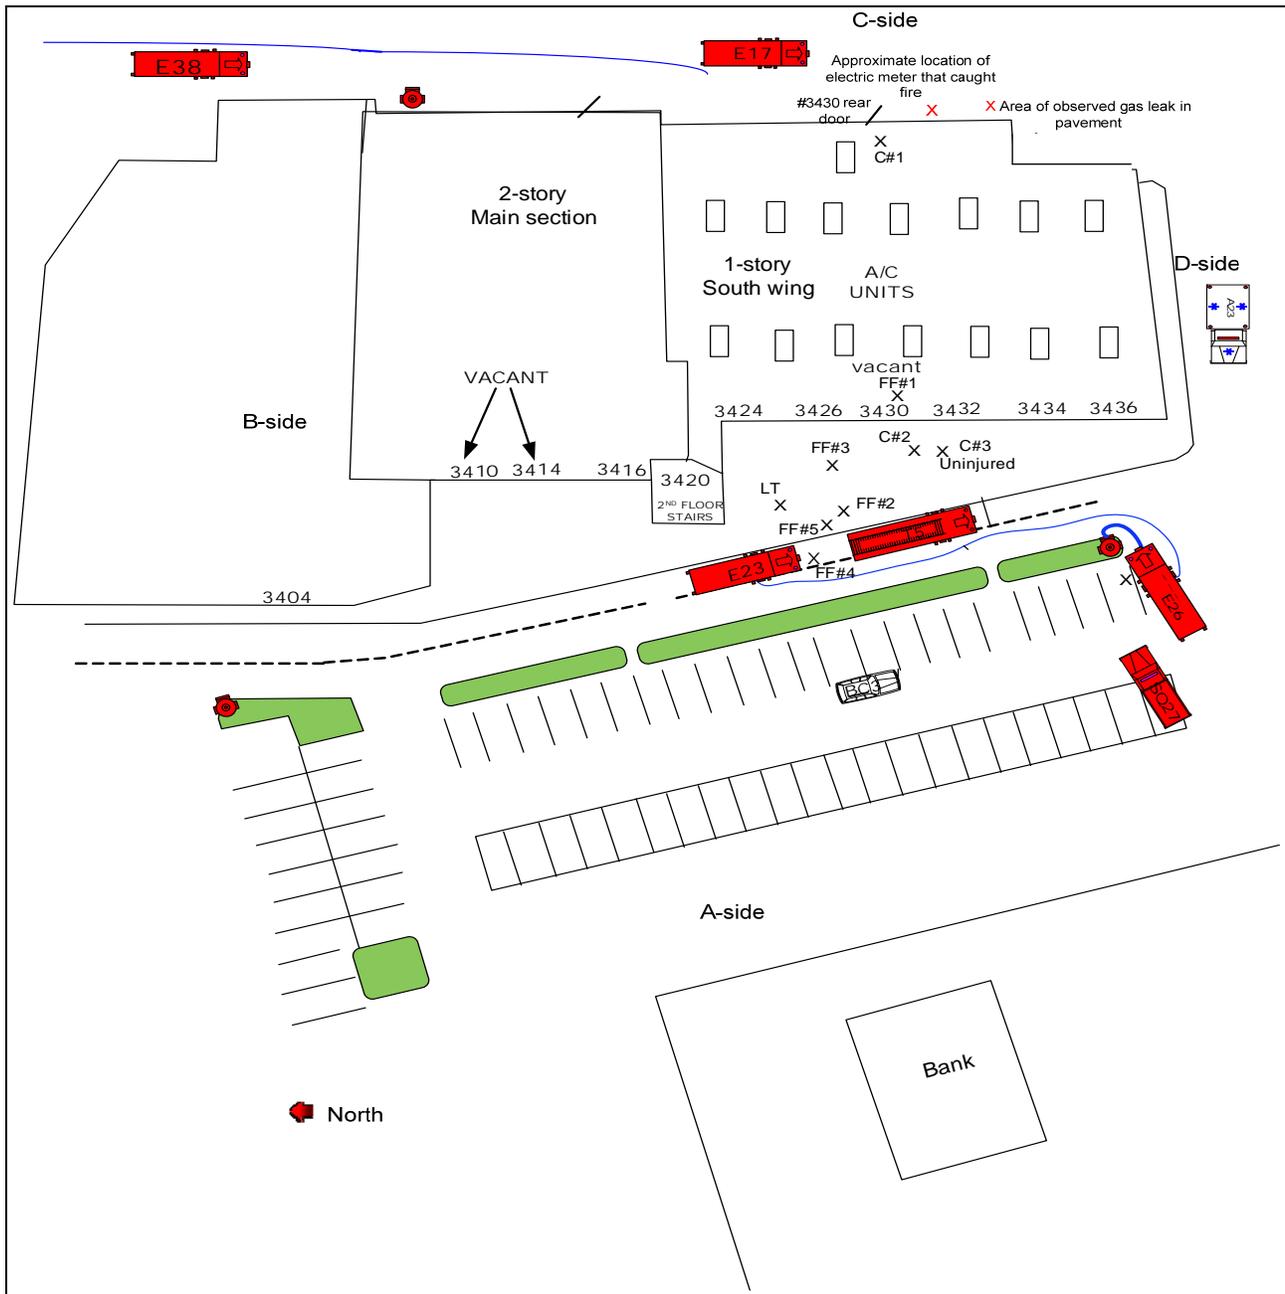
By 1322 hours, approximately 45 civilians had been evacuated from the businesses on the southside of the strip mall. C#1 and FF#3 were exiting the office area when they heard what they thought was a door slamming shut. *Note: During interviews, several other fire fighters reported hearing the same sound while evacuating the other businesses. It is now thought to have been a small explosion possibly igniting the fire along the roof line and electric meter.* At 1323 hours, the captain from Squad #27 exited the rear door of business #3426 and noticed a fire along the C-side roof line underneath the gutter and an electric meter on fire near the C/D corner. The gas company employee retrieved a fire extinguisher from his vehicle and tried unsuccessfully to extinguish the fire at the electric meter. He then ran to move his vehicle back from the building. At 1324 hours, the IC requested a rapid intervention team (RIT) and a second alarm for the working fire. Hearing the report of fire in the rear, E17 and E38 crews in the rear and E23's crew in the front of the structure began to pull hoselines and T5's driver started putting down the outriggers on the truck. C#1 was sizing up the interior/exterior conditions of business #3430 before committing his crew to fire operations. He looked out the C-side doorway of the vacant business #3430 and noticed the electric meter on fire on the exterior wall of the structure. Anticipating an explosion, he tried to leap out the rear doorway. At the same time, FF#1 with a pike pole in hand had entered the A-side door of the vacant business #3430 and noticed the heavy smell of natural gas and felt air rush by as the structure exploded (see Photos 1, 2, 3 and 4). At approximately 1326 hours, debris and fire blew out the A-side, C-side, and roof of the south section of the structure. C#1 was blown into the rear parking lot and FF#1 was blown out the A-side door and covered with debris. On the A-side of the structure, C#2, the Lieutenant from E26, FF#2, FF#3, FF#4, FF#5, and several other fire fighters were blown off their feet and hit with debris (see Diagram).

Diagram. Approximate locations of key apparatus and personnel at the time of the explosion.
(Courtesy of Fire Department)

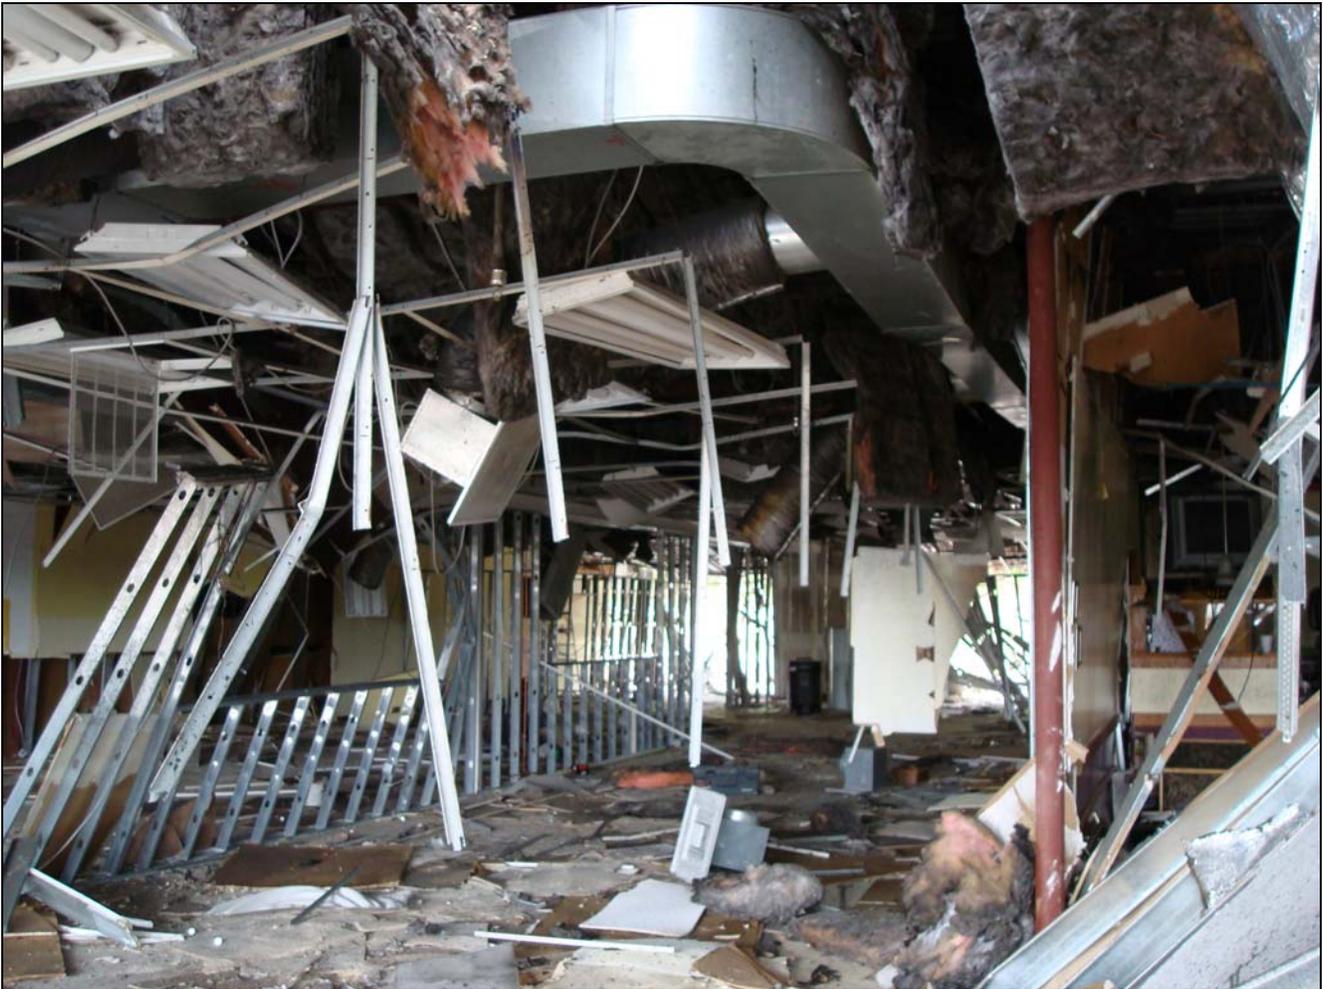
**Photo 1. Vacant business #3430 after the explosion; C#1 was at the C-side door and FF#1 had just entered the A-side door.
(NIOSH photo.)**

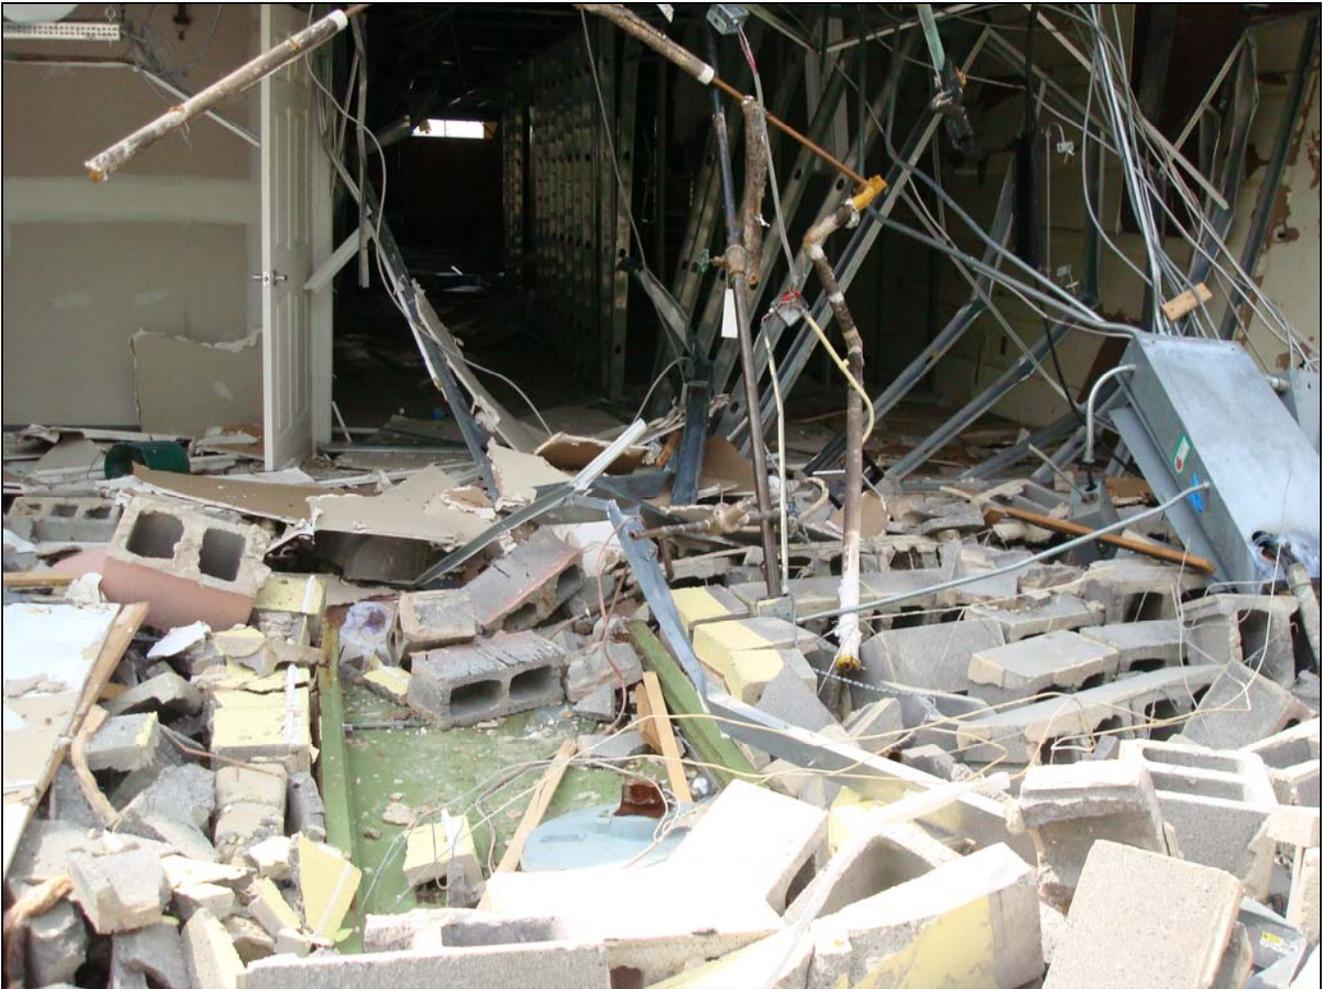
Photo 2. C-side of business #3430 after the explosion. The green exterior door in the lower part of the picture was the location of C#1 at time of explosion. (NIOSH photo.)

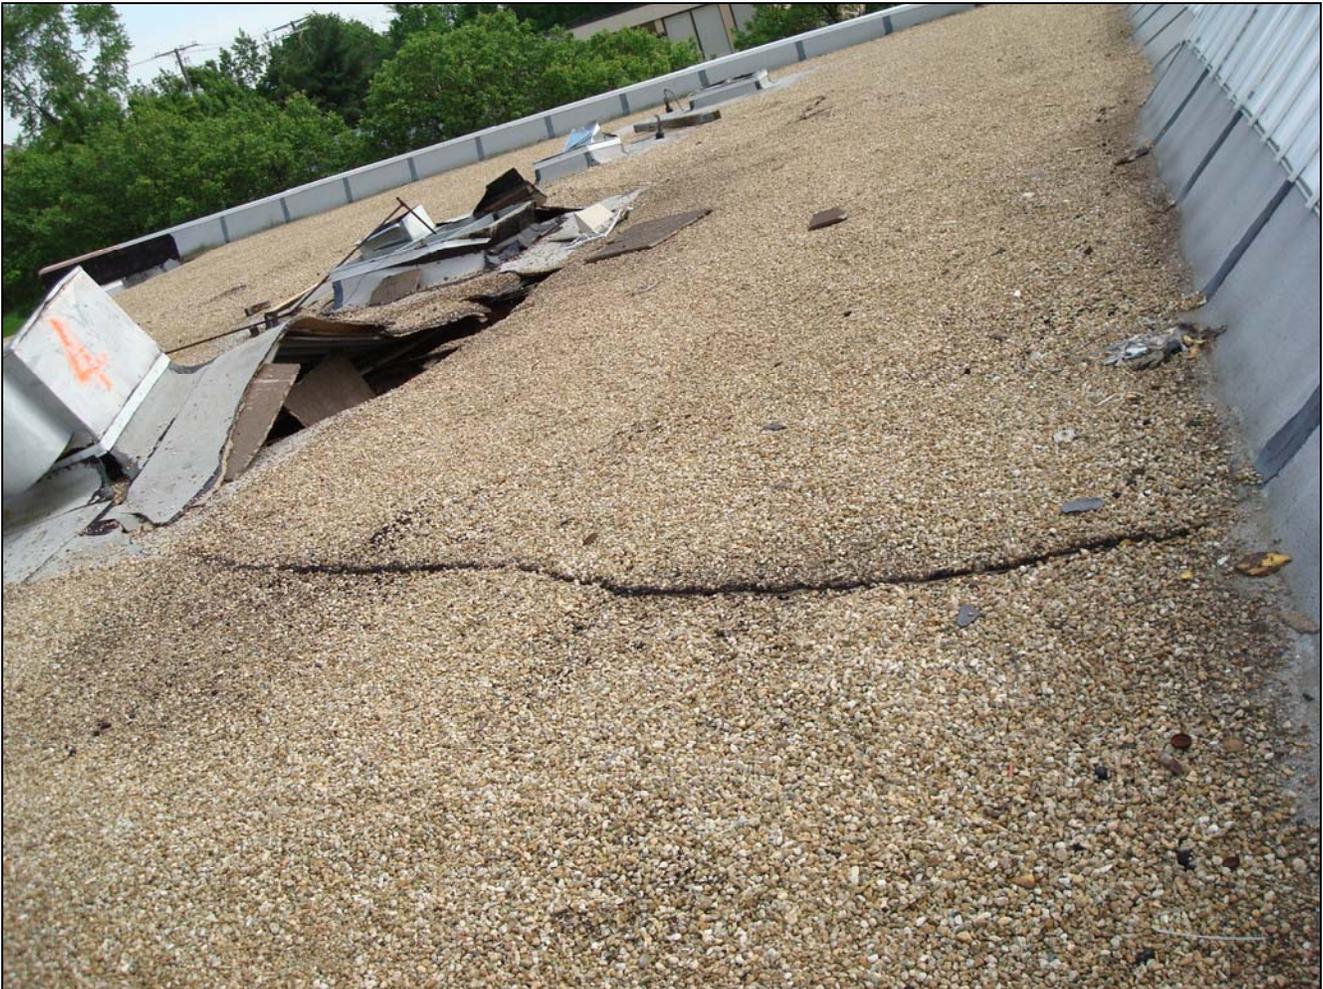
**Photo 3. Shows damage to roof's exterior which was directly above FF#1 at the time of explosion.
(NIOSH photo.)**

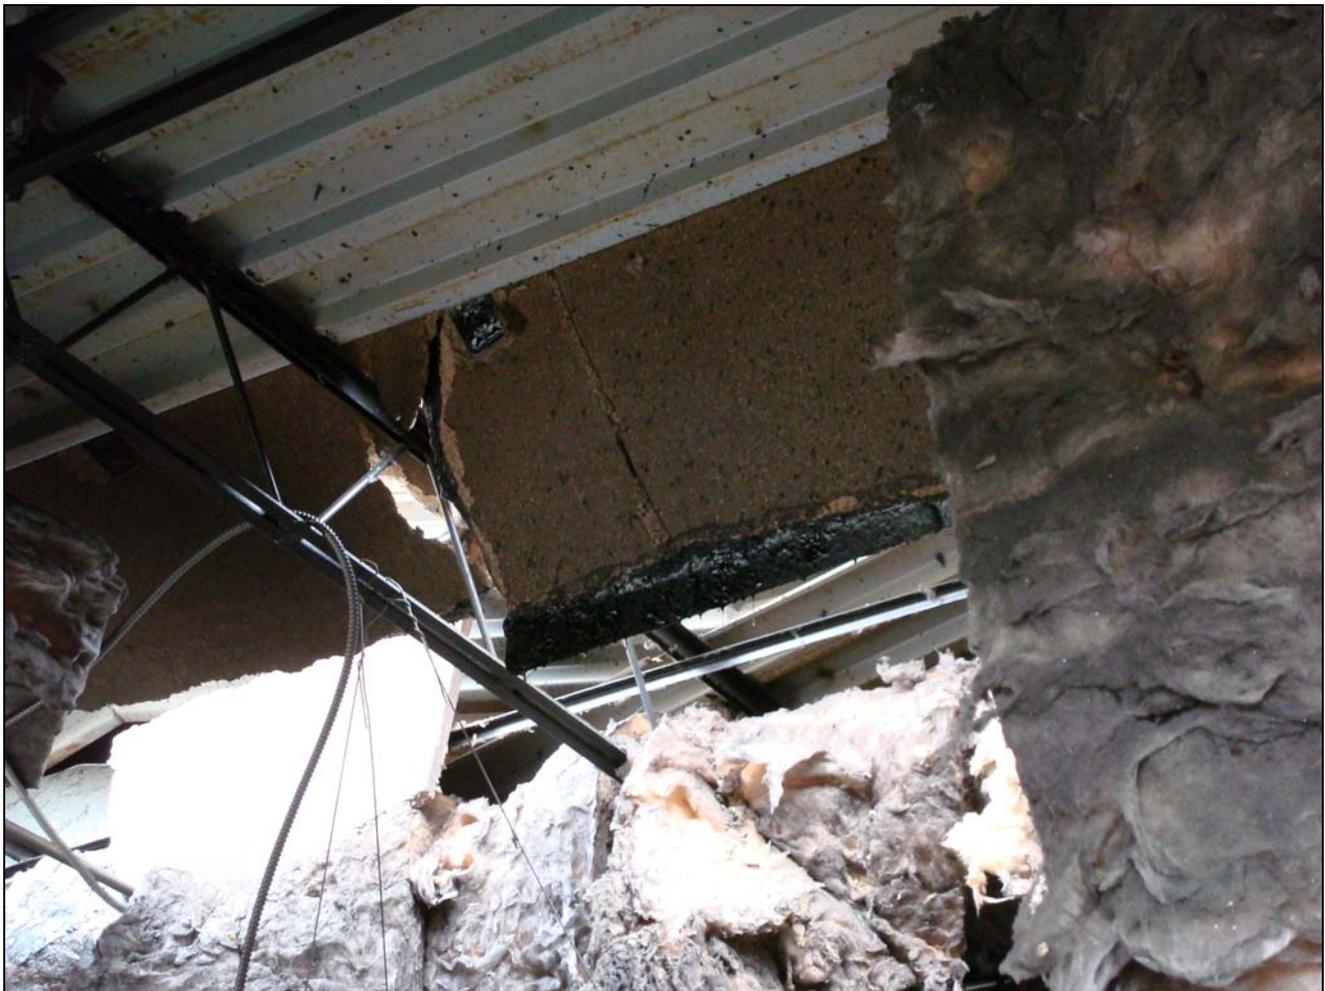
**Photo 4. Shows hole through ceiling and roof which was directly above FF#1 at time of explosion.
(NIOSH photo.)**

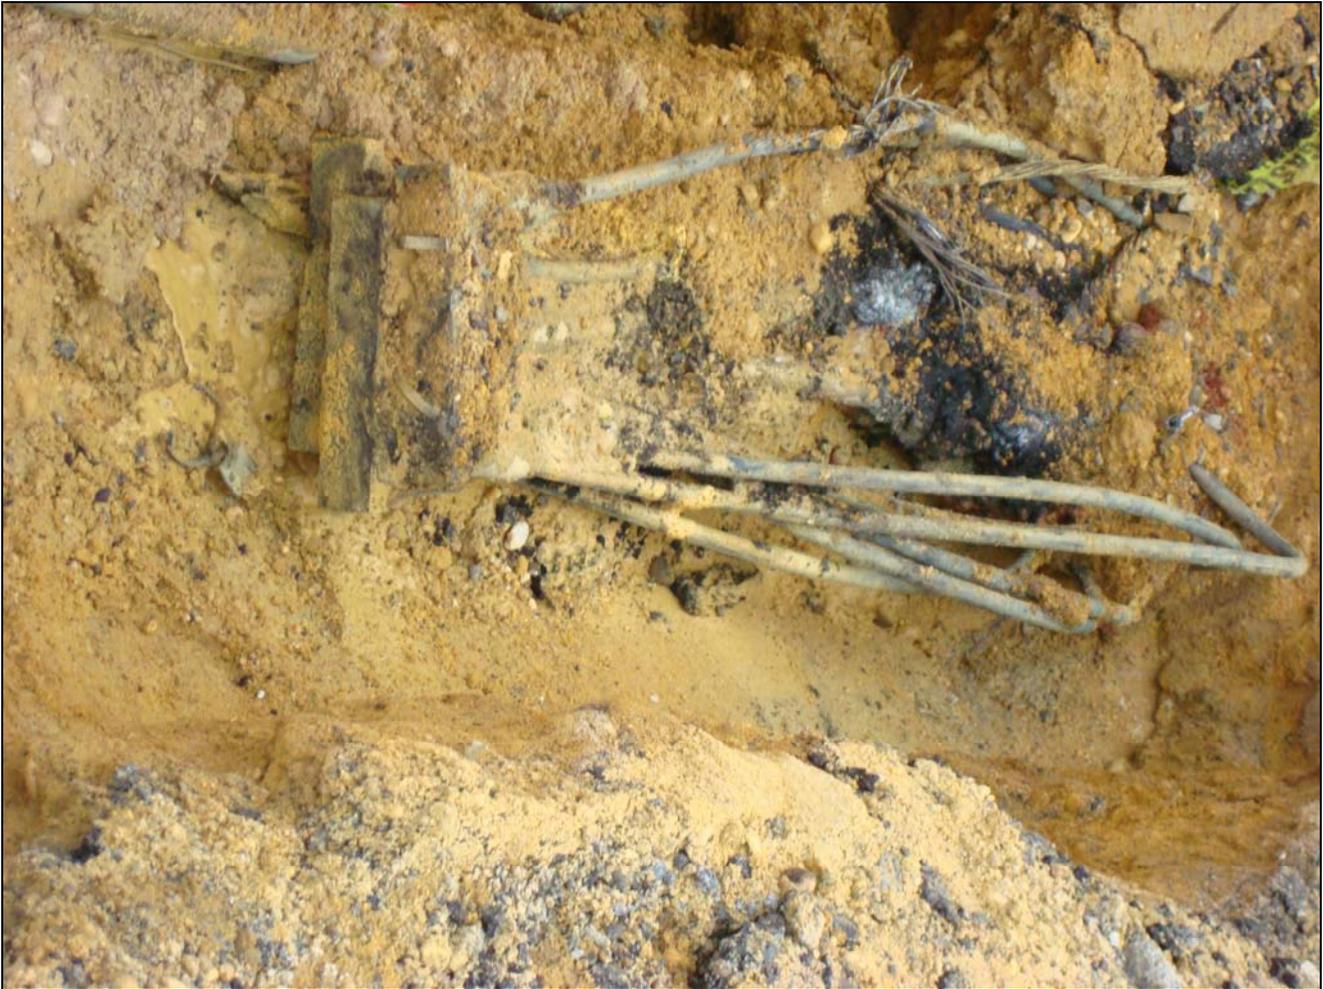
Baltimore, MD 21202. The cause and source of the gas leak was determined to be the result of the main underground electric line failing, which resulted in the main gas line melting. This allowed natural gas to escape and migrate into the structure (see Photo 5). The replacement of a section of pavement in the area of the electrical short and bubbling of natural gas up through the pavement was never explained (see Photo 6). Per the Maryland Public Service Commission Report, the electric company's records indicate that the line was buried in March of 1977 and the gas main was installed in October of 1998.

**Photo 5. Shows overheating of electrical wires 6 to 8 inches above 2 ½ inch plastic natural gas main which was softened from the heat.
(NIOSH photo.)**

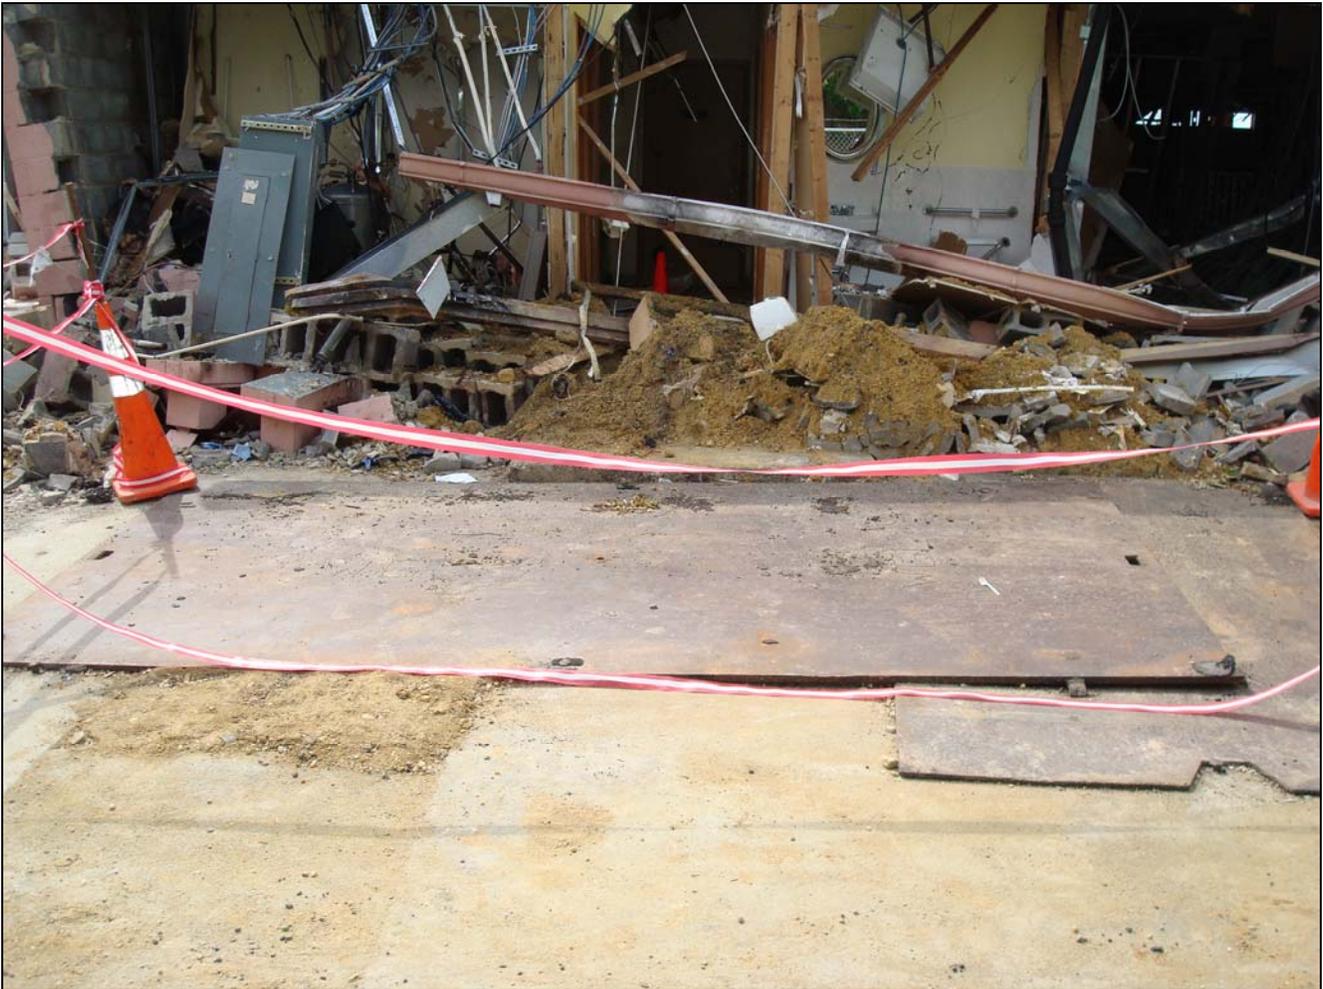
to see natural gas bubbling up out of three ¾ inch holes in the asphalt which had been found minutes earlier. The gas company employee indicated it was an underground leak but didn't know the source.

**Photo 6. Area underneath the steel plate is where gas was bubbling up through pavement. The cause of this gas leak is unknown. Also, shows section of replaced asphalt suggesting work had been done in this area.
(NIOSH photo.)**
