Broward Marine Fire Fort Lauderdale, Florida

BROWARD MARINE FIRE

FORT LAUDERDALE, FLORIDA

SEPTEMBER 5, 1996

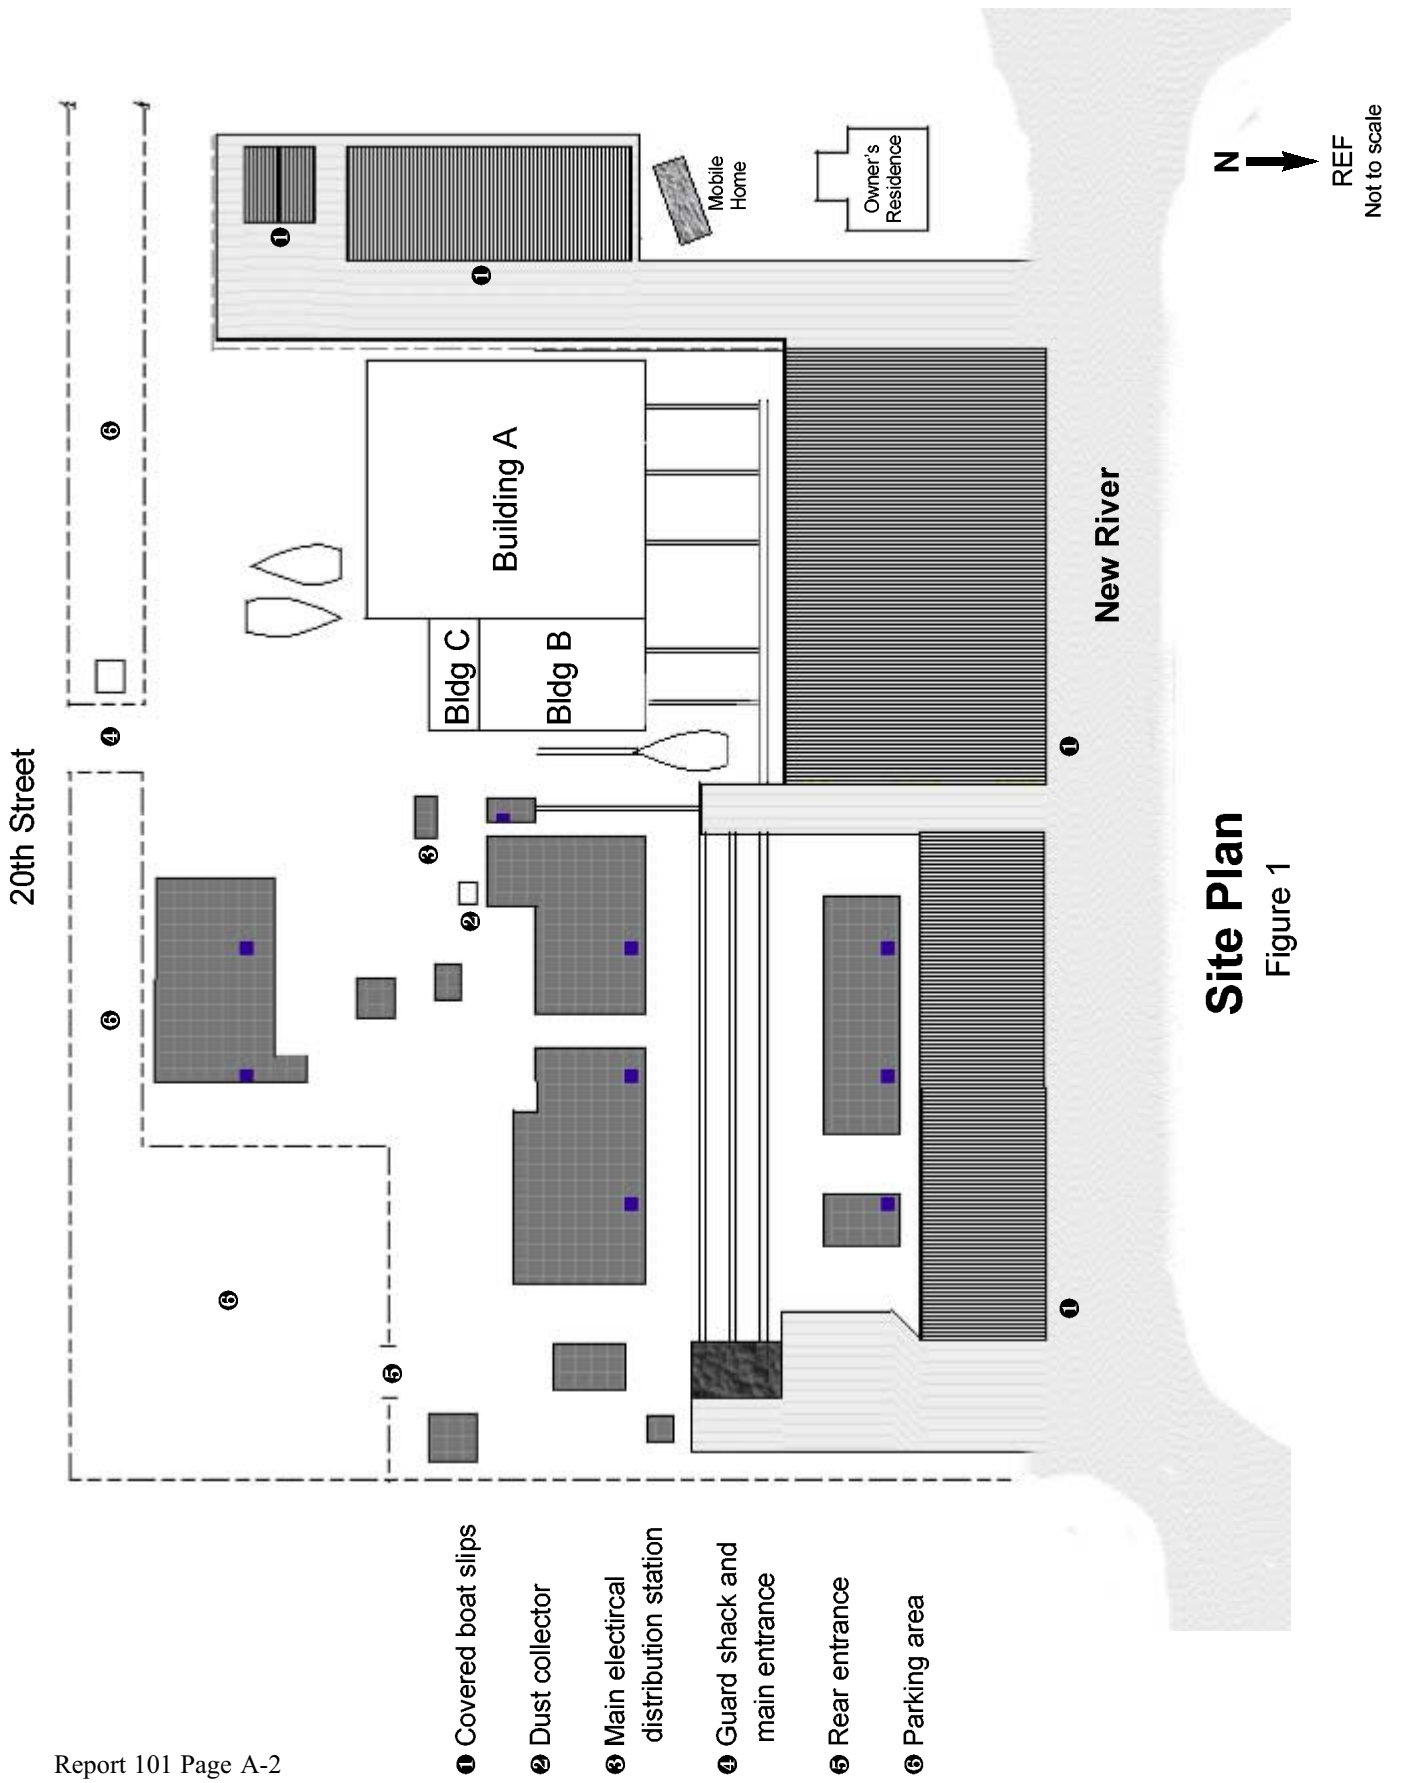
Site Plan
Figure 1

Area of Origin

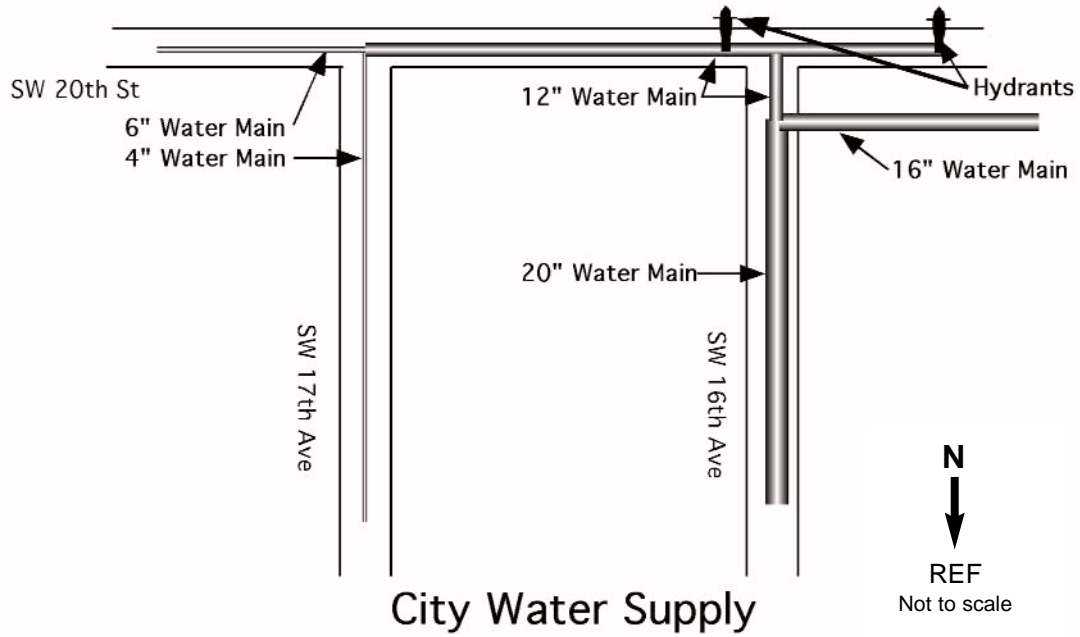
Figure 3

The hydrant located at the intersection of Southwest 20th Street and Southwest 15th Avenue had a static pressure of 72 psi and a residual pressure of 65 psi at a flow of 1300 gpm. This hydrant is supplied through approximately 150 feet of 12-inch underground pipe, which is connected to a 20-inch city water main located under Southwest 15th Avenue. This 20-inch city water main also supplied a 6-inch loop to the west, which ties back into the 20-inch water main to the south. (See Figure 3)

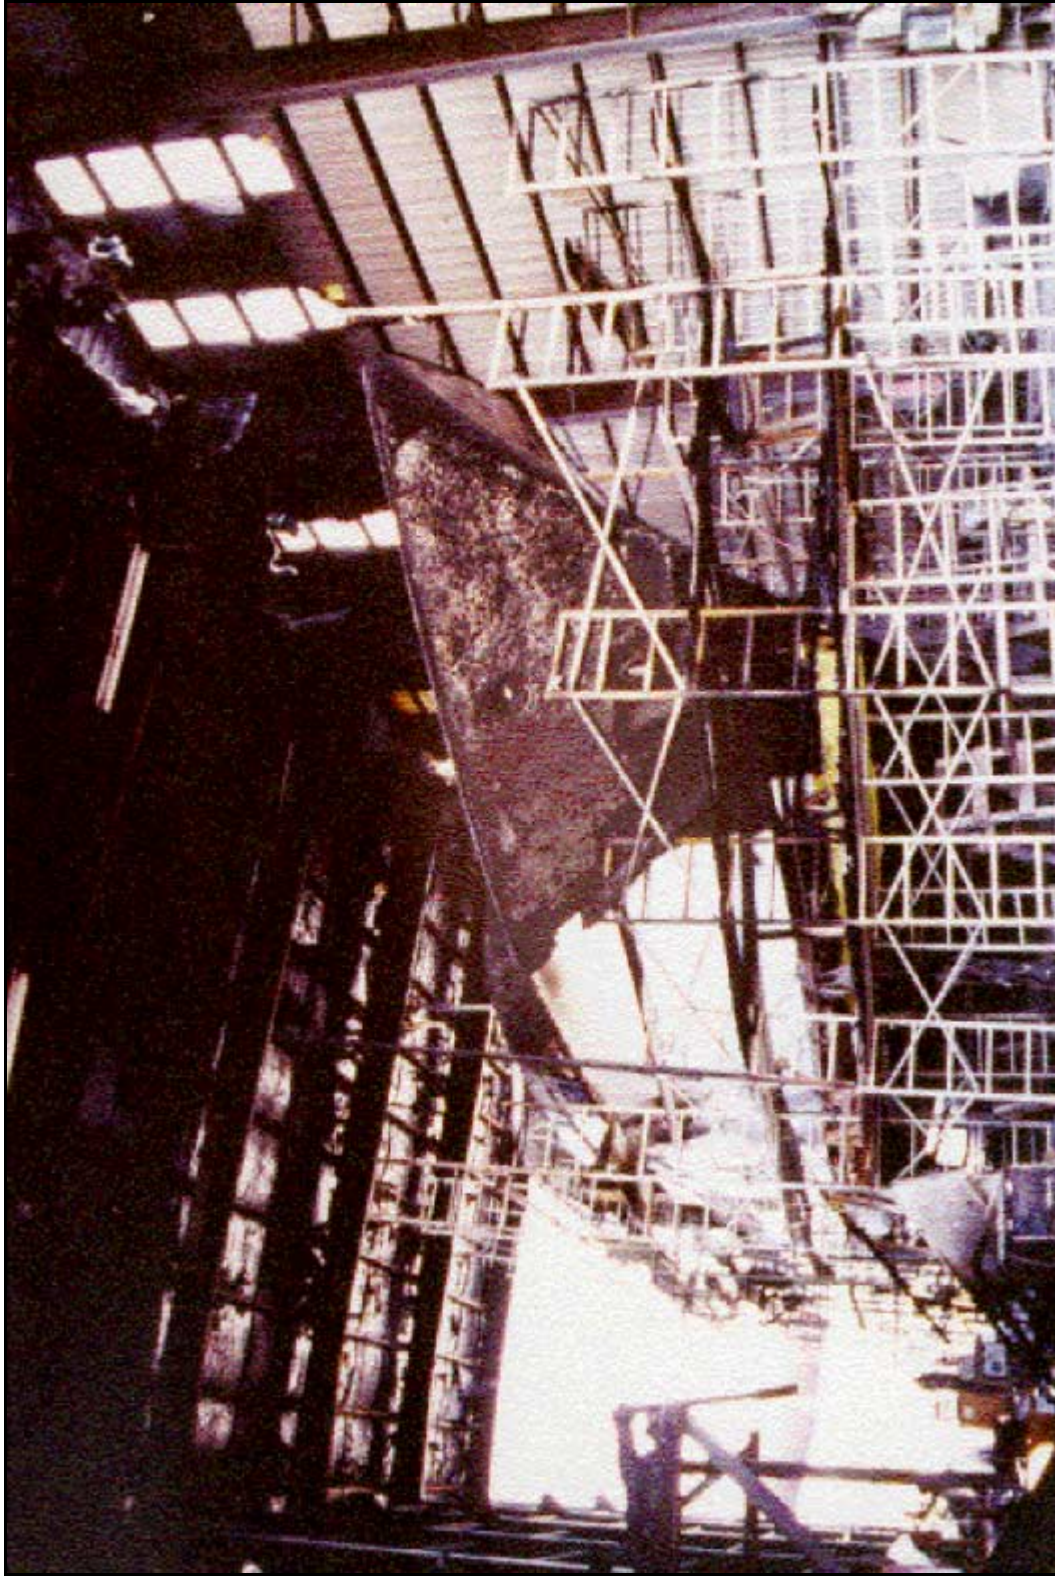
1. View of yacht under construction in Building B. Scaffolding constructed around the yacht hindered the firefighting efforts.

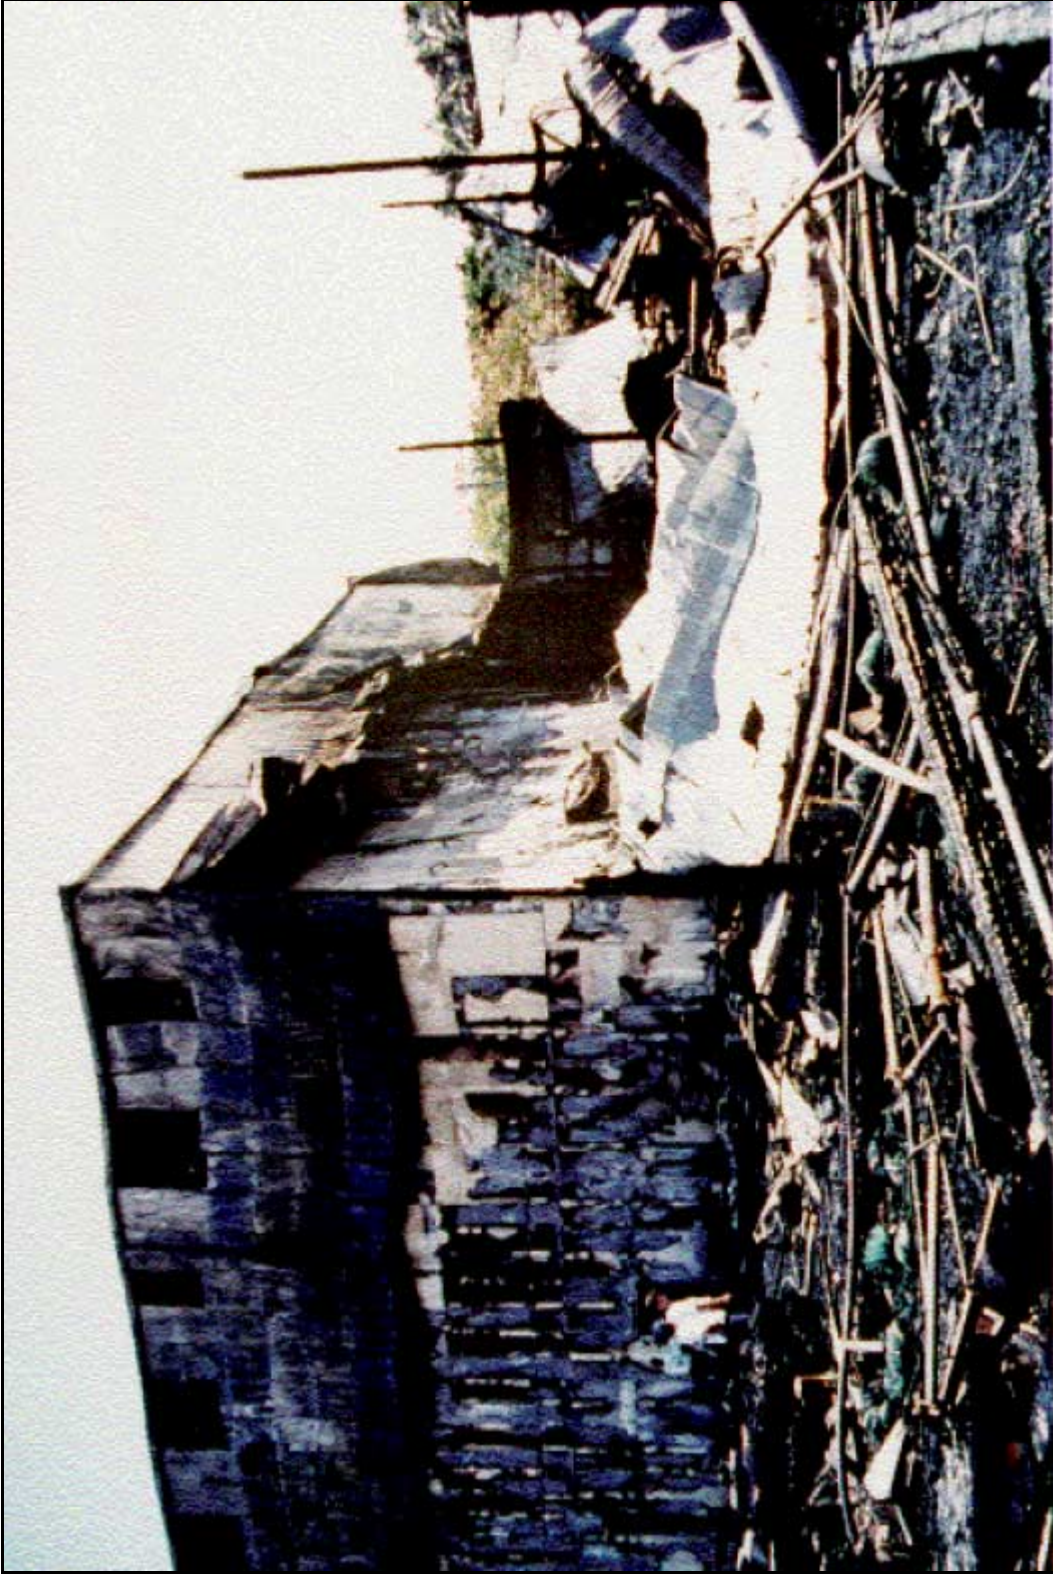
2. View looking east from Manufacturing Building (Building A) towards the destroyed Office Building (Building C).

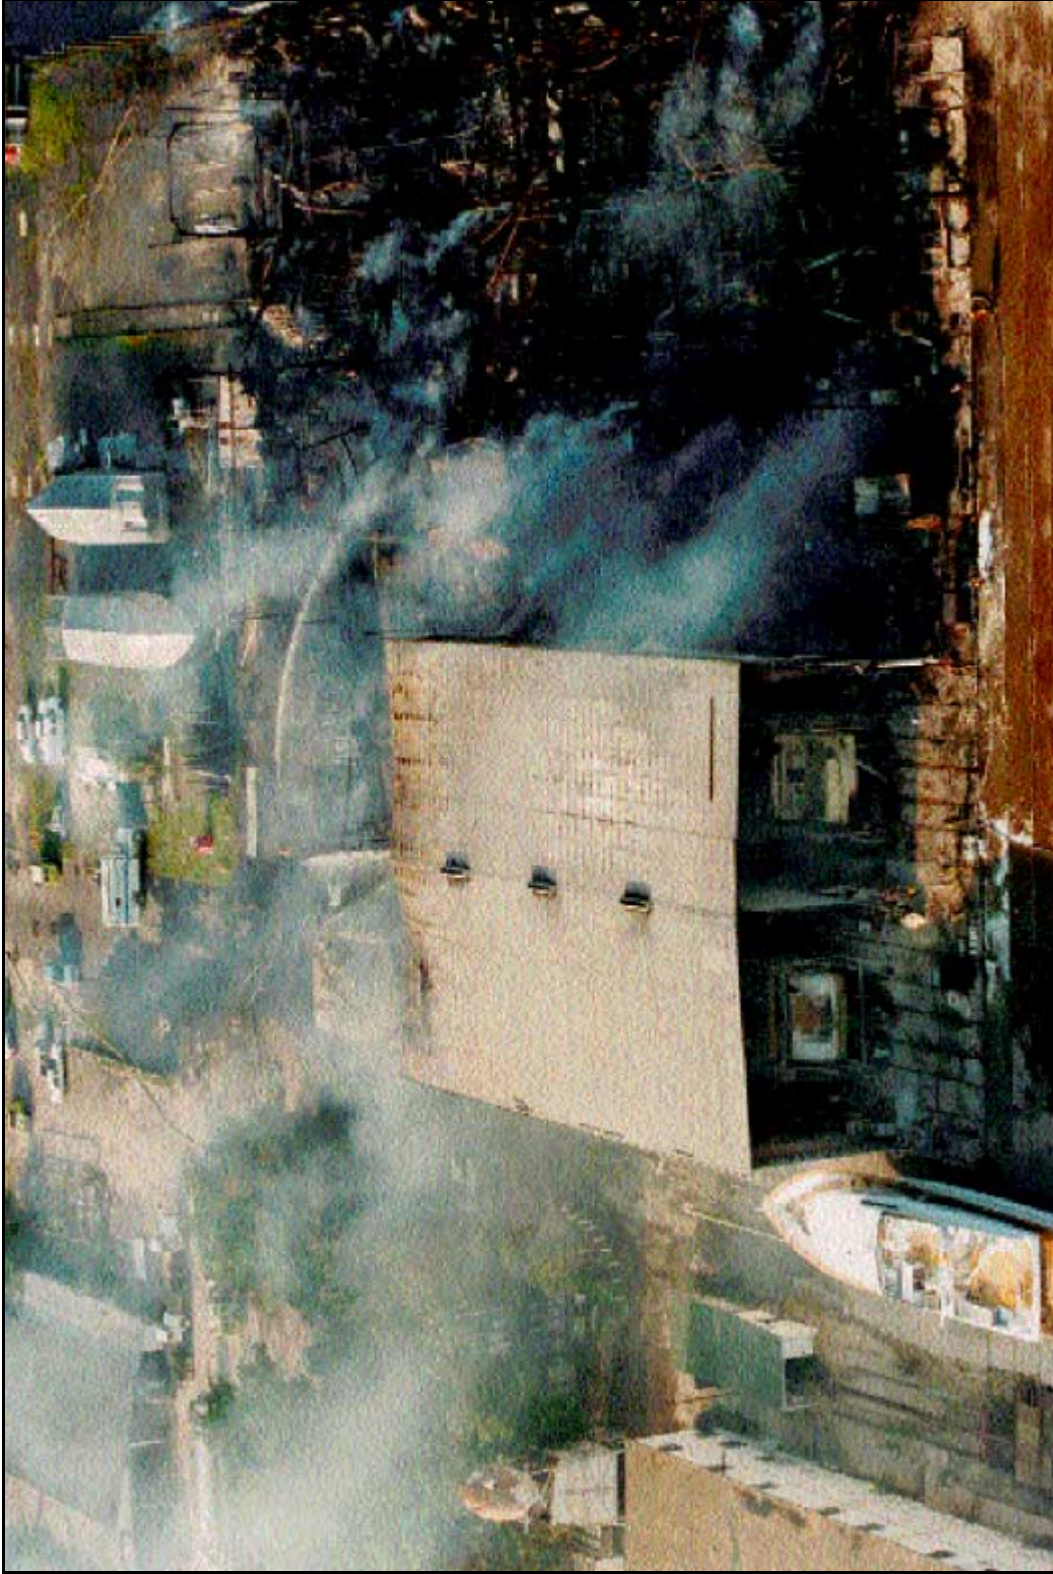
One yacht in Building B incurred heavy smoke and water damage; two yachts in Building A were destroyed. Two aluminum hulls stored to the south of Building A were damaged. Building A and Building C were destroyed as well as the dust collector. Spot fires caused by flying brands caused minimal damage, burning the contents of several dumpsters and causing damage to some outbuildings located around the property and neighboring properties.

3. Aerial view of fire scene; the two boat hulls located at the top of the photograph are situated south of Building A.

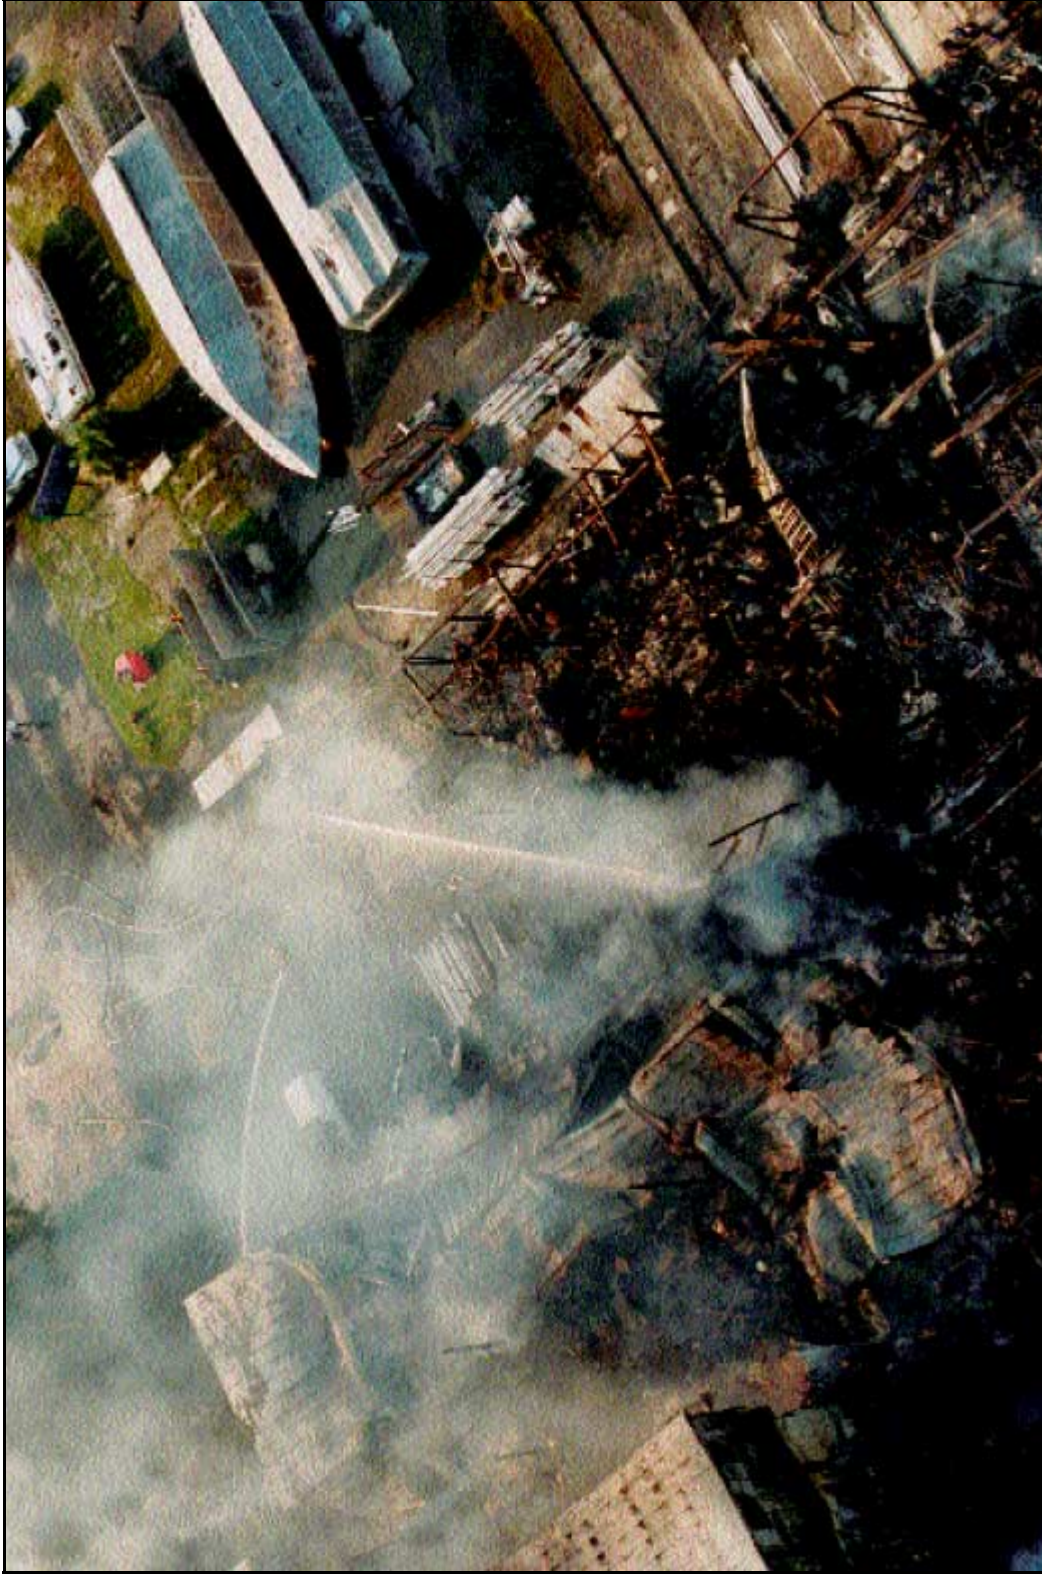
4. Aerial view of the south corner of the collapsed Manufacturing Building (Building A).

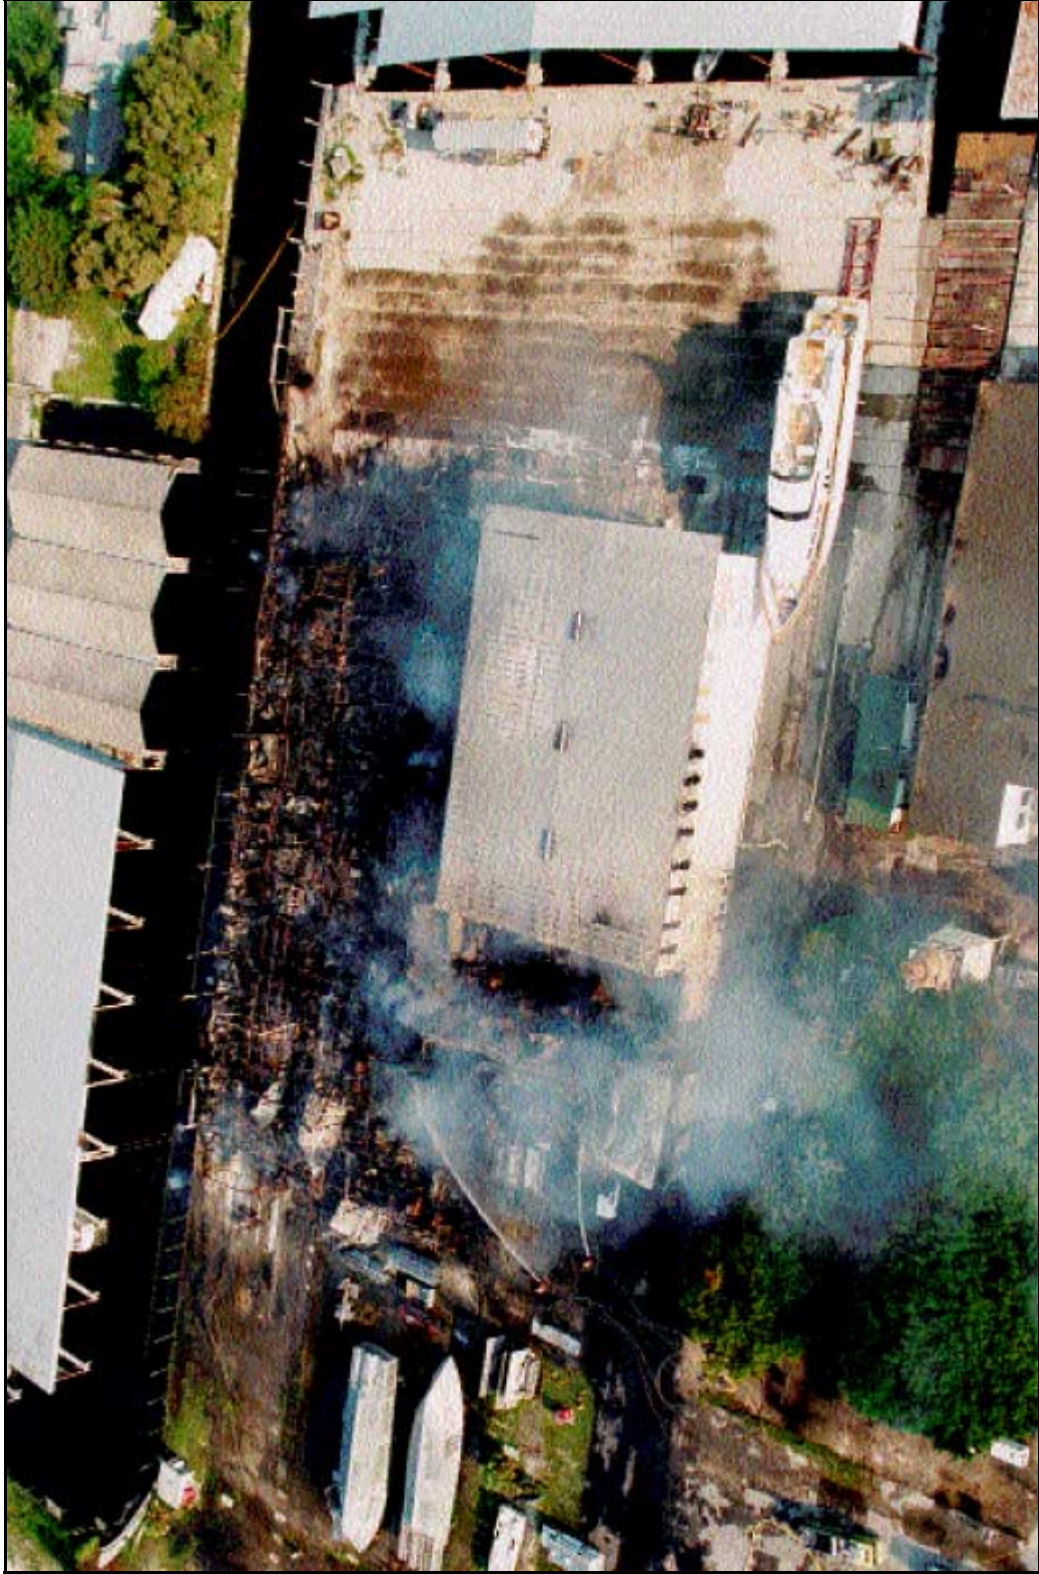
5. Aerial view of the fire scene, with the canal and neighboring covered boat slips (to the west) at top of photograph.
