Structural Collapse at Dwelling Fire Results in Two Firefighter Fatalities Stockton, California

This is Report 102 of the Major Fires Investigation Project conducted by Varley-Campbell and Associates, Inc./TriData Corporation under contract EMW-94-4423 to the United States Fire Administration, Federal Emergency Management Agency.

Stockton, California Structural Collapse At Dwelling Fire Results In Two Firefighter Fatalities February 6, 1997

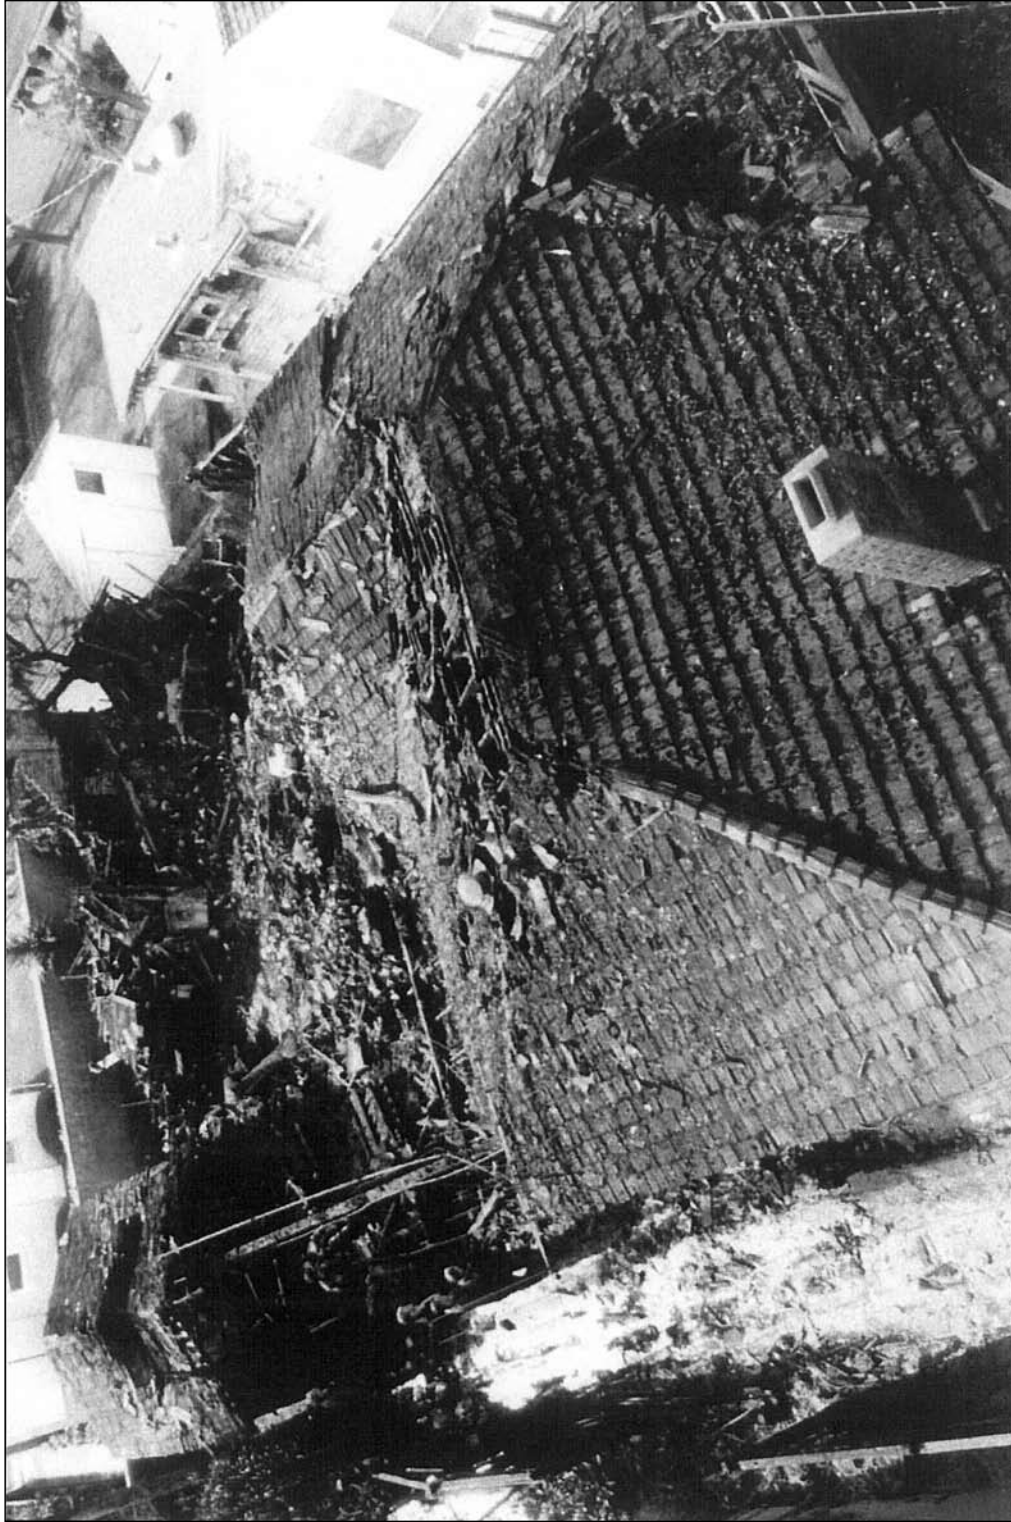
At 4:37 a.m., as the E6 Captain was stepping over the threshold from the kitchen into the addition, the second floor addition collapsed with a loud crack and rumble. The E6 Captain was trapped under the debris, along with the E9 firefighter and the E6 firefighter who were advancing the attack line, several feet inside the addition at the rear of the house. The two T4 crew members who were operating the back-up line were pushed back into the kitchen area by the falling debris and narrowly escaped being trapped.

2. Looking south towards rear of house -- note area of second floor collapse
