# Shenandoah Retirement Home Fire

Roanoke County, Virginia

USFA-TR-038/December 1989

This is Report 038 of the Major Fires Investigation Project conducted by TriData Corporation under contract EMW-88-C-2649 to the United States Fire Administration, Federal Emergency Management Agency.

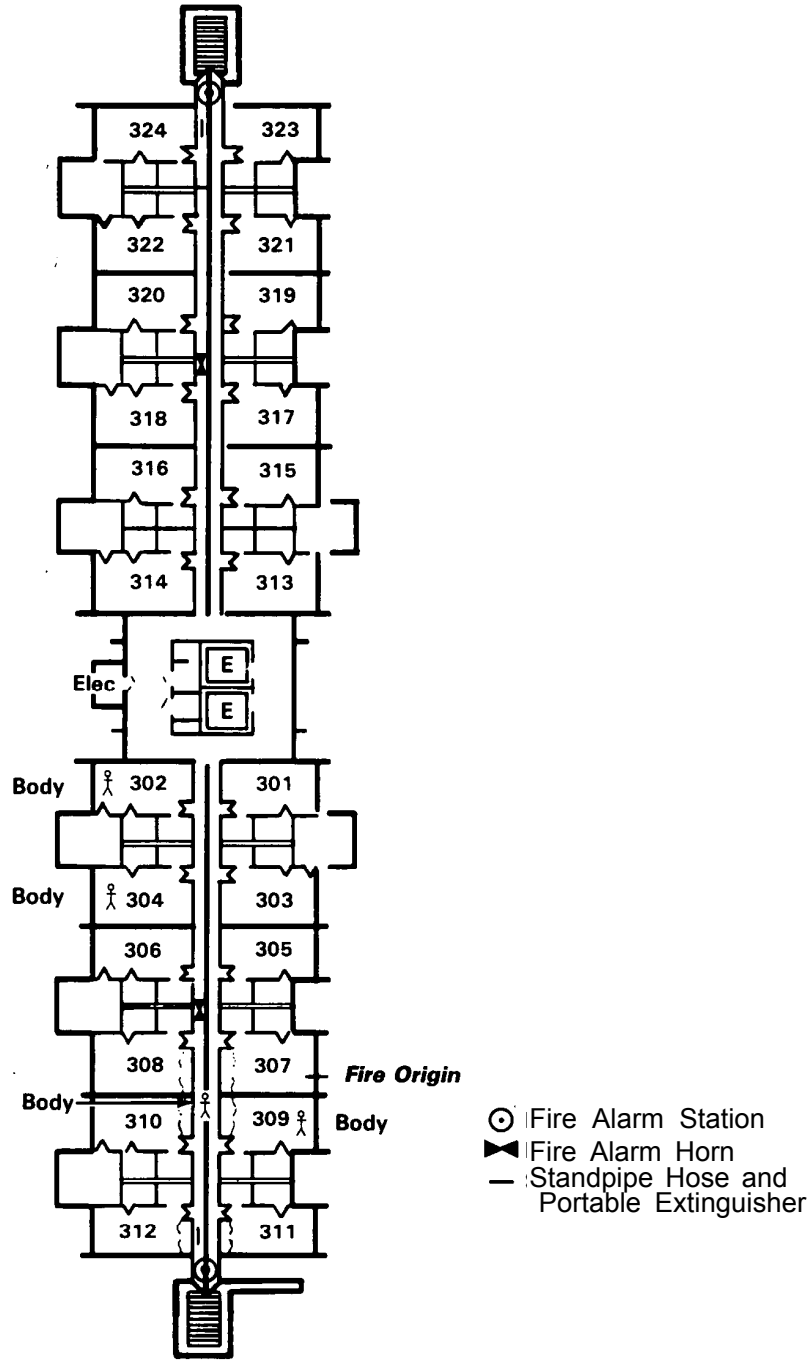
## Shenandoah Retirement Home Third-Floor Plan and Location of Fatalities

Four elderly residents from the third floor died as a result of smoke inhalation -- three women and one man, ranging in age from 79 to 87 years. The body of the resident in Apartment 307, (area of origin), who was confined to a wheelchair, was found in the hall a few feet south of his apartment door. One female victim of Apartment 309 was found in her unit on the floor next to her bed. The third victim (female) was found in Apartment 302. The fourth victim (female) was found in Apartment 304, between the rear of the television and the window. This person was actually having a telephone conversation with the fire dispatcher while fire operations were taking place in the building. She was provided with instructions by the dispatcher regarding covering her nose and putting towels under the apartment door. Meanwhile, the dispatcher was advising firefighters on the scene of the woman's situation and her location. Because of heavy smoke conditions and locked doors, rescuers were unable to locate her in time to save her (see Appendix A).

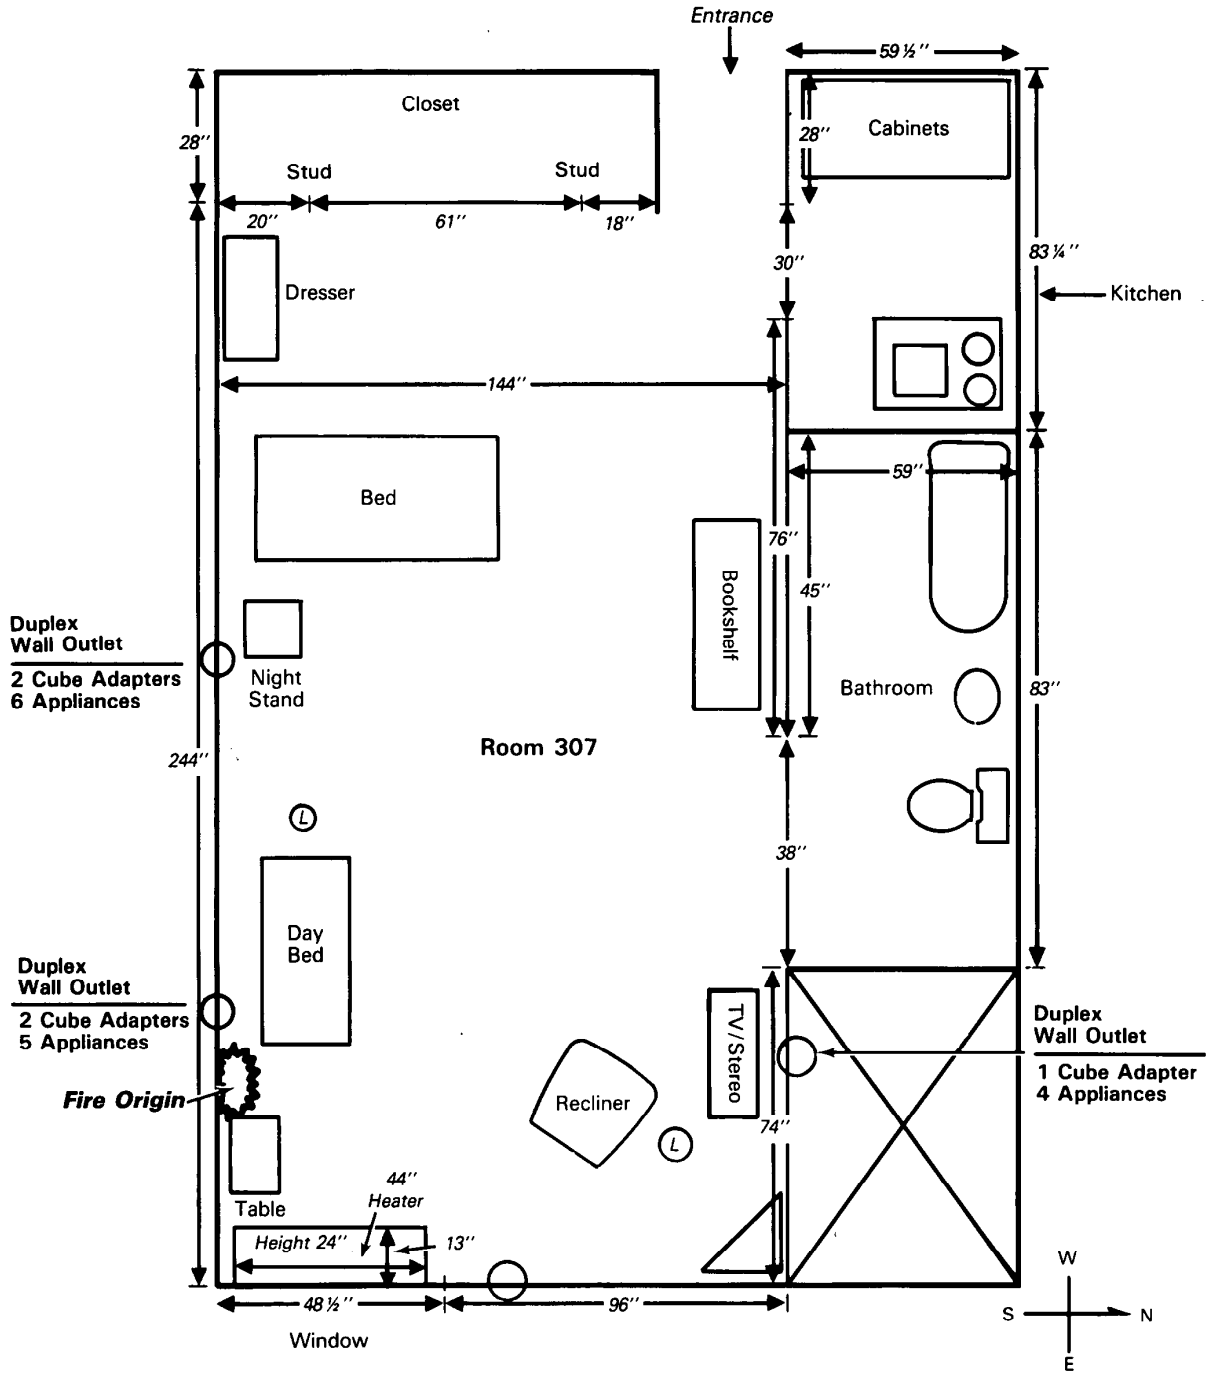
## Room of Fire Origin

The fire originated in Apartment 307 and is believed to be the result of an electrical overload which caused ignition of wood paneling. This particular one-room unit had 17 appliances of various types connected to the electrical receptacles provided for the unit (see Appendix B).

The wood paneling began to burn rapidly, generating tremendous heat and smoke. Because the room was not equipped with an automatic sprinkler system, the fire burned unchecked.

Examination of the apartment door of the room of origin revealed that the door was open, which allowed the fire and smoke to escape to the hallways. There is some evidence that the self-closing device installed on the door had been adjusted to afford the least resistance possible as the occupant passed through in his wheelchair. This, perhaps, accounts for the door not closing. Also, since the apartment occupant was confined to a wheelchair, he probably found it more suitable for his coming and going through the door.

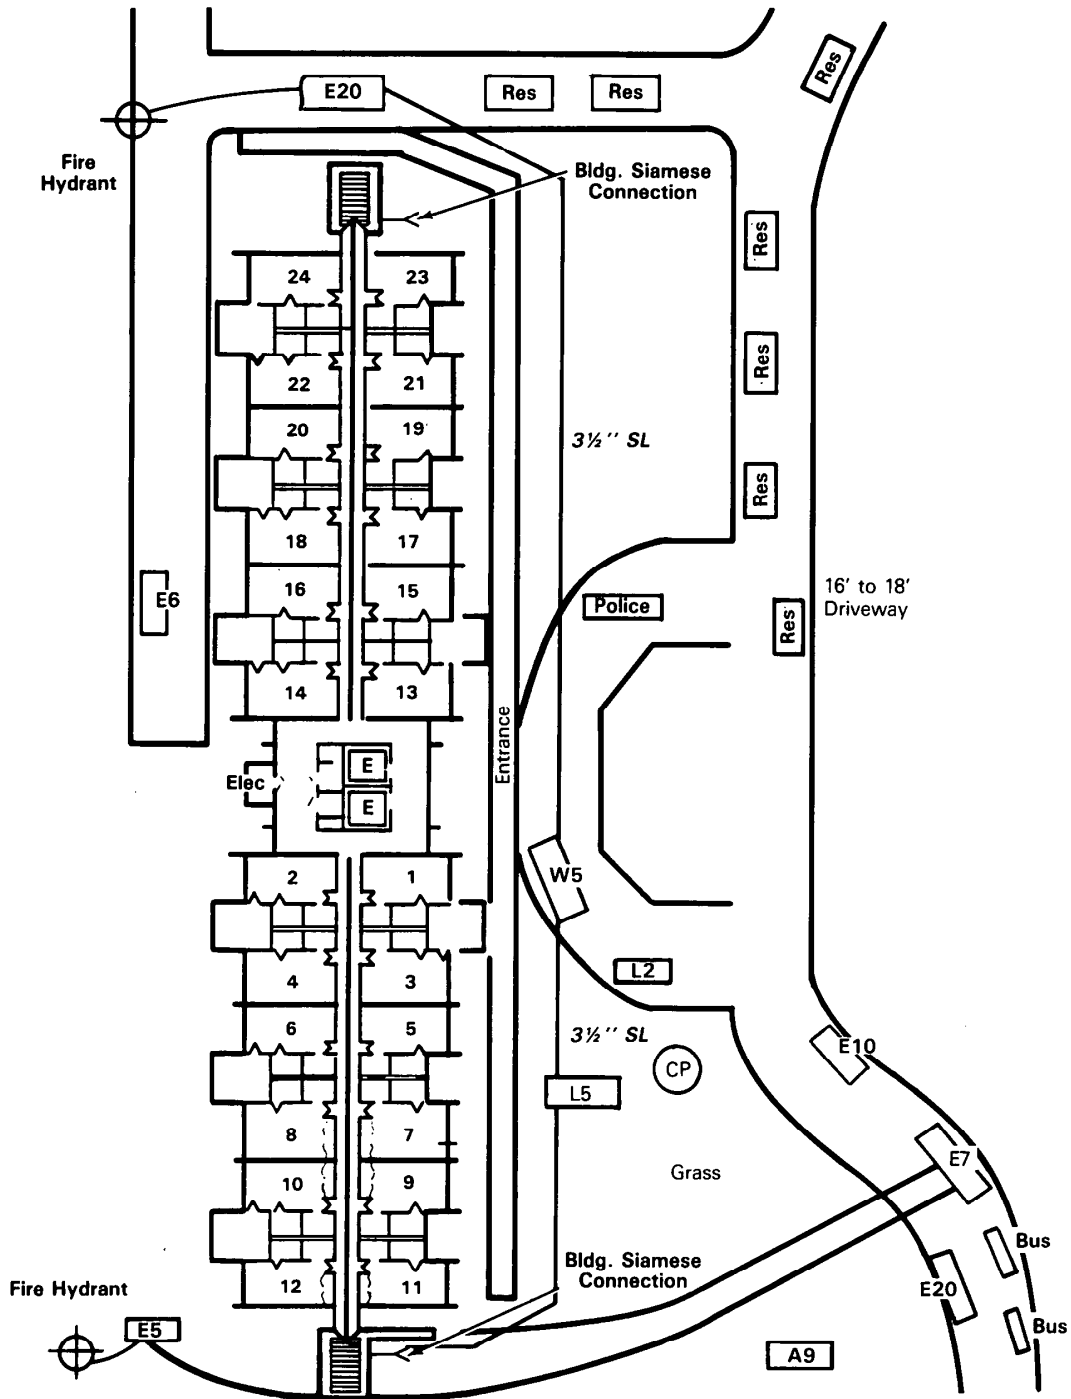
## Fireground Diagram Showing Position of Fire Units at Scene

The emergency vehicle access designed for the Shenandoah Homes building is inaccessible at best. It only affords vehicle access to a very small portion of the structure and to one fire

hydrant. This problem was most apparent when fire apparatus had to be placed on a snow-covered lawn in order to reach the building and to use the fire hydrant. A complete review of other existing structures that present similar problems should be taken without delay.
