Five Fatality Residential Motel Fire Thornton, Colorado

**Five Fatality Residential Motel Fire
Thornton, Colorado
January 27, 1997**

This is Report 104 of the Major Fires Investigation Project conducted by Varley-Campbell and Associates, Inc./TriData Corporation under contract EMW-94-4423 to the United States Fire Administration, Federal Emergency Management Agency.

**11 EAST 84TH AVENUE
THORNTON, COLORADO**

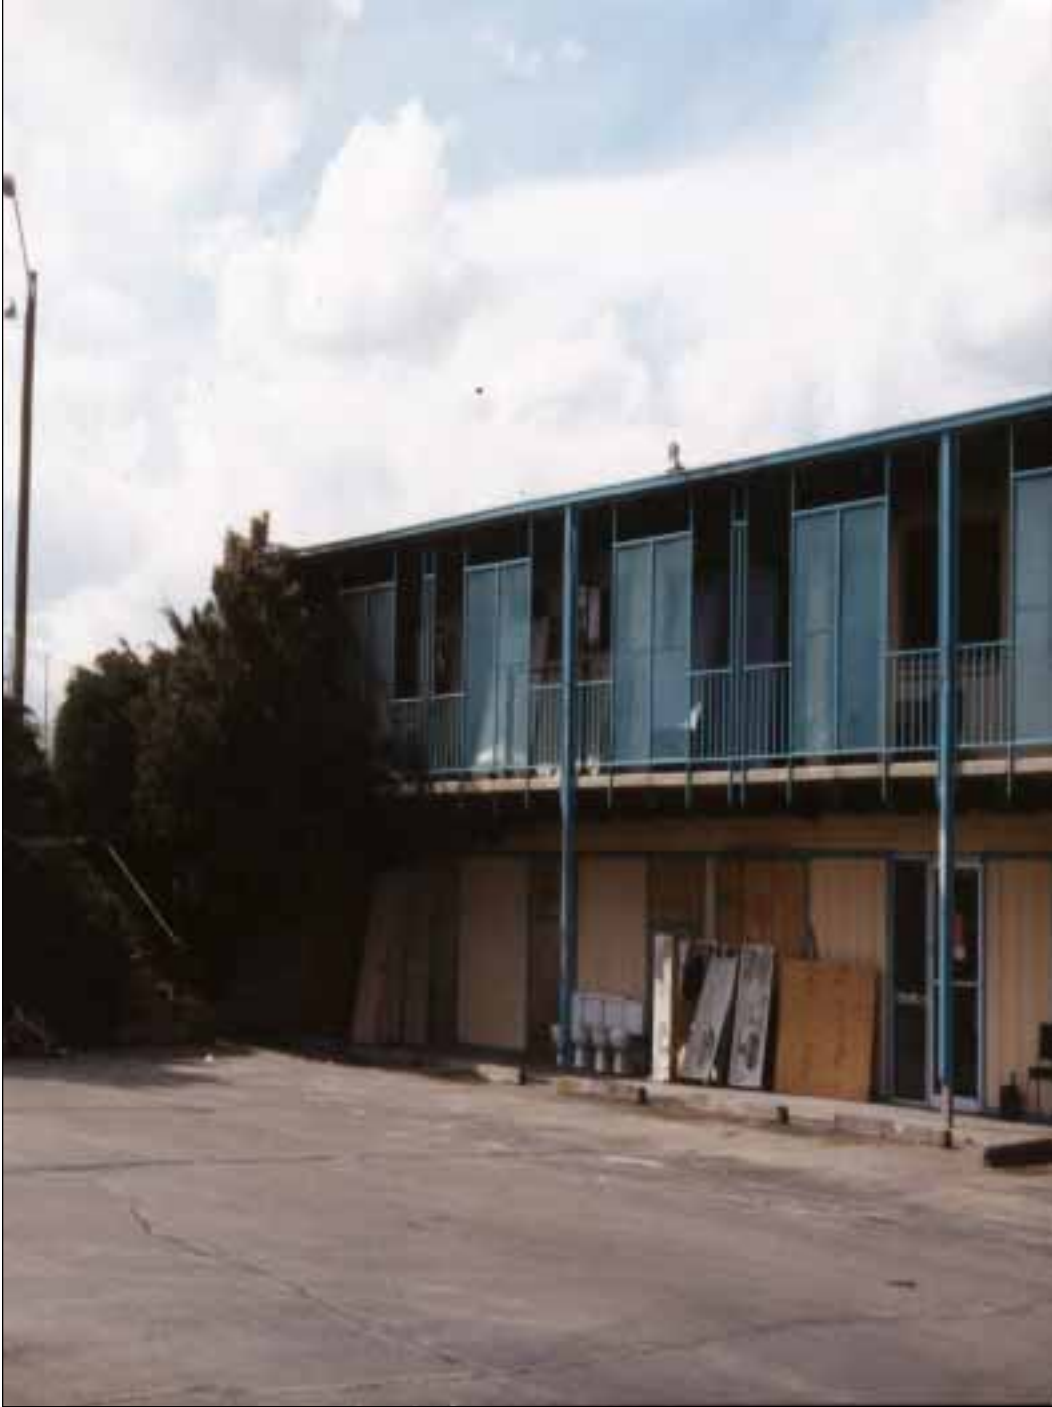
1. Southwest corner of the front wing looking northwest. The 100 level commercial and offices and the 200 level guest rooms are shown. The pine tree shields the entrance to the stairway and storage closet which was the point of origin.

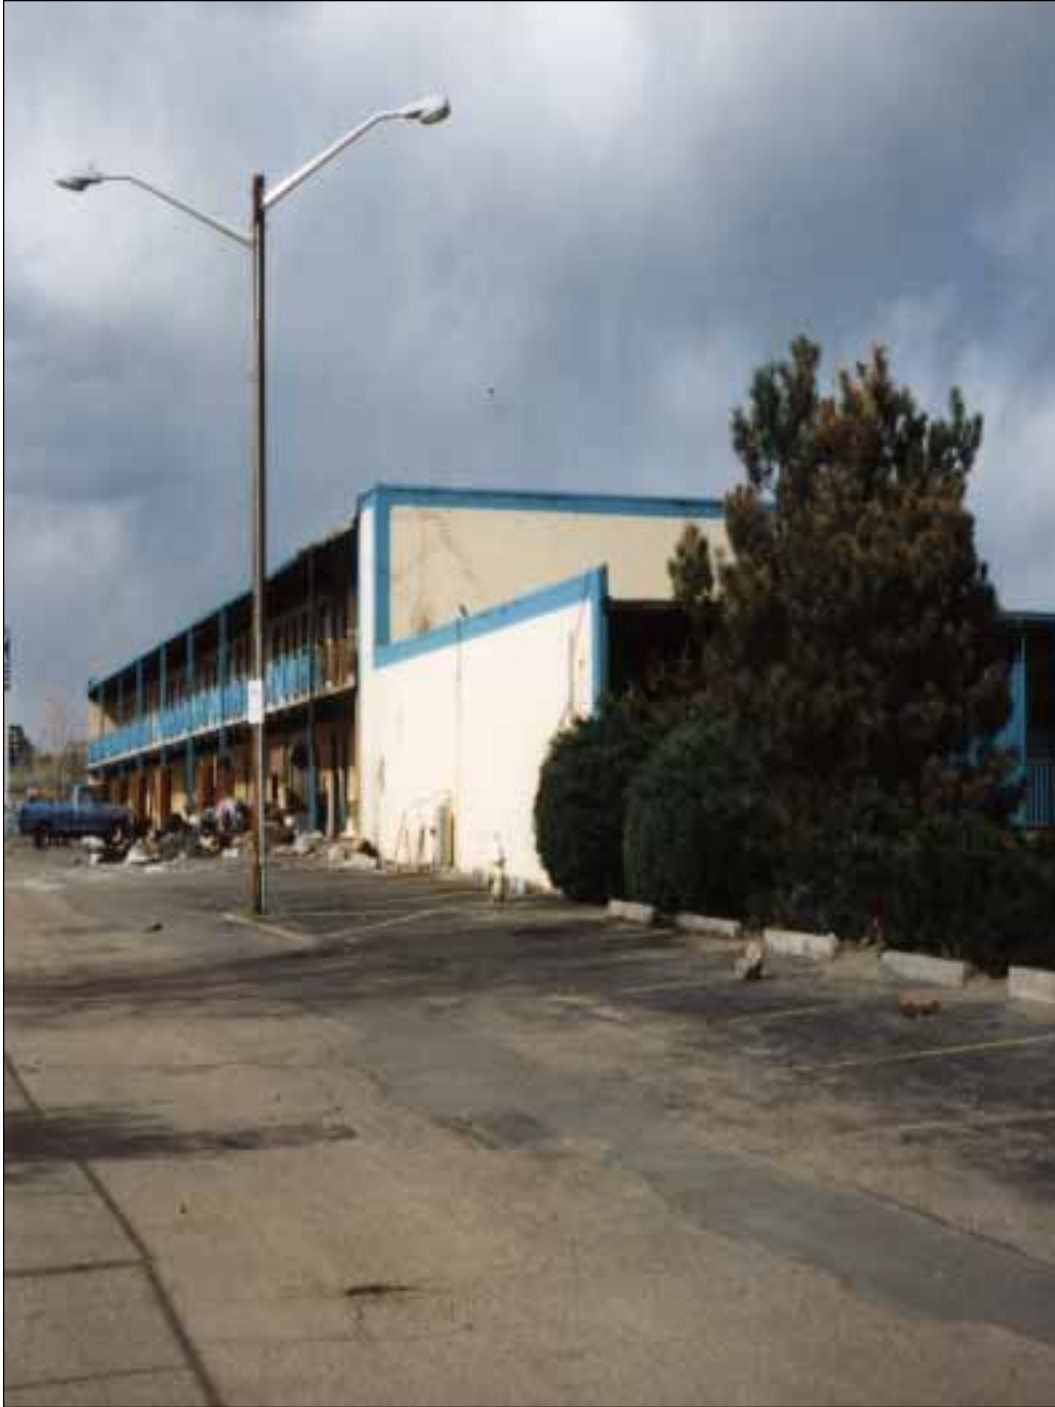
2. The west side of the property looking north. This is the 200 and 300 level guest rooms of the west wing and the end of the front wing. Engine 67 used the fire hydrant to the right of the light pole.

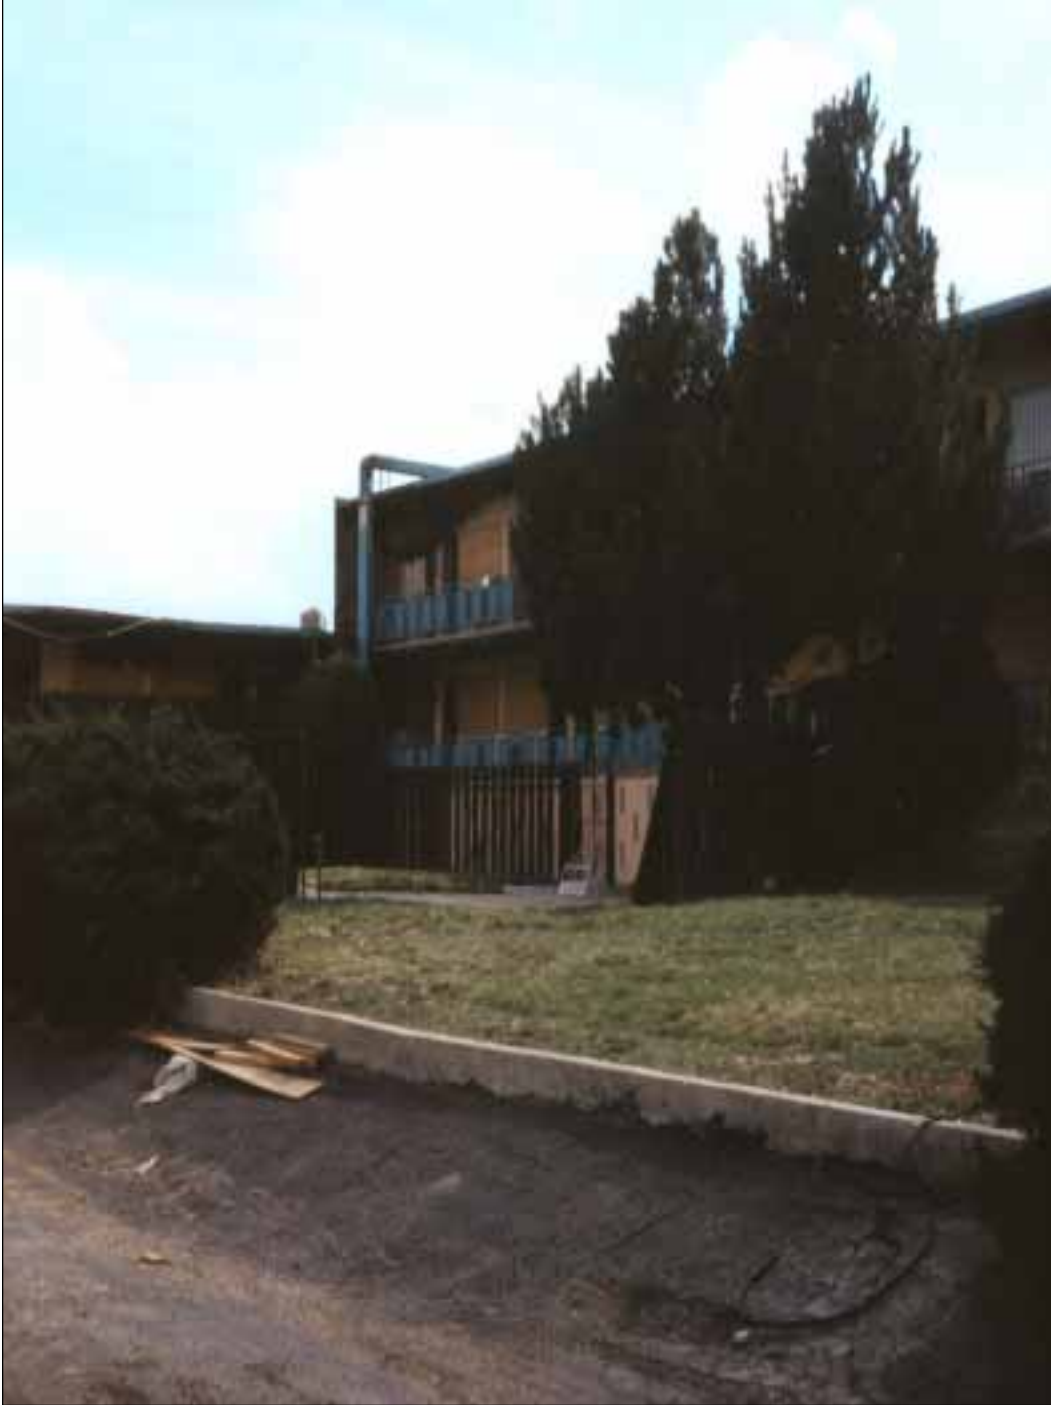
3. The inside corner of the junction between the front and west wings; part of the U shape. This illustrates all three levels of the property and the grade change.

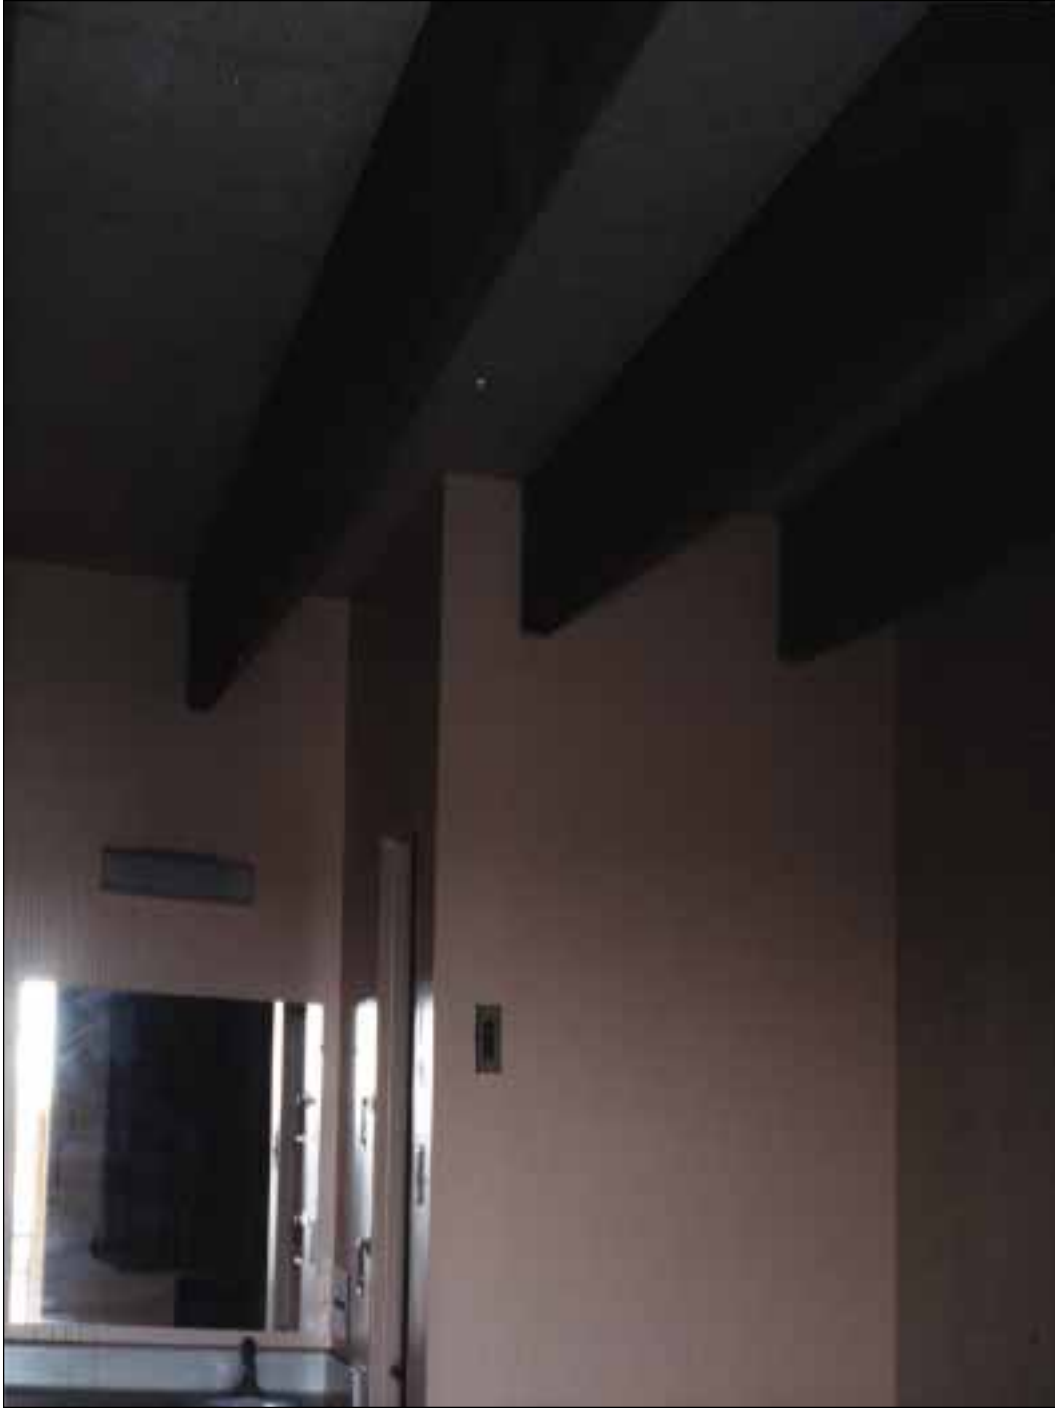
4. Typical guest room ceiling, bathroom, and sink on the utility chase wall.

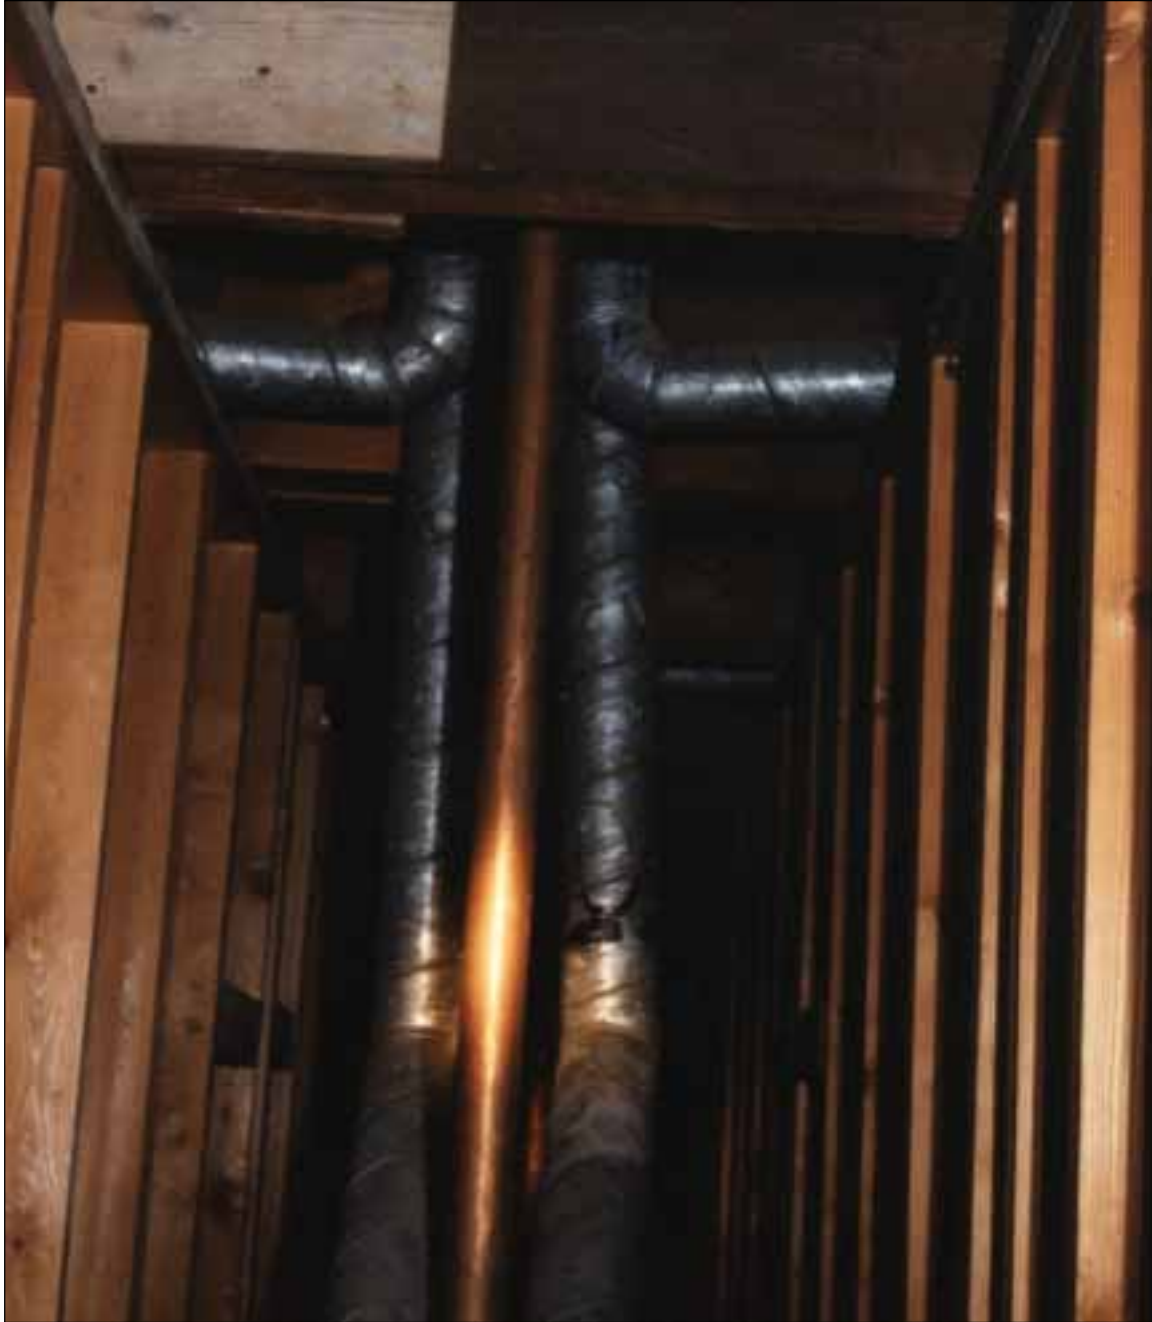
On the second floor, the utility chase was constructed of parallel 2" x 4" wood stud walls covered only on the guest room side only with drywall. (See photograph 5). The chase walls formed the center support for the 4" x 12" wood roof beams which were spaced about 34-inches on center. The beams held up a light weight roof consisting of Tectum board¹ covered with a hot mopped asphalt built-up gravel topped roof covering. (See photograph 6.)

5. The interior of the utility chase between rooms showing the second floor wall construction and the wood beams supporting the roof.

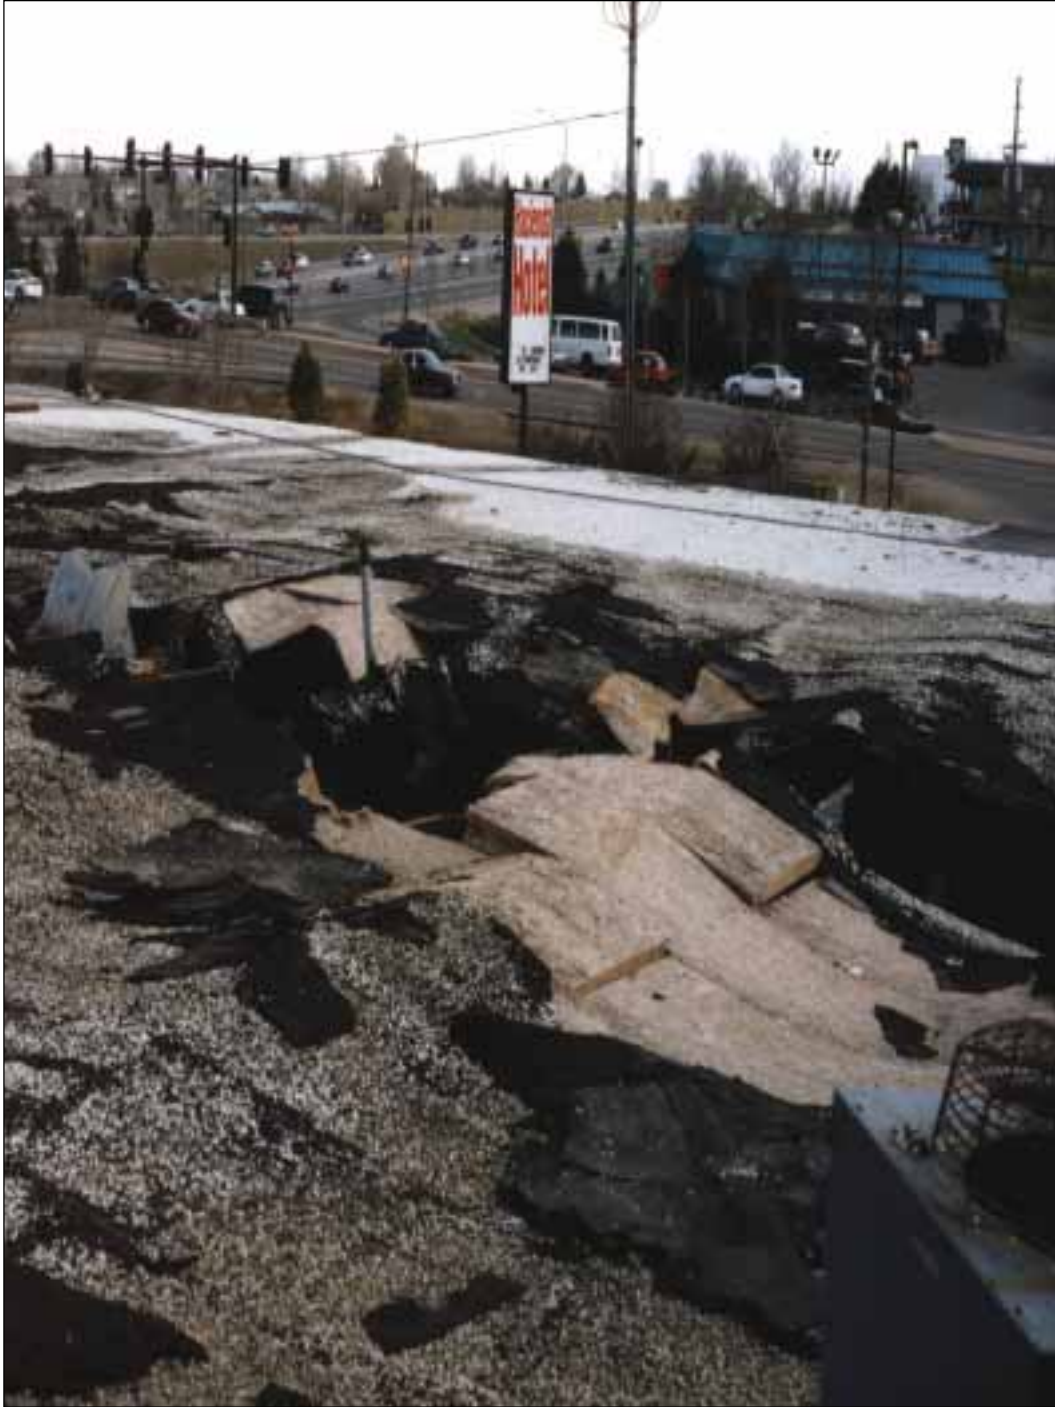
6. Roof over the front wing. The collapsed area is above the utility chase. The roof construction of Tectum board, built-up roofing, and gravel topping is illustrated.

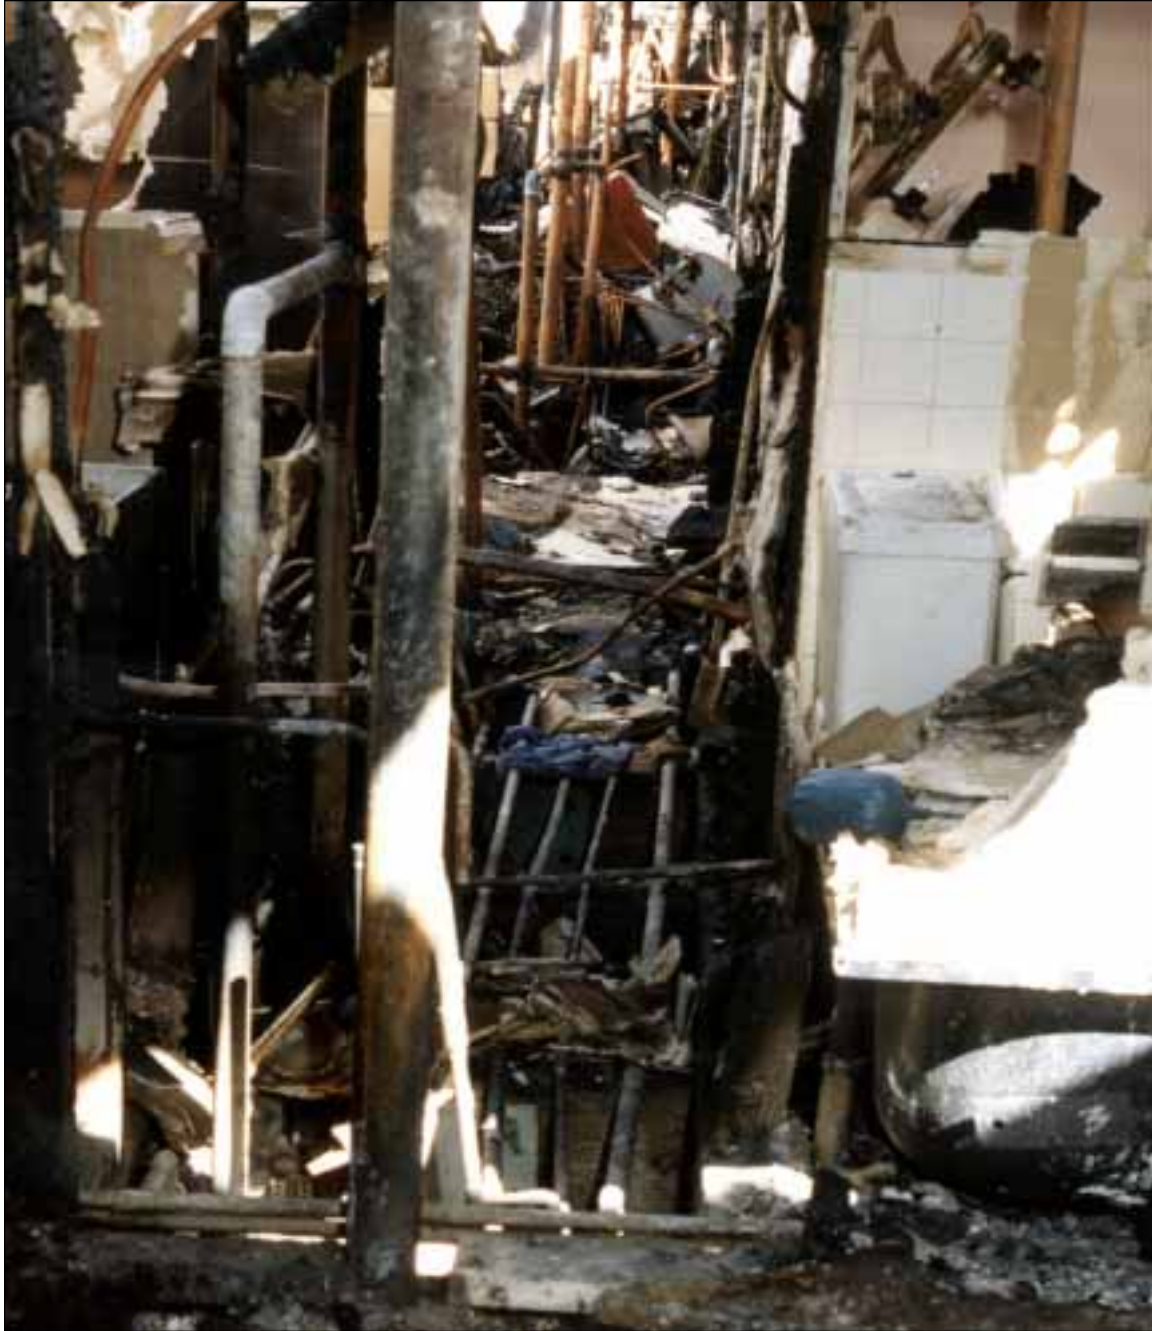
While the fire was essentially contained to the front wing, it was burning within the entire length of the utility chase. The fire broke out of the chase at several locations on the first and second floors. Inside the utility chase, the exposed 2 x 4 wood studs were heavily damaged the entire length and the studs near the westend were totally consumed by the fire. This resulted in the roof collapsing over almost the entire length of the chase. Partial roof collapse also occurred over Rooms 219 to 222 and at the rear (by the utility chase) of Rooms 208 to 211. The fire entered several rooms on the second floor, consuming most of the rooms' contents. Yet adjacent rooms were not heavily damaged. On the first floor north side, the fire followed along the wood construction in the separator walls between rooms, consuming the 2 x 4 wood studs from the inside out.

7. The west end of the utility chase in the front wing. Room 222 is to the left and Room 211 to the right. The second floor utility chase walls were burned away.

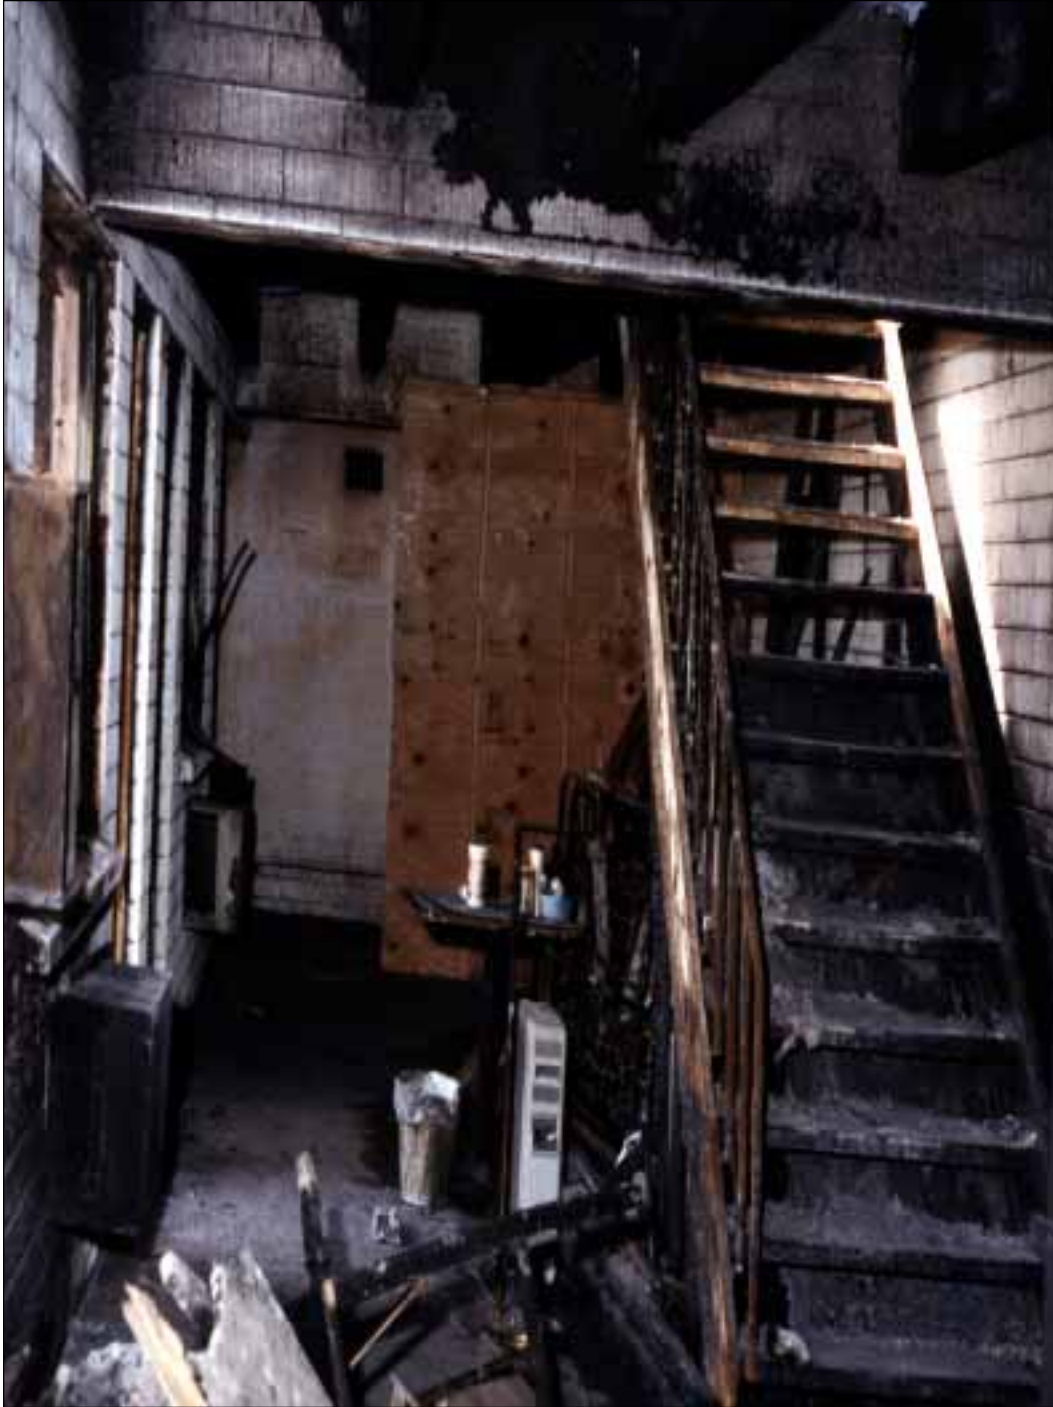
8. The 200 level breezeway area outside of Rooms 220 to 222 looking west. The open stairway to the 300 level is on the right. Under the stairs is another storage room whose wood stud and gypsum board walls were destroyed by the fire.

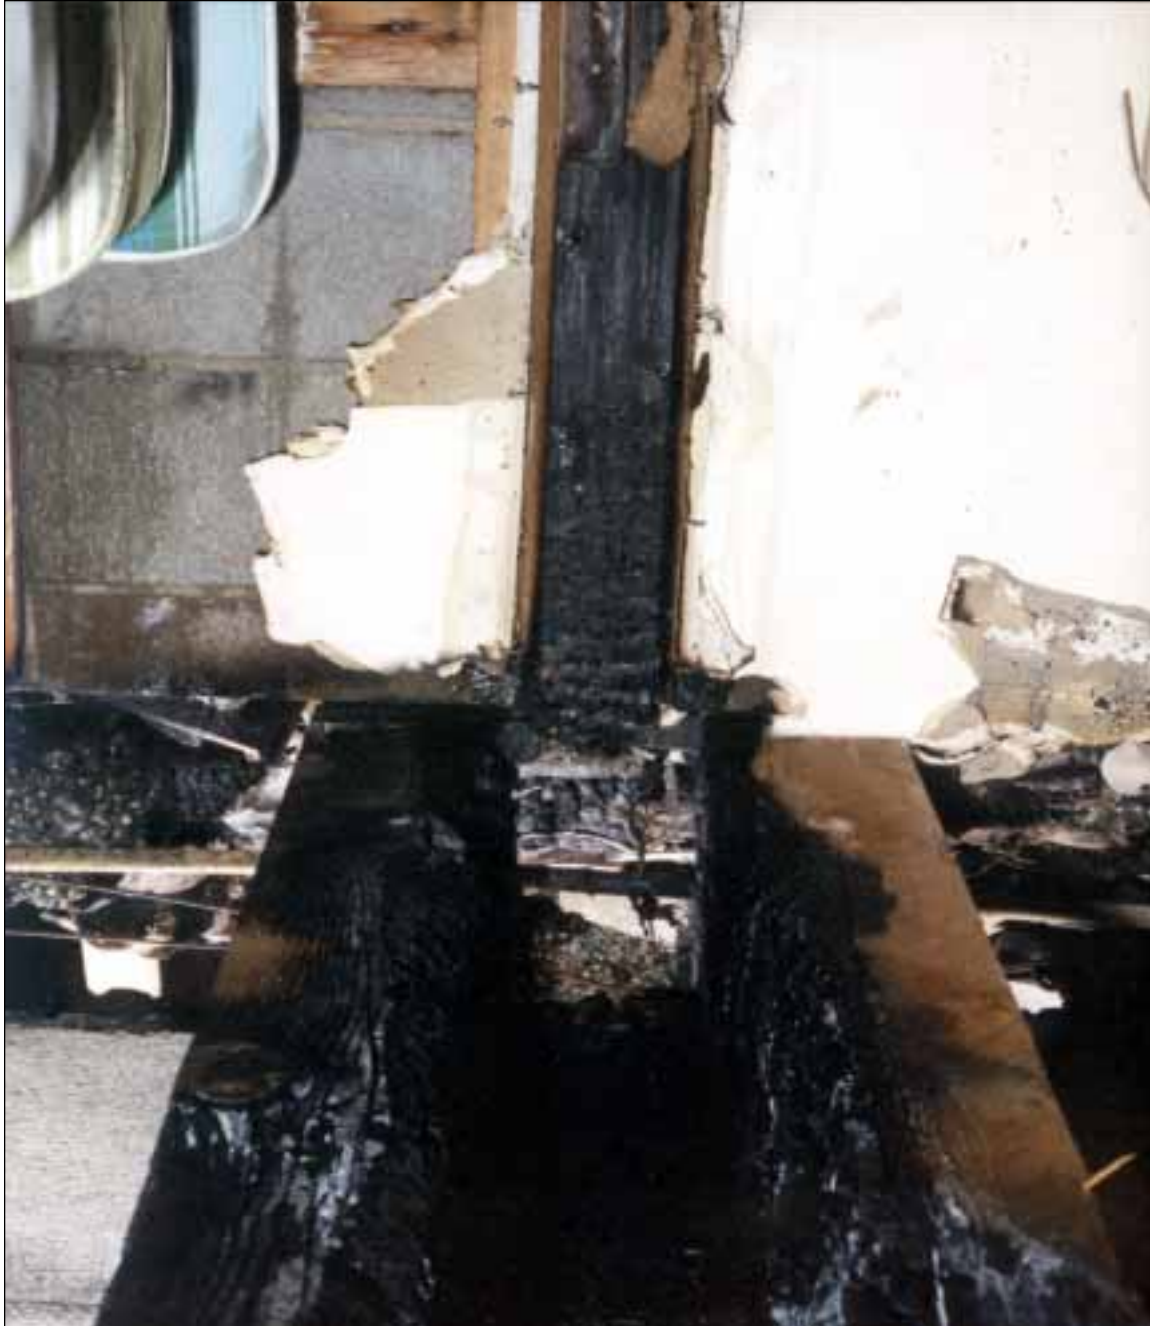
9. A separation wall between 100 level guest rooms that was burned from the inside out. The parallel wood beams formed the top of the wall and the communication to the utility chase is at the back.

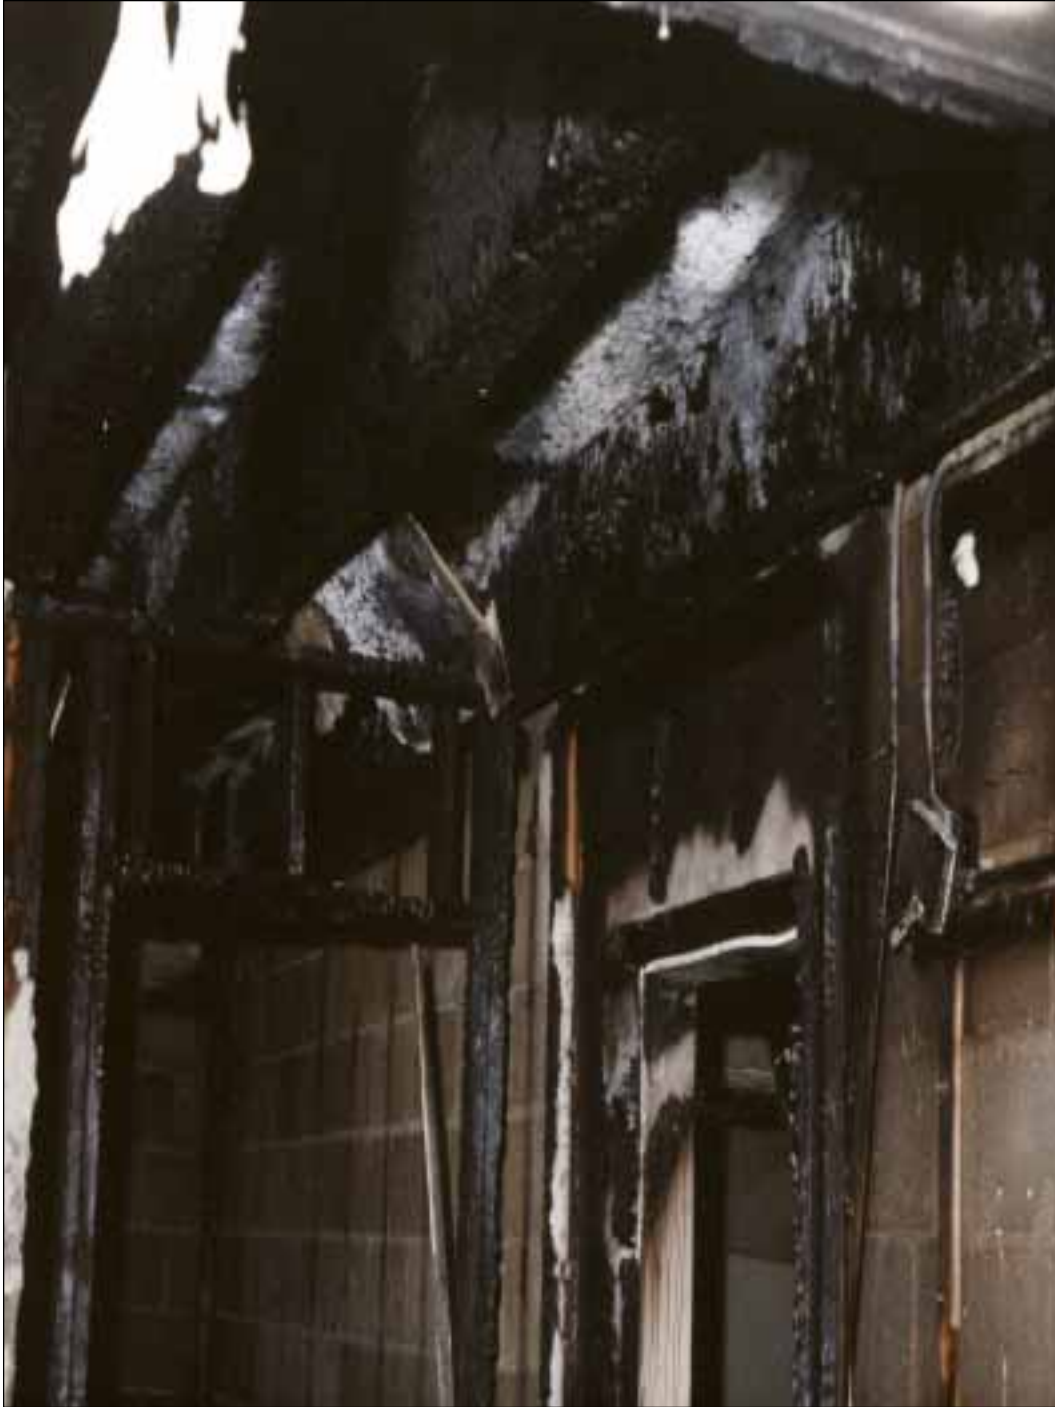
The point of origin is believed to be a first floor storage closet at the stairway located at the west end of the front wing. The closet was formed using the space under and adjacent to the stairway. The metal stairway with concrete filled steps and landing was enclosed on the underside with 5/8 inch drywall. The hollow concrete block stairway walls were also covered with furred out drywall. Where walls were needed to complete the closet enclosure, 2 x 4 wood studs were erected and covered with 5/8 inch drywall on each side.

The closet was nearly filled with rolls of carpet and foam padding at the time of the fire. The wood door of the closet at the beginning of the fire is believed to have been partially open. This allowed combustion air into the closet and the heat, smoke, and flames to quickly rise up the adjacent stair opening to the second floor corridor and breezeway. The storage closet was also adjacent to the utility chase which allowed smoke, and eventually fire, to enter the chase and then extend to the guest rooms.

10. The top of the door frame for the 100 level closet determined to be the point of origin. The open stairway to the 200 level is to the top left off the photograph.

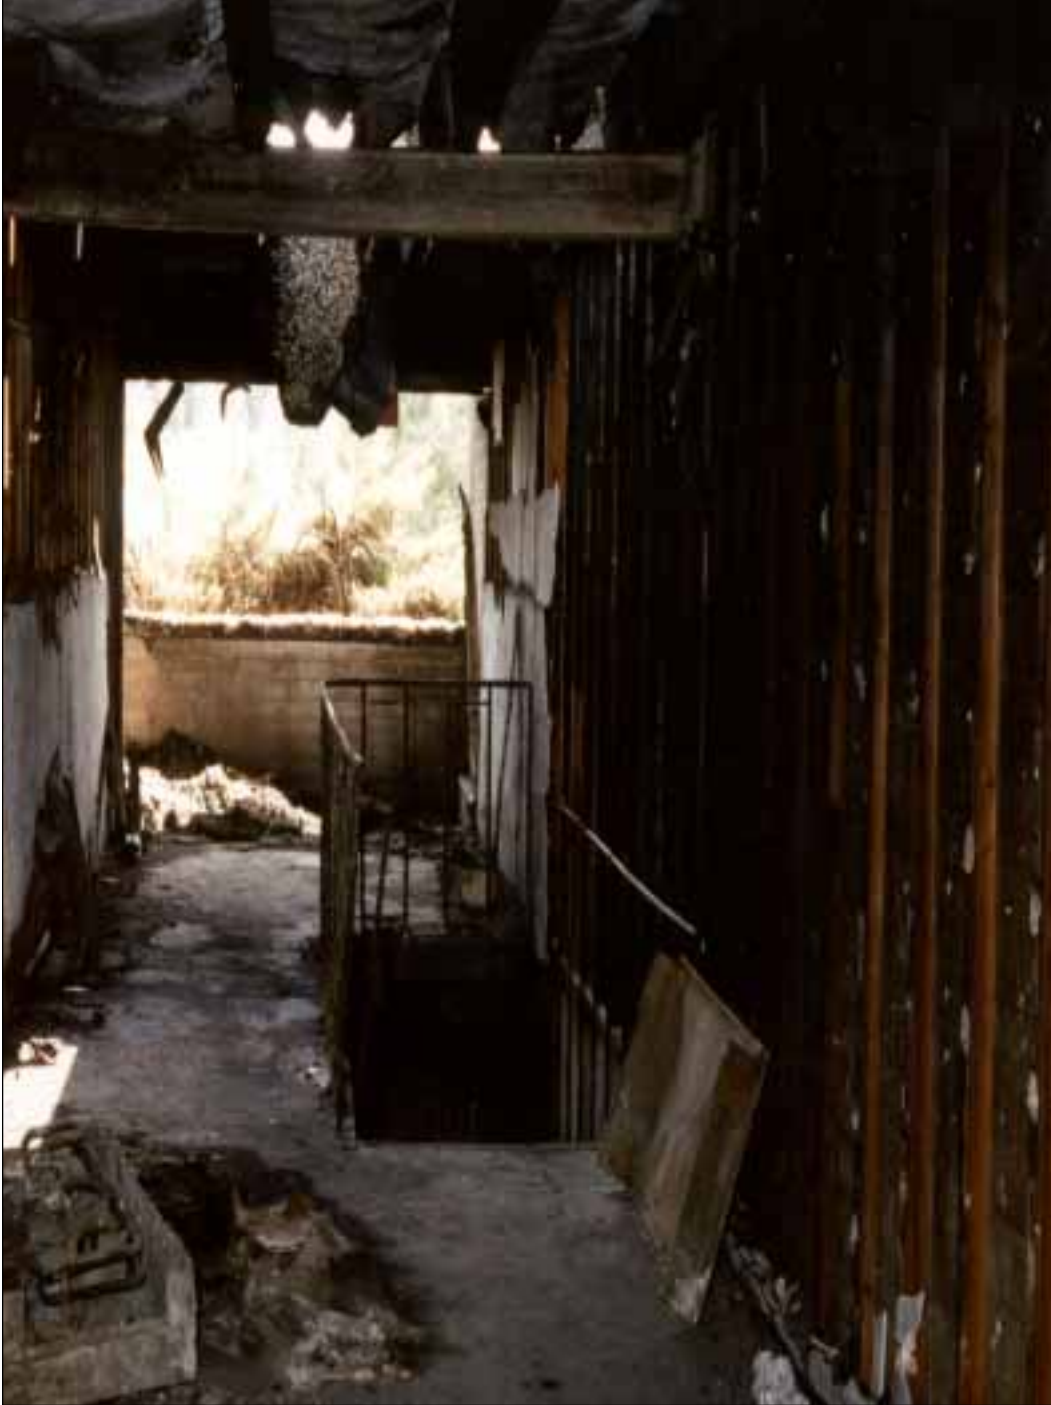
11. The top of the open stairway from the 100 level looking south. A glass in aluminum frame wall enclosed this area just before the partial height brick wall in the background. Room 222 is to the left.
