Old Buckingham Station Chesterfield, Virginia

Old Buckingham Station

58 Unit Apartment Building

May 19, 1995

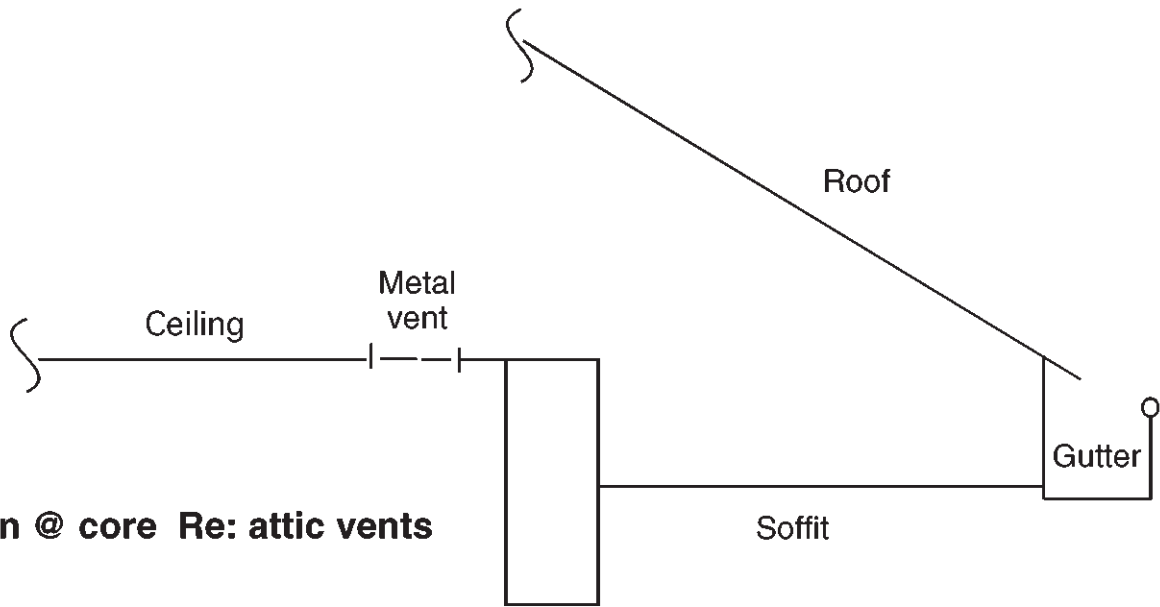
Section @ core Re: attic vents

The floors were 2x4 parallel cord trusses 18 to 24-inches deep supporting a plywood subfloor that was topped with a thin (about 1-inch) layer of lightweight concrete. Gypsum board ceilings were attached directly to the bottom cords of the truss. The roof was constructed of a chip board deck over peaked wood trusses made from 2x4 and 2x6 members. The truss span was approximately 40 feet with a peak height of 13.5 feet and an 8/12 pitch. The roof contained a ridge vent and continuous soffit vents were provided around the perimeter of the building. (See Appendix C for soffit vent details.)

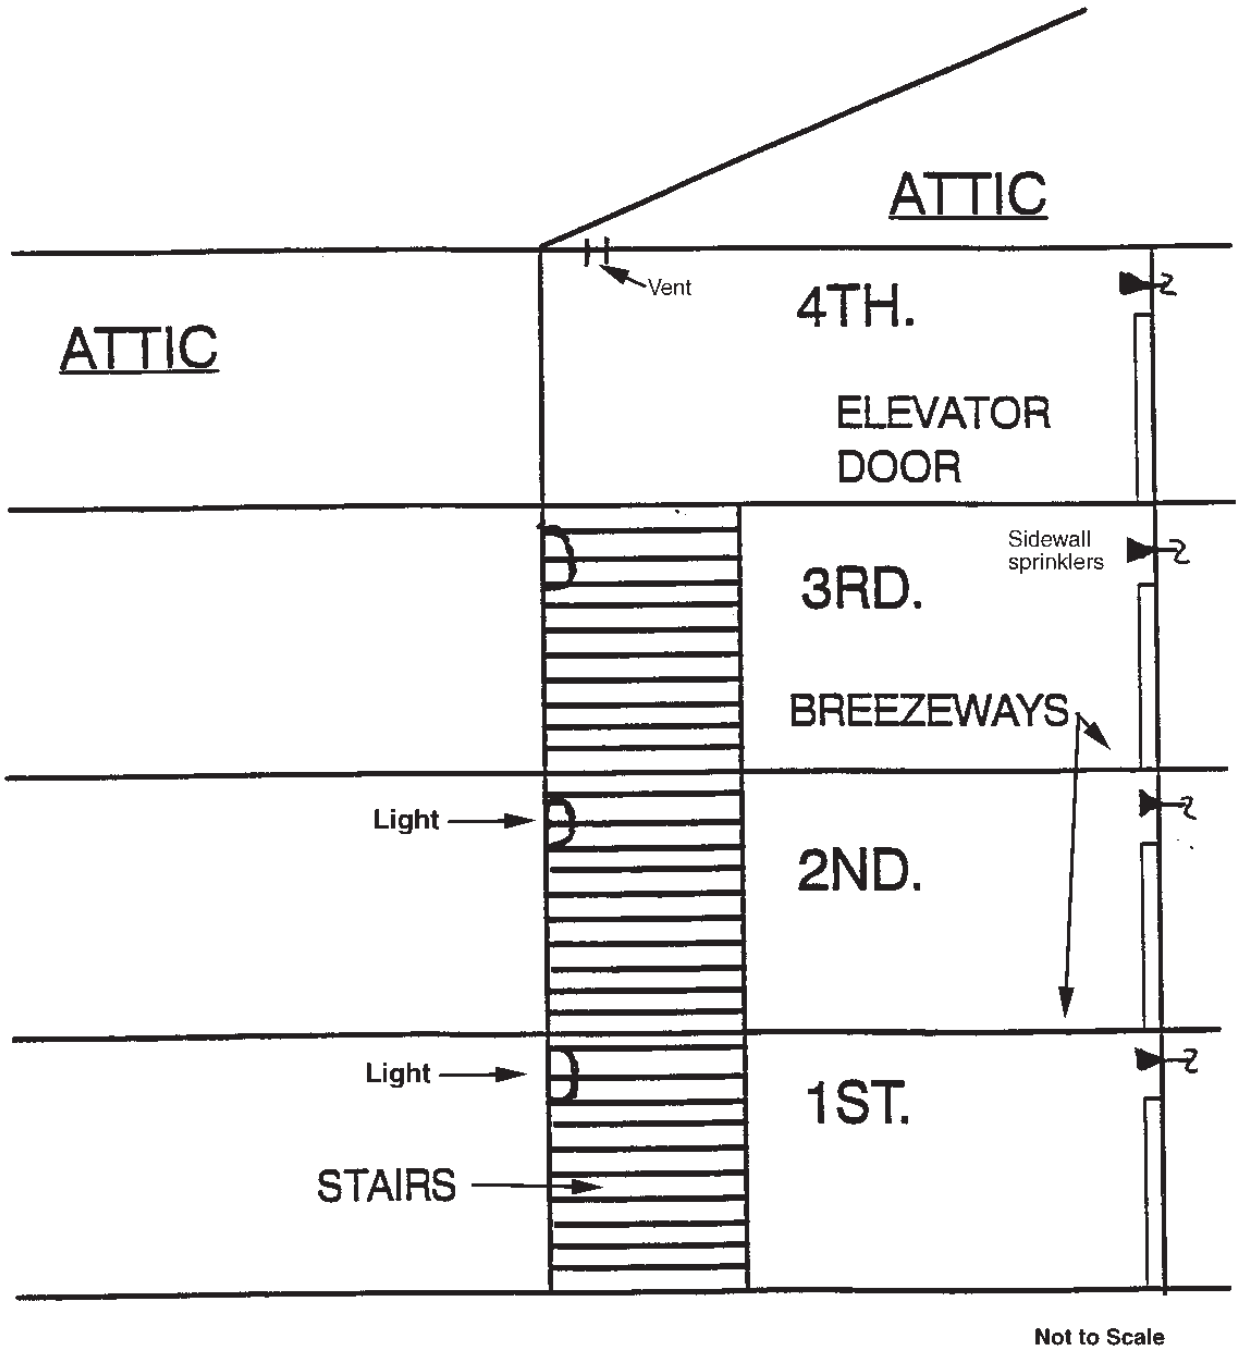
Section at Core Walkway
Lodge Building
 Appendix E

The siding fire quickly moved up the nearby open, wooden stairway before the sidewall sprinkler on the wall opposite the light fixture was able to operate. (See Appendix E for Section Drawing) The fire continued to burn upward until it reached the ceiling of the fourth floor open walkway. At this point it entered the combustible attic through a vent opening at the outside perimeter of the ceiling. The soffit vents in the fourth floor core area were located inside, rather than outside, the perimeter support beam for the roof. This design contained the heat and flames at the fourth floor ceiling and allowed them to pass through the vent into the unprotected combustible attic. Once in the attic, the fire was out of reach of the exterior sprinkler heads.

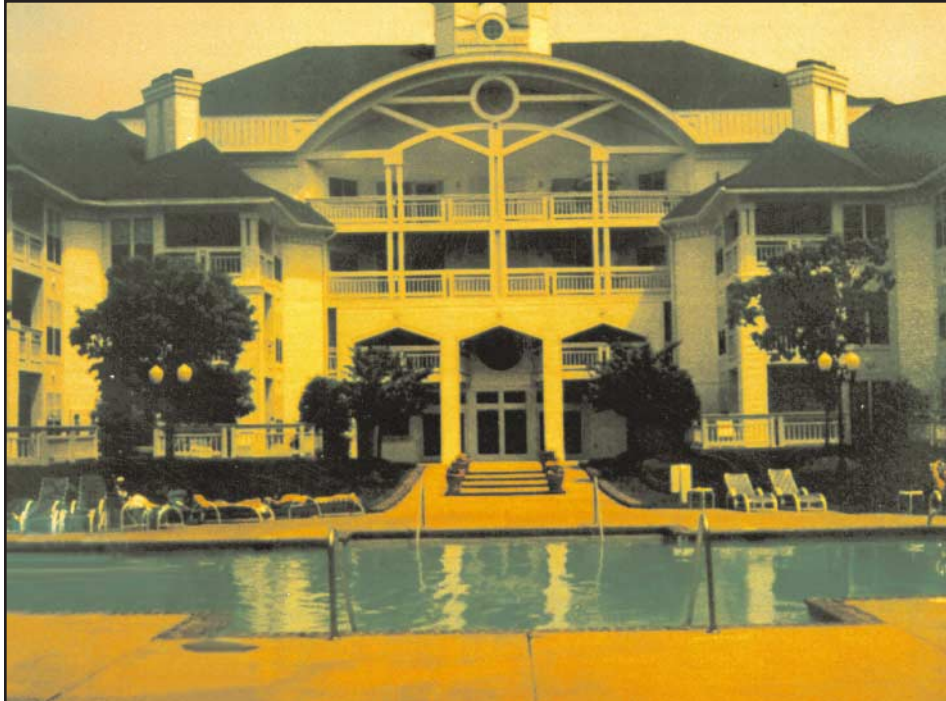
4. The rear or swimming pool side of the four story core building before the fire. The fire started on a second floor breezeway on the left side of this photograph.

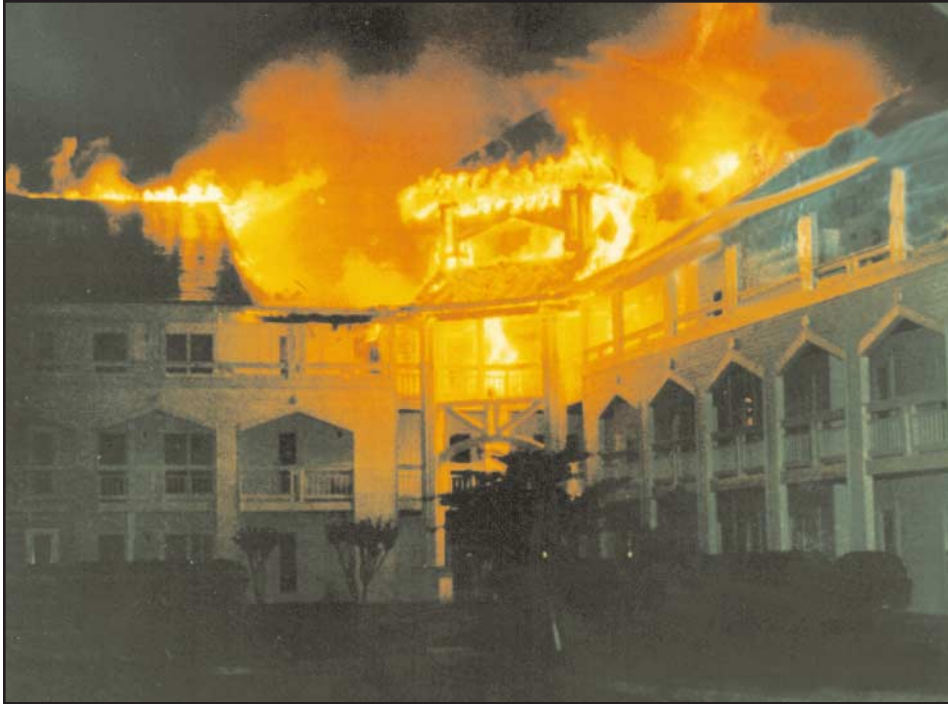
5. Fire involvement in Sector D (North side) as units were preparing to operate in this sector. The fire was well-established in the attic, third floor walkway, and fourth floor.

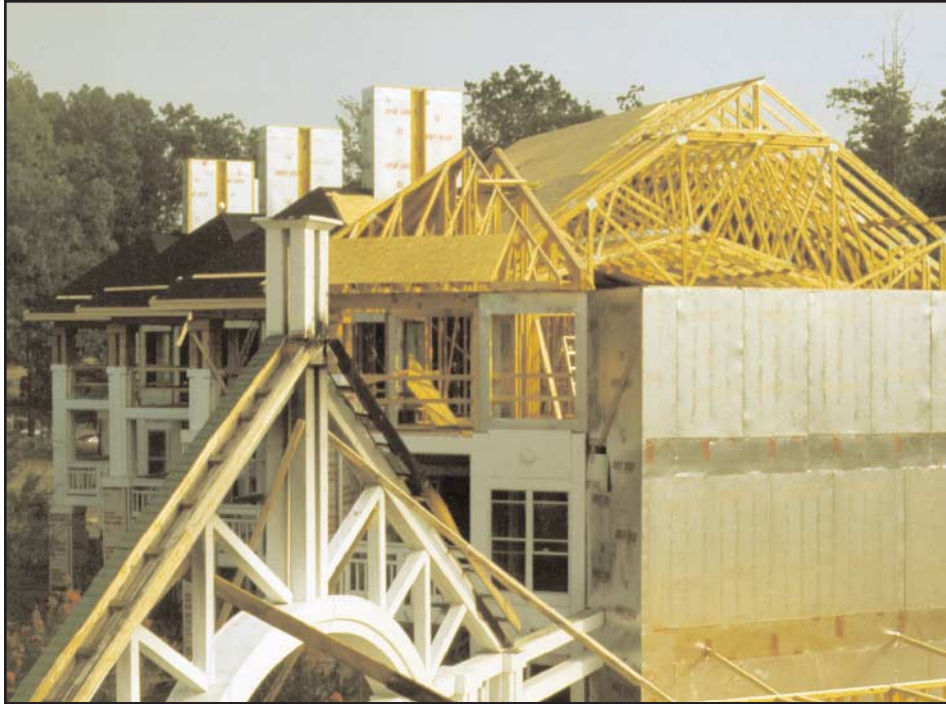
7. The remains of the front archway and the repairs and reconstruction underway for the wing in Photograph 6. The attic trusses and exterior sheathing materials are illustrated.

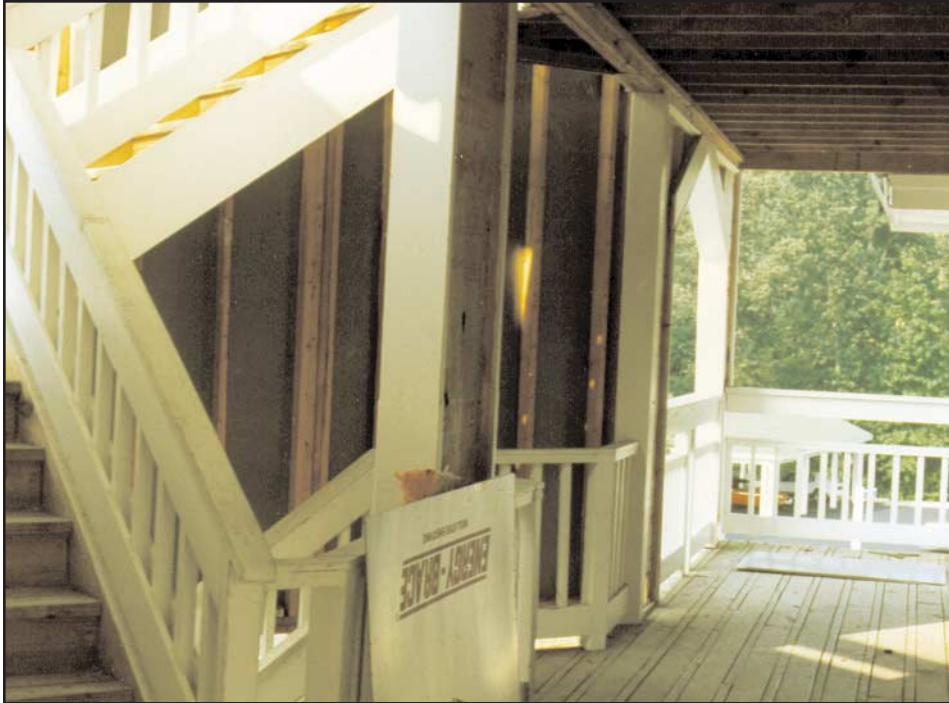
located at the core and the other at the ends of the wings (See Appendix C for diagram). The walkways were of wood construction and contained small gaps between the deck boards to permit water to drain through. With the exception of horizontal sidewall automatic sprinkler heads that were located near the two core stairways, the covered walkways were not protected by automatic sprinklers.

10. The stairway and exterior walkways used throughout the building. Note the gaps in the walkway to allow water to drain and the piece of thin exterior sheathing leaning against the stairway.

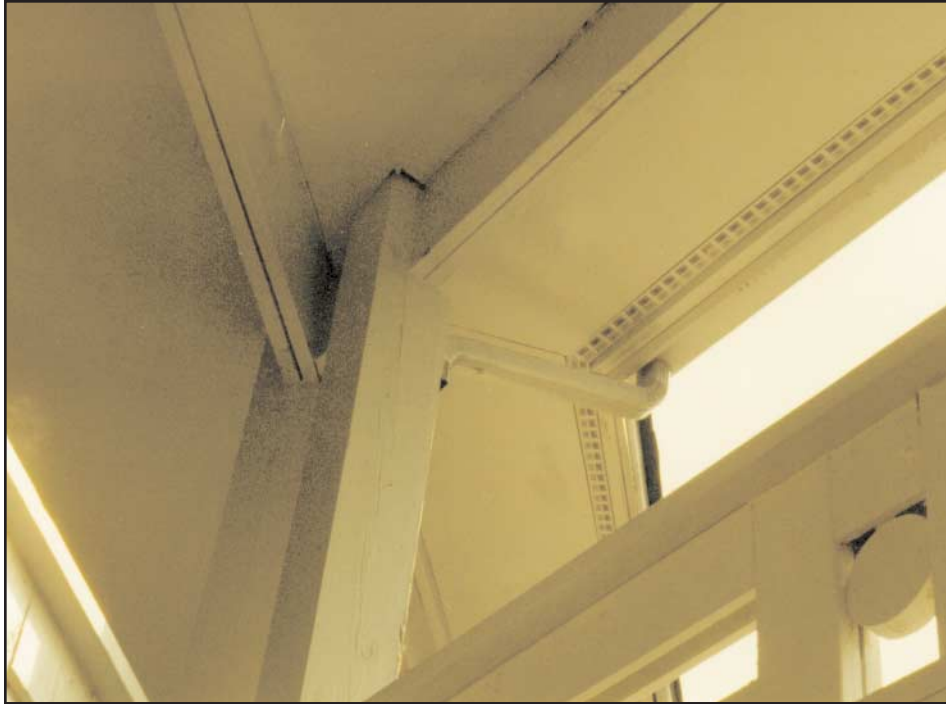
Ventilation Openings into Attic	Air vent openings at the building eaves permitted the fire to easily access the unprotected combustible attic space.
Fire Spread	The open combustible corridors and balconies and lightweight exterior wall finish supported rapid vertical and horizontal fire spread.

11. Typical eave line vents installed around the perimeter of the building. The fire is believed to have entered the attic through these vents.

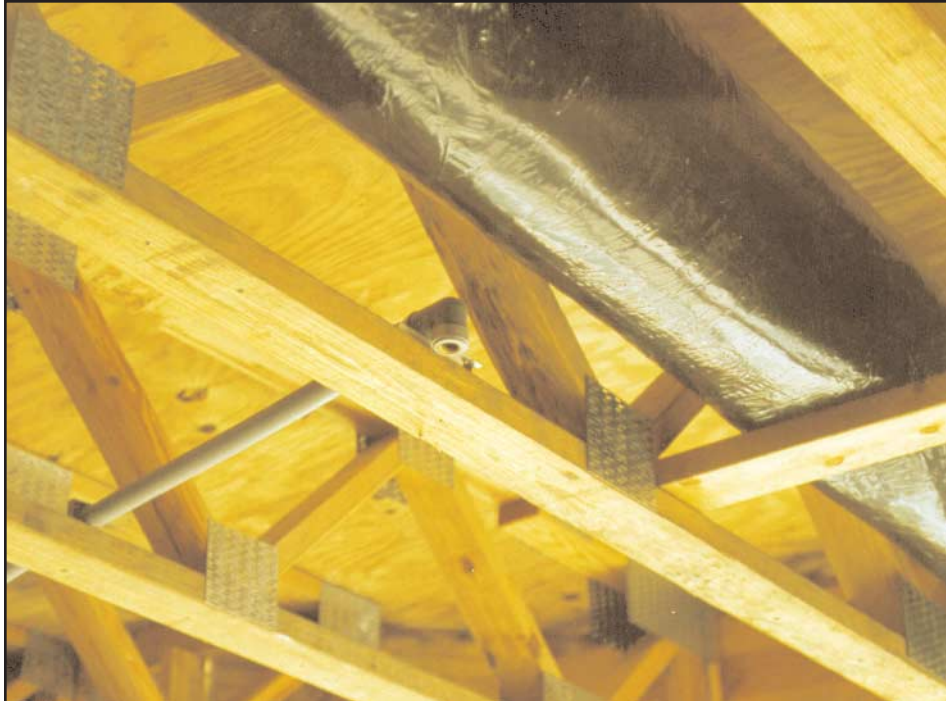
12. The parallel cord wood floor trusses used in the original construction and a polybutylene automatic sprinkler line.
