## **Sprinklered Records Storage Facility**

**Chicago, Illinois**

**Sprinklered Records Storage Facility  
Chicago, Illinois  
October 29, 1996**

This is Report 106 of the Major Fires Investigation Project conducted by Varley-Campbell and Associates, Inc./TriData Corporation under contract EMW-94-4423 to the United States Fire Administration, Federal Emergency Management Agency.

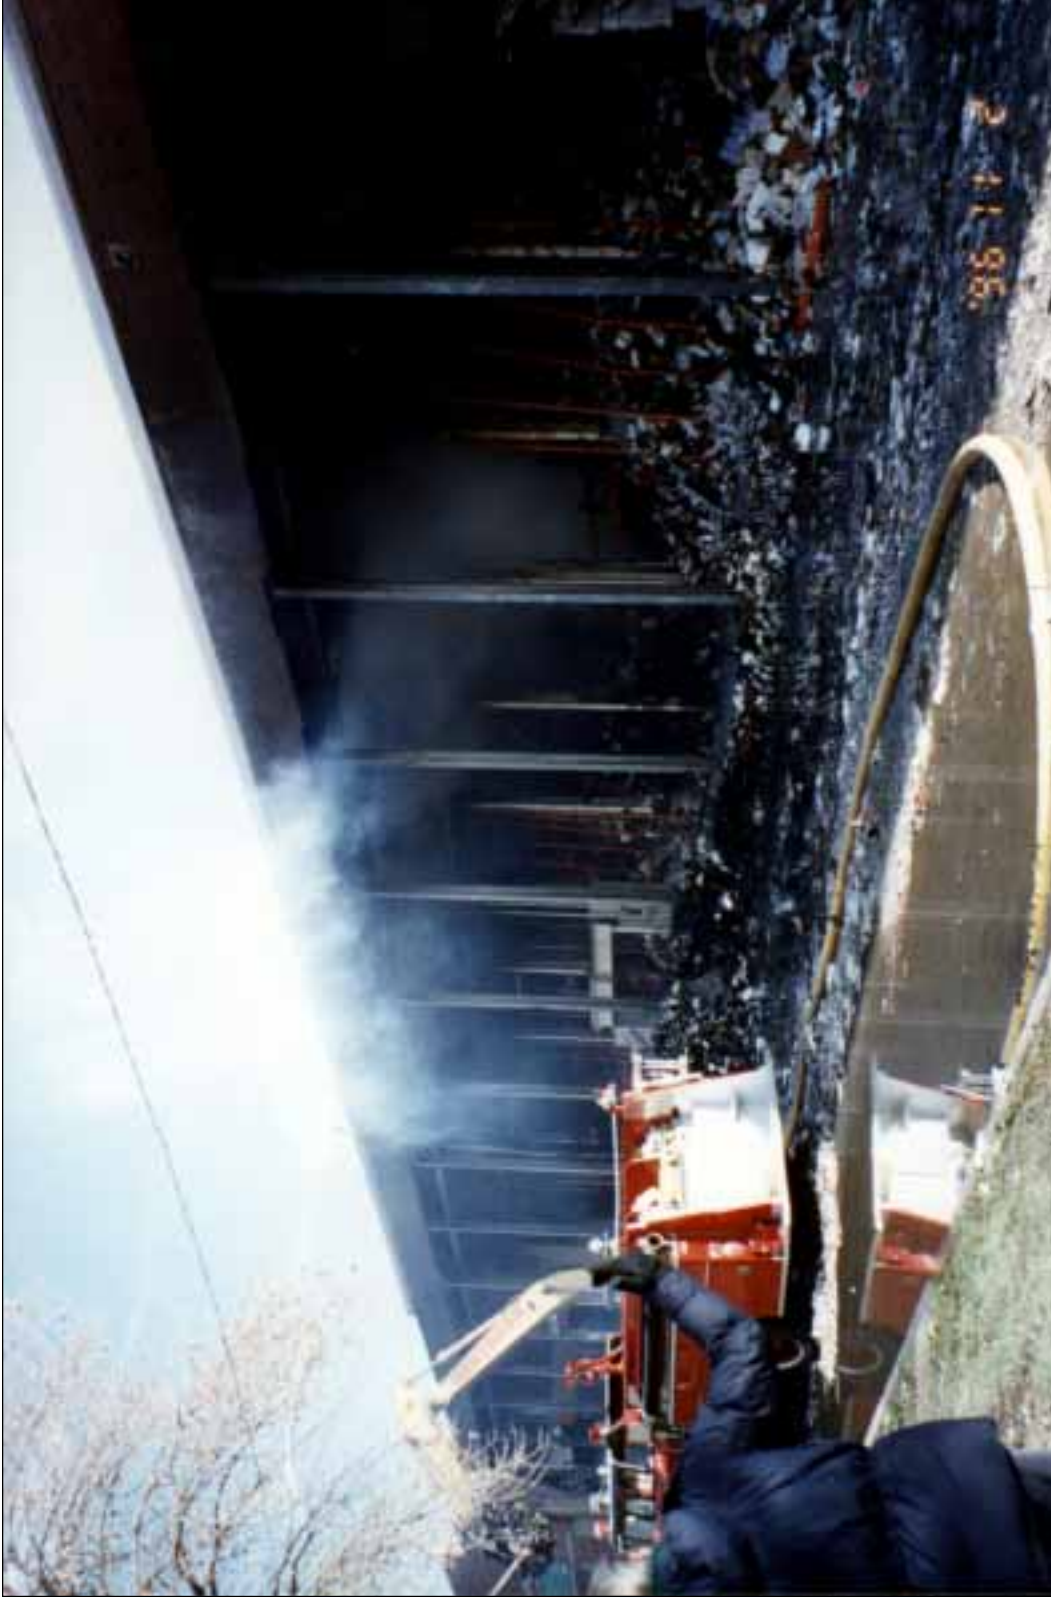
1. Knox Avenue and the front of Building III several days after the fire during overhaul. The west street curb line is at the bottom left corner.

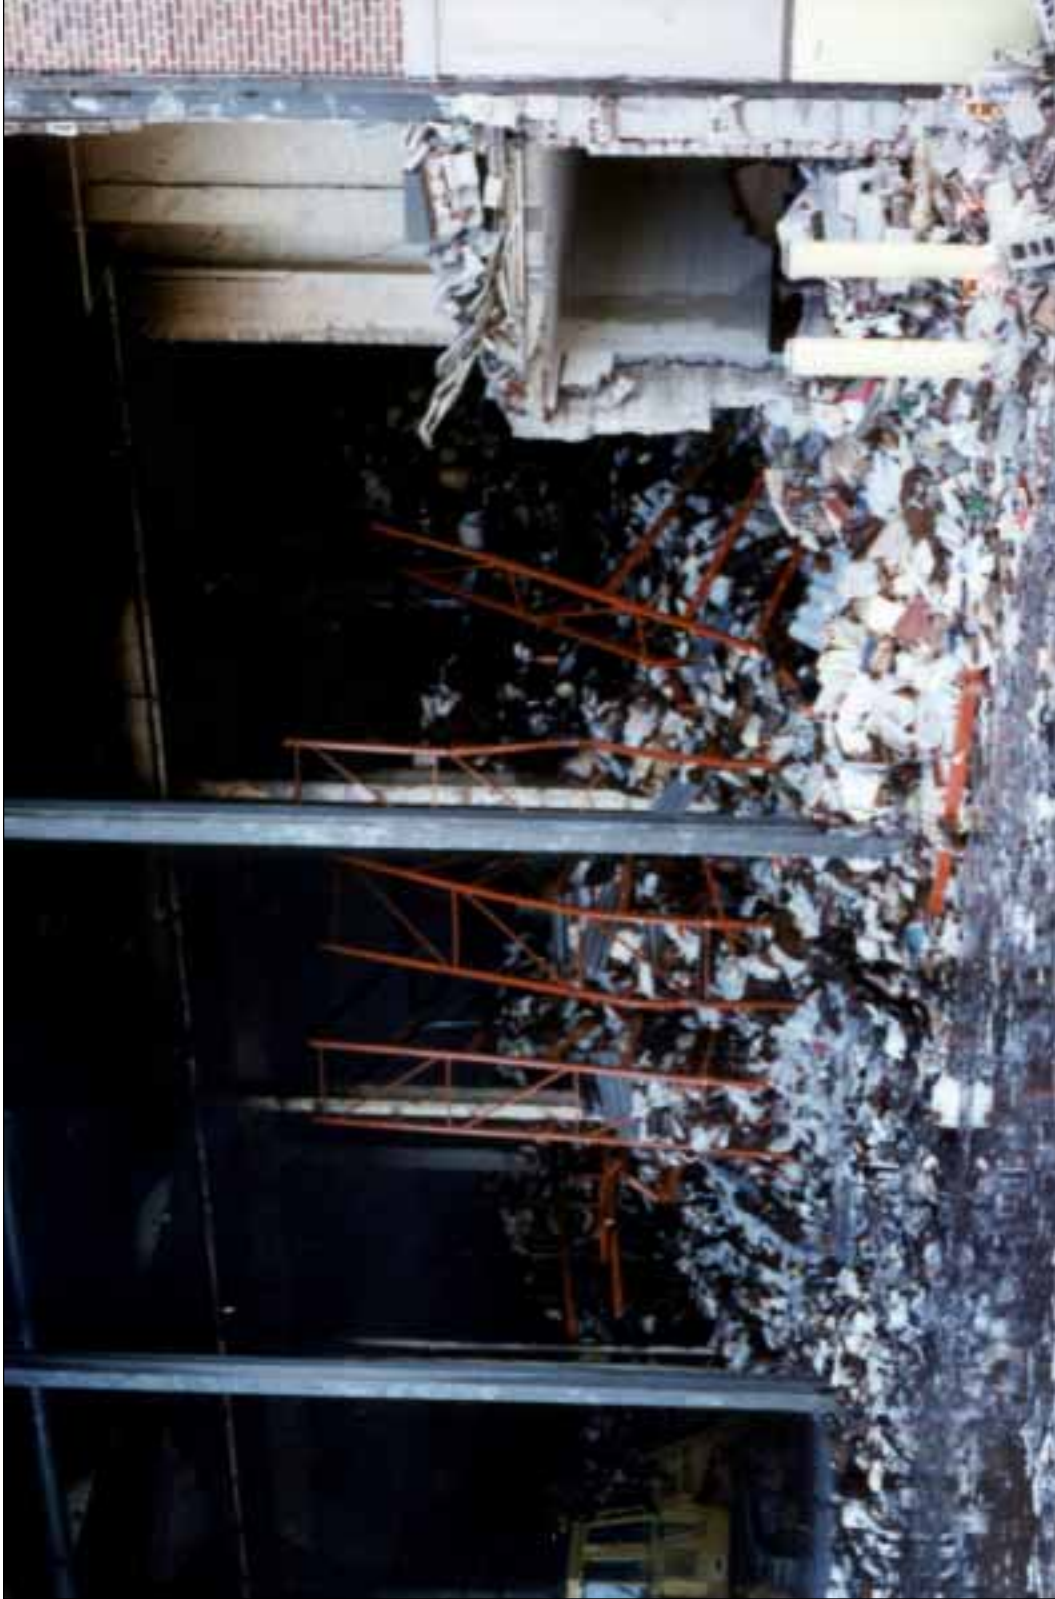
structural collapse of both the storage racks and the building. By themselves, paper records and their storage means can provide a load very close to the capacity of the structure; with the additional weight of the fire fighting water absorbed by the boxes and their contents, a floor can become quickly overloaded. In addition, storage racks are typically unprotected steel which will lose their structural stability when exposed to heat and flame. They can also be overloaded by the extra weight of the water absorbed and collected in the items stored in the racks. Failure of one rack may cause adjacent ones to topple because of insufficient anchorage or simple overload.

2. Typical of the rack collapse, record box failure, and documents filling the aisles. The brick-faced, hollow concrete block front wall was removed on the night of the fire.

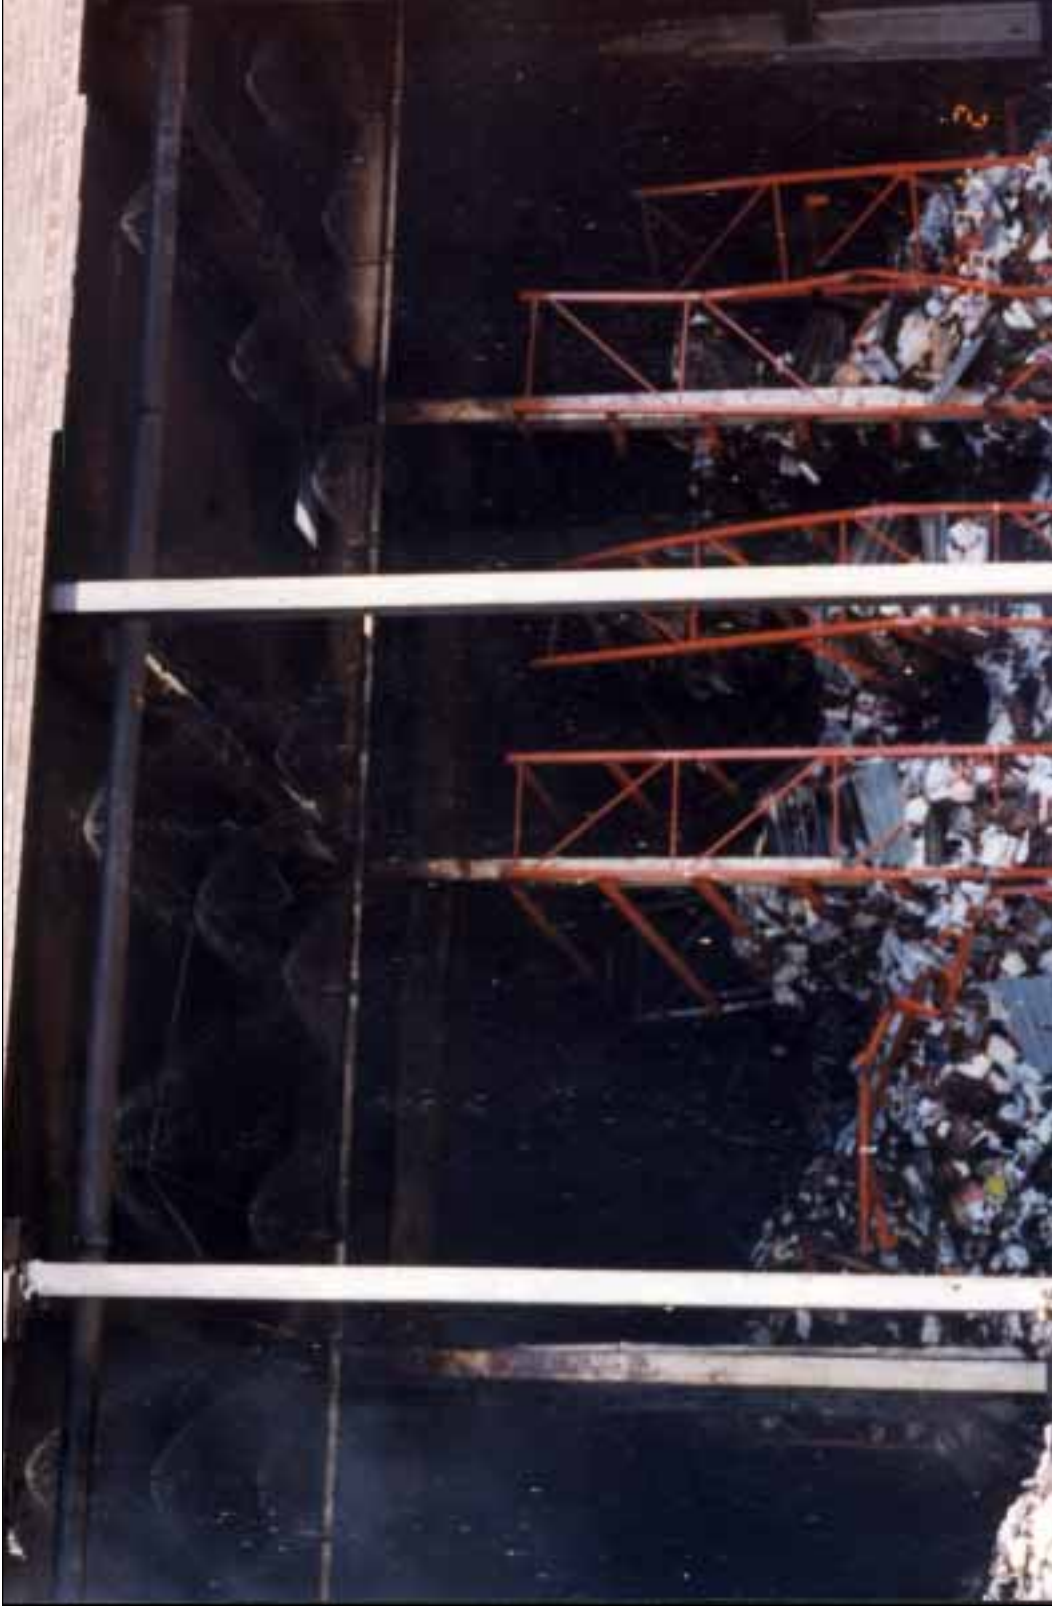
Because of the storage height, arrangement in the racks, solid shelves, and modest water density, it is unlikely that this fire would have been controlled by the ceiling only automatic sprinklers even if all of the systems had functioned properly. The back-to-back racks with boxes two and three deep in each rack provided excellent conditions for a shielded fire burning out of the reach of the automatic sprinkler discharge. Cardboard boxes and their contents are very susceptible to smoldering fire development even when the outside surface is water soaked.

The automatic sprinklers installed at the ceiling were inadequate for the hazard and did not comply with NFPA Standards. Because of the solid shelves, it is likely that sprinklers should have been provided at each shelf level. The narrow aisles may have justified the use of automatic sprinklers along the rack face to slow the fire spread on the face and between racks.

3. Racks and operating overhead automatic sprinklers near the northwest corner of Building III. Complete and partial collapse of the storage racks, shelves, and contents.

1. Automatic sprinklers must be designed, installed and maintained for the specific hazard present.

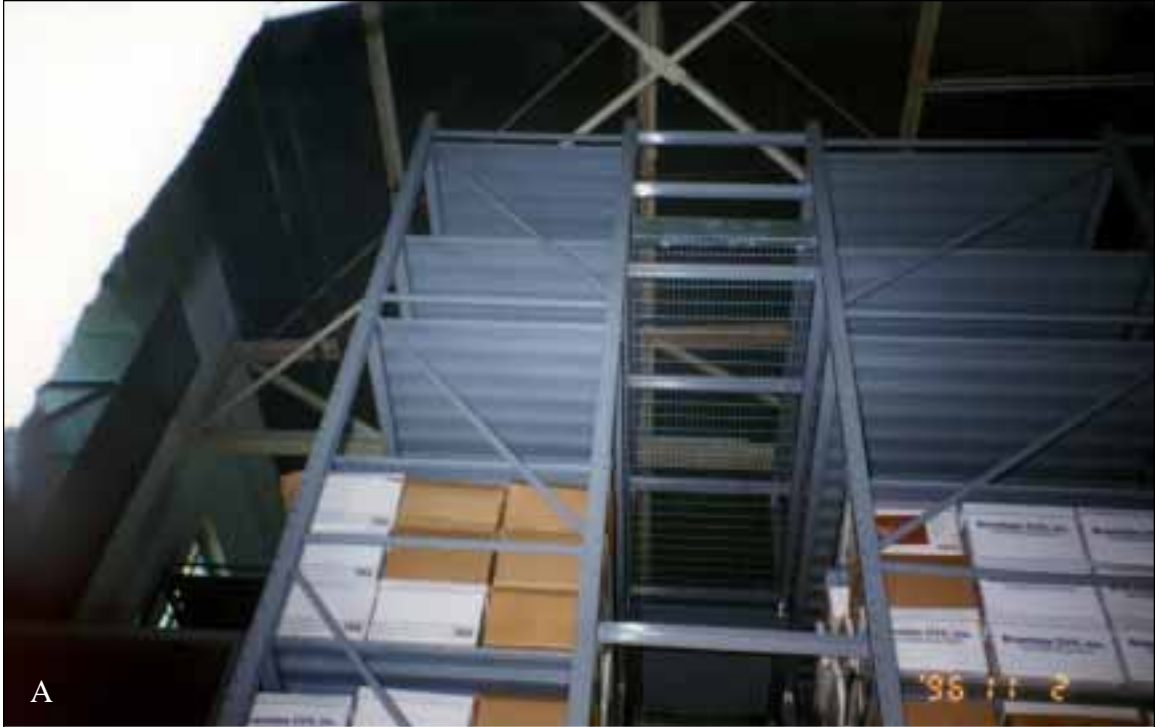
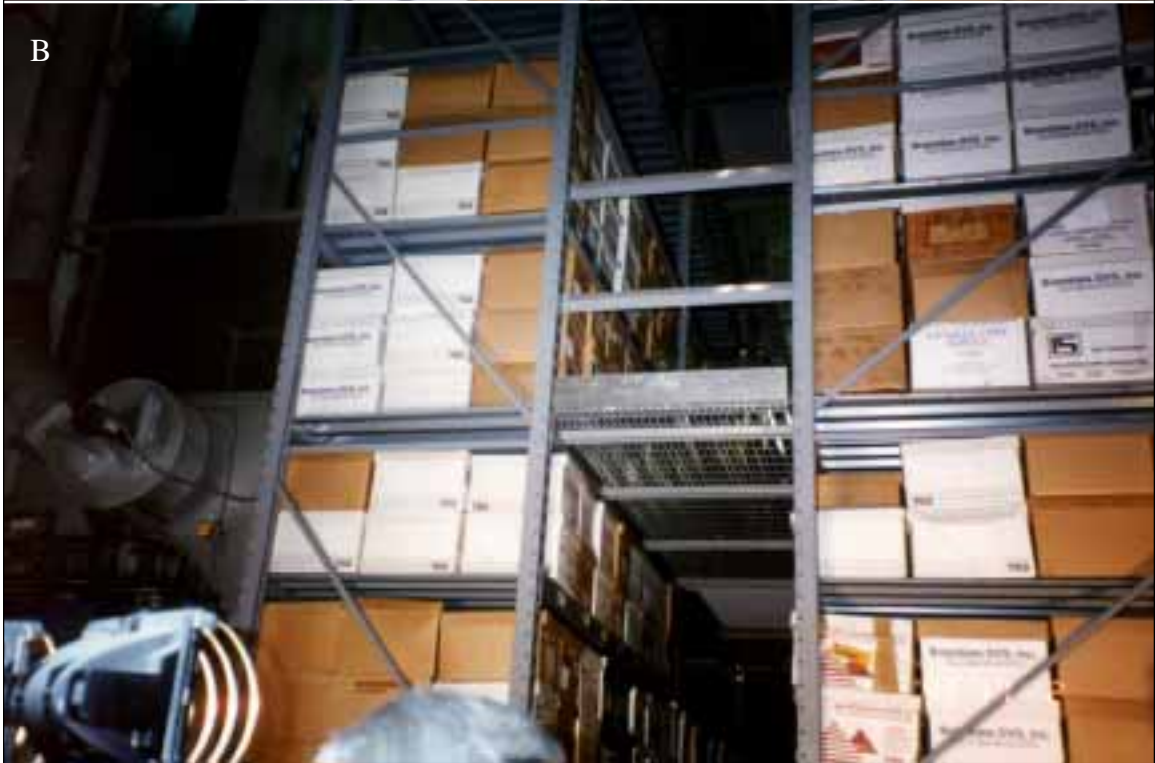
The use of tall racks with grated intermediate walkways is not recommended by NFPA No. 232A. Rather, full floors with fire resistance ratings are recommended to limit the extension of fire travel and to reduce the number of records subject to destruction or damage in a single fire. Where tall storage racks are used, cautions on fire detection, complete automatic sprinkler protection, and fire department preplanning are provided. Preplanning should include how to gain access to the racks, smoke and heat venting from the fire area, reaching the fire in the upper area, and fighting the fire at its source.

4. A and B. The shelving and records storage arrangement in the adjacent compartment to the east of the fire compartment. Taken from the floor, the two levels of elevated, grated walkways and the building's roof are depicted.

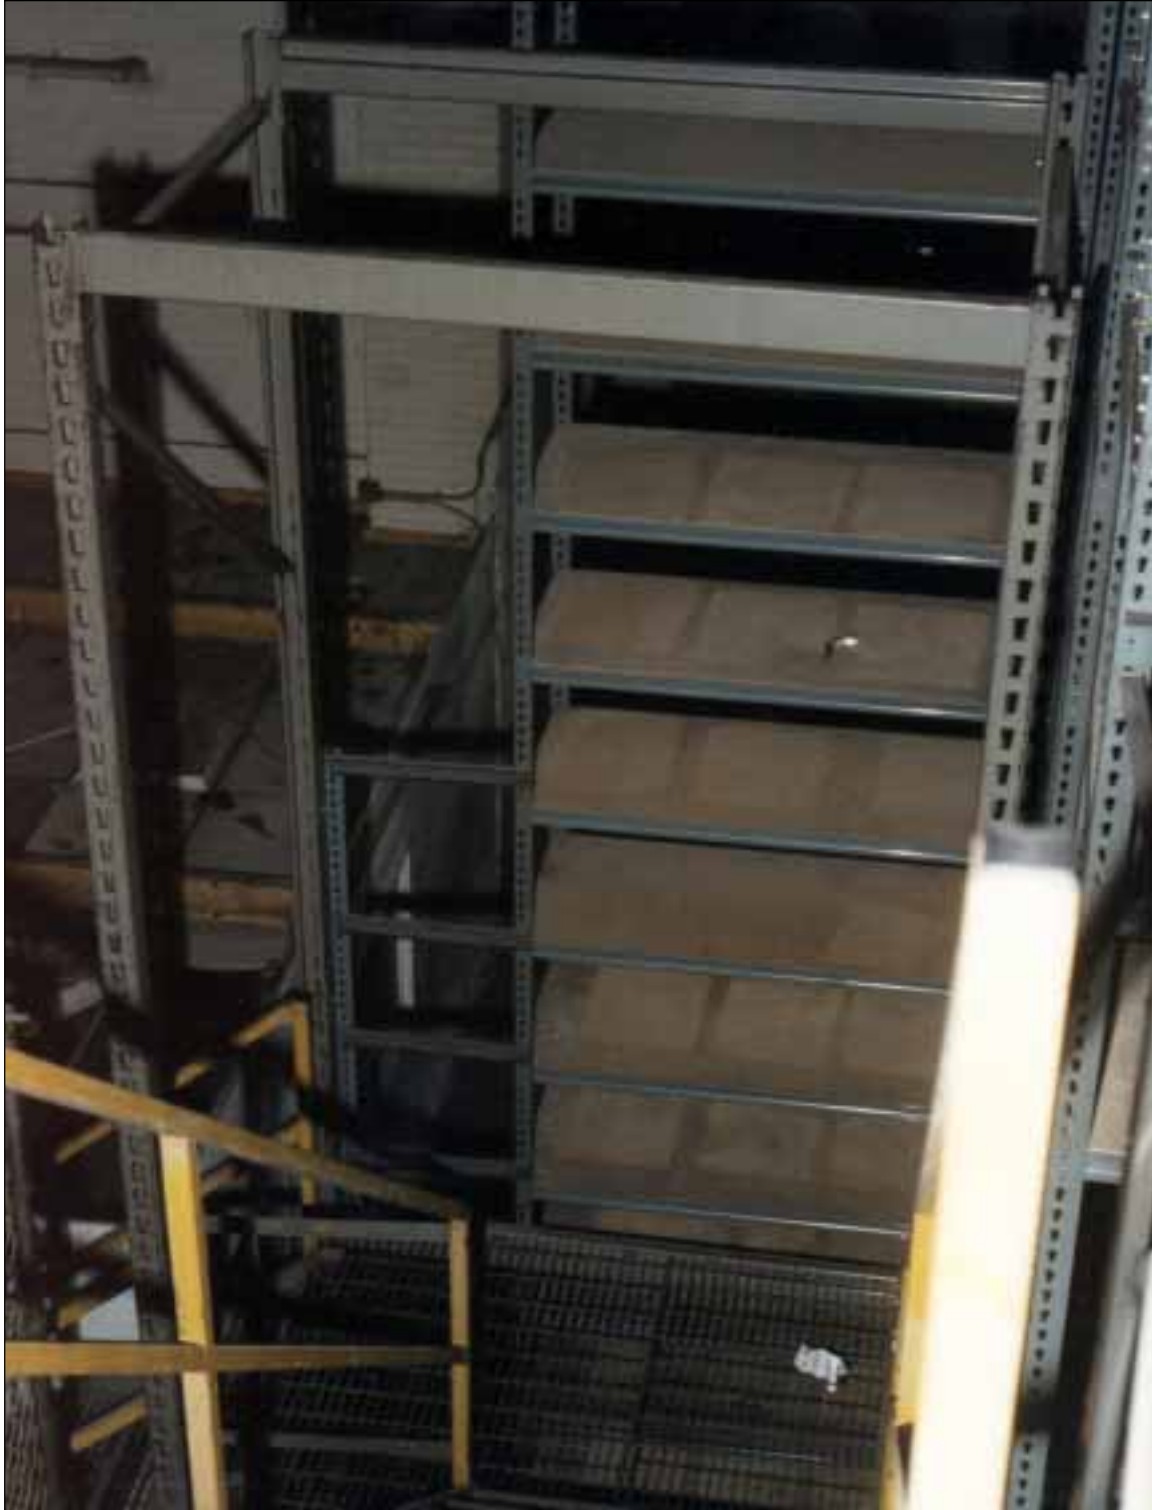
5. Looking down from the top walkway gives a different perspective to the storage arrangement in the adjacent compartment to the east. Note the solid shelves, unprotected steel racks, and typical access stairs.

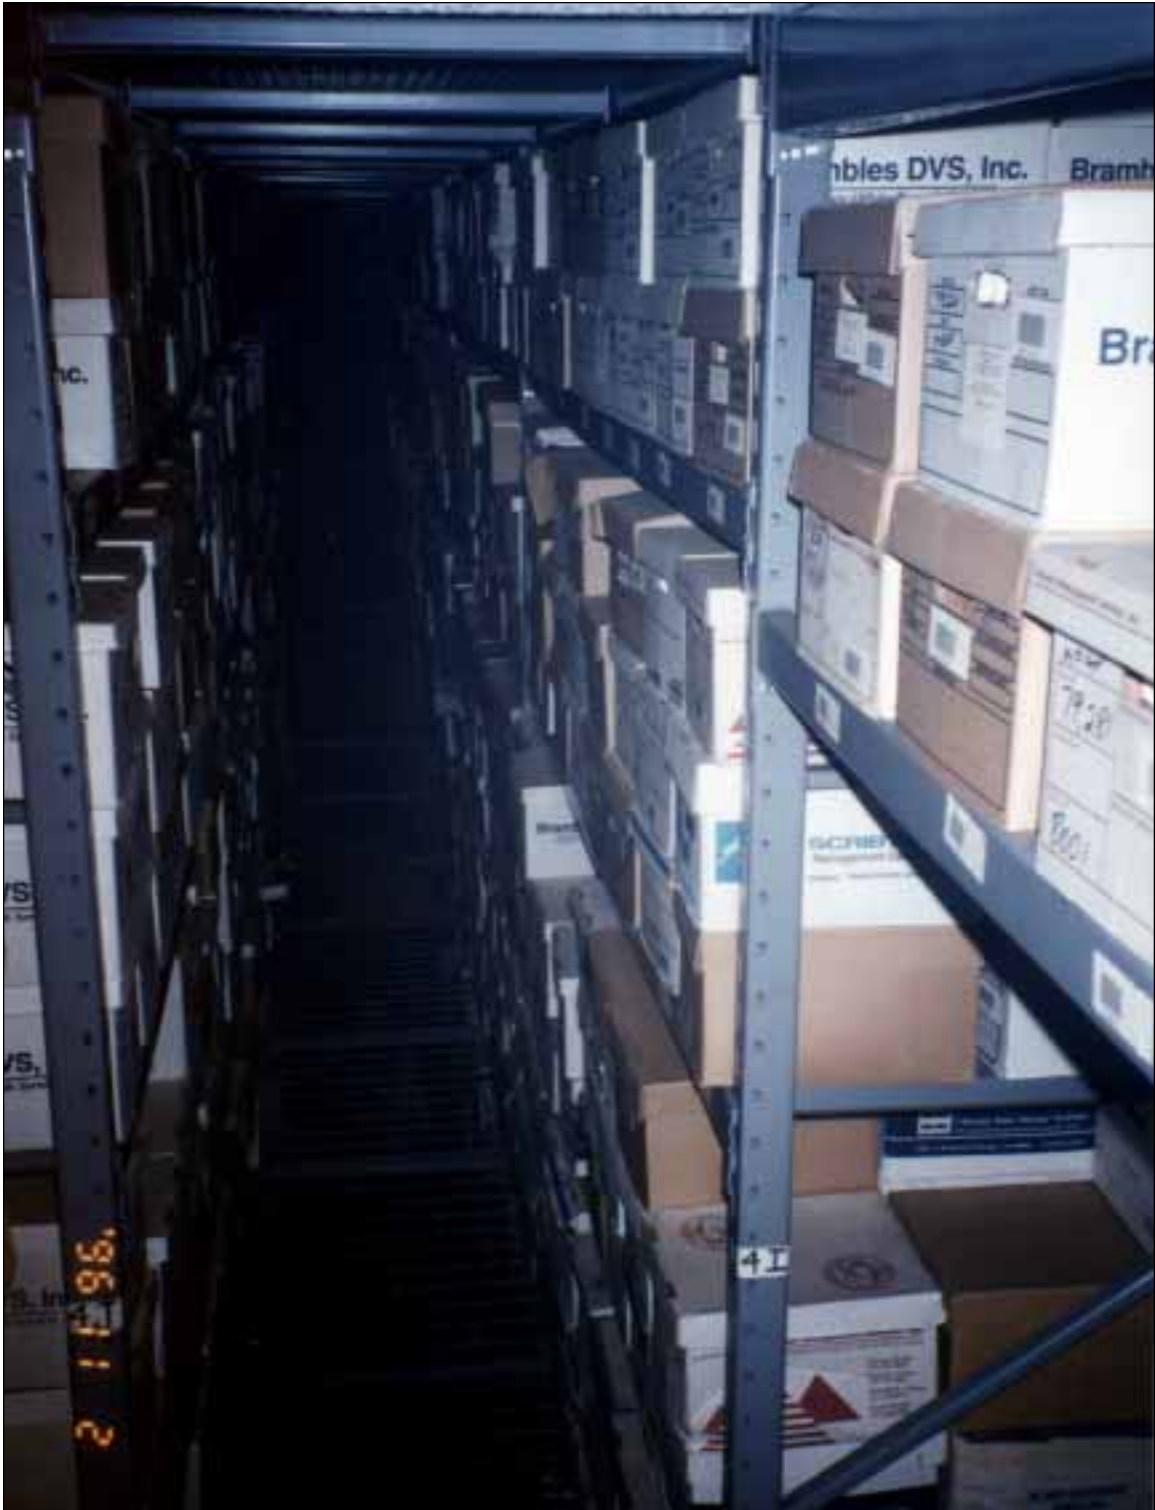
6. An intermediate level storage aisle with records boxes in place. The size and style of the storage boxes varied by section.

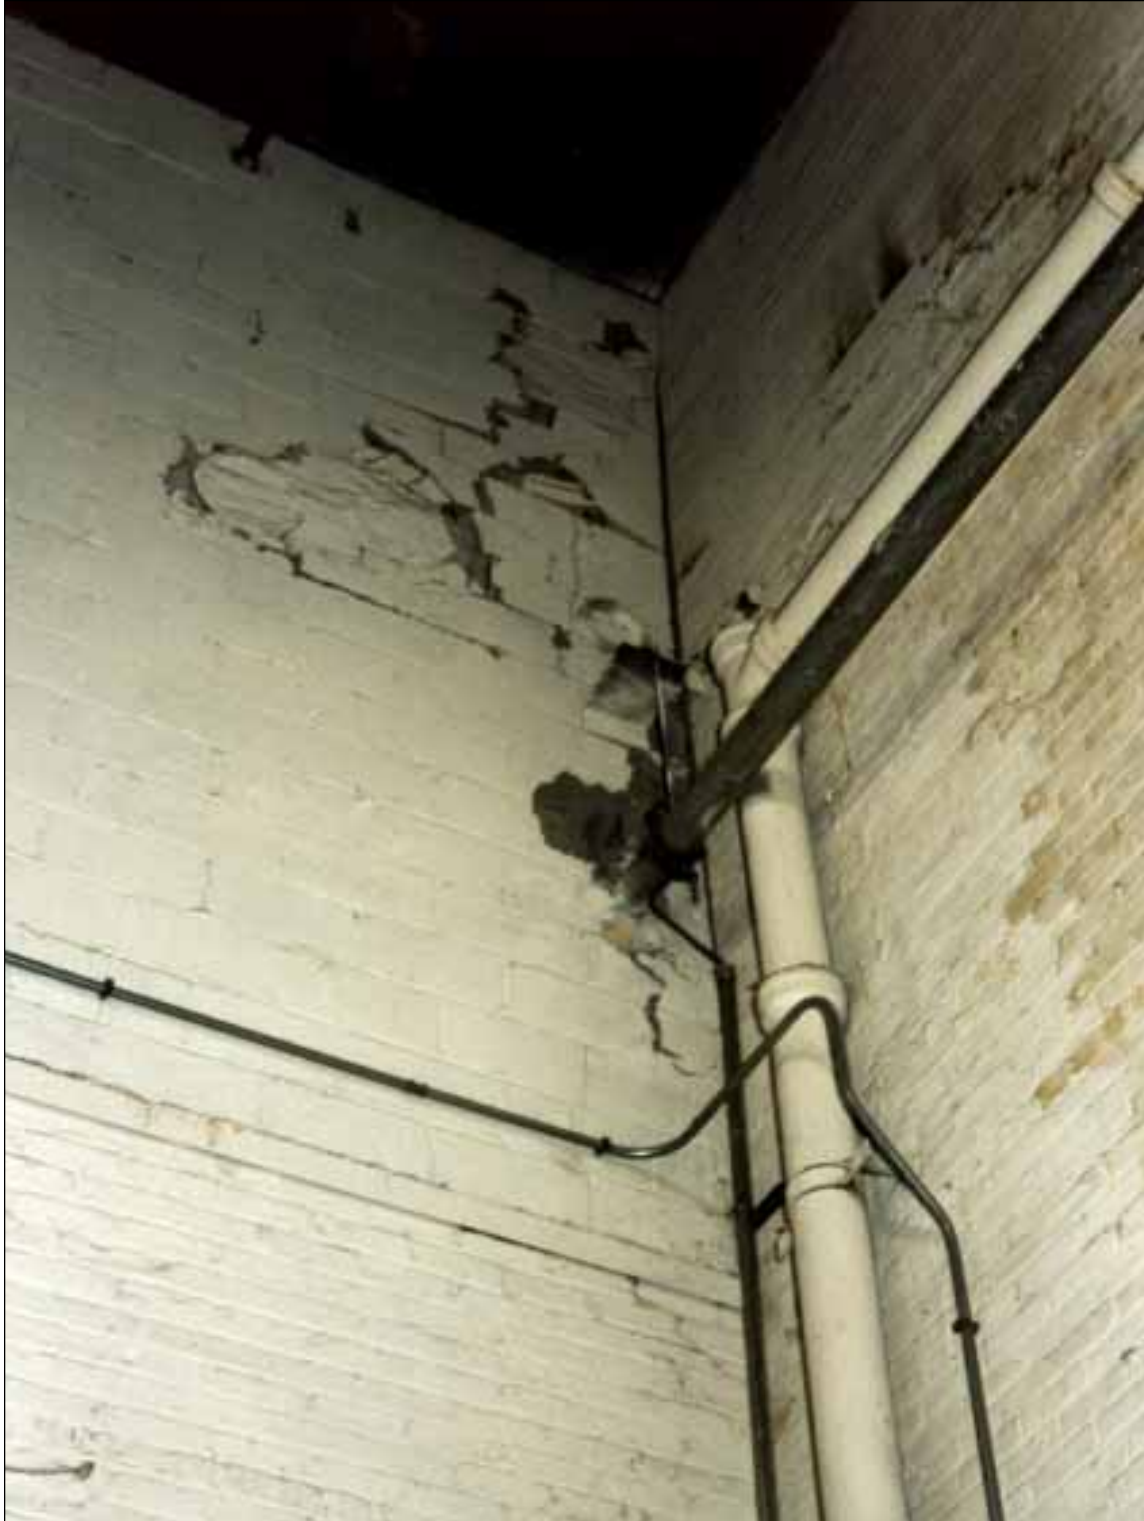
The adjacent building construction to the north was noncombustible with masonry walls and a gypsum roof deck on unprotected steel trusses, beams, and columns. The expansion of the fire area caused buckling in the steel trusses. In addition, the masonry separation wall was displaced and cracked in several locations. (See Photograph 7)

Battalion 6, who responded on the Second Alarm, was assigned to check the interior of the north exposure in Sector 2. This one story masonry walled building with a metal trussed roof was occupied by a paper records destruction company and did not contain a lot of combustible contents. During the fire, the overhead steel trusses began to deform and the masonry wall between the fire building and the exposure was pushed to the north. This opened cracks in the wall and resulted in some crushed bricks.

7. Masonary wall damage in Building II, north of the fire building, due to expansion of the fire wall between buildings. This corner is the southeast corner of Space 6.

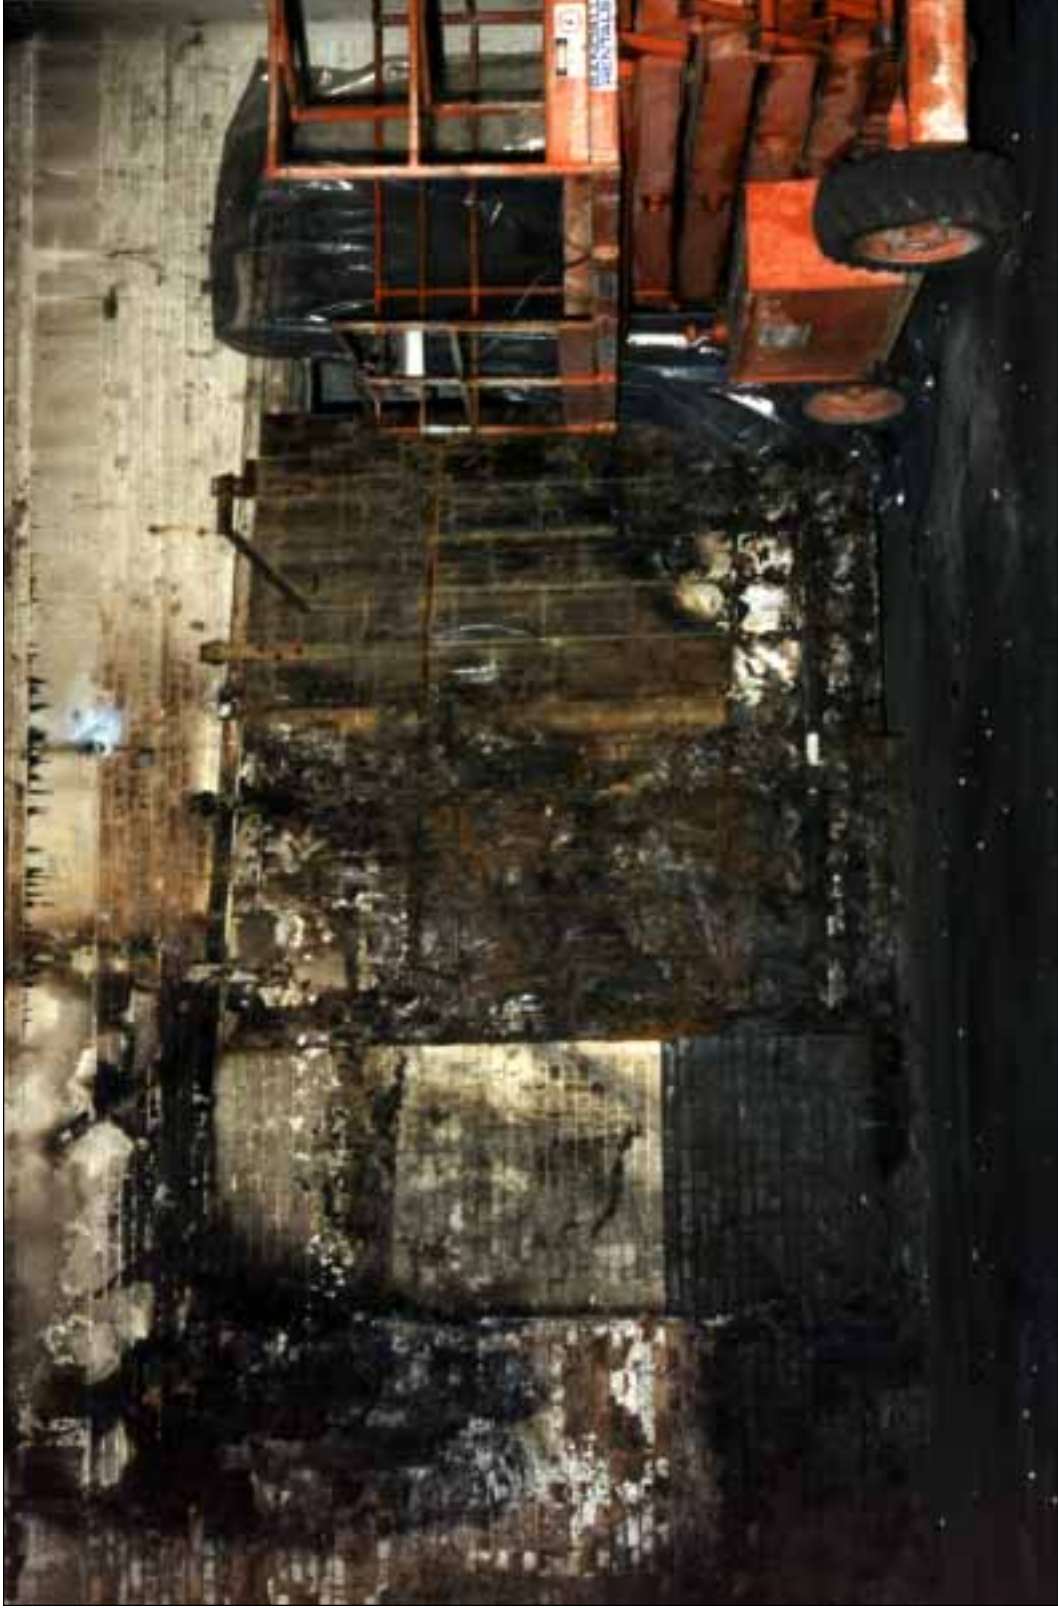
8. The fire side of the metal clad sliding fire door between Buildings III and IV. This door was supported by fire companies operating from the non-fire side of the door.

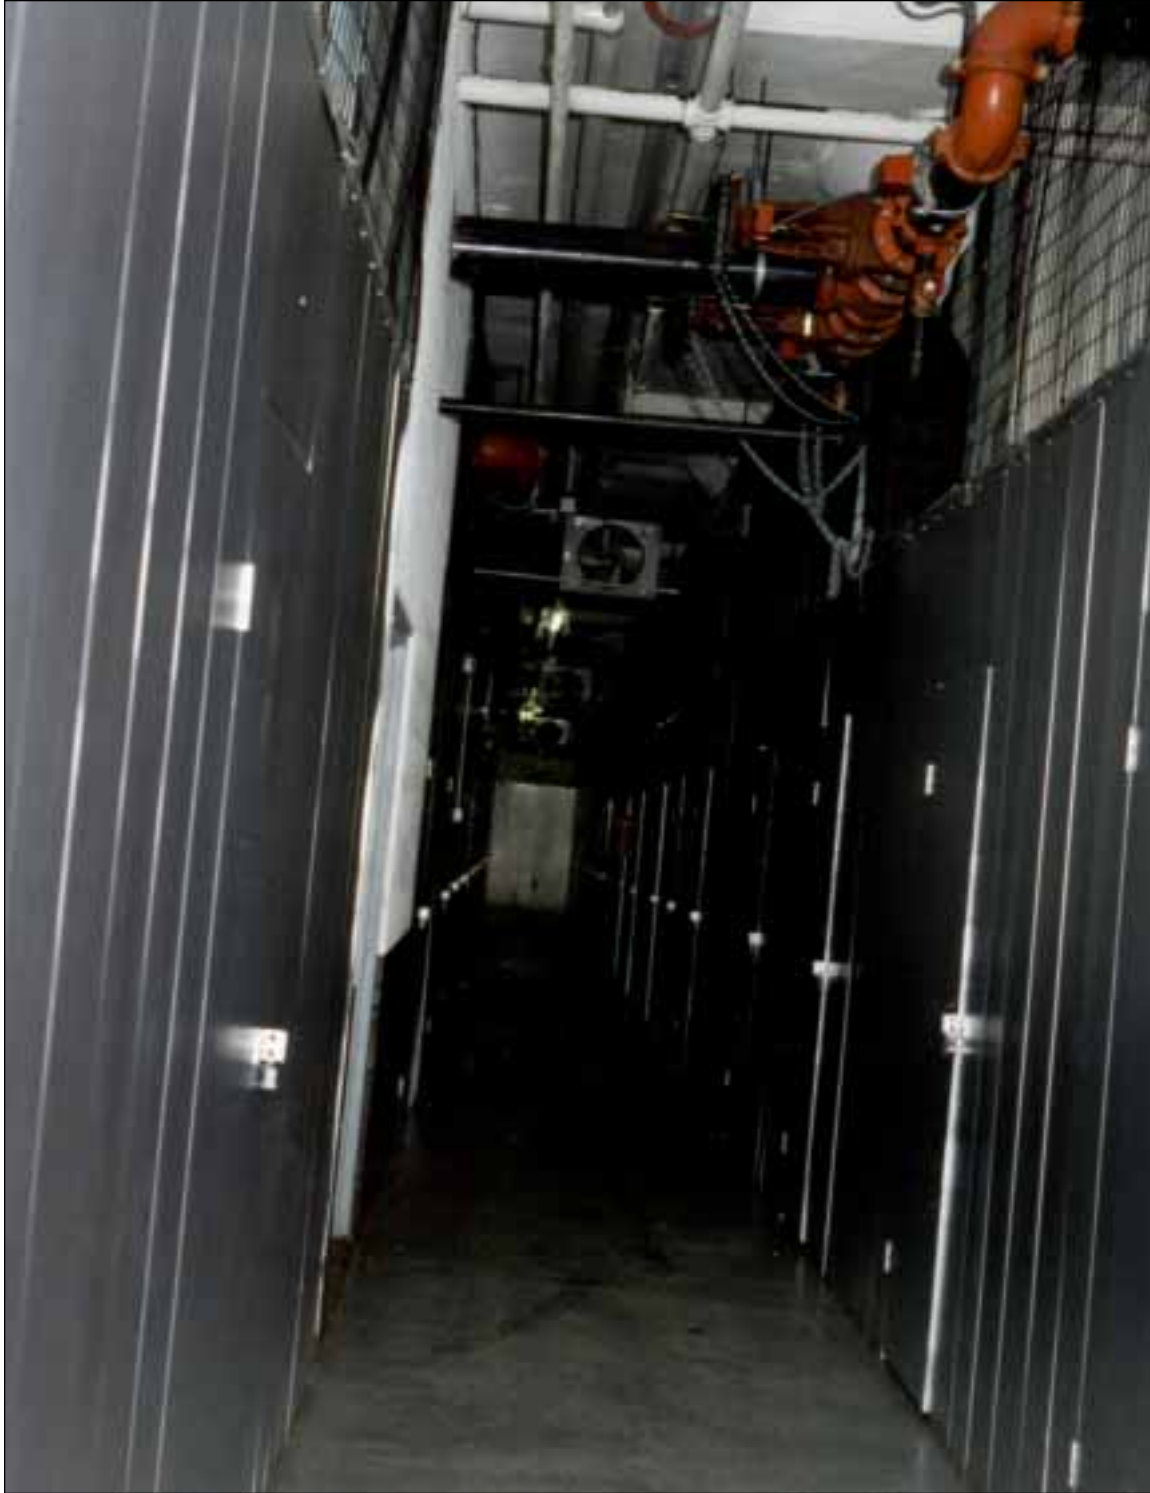
The storage "cubicles" on the second floor consisted of metal walls about eight feet high that were closed to the roof deck by heavy wire formed into about 3 inch by 3 inch squares. The access door to each unit was secured by a tenant provided lock. This arrangement provided security for each space yet did not necessarily interfere with the automatic sprinkler water distribution. Sprinkler heads were provided at the ceiling only and were spaced using an ordinary hazard schedule. There did not appear to be an attempt to locate an individual sprinkler head within each storage locker.

9. Typical public storage rooms or lockers located on the floor above the fire. Note the automatic sprinkler control valves and flow switch located at the ceiling level and the eight feet high solid walls topped by heavy wire mesh.

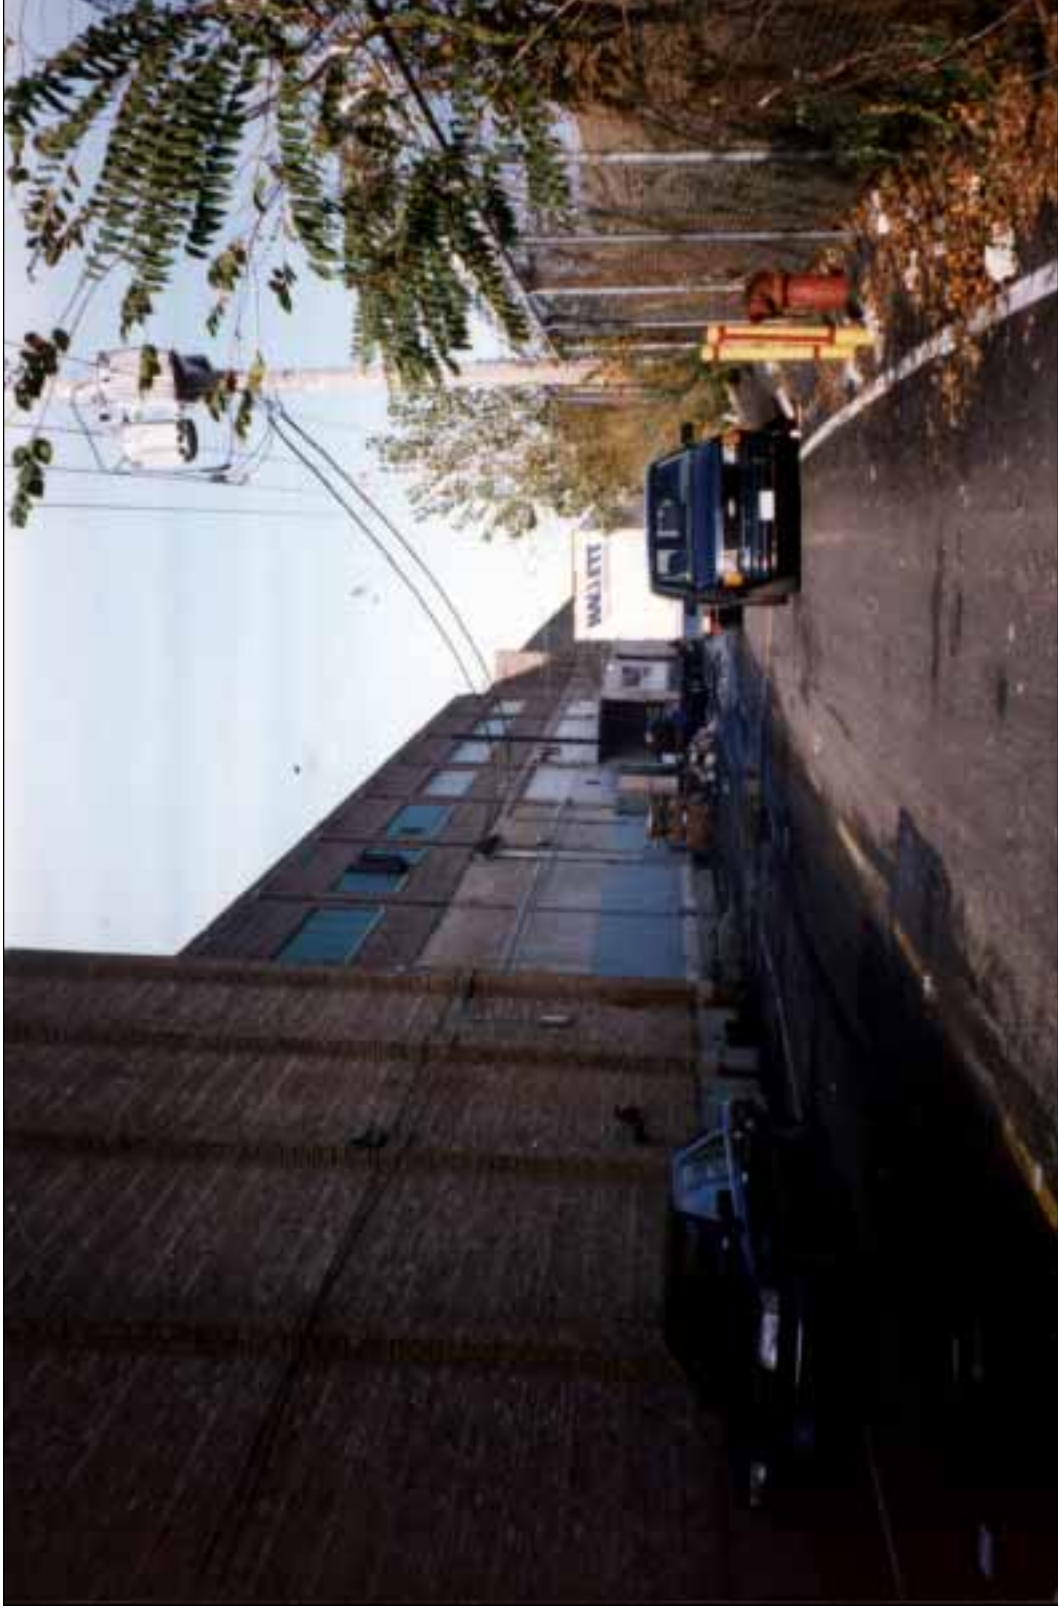
10. Hall Drive on the east side of the building looking to the north. The southeast corner of the fire building is just left of center.
