Technical Report Series

Fire Apparatus/Train Collision Catlett, Virginia

**Fire Apparatus/Train Collision
Catlett, Virginia
(September 28, 1989)**

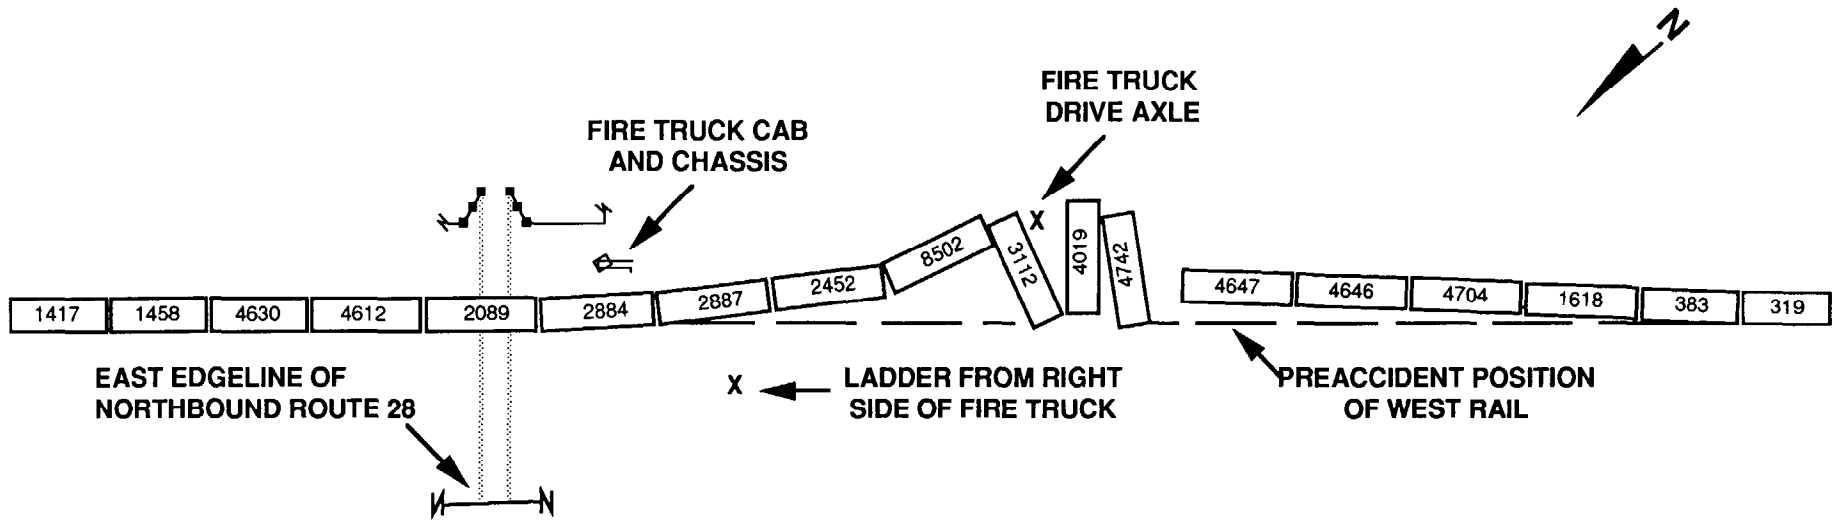
FINAL REST POSITIONS OF WAGON 7 AND RAILROAD CARS

The impact destroyed Wagon 7 and derailed much of the train. The gasoline tank on Wagon 7 ruptured and the gasoline ignited, forming a fireball and flame that travelled down the tracks as the train pushed the wreckage of Wagon 7 approximately 970 feet past the crossing. The driveway from Route 28 to the vehicle fire was blocked by derailed train cars. All but the last five cars of the 18-car train derailed. Several passenger cars came to rest in a tilted position as the train telescoped after the collision. None of the cars overturned, however.

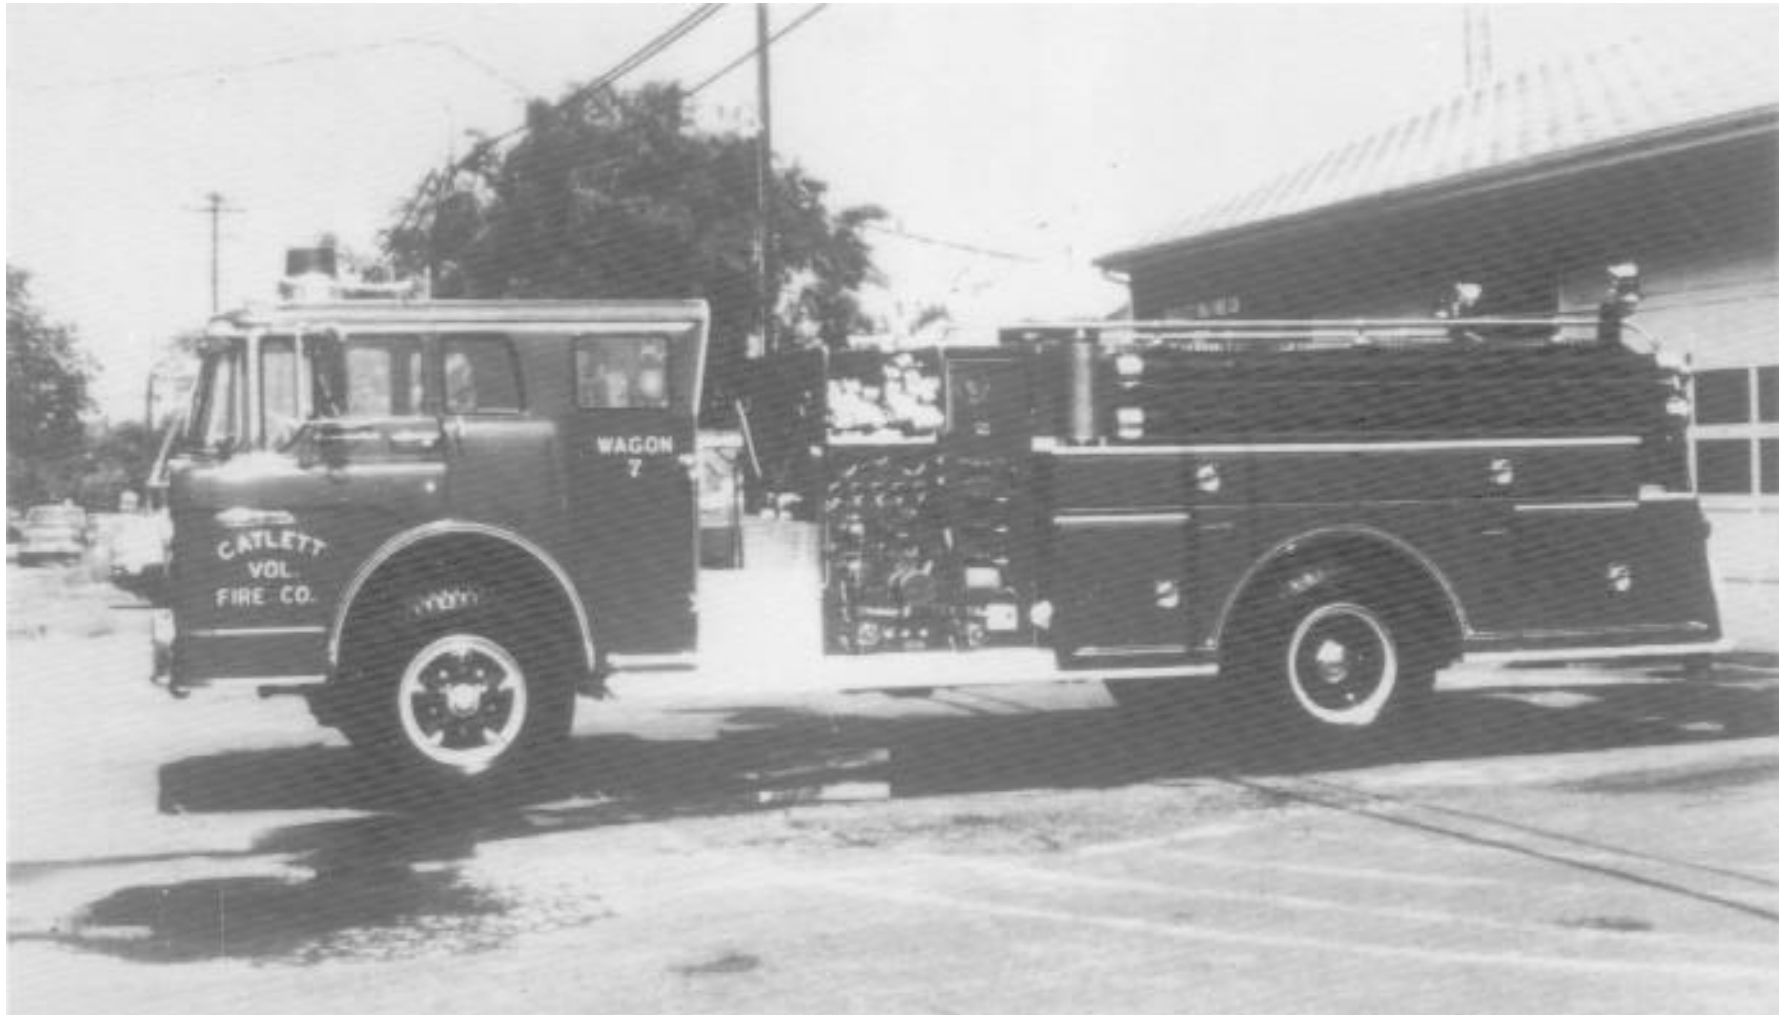
The brunt of the collision was directed at the rear of the vehicle, at about the rear axle. When the collision occurred, the cab and chassis of the Catlett pumper rotated counterclockwise 450 degrees and came to rest about 80 feet southeast of the crossing. The lead locomotive stopped about 965 feet past the crossing with the left side of Wagon 7's hose body wrapped around its front end. Most equipment and the rear bodywork were scattered along the collision area. Gasoline fires that broke out near the second locomotive and several derailed cars were extinguished by other firefighters responding to the emergency. The primary fuel for these fires was from the fuel tank aboard Wagon 7, which ruptured in the crash.

Left side of Wagon 7

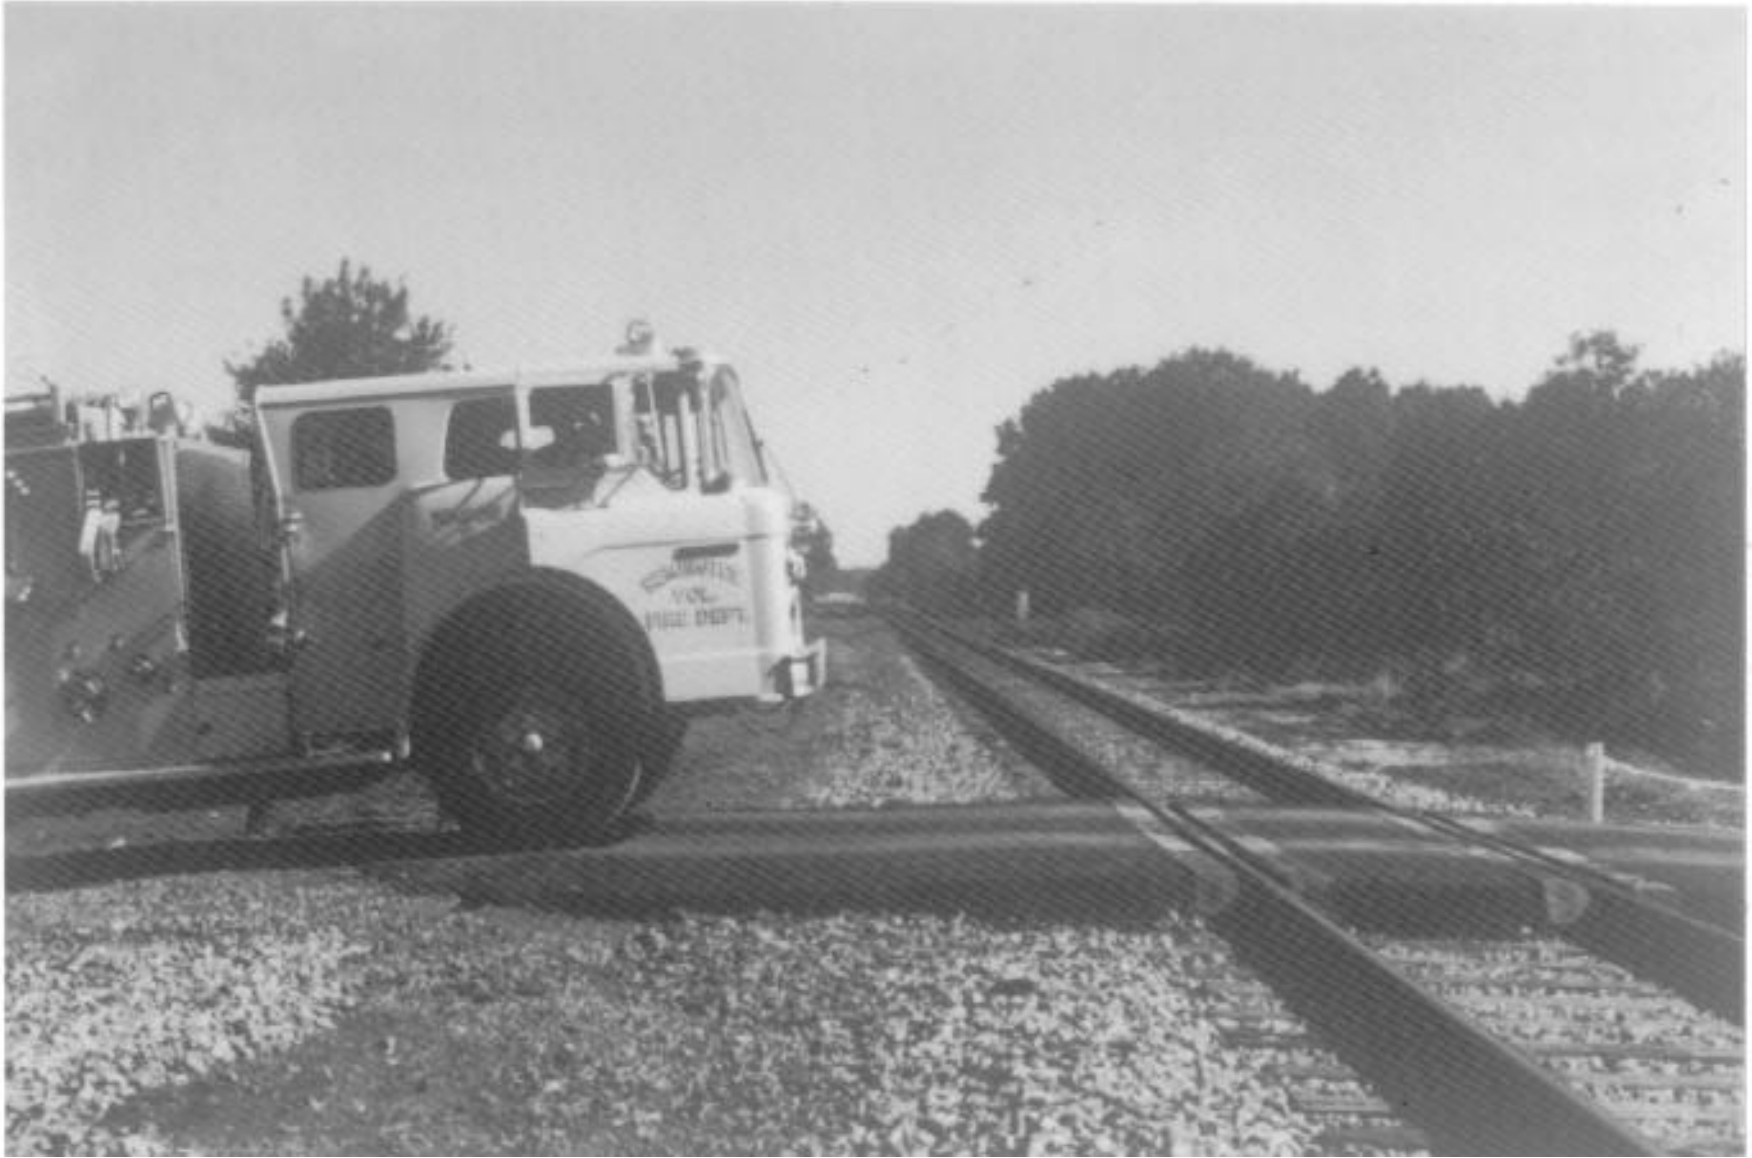
The crossing where the collision occurred was not equipped with any automatic warning equipment such as flashing lights or gates. The only warning was a standard crossbuck (railroad crossing) sign. The driveway led from Route 28 to a private residence.

Even though it was dusk, the weather conditions at the time of the accident were clear. The 59-foot section of the driveway from the highway to the rail crossing had an 11.9 degree grade. But the tracks were straight and there were no visual obstructions that prevented the driver of Wagon 7 from seeing the approaching train. National Transportation Safety Board investigators estimate that the railroad tracks are visible for approximately 3,700 feet in the direction the train came from.

Wagon 2 at accident crossing - camera facing north

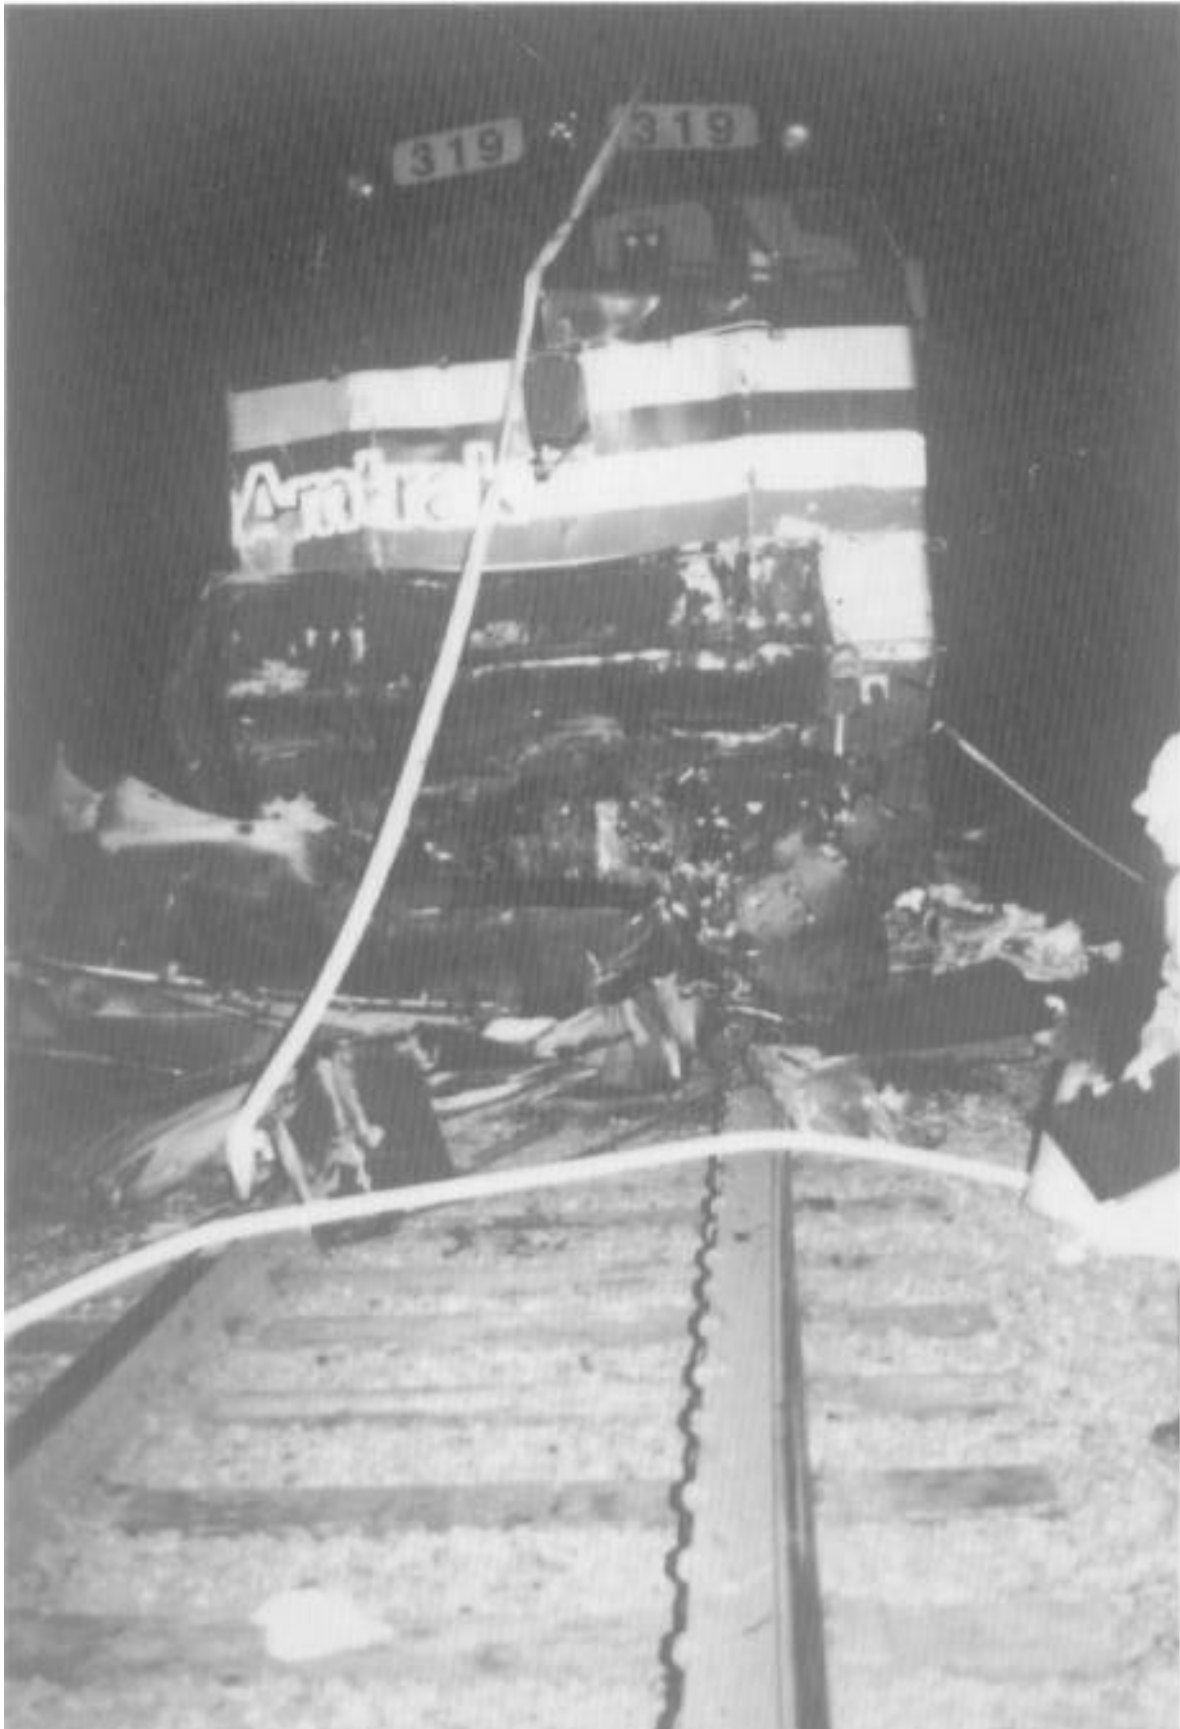
Front of locomotive 319

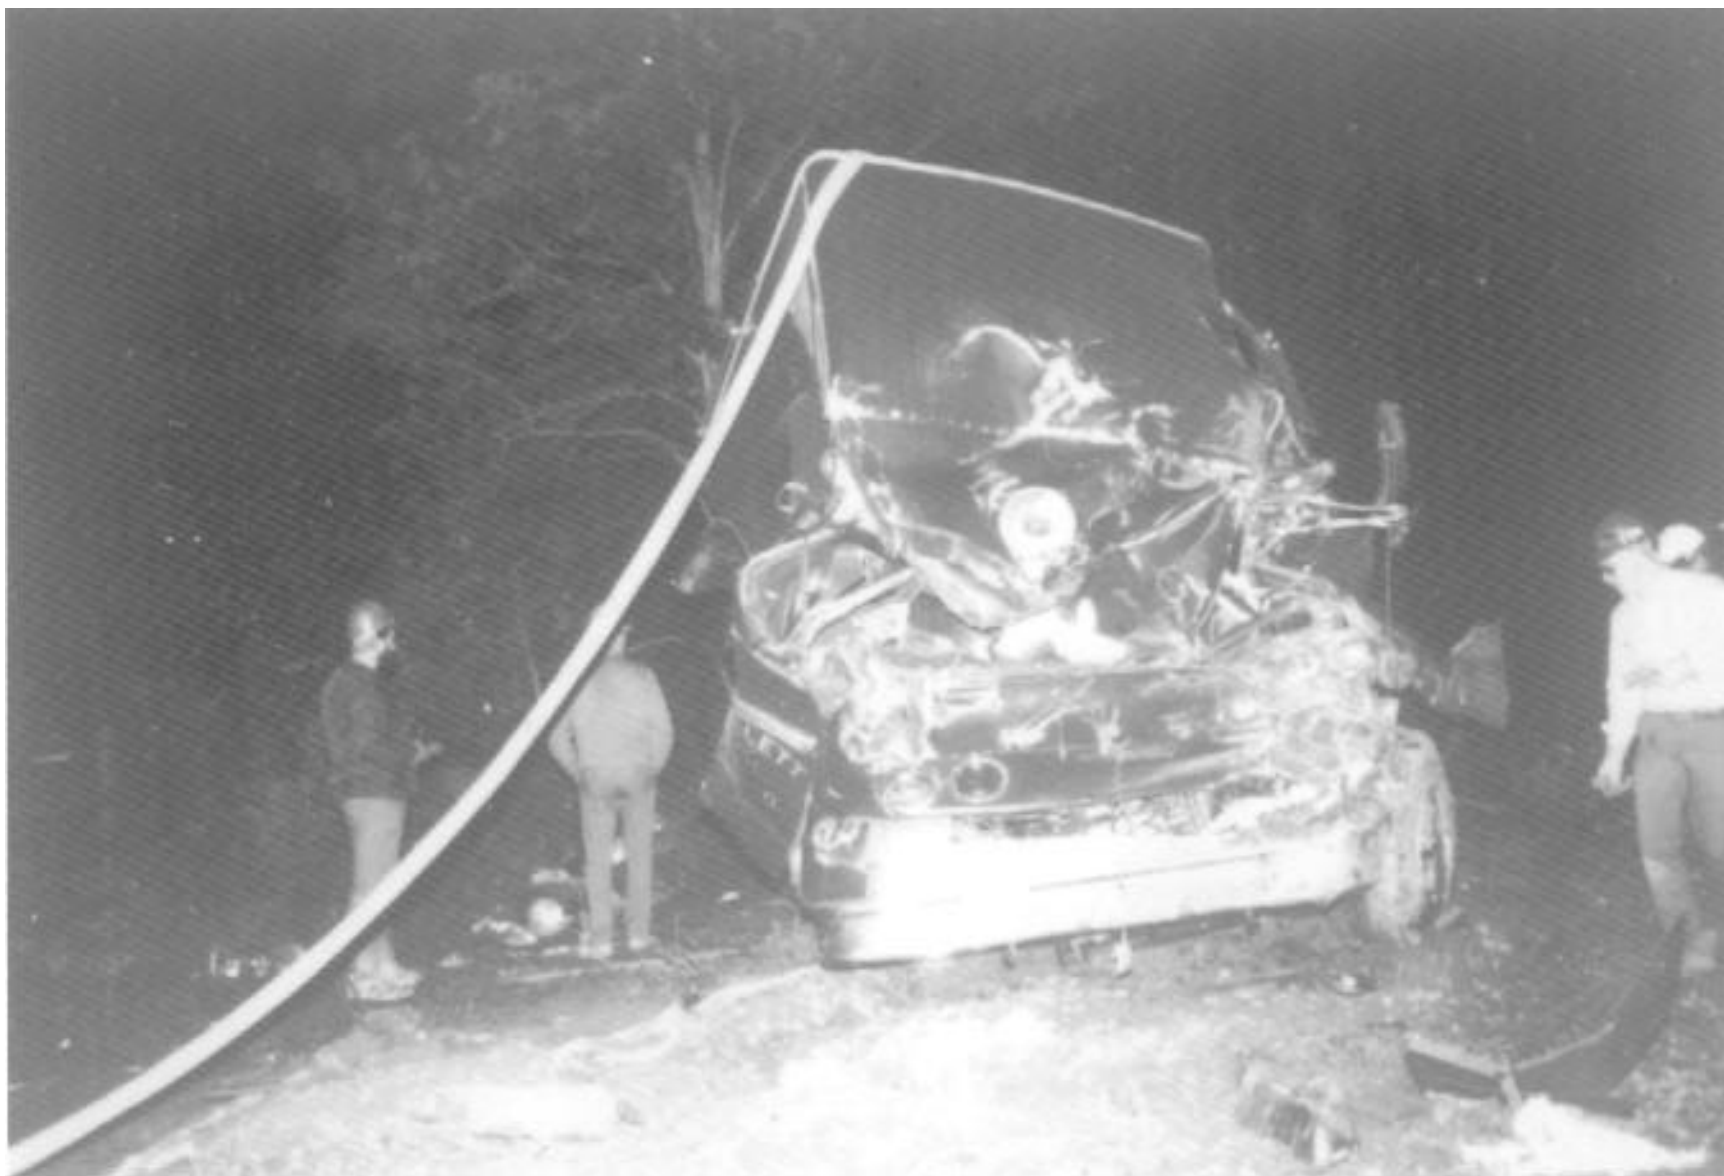
Cab of Wagon 7 - camera facing southeast

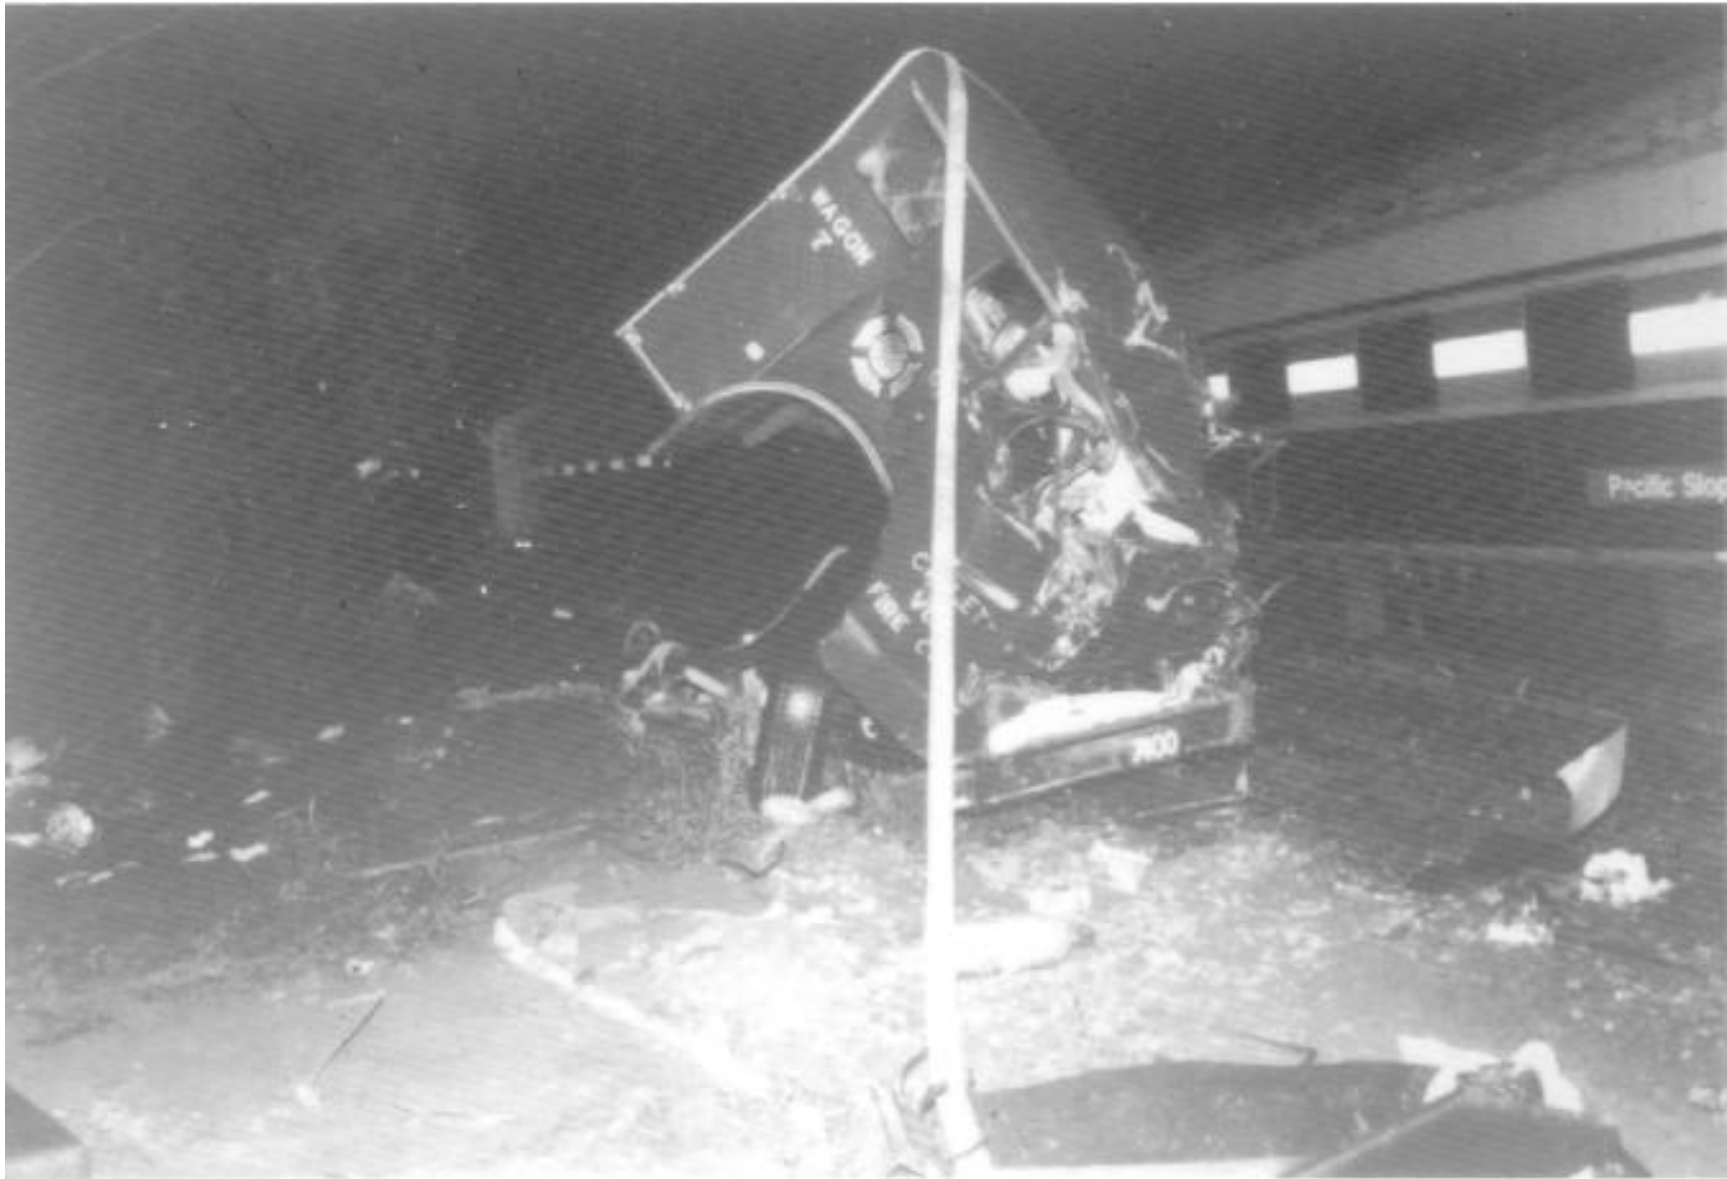
Cab of Wagon 7

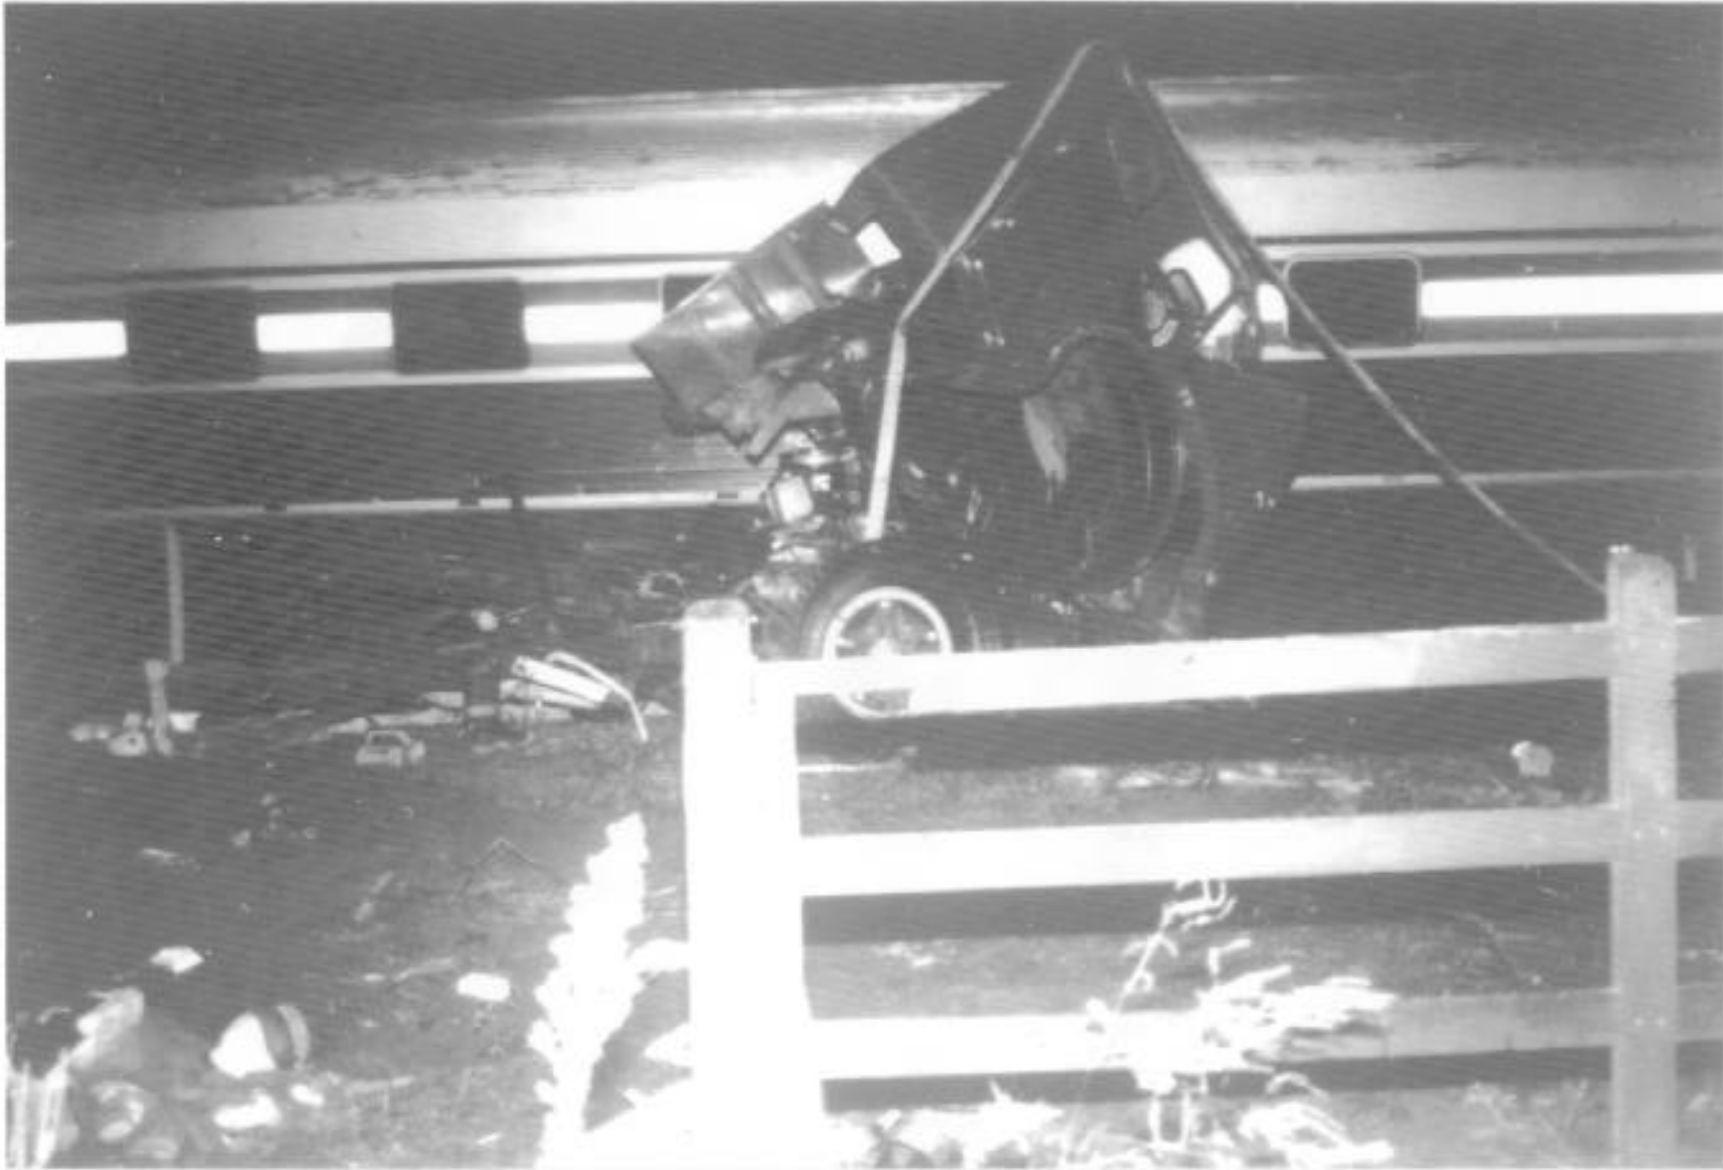
Cab and chassis of Wagon 7
Southwest corner of fence around private residence is in center foreground.
NOTE: Injured firefighters were found in the area at the bottom left of the photo.

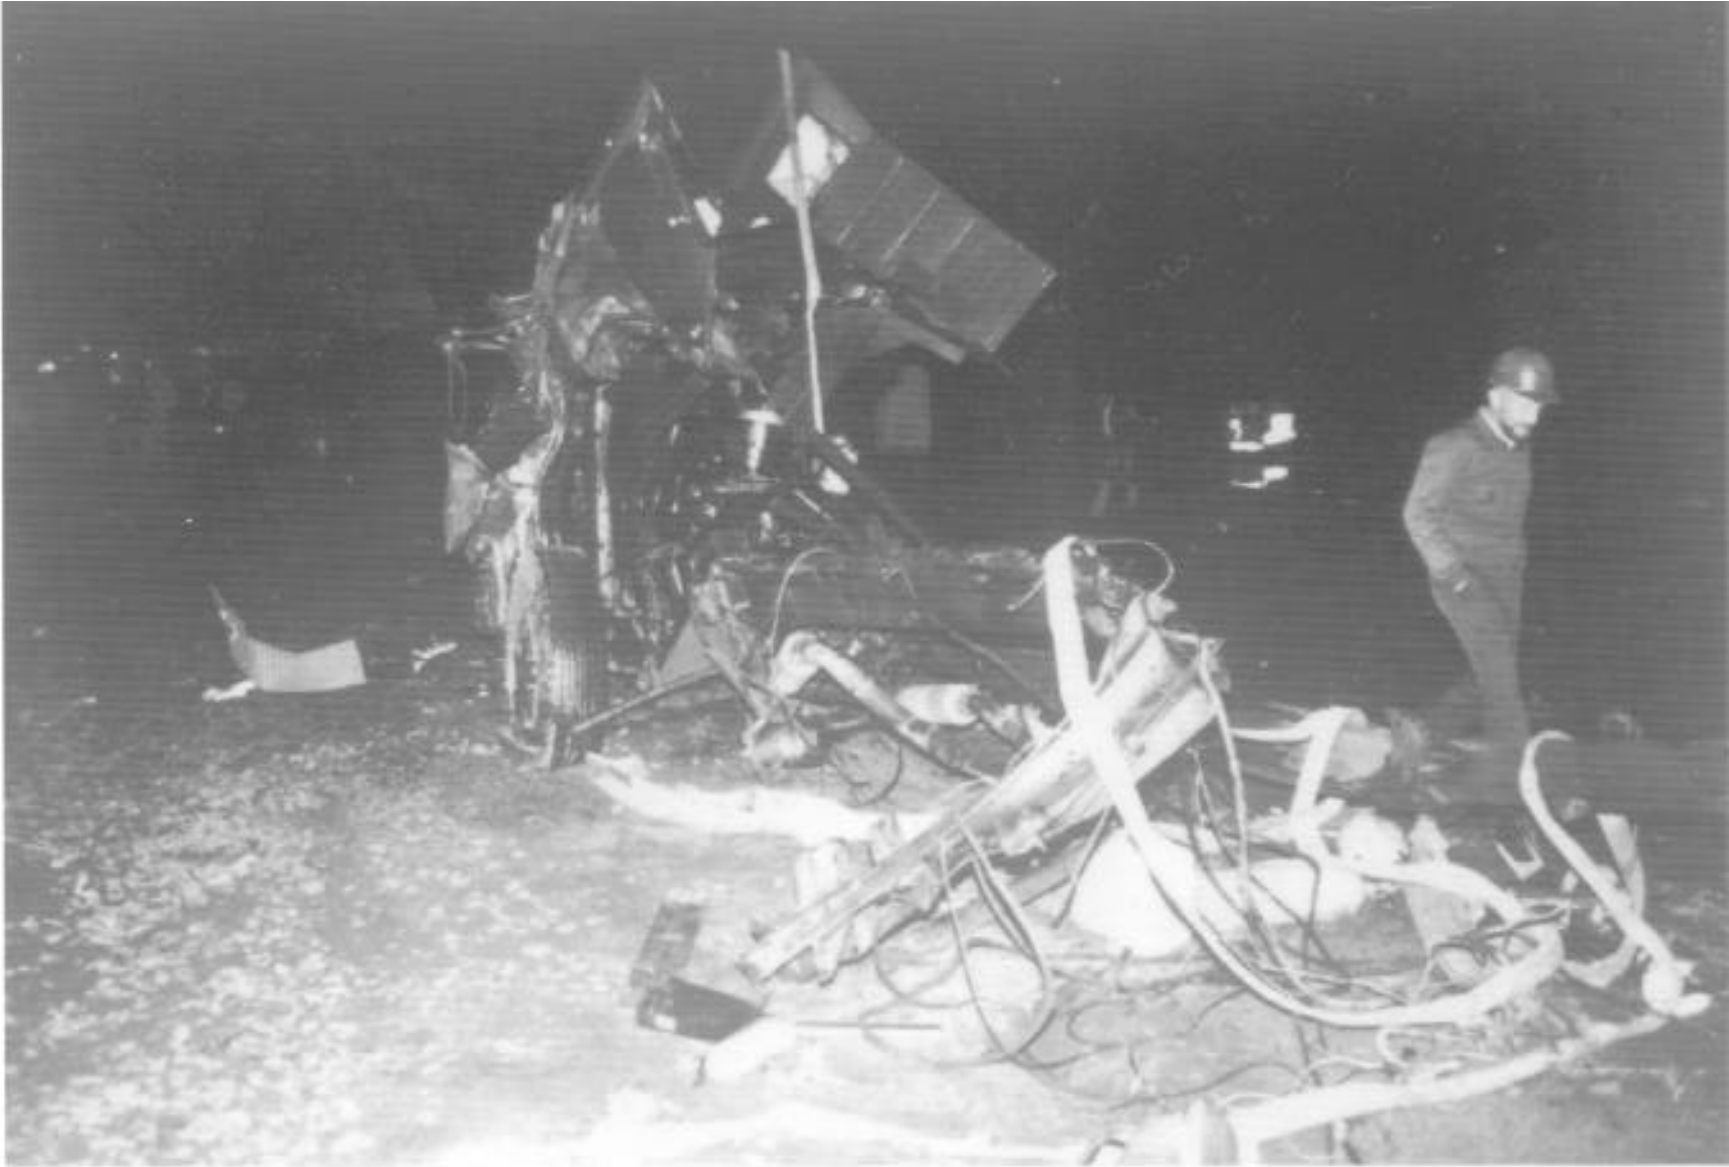
Chassis and cab of Wagon 7

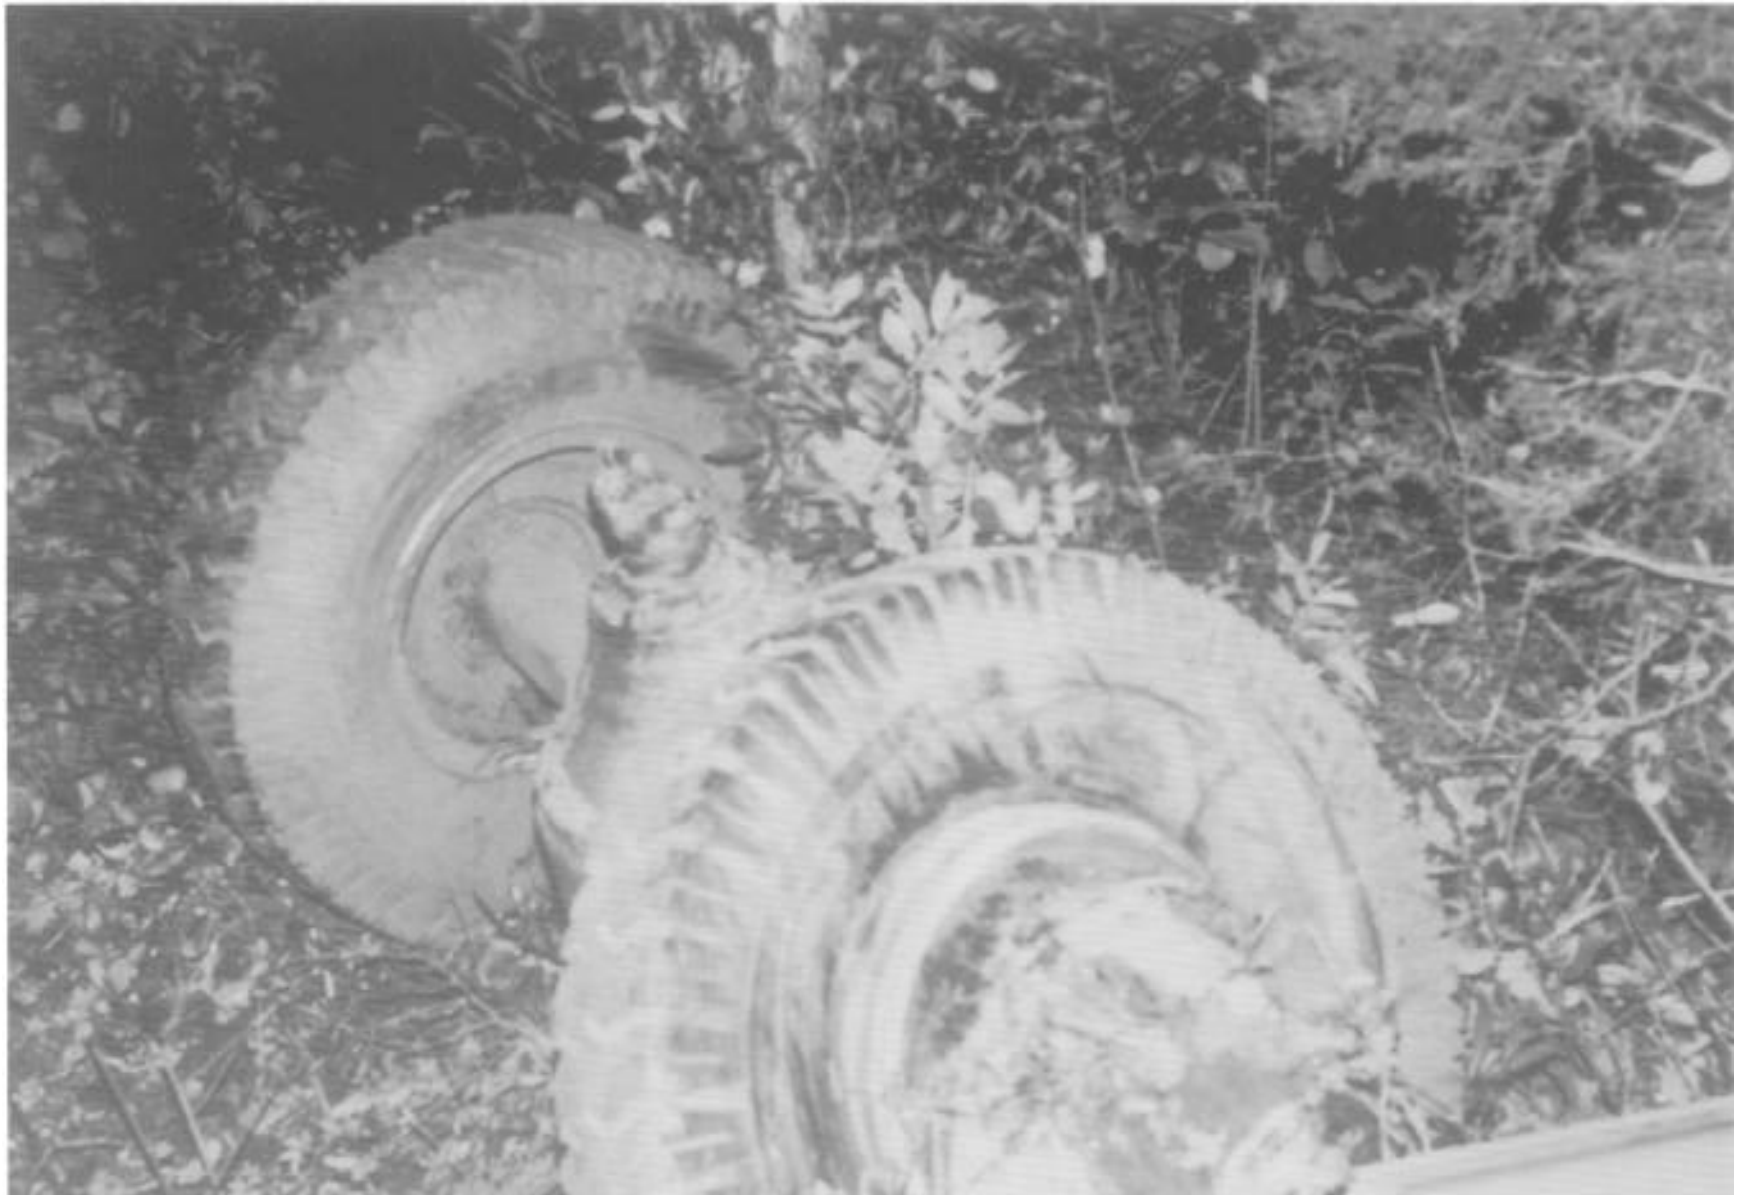
Closeup of fire truck drive axle

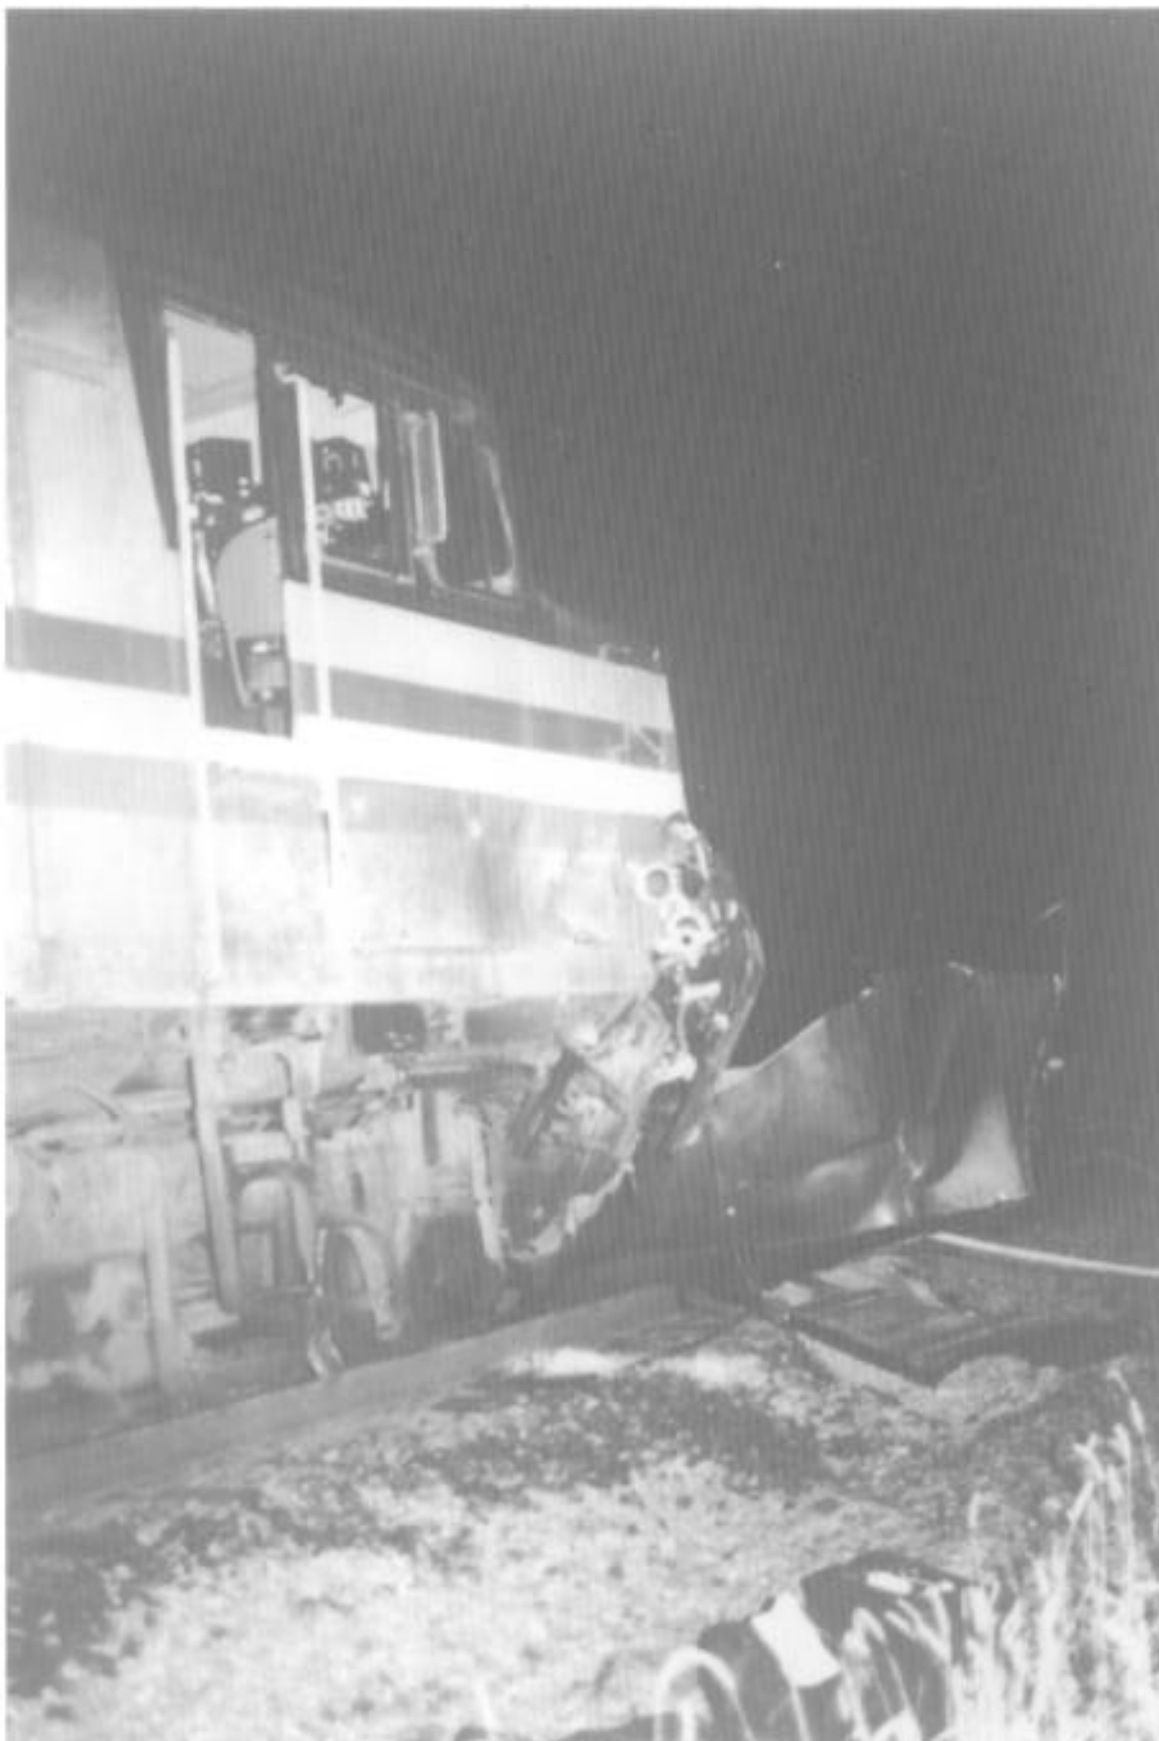
Right front of locomotive 319

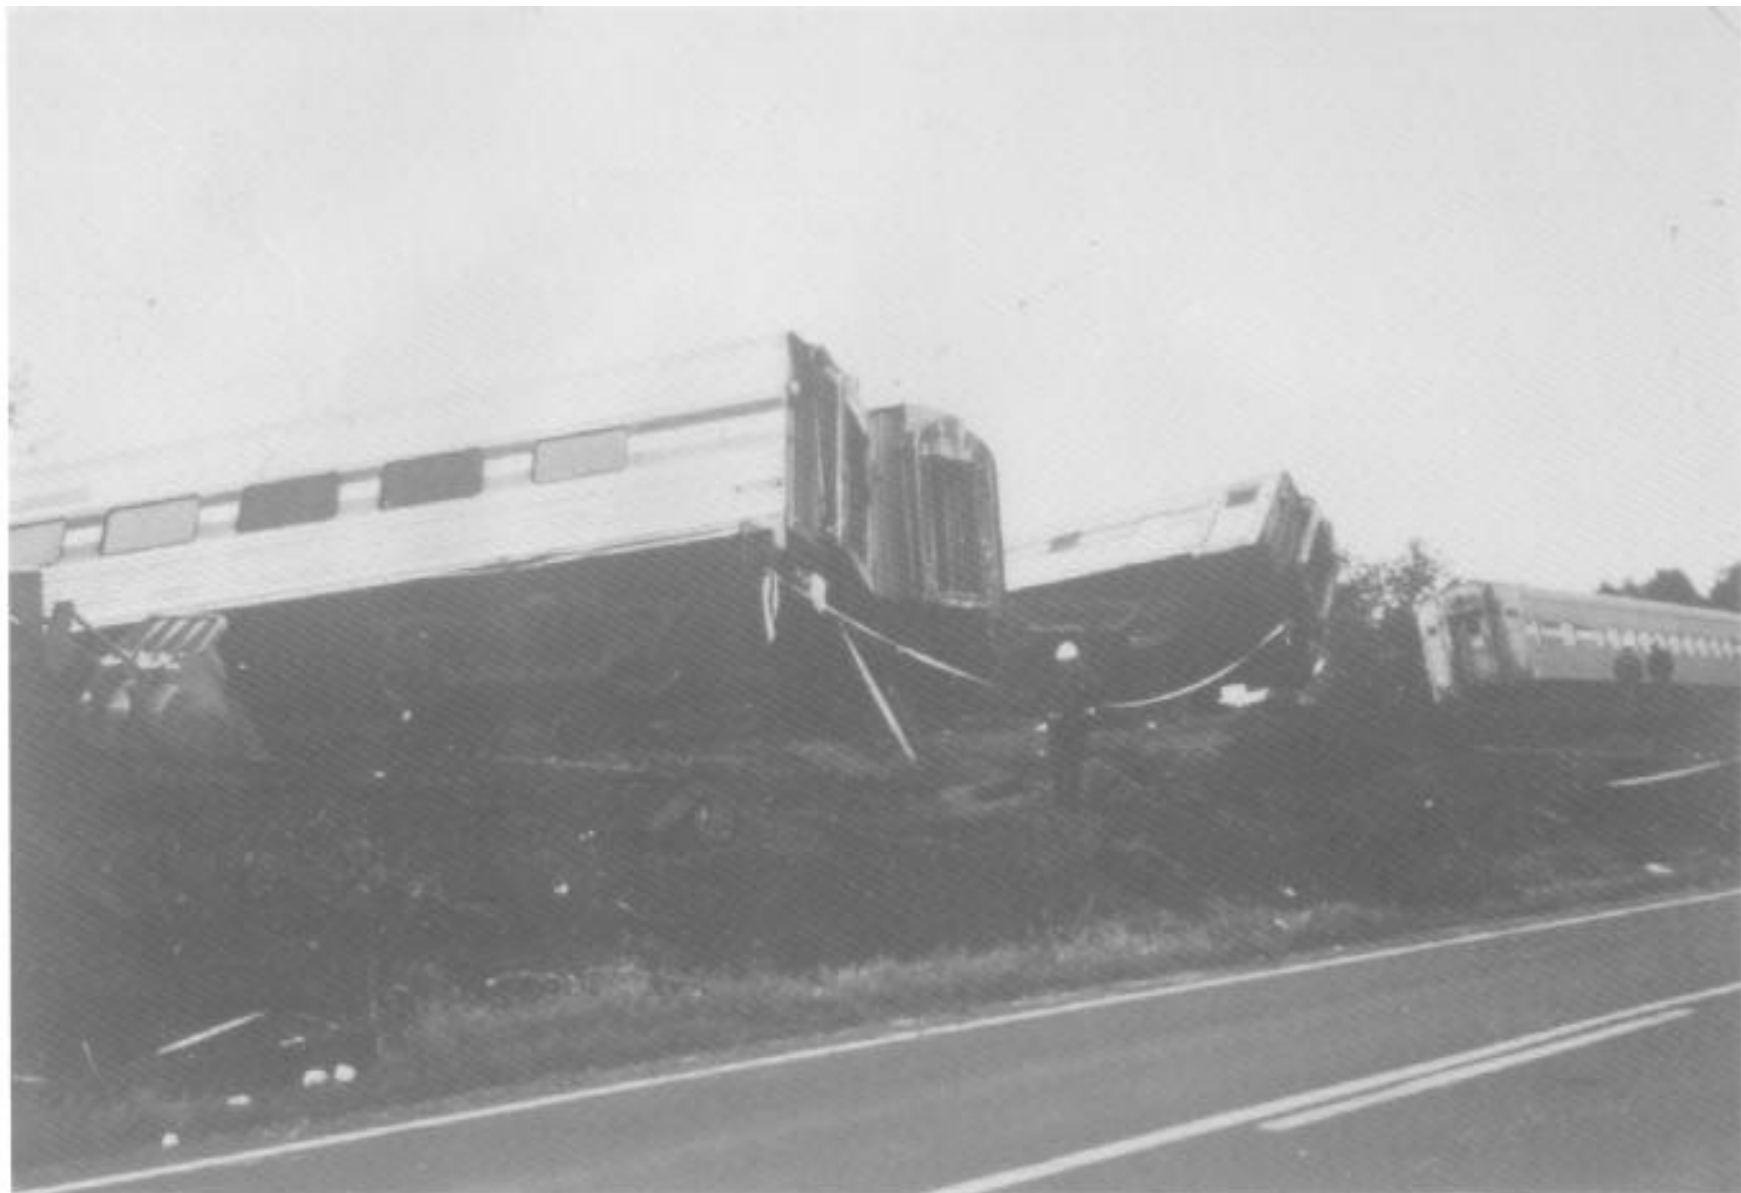
West ends of cars 3112, 4019, and 4742
