Technical Report Series

Fire Apparatus/Train Collision Catlett, Virginia

**Fire Apparatus/Train Collision
Catlett, Virginia
(September 28, 1989)**

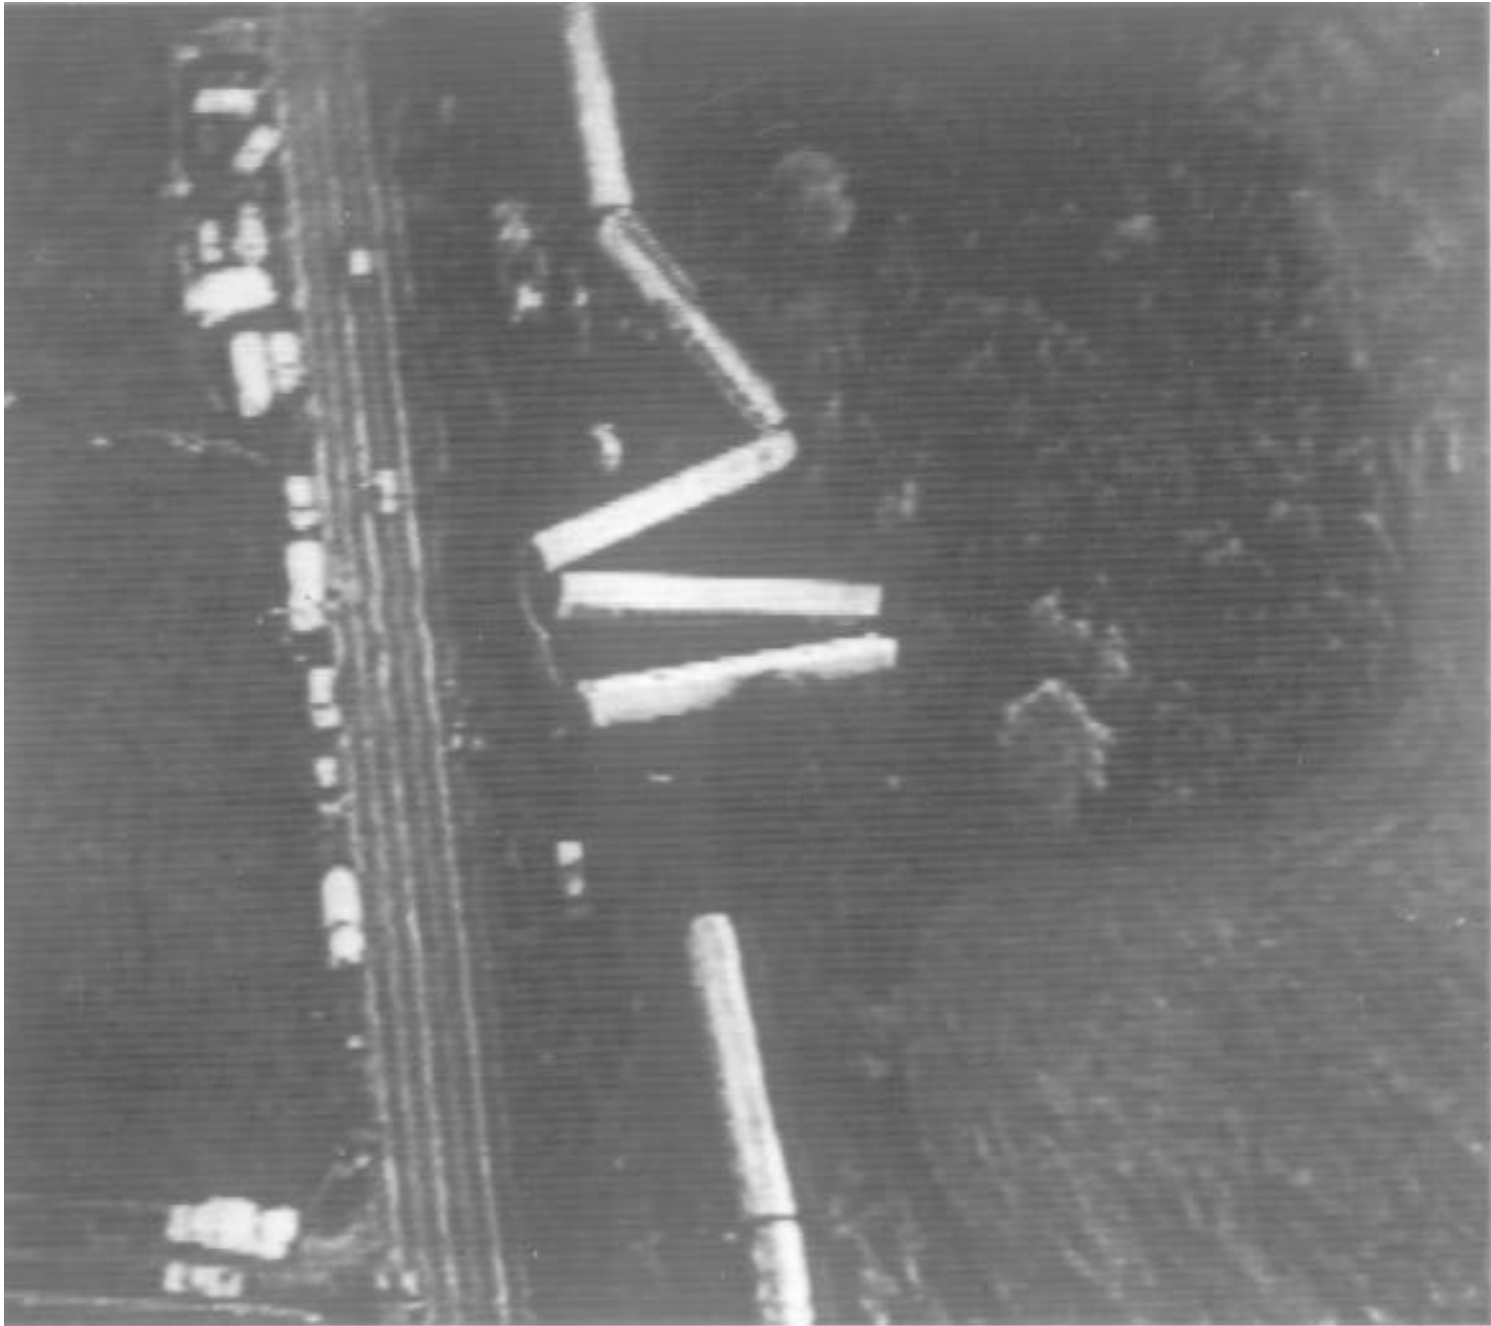
Aerial view of accident site

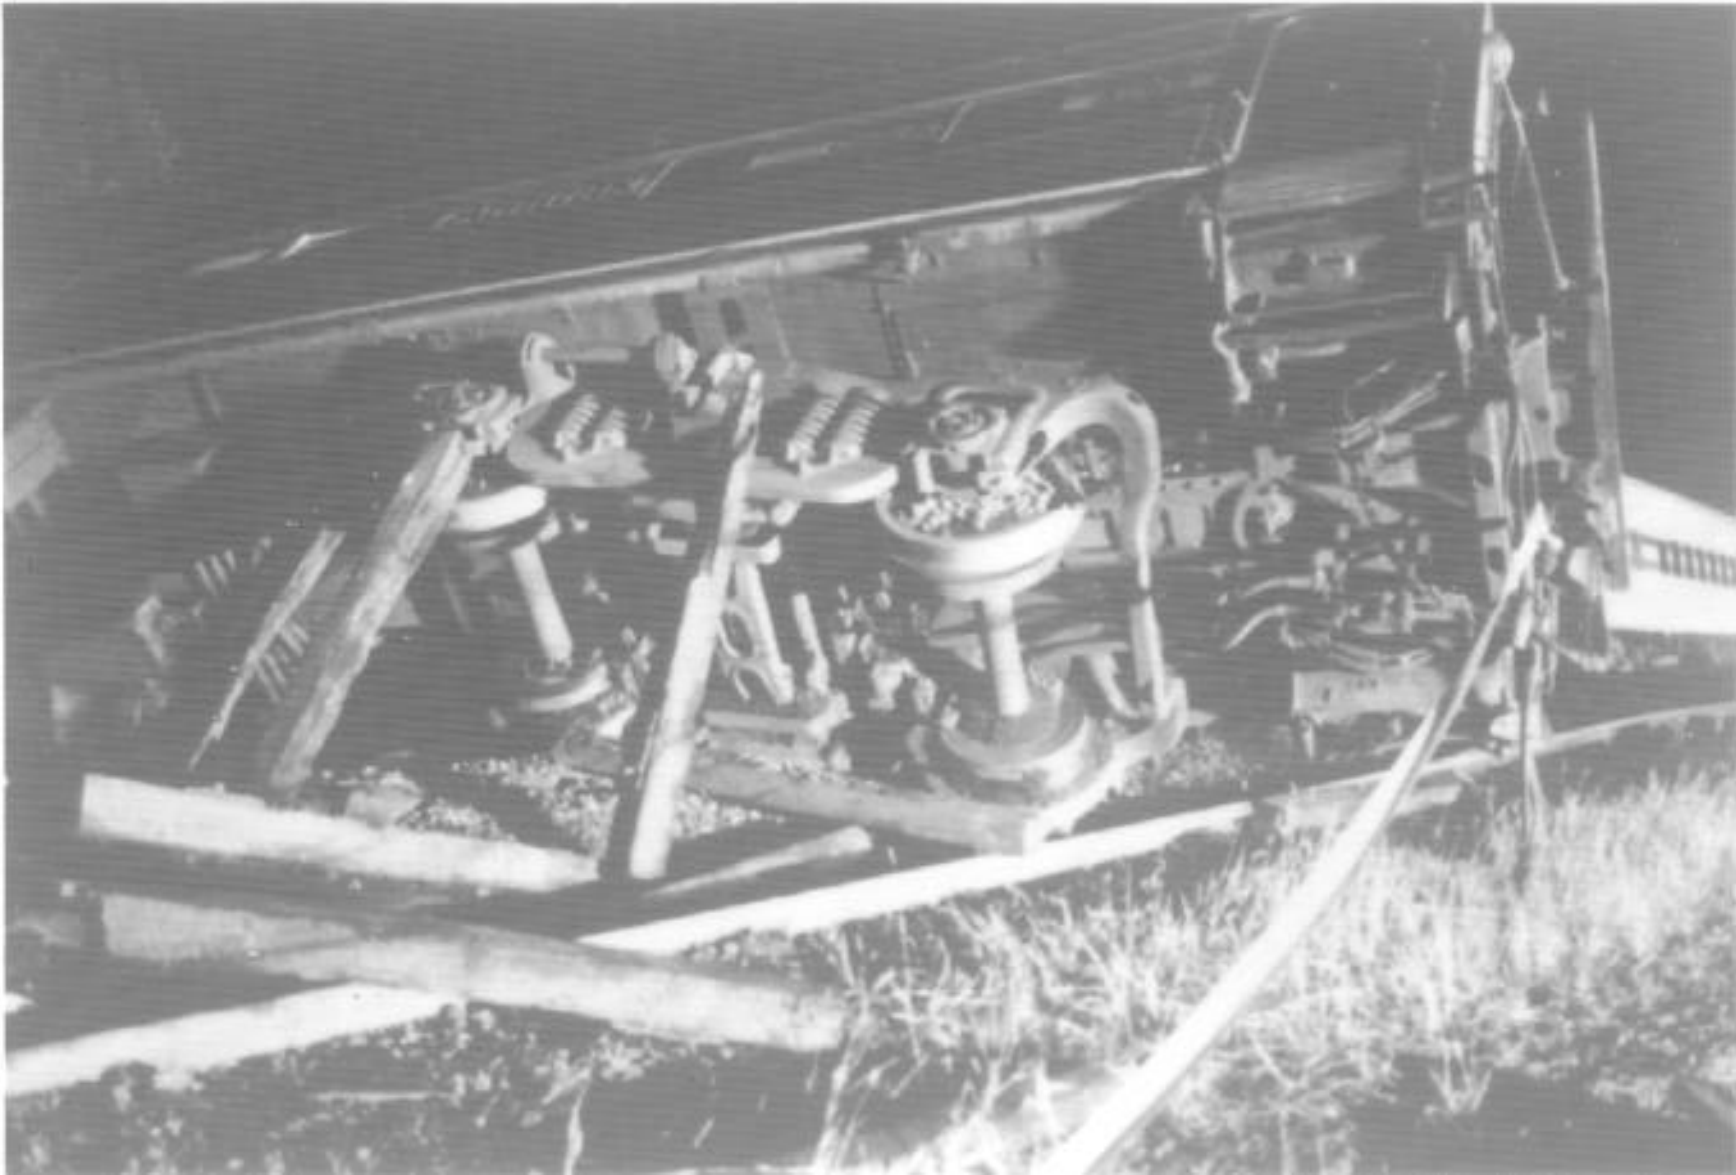
North side of car 4742

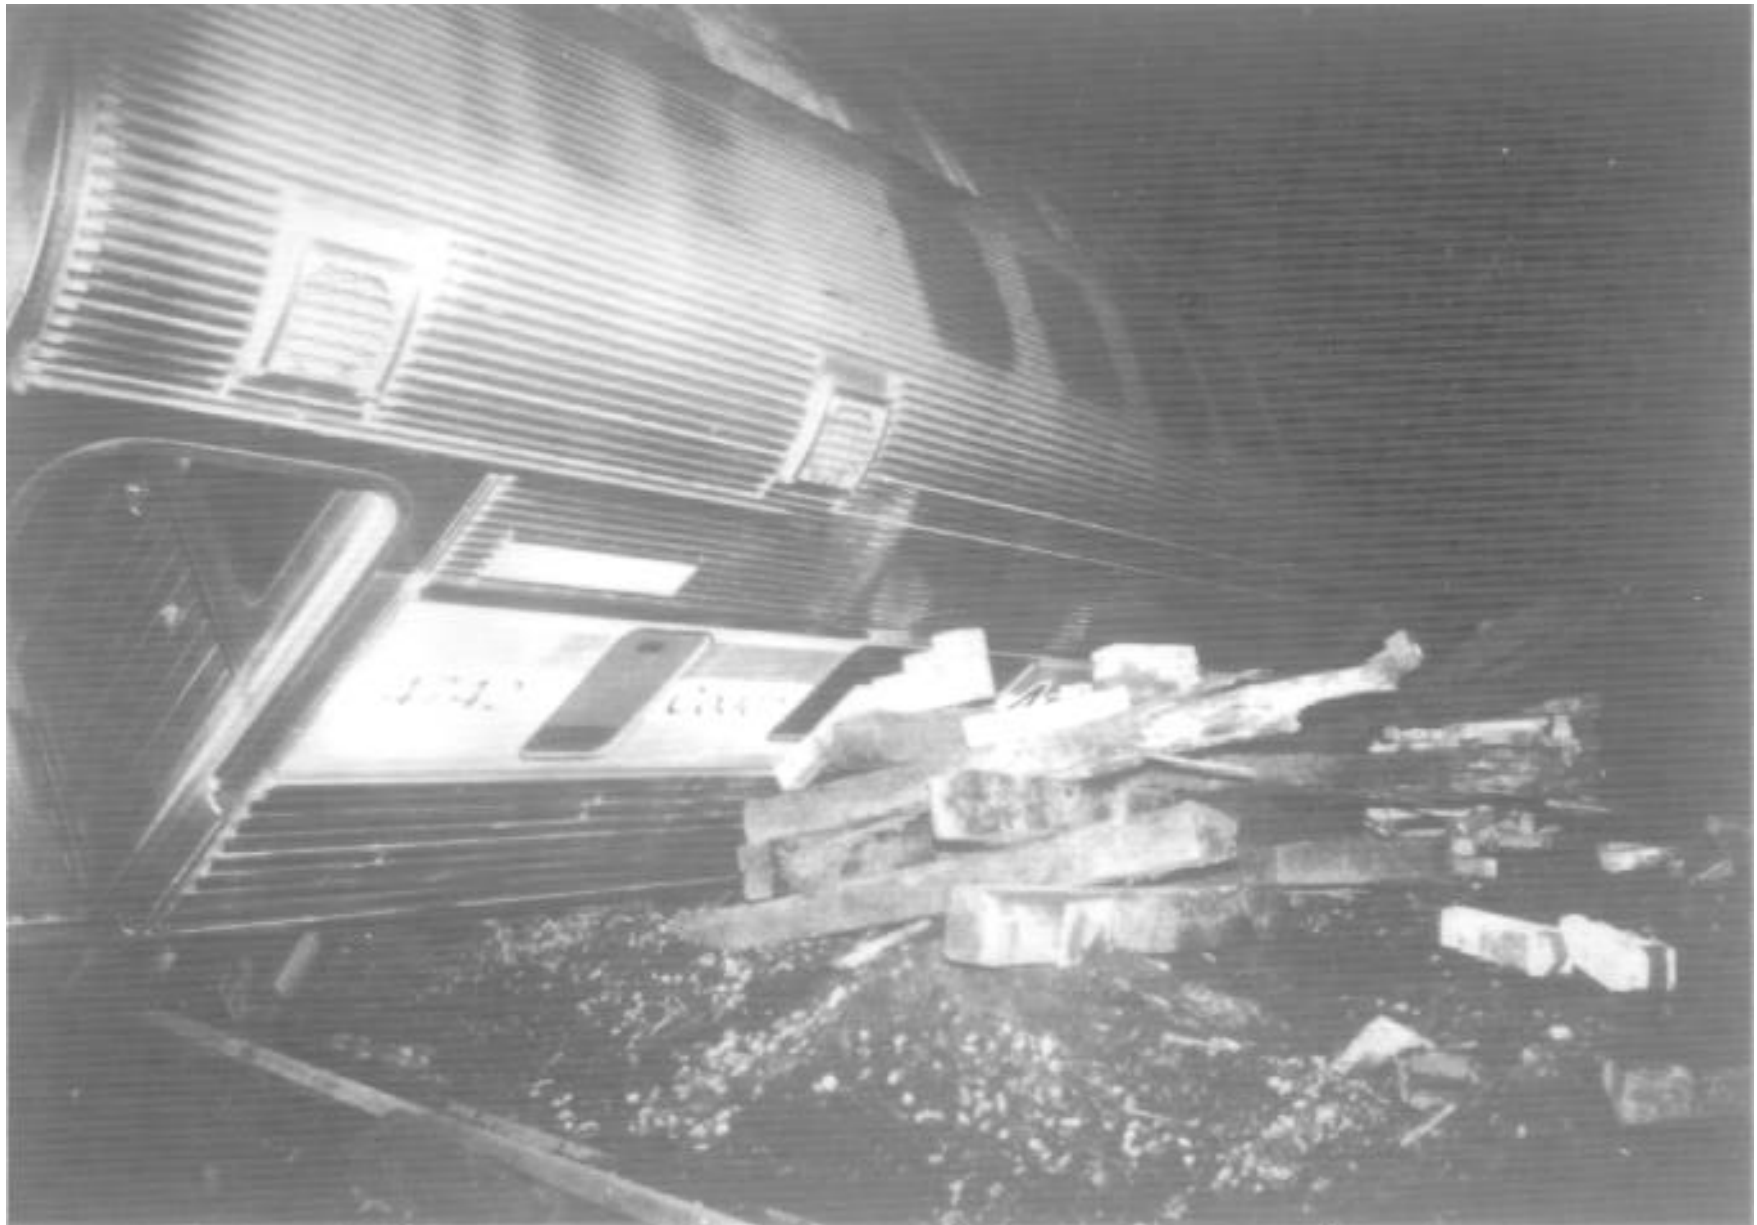
South side of car 4742

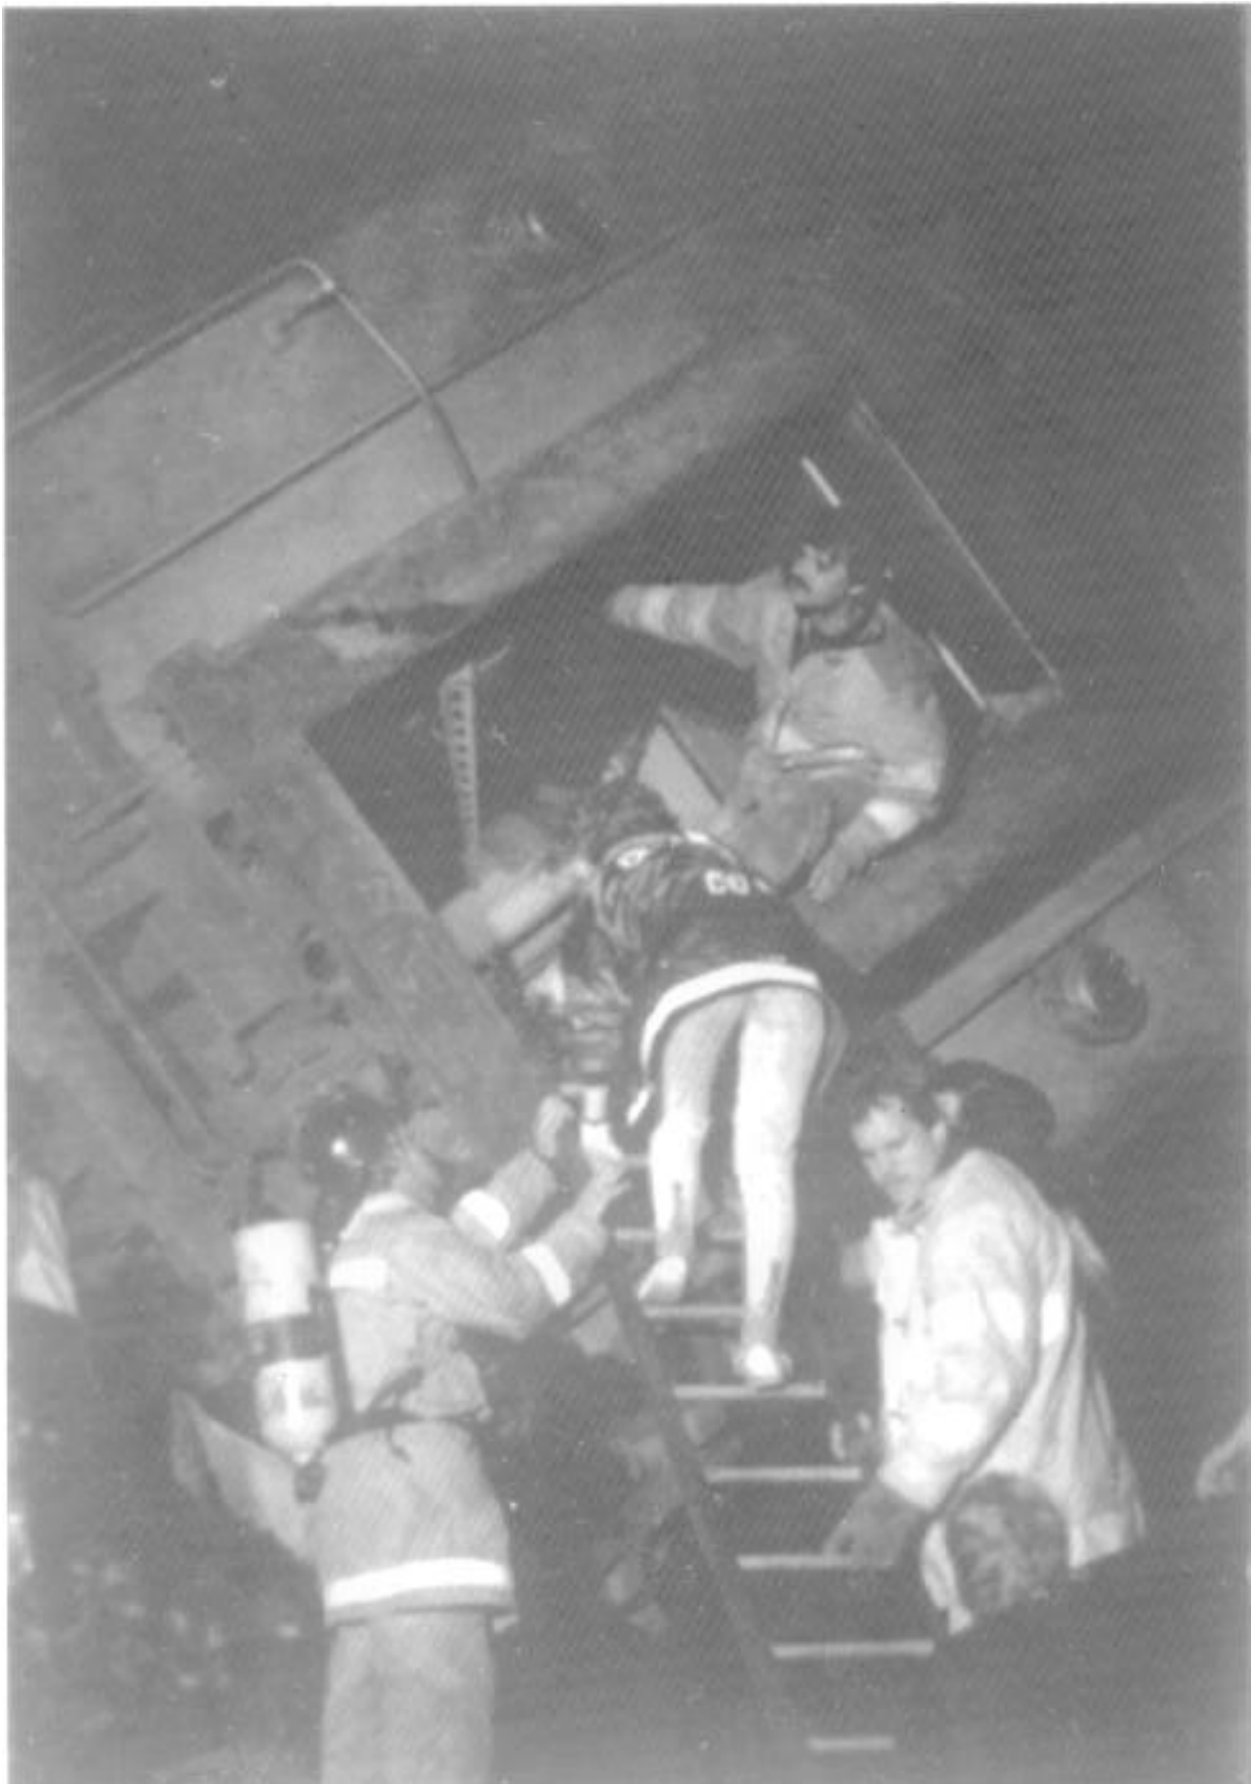
Evacuation operations from west end of car 4742

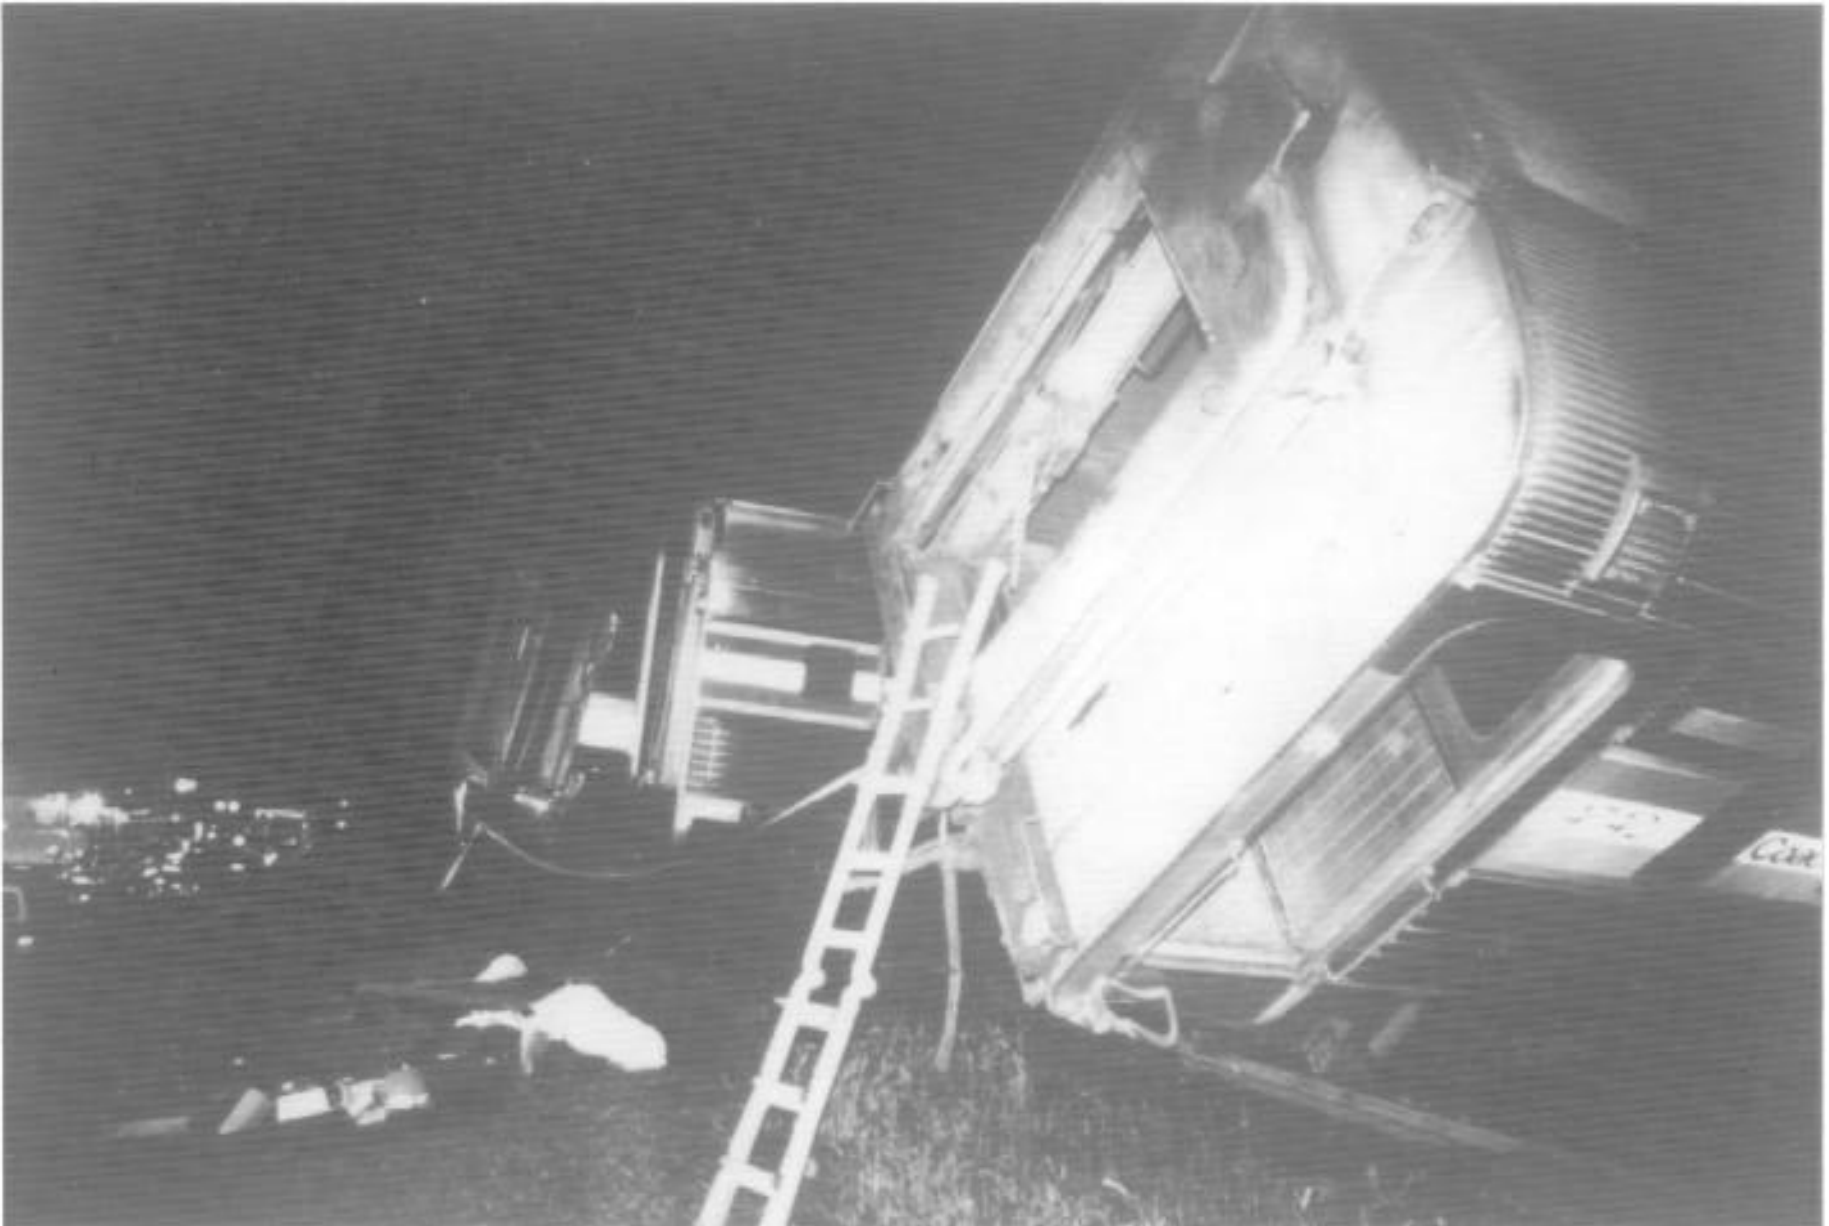
West end of car 4742

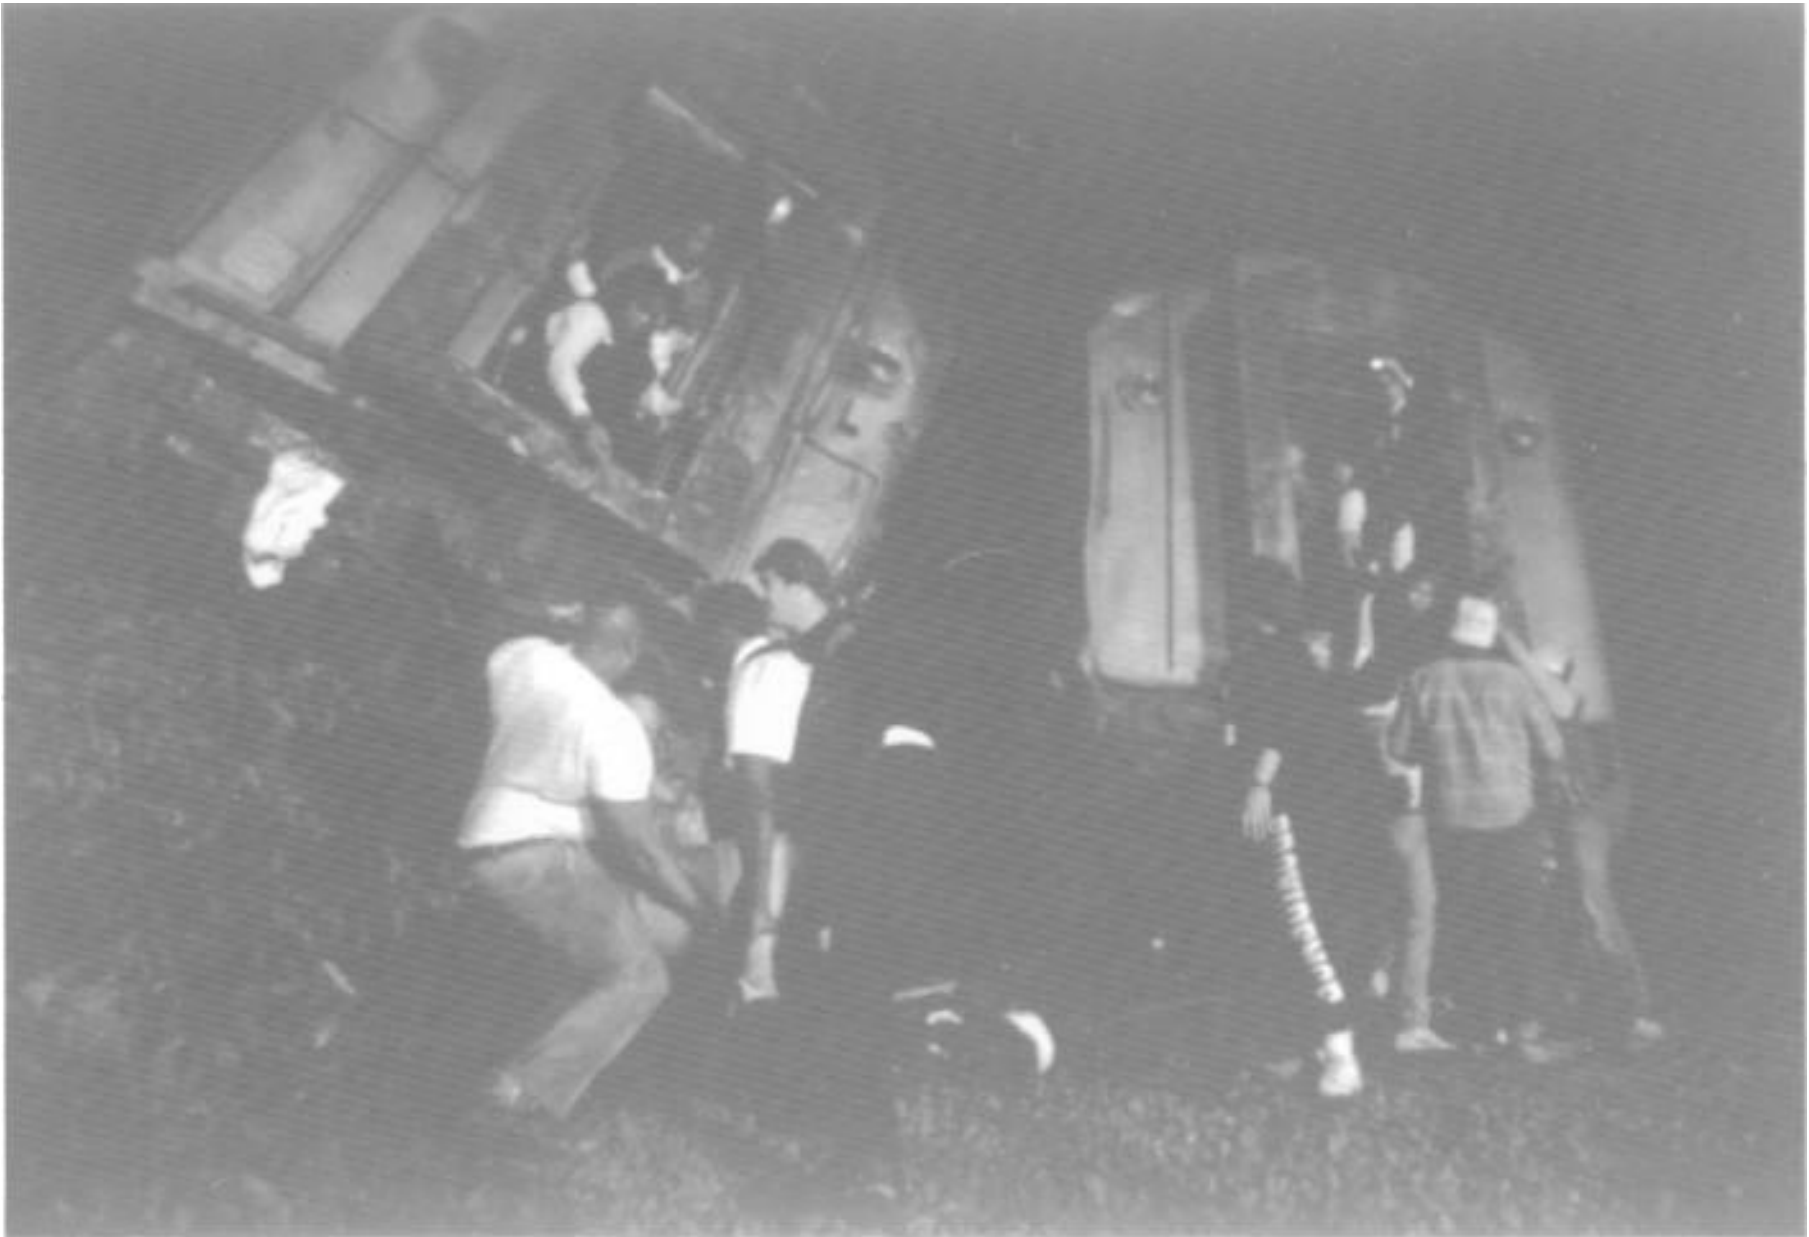
Evacuation of passengers from west ends of cars 4019 and 3112
