Technical Report Series

Chicken Processing Plant Fires Hamlet, North Carolina, and North Little Rock, Arkansas

**Chicken Processing Plant Fires
Hamlet, North Carolina
(September 3, 1991)
North Little Rock, Arkansas
(June 7, 1991)**

This is Report 057 of the Major Fires Investigation Project conducted by TriData Corporation under contract EMW-90-C-3338 to the United States Fire Administration, Federal Emergency Management Agency.

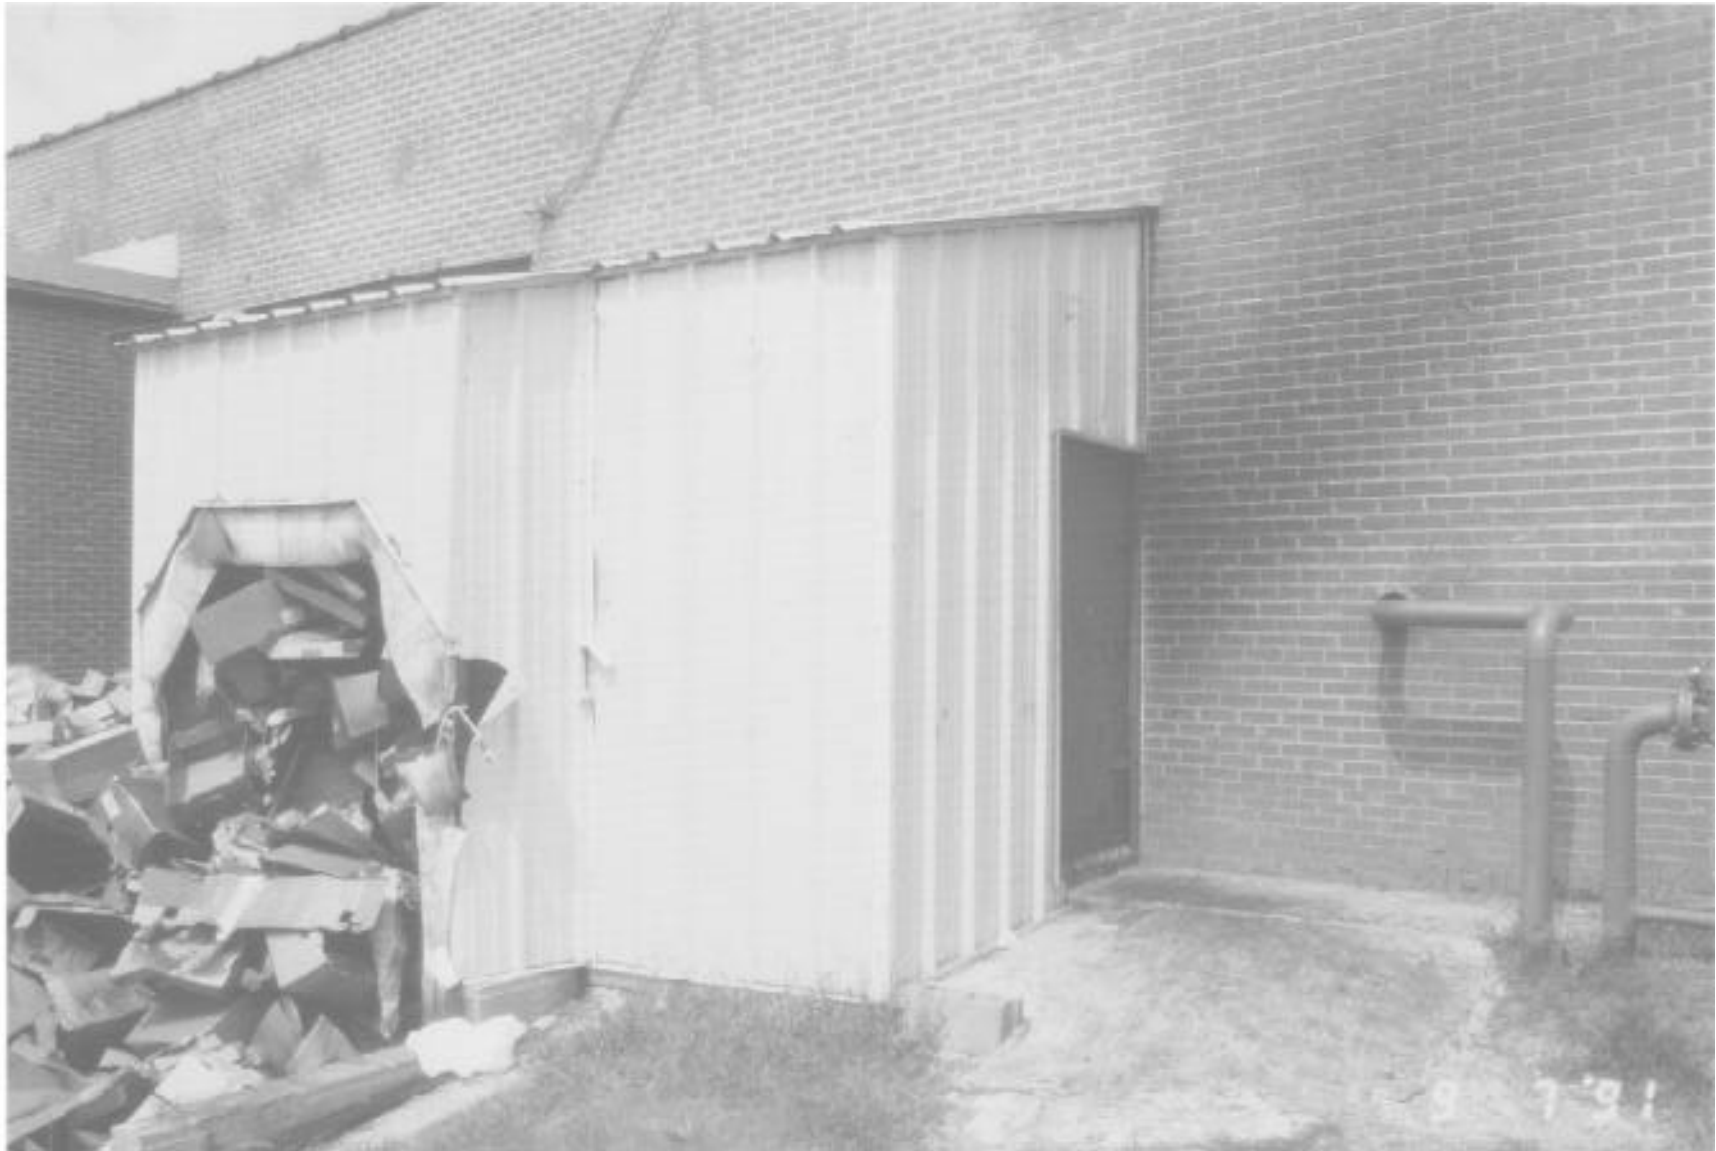
The compactor area and one of the exit doors that was locked.

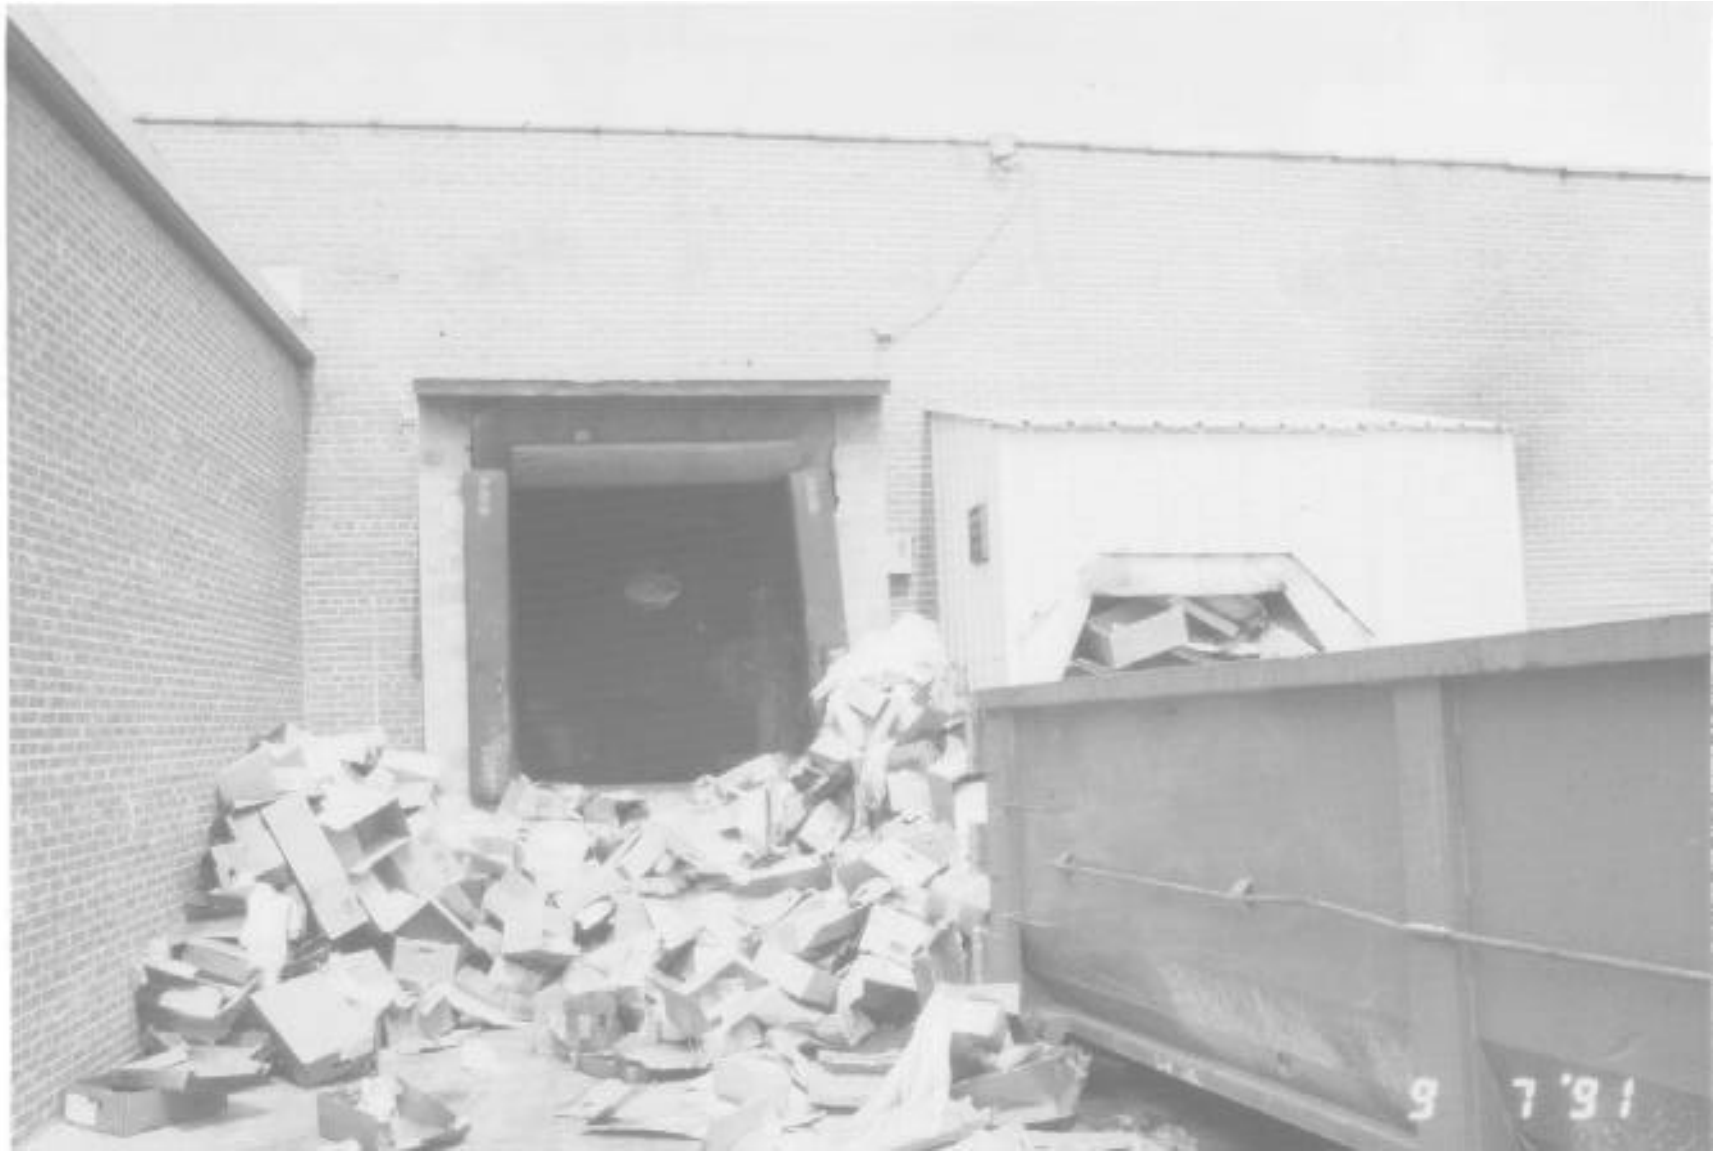
The loading dock area and sealed doors next to the compactor. The pads around the doors are designed to form a seal when the trailer backs into this dock.

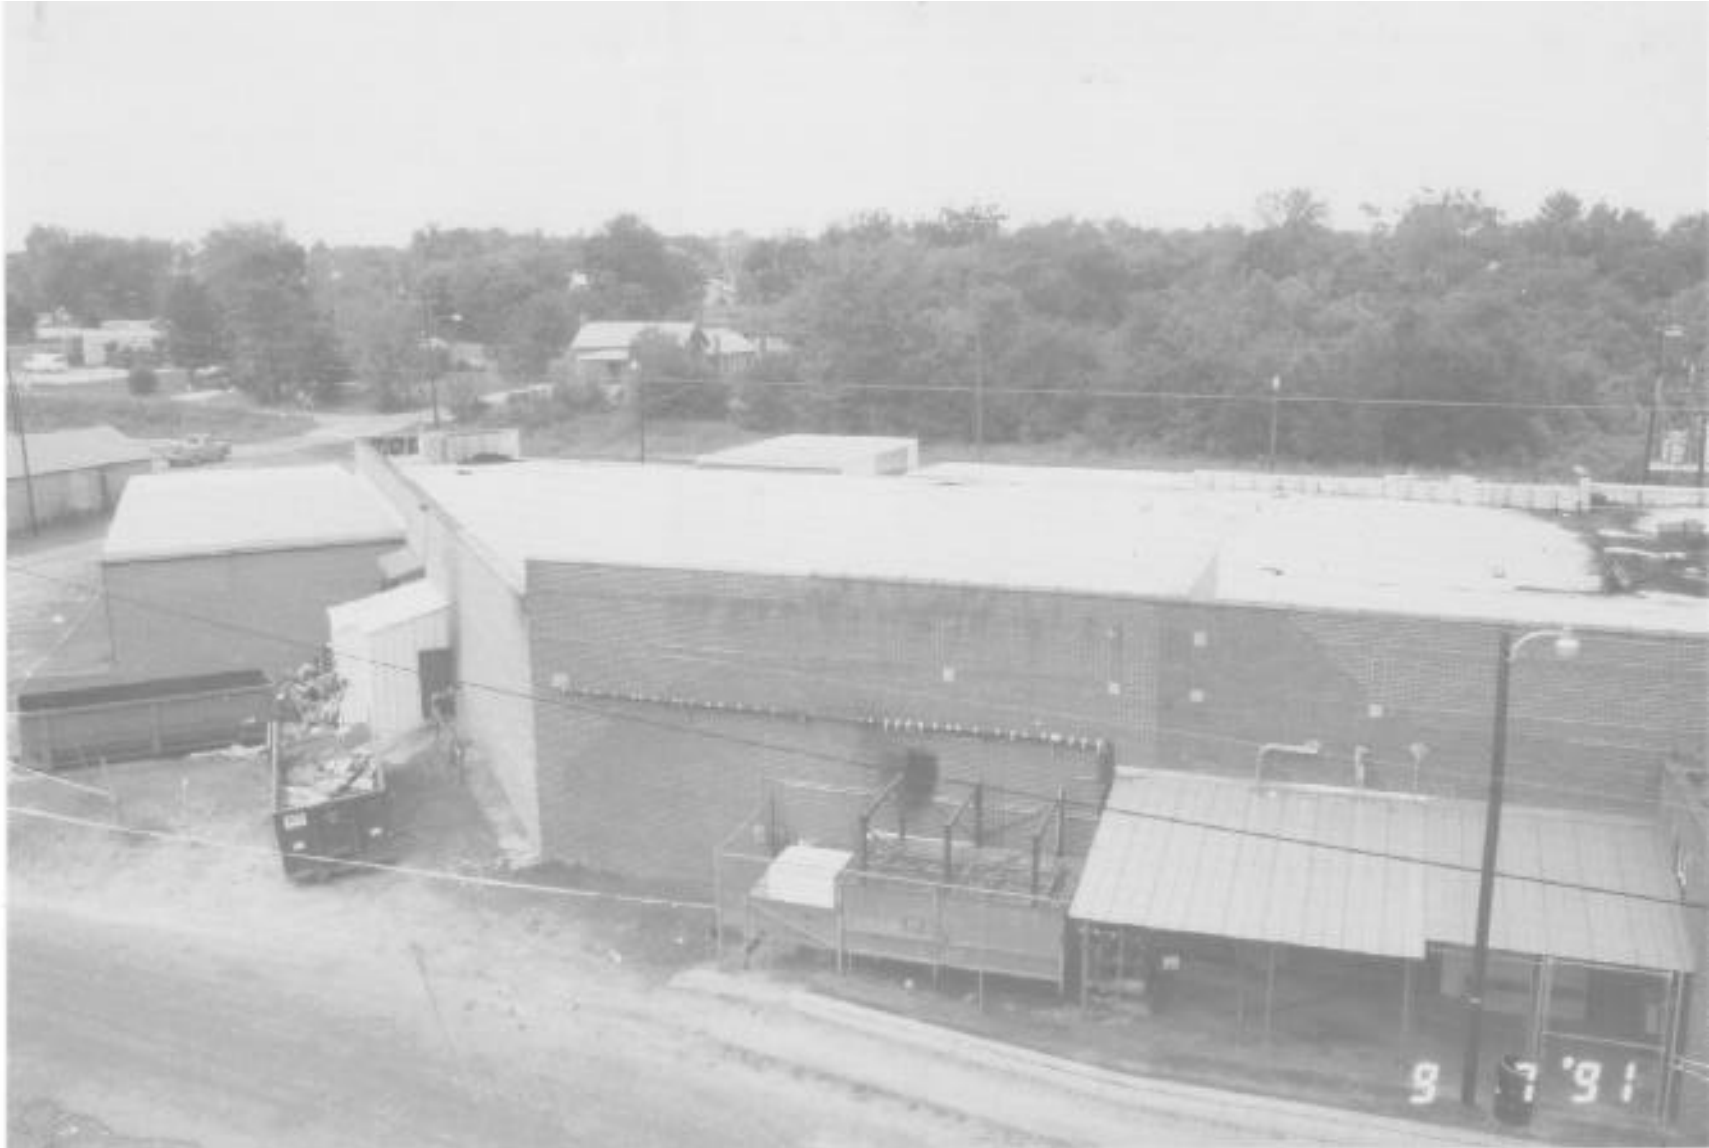
A view from an aerial ladder from the east looking southwest. Some roof damage is visible at the extreme right.

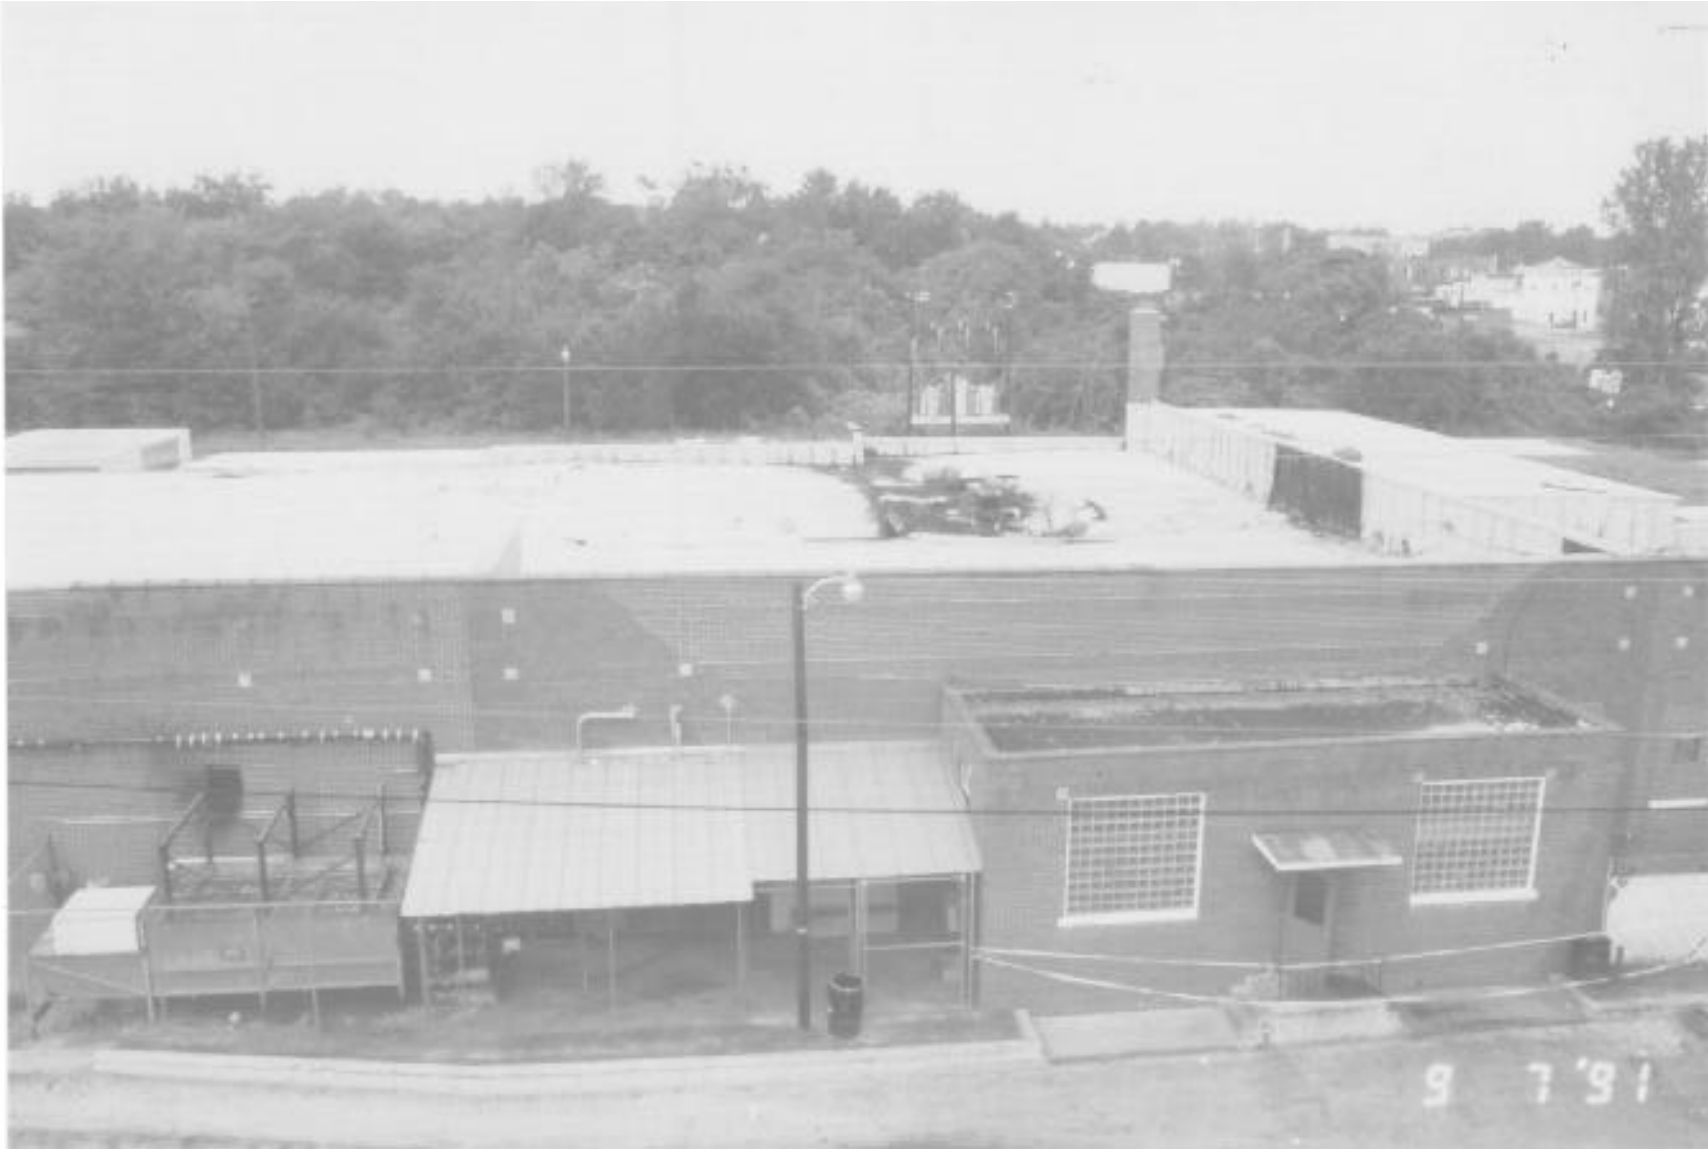
Another view from the aerial ladder from the east looking west, shows the portion of the roof collapsed over the area of origin.

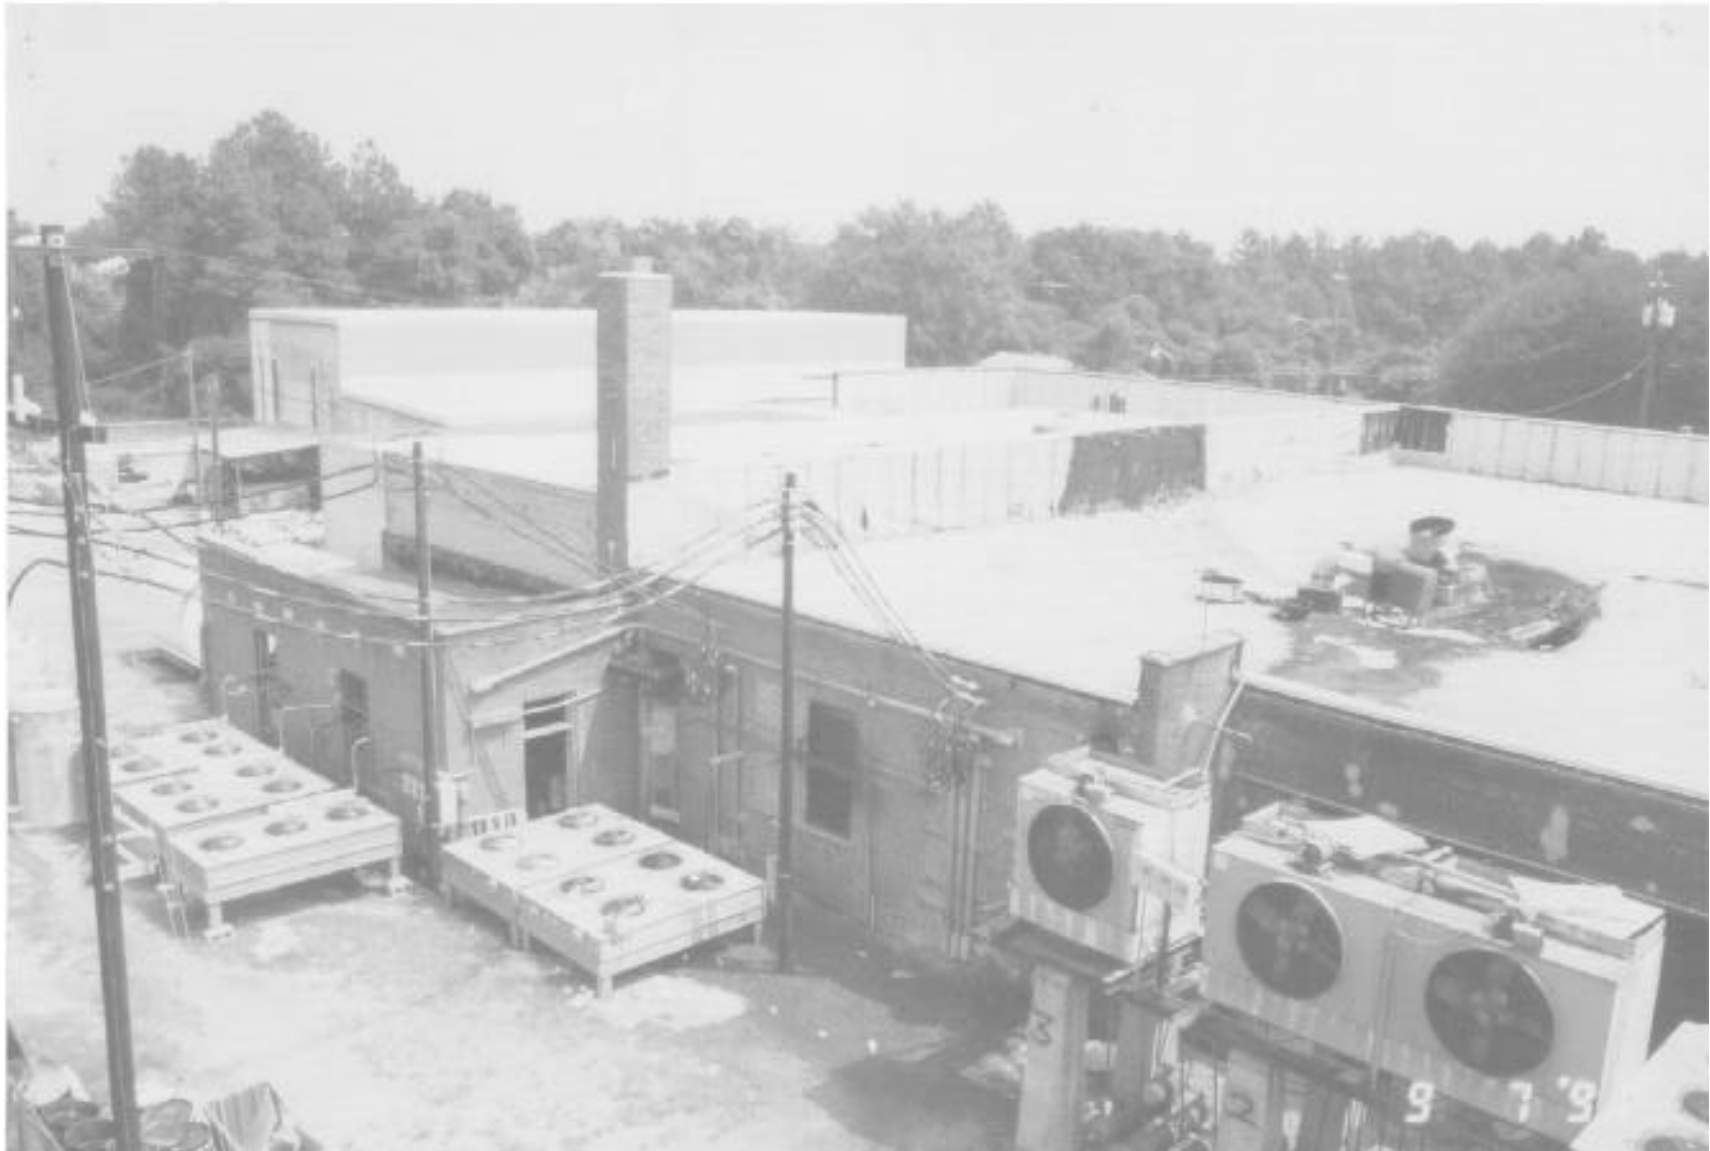
A view from the aerial ladder from the west side looking to the northeast. The roof collapse can be seen on the right, refrigeration compressor equipment is seen on the ground in the lower left.

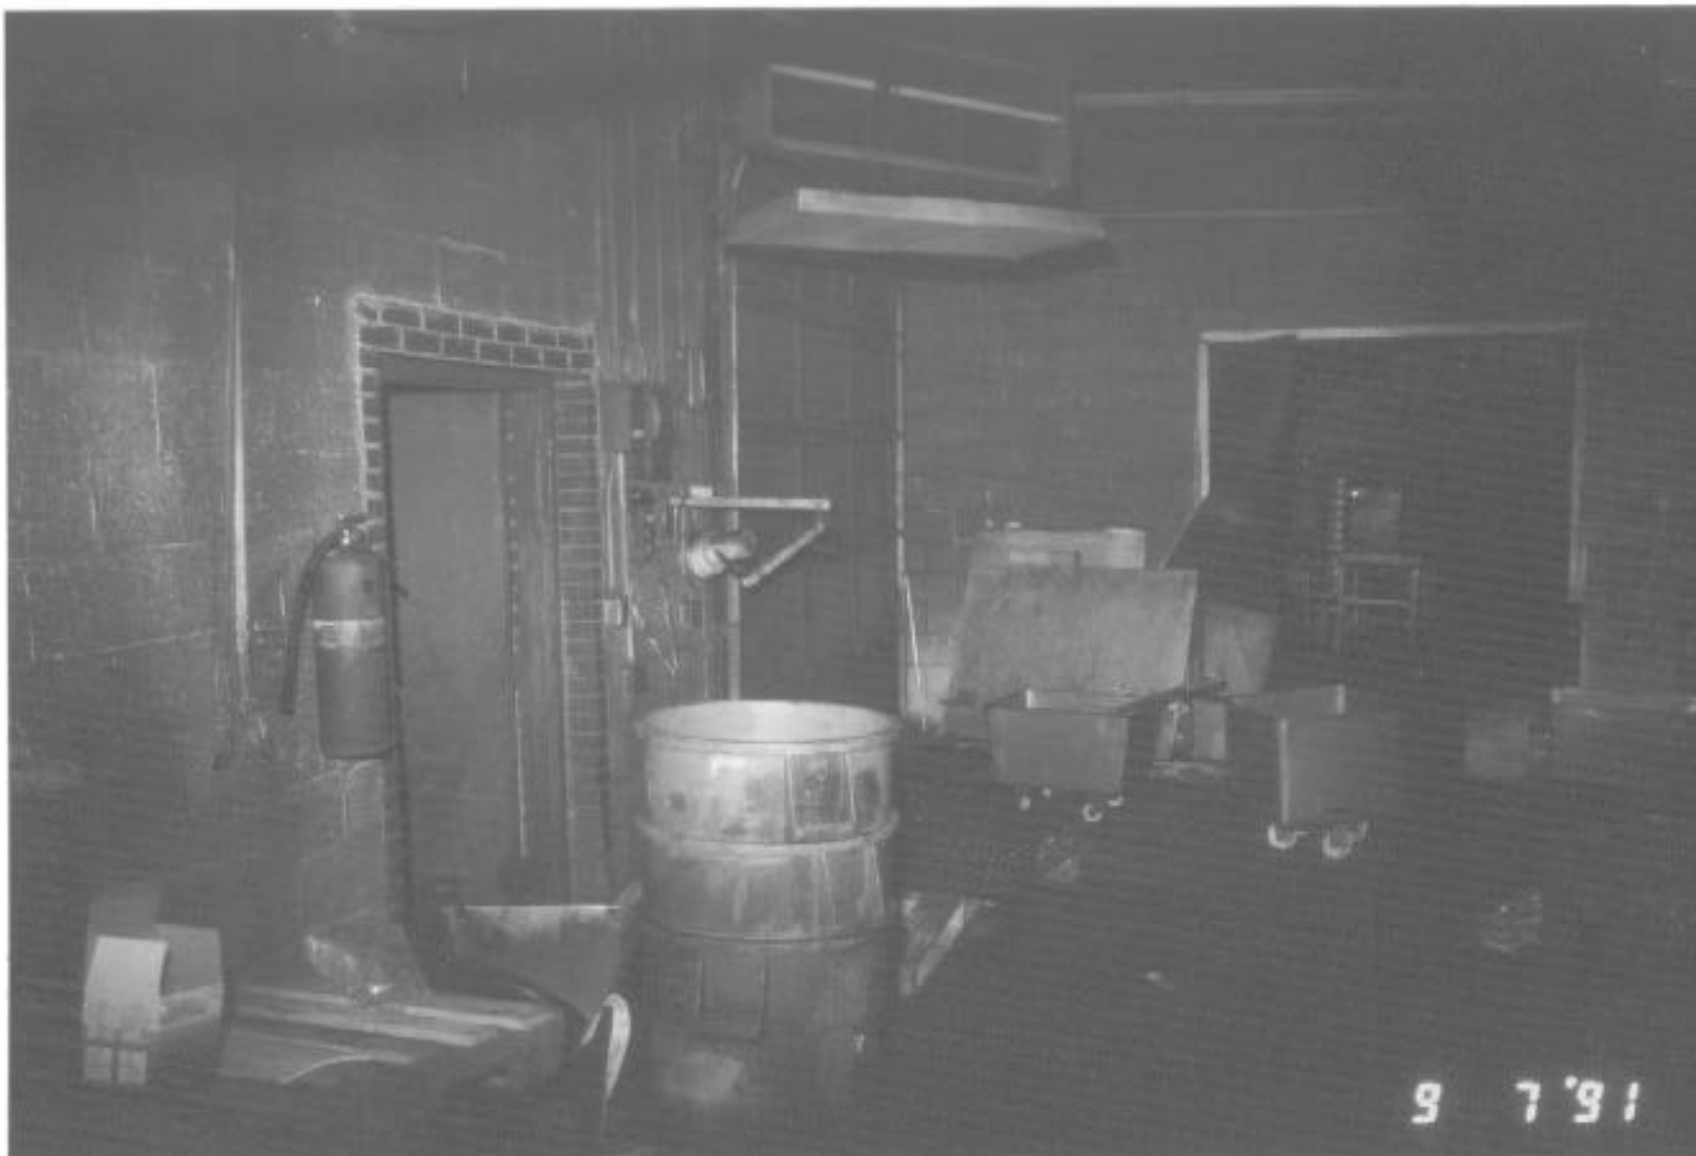
The trash and loading dock area. It was into this compactor area that several people tried to escape only to find the door to the outside locked. Upon coming back out of this area, they went through the large doors at the right which ultimately led to the large walk-in cooler where the largest fatality count was found. View is from the east toward the west southwest.

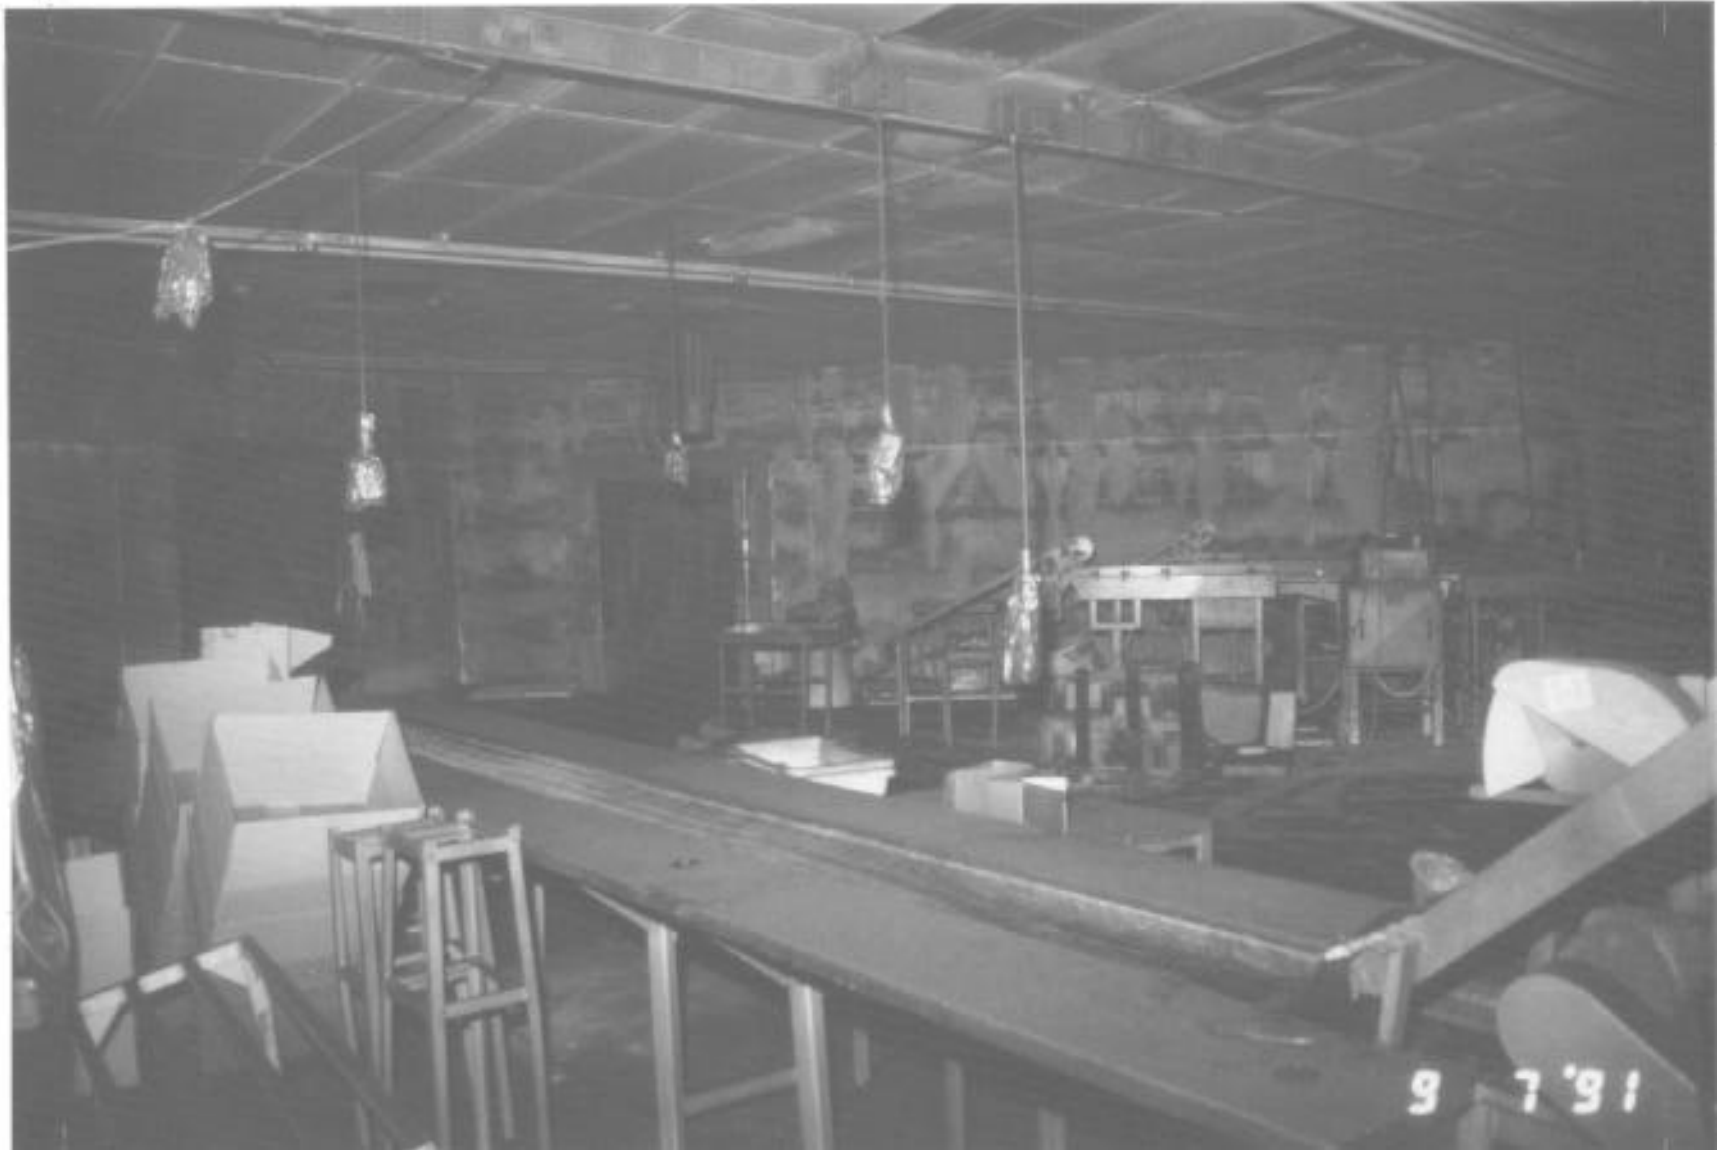
View showing the trim room as seen from the west center looking to the southeast. This view is looking toward the door to the cooler where the highest fatality count was located.

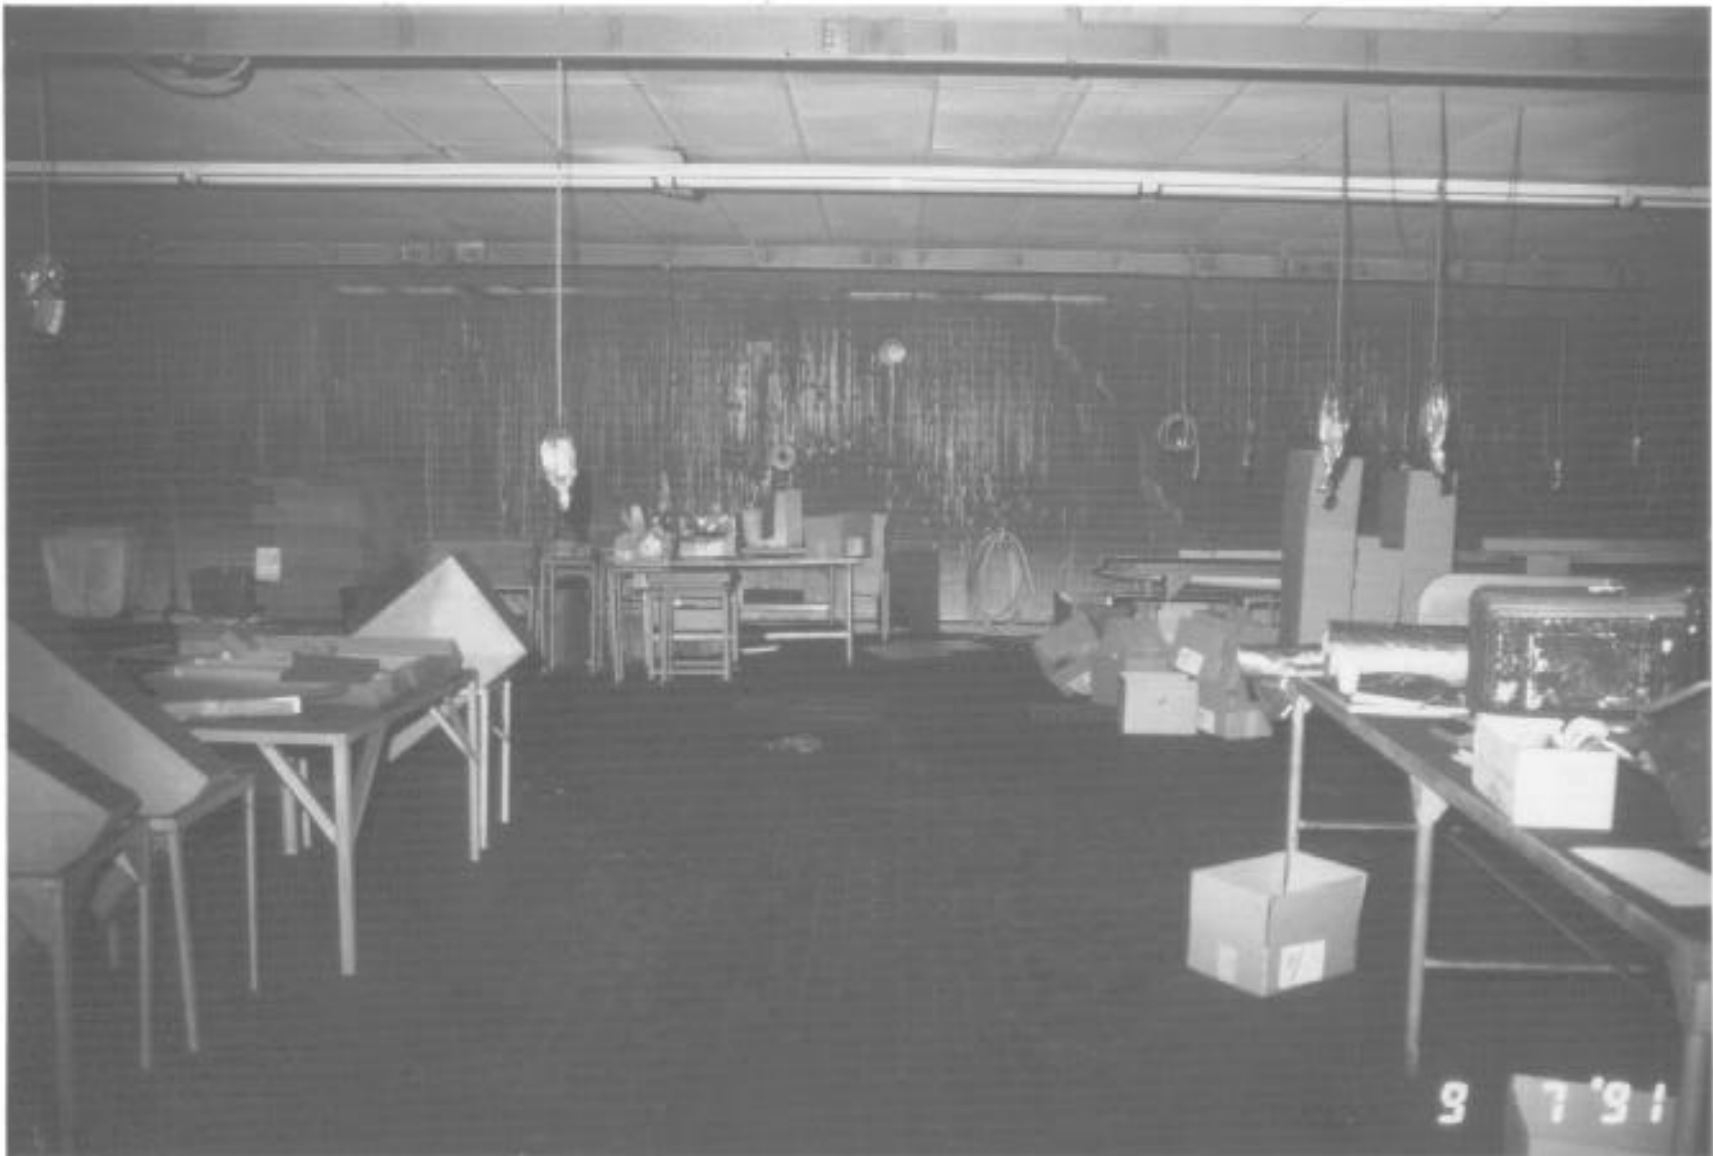
Inside the marinating and cutting room; no direct flame impingement actually entered into this area. View is from the east to the west.

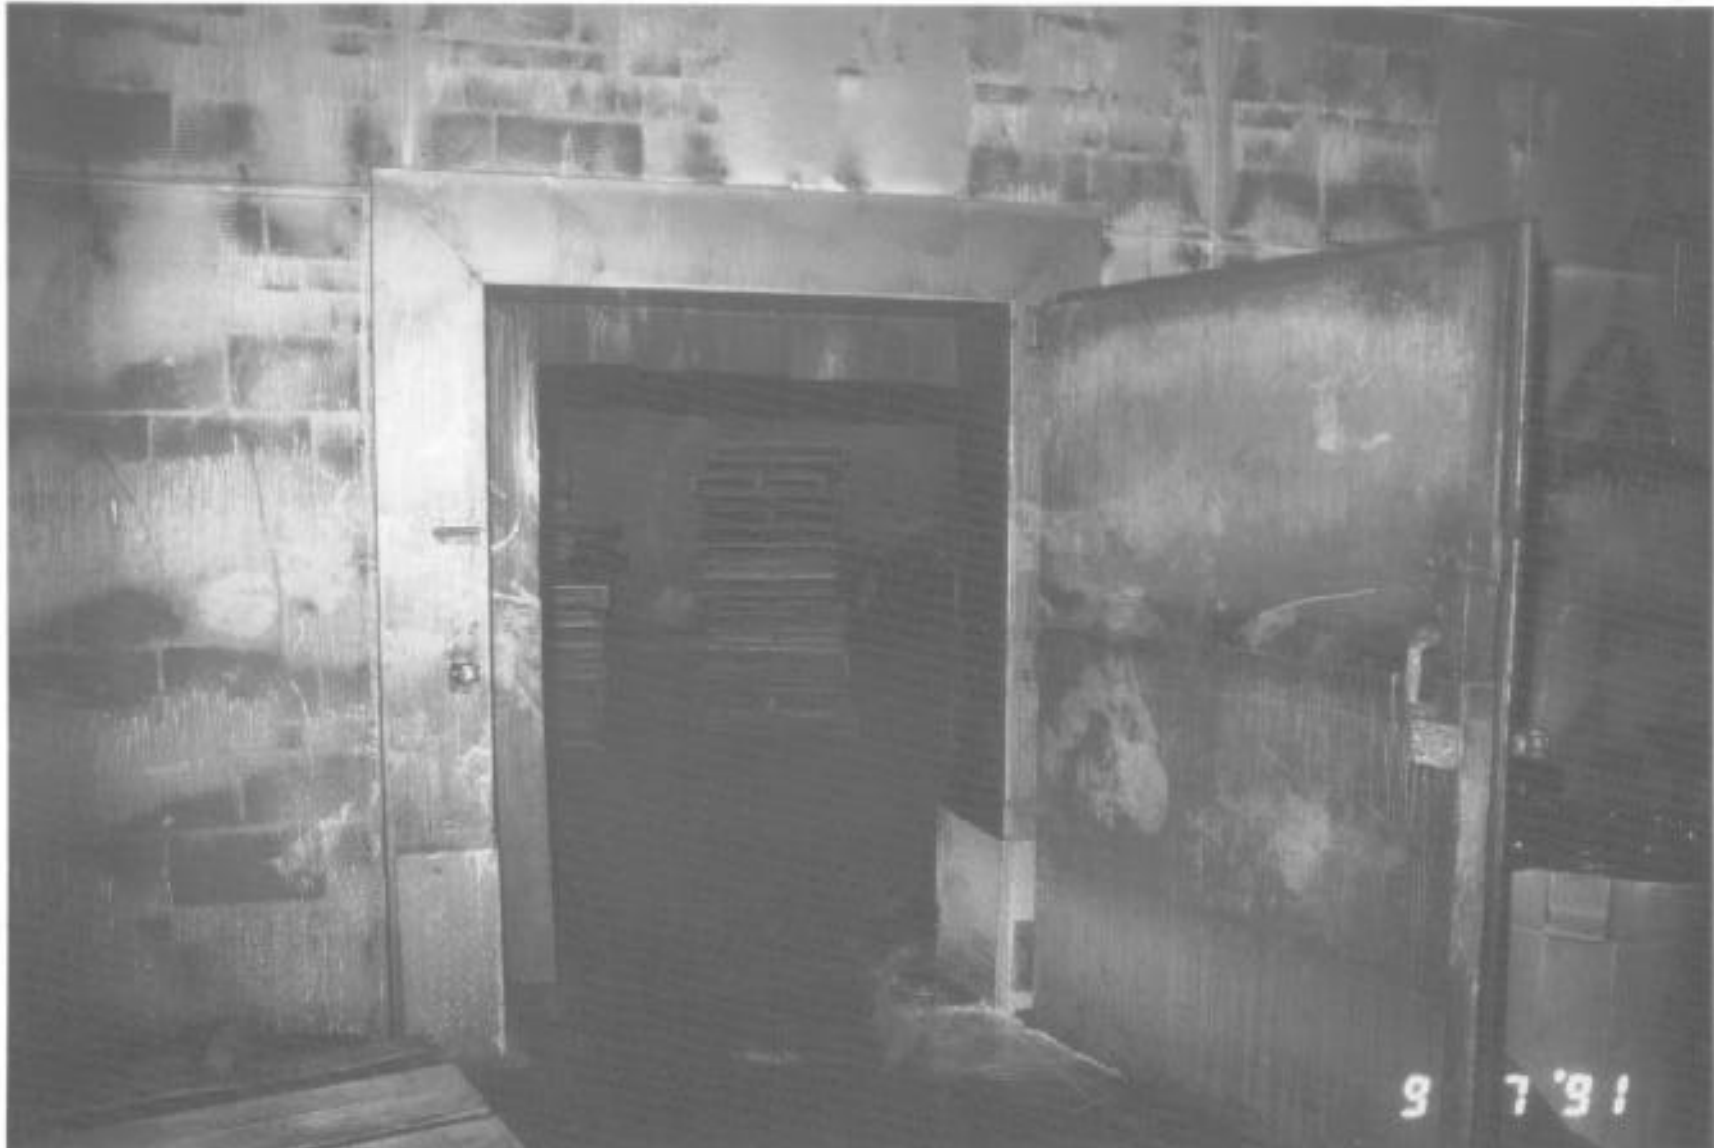
The cooler door, which was at the south end of the building, where the highest fatality count was found.

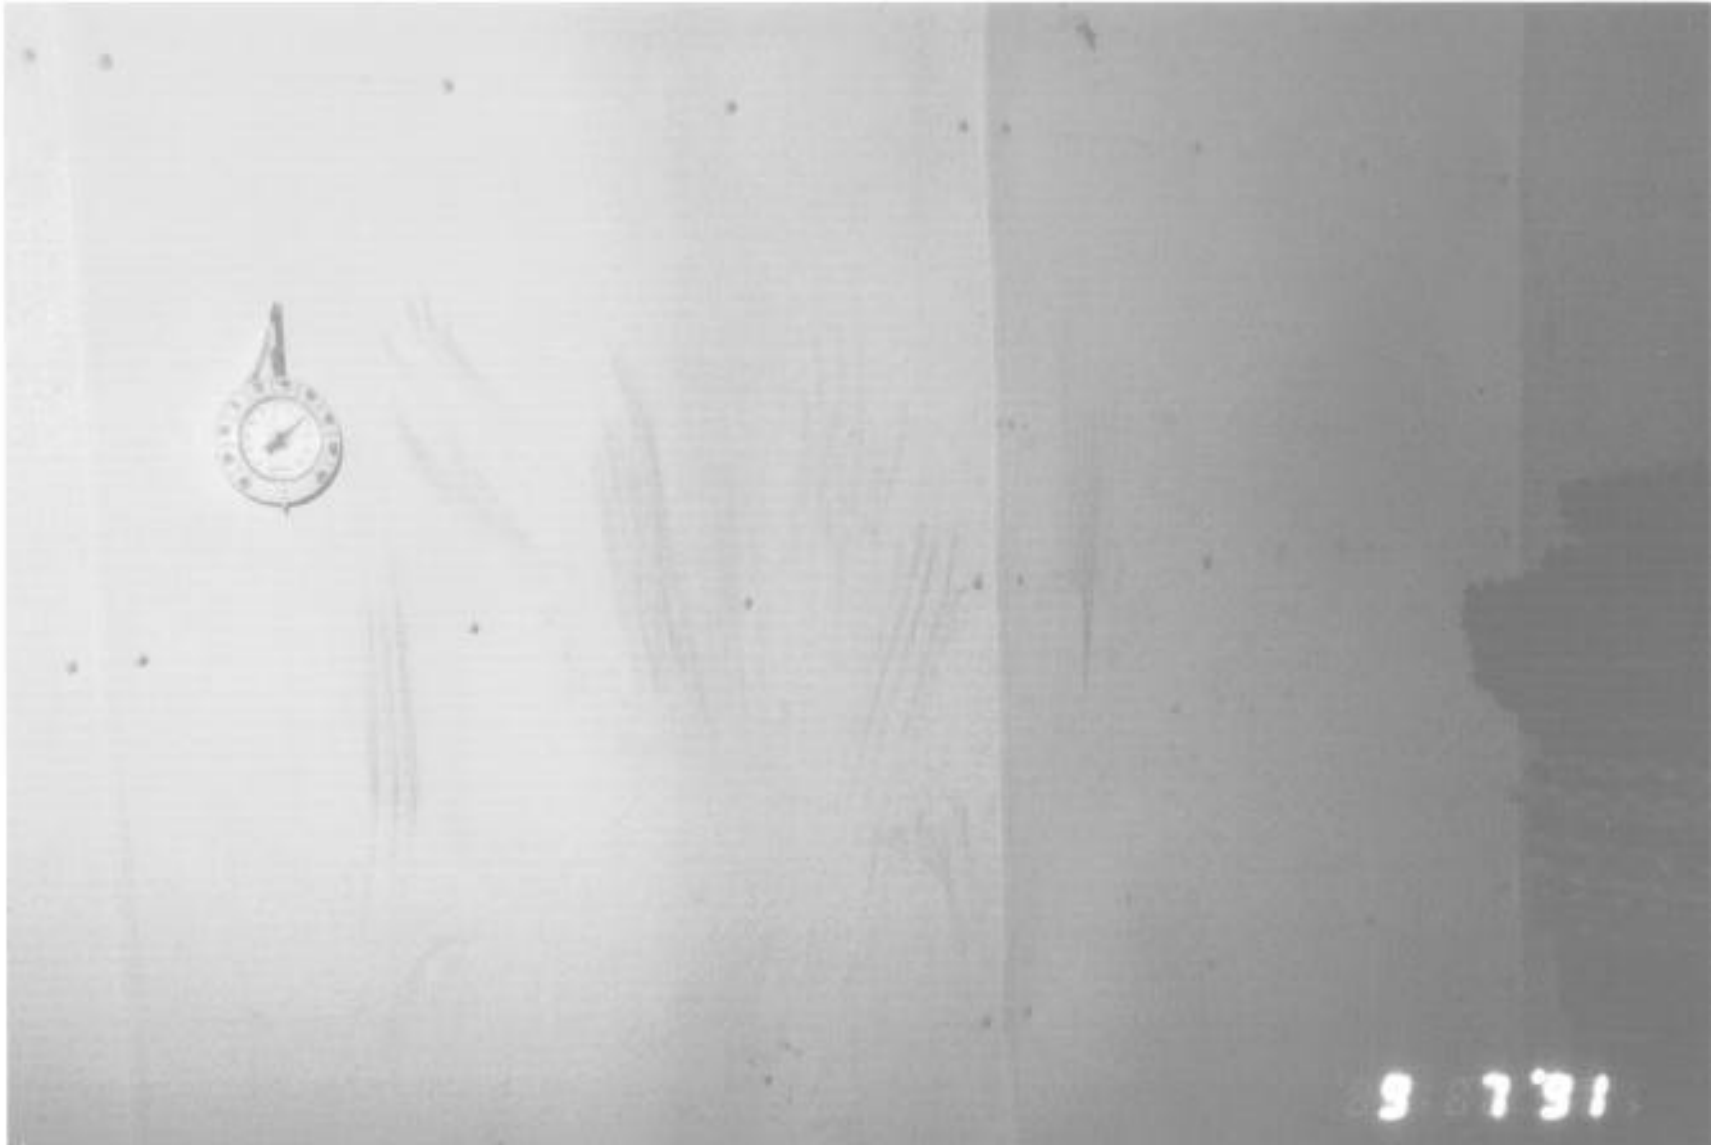
The west wall in the west portion of the cooler. Numerous handprints were found where people were trying to find escape routes.

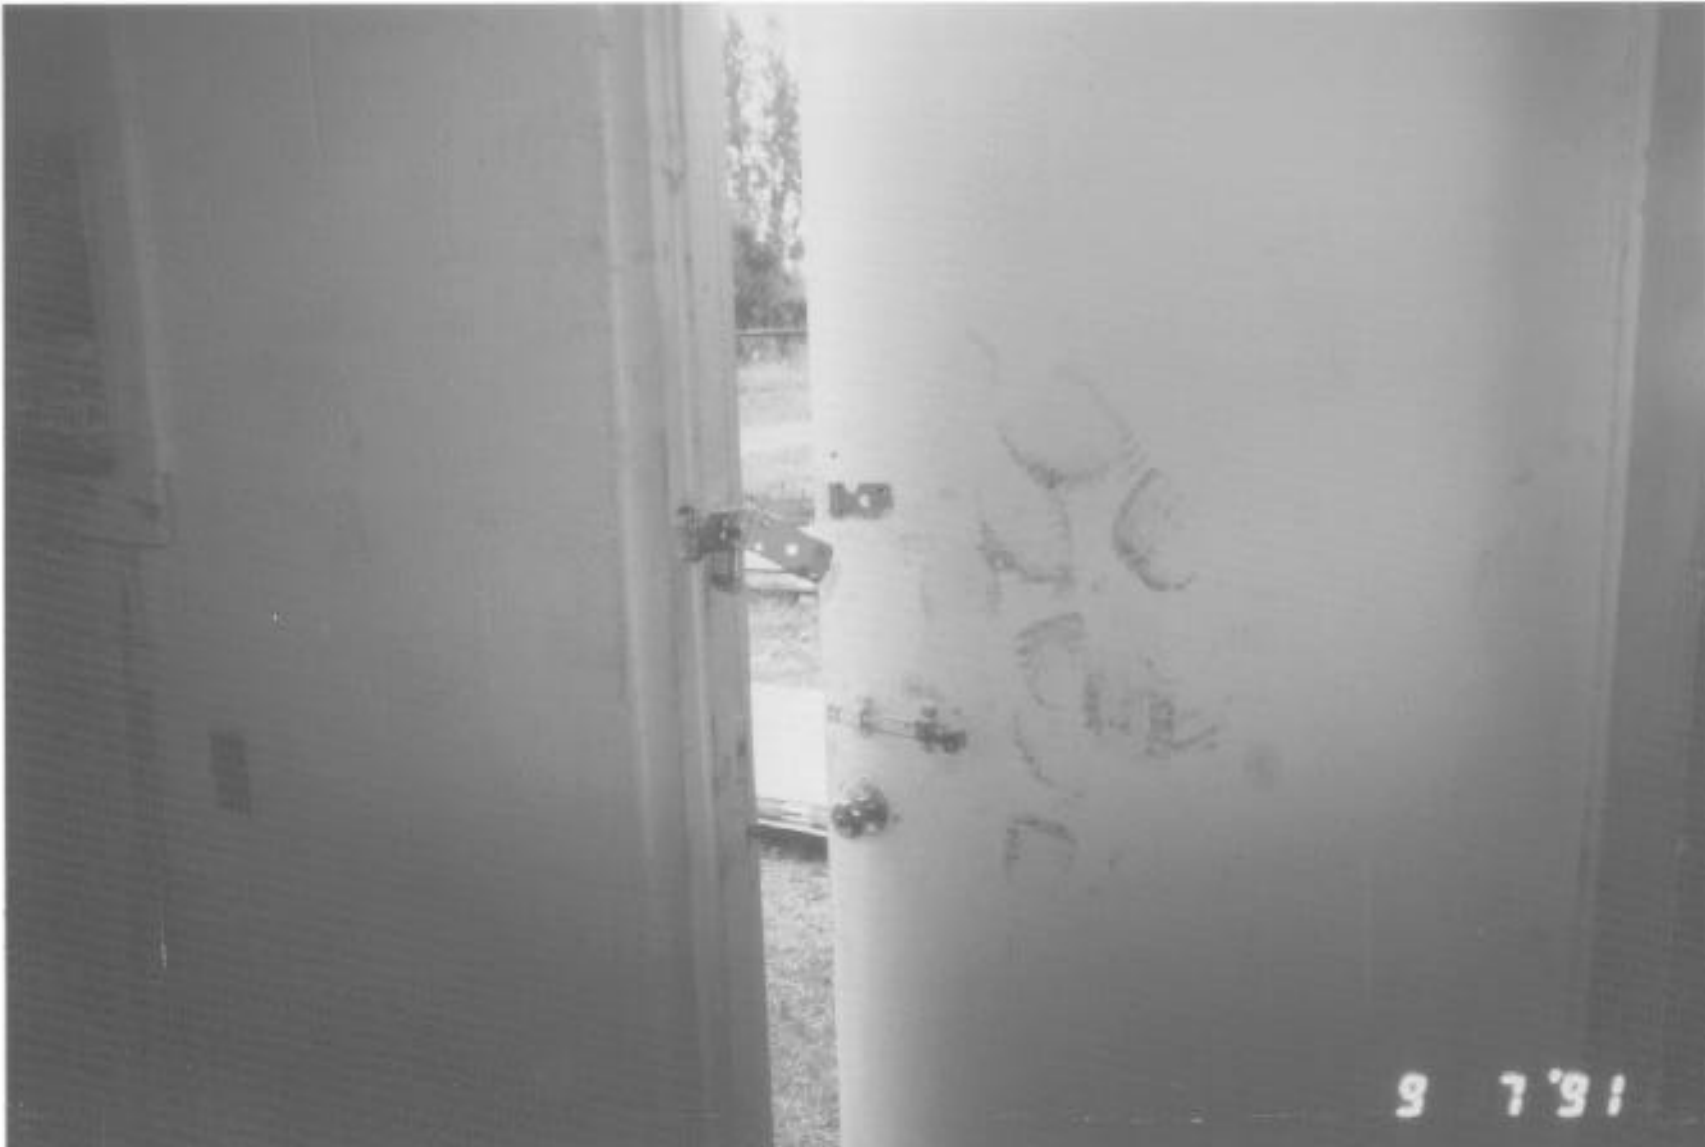
A close-up view of the north door to the break room. Note the footprints and padlock in place where the door was kicked; it was eventually opened for the escape of some personnel.
