Technical Report Series

Chicken Processing Plant Fires Hamlet, North Carolina, and North Little Rock, Arkansas

**Chicken Processing Plant Fires
Hamlet, North Carolina
(September 3, 1991)
North Little Rock, Arkansas
(June 7, 1991)**

This is Report 057 of the Major Fires Investigation Project conducted by TriData Corporation under contract EMW-90-C-3338 to the United States Fire Administration, Federal Emergency Management Agency.

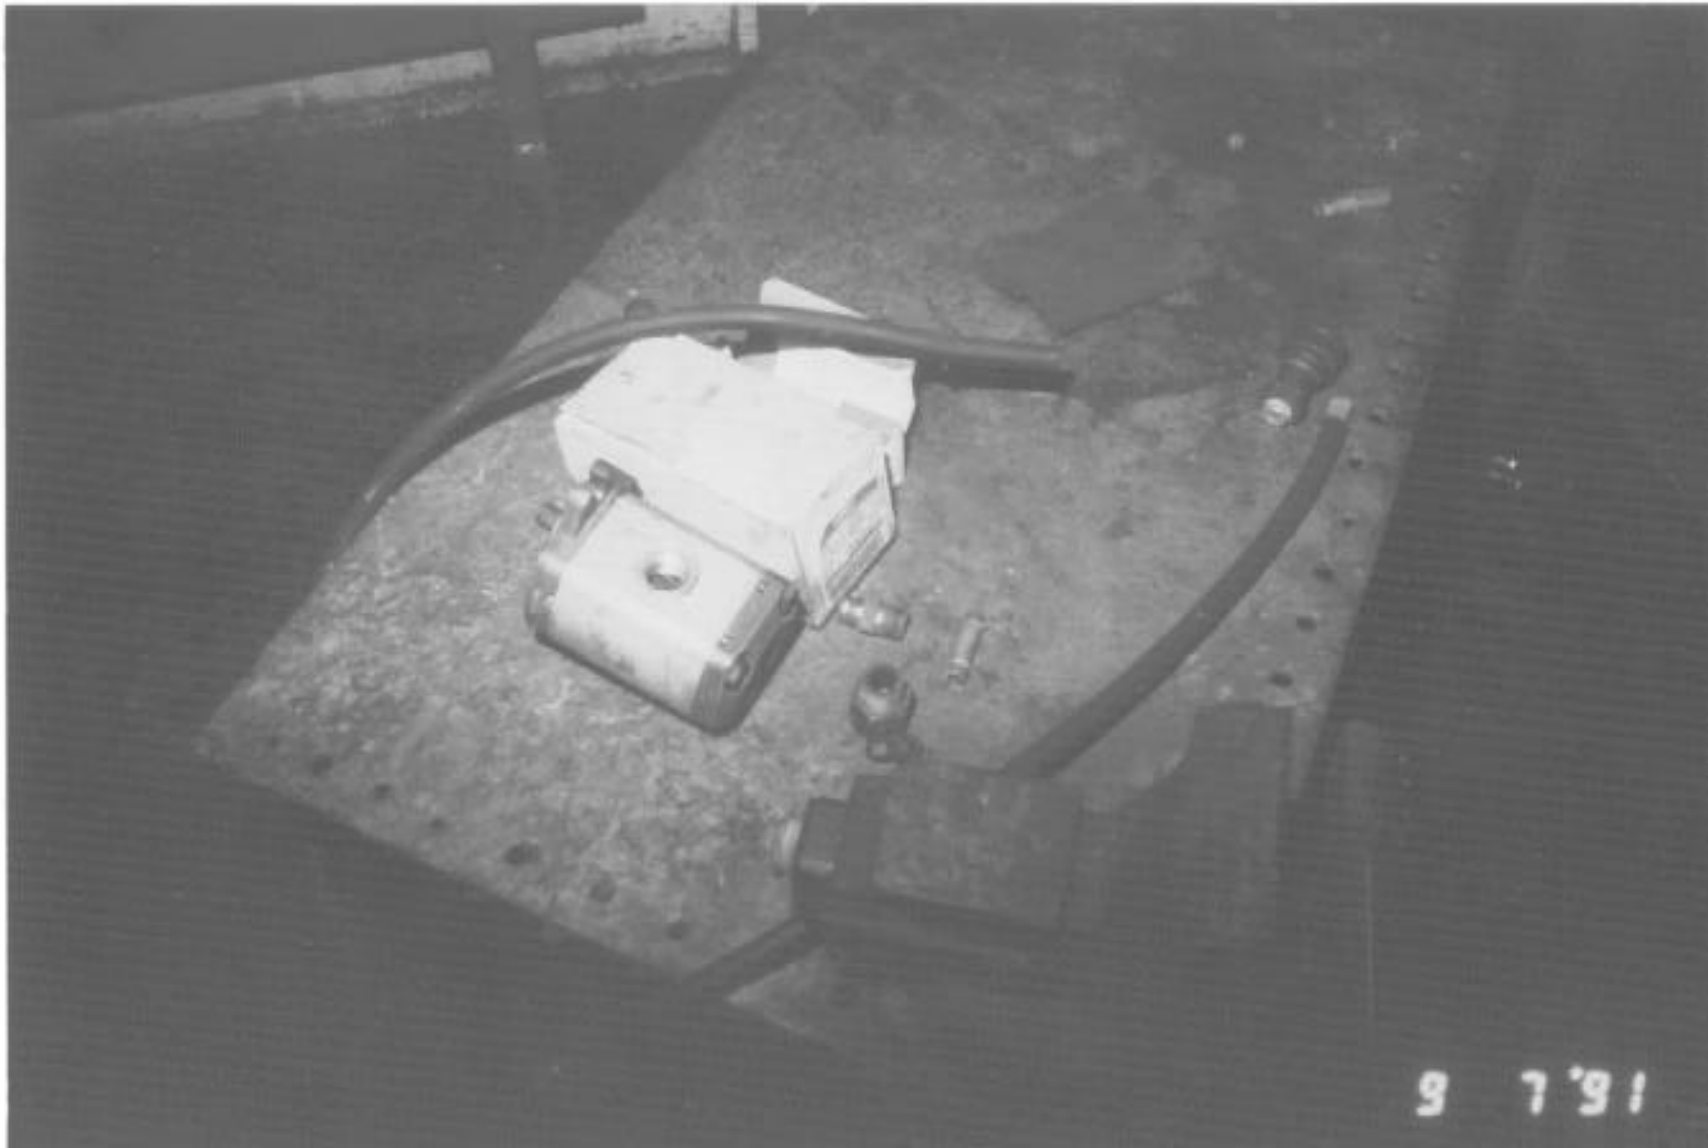
A maintenance worker who survived the fire indicated that the hydraulic line that drove the conveyor had developed a leak. The hydraulic line was turned off and drained of fluid. Then the maintenance worker disconnected the leaking line and replaced it with a factory prepared line.

The factory prepared line, however, was found to be too long and would have dragged on the floor, possibly causing people working in the area to trip. So the maintenance worker reportedly asked for and gained permission to cut the factory prepared hydraulic line to an appropriate length, replaced the end connector with their own connector, and put the line back in place. This line has been described as a 3/4-inch flex line rated to carry 3,000 psi. Information from plant personnel indicated normal pressure was kept at approximately 800 psi, but it would at times fluctuate as high as 1,200 to 1,500 psi.

The hydraulic line was brought back to operating pressure. Shortly afterward it separated at the repaired connector point. The connector was some four to six feet above floor level with hydraulic fluid being expelled at a pressure of 800 to 1,500 psi. It obviously began to splatter off the concrete floor. Droplets were bouncing back onto the gas heating plumbs for the cooking vat, which turned them into vapor. The vapors then were going directly into the flame. The vapors had a much lower flashpoint than the liquid hydraulic fluid and therefore rapidly ignited.

In sum, the pressurization of the hydraulic fluid combined with the heat was causing an atomizing of the fuel which in all probability caused an immediate fireball in and around the failed hydraulic line and the heating plumbs.

The remains of the hydraulic line that had been cut by the maintenance worker for the repair process **that** took place just preceding the fire.

4. High pressure equipment maintenance and repairs must be limited to factory trained personnel and specifications.

Inlying valves have been designed that are sensitive to multiple functions for high pressure hydraulic equipment. These valves are calibrated to the prescribed hydraulic fluid velocity or flow of the equipment needed. The valves will automatically shut down fluid flow if there is 1) a sudden free flow, 2) a drop in line pressure, or 3) an electrical failure. In addition, these valves can be linked to the CO₂ fire suppression systems.

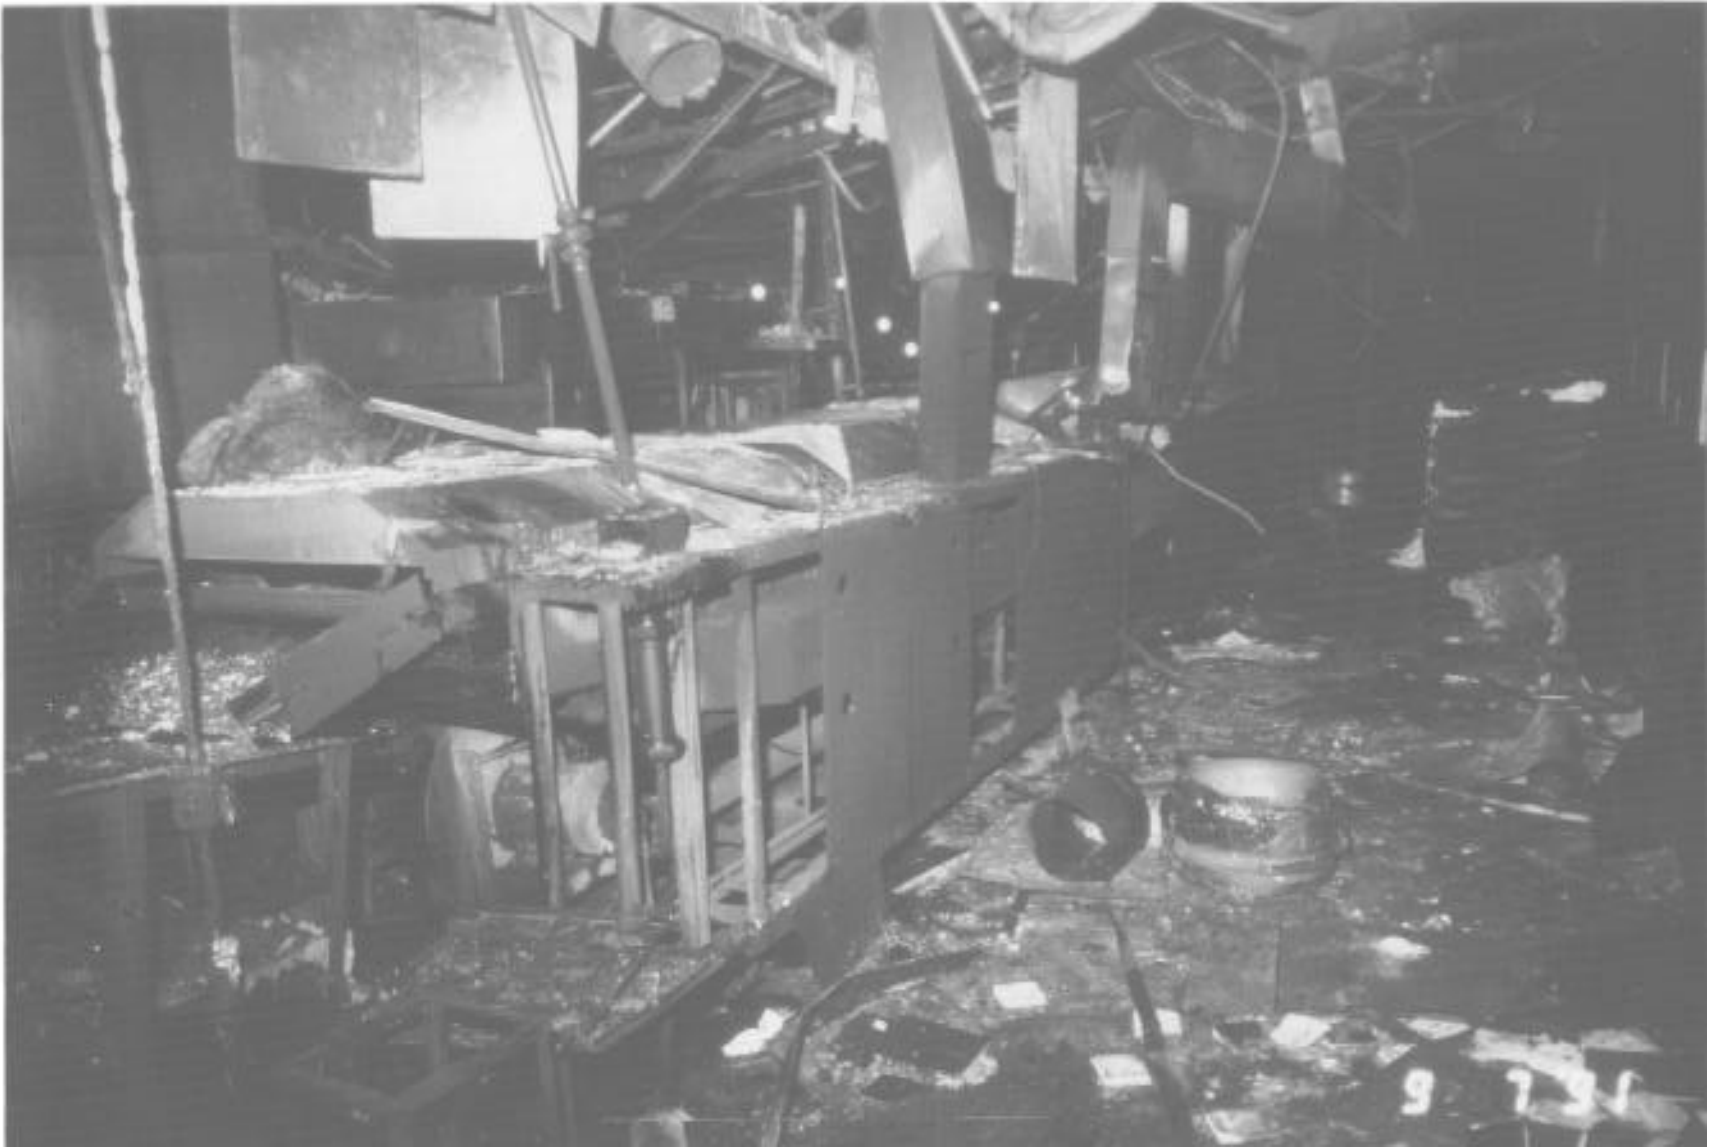
The west side of the cooking vat. View taken from the north to the south.

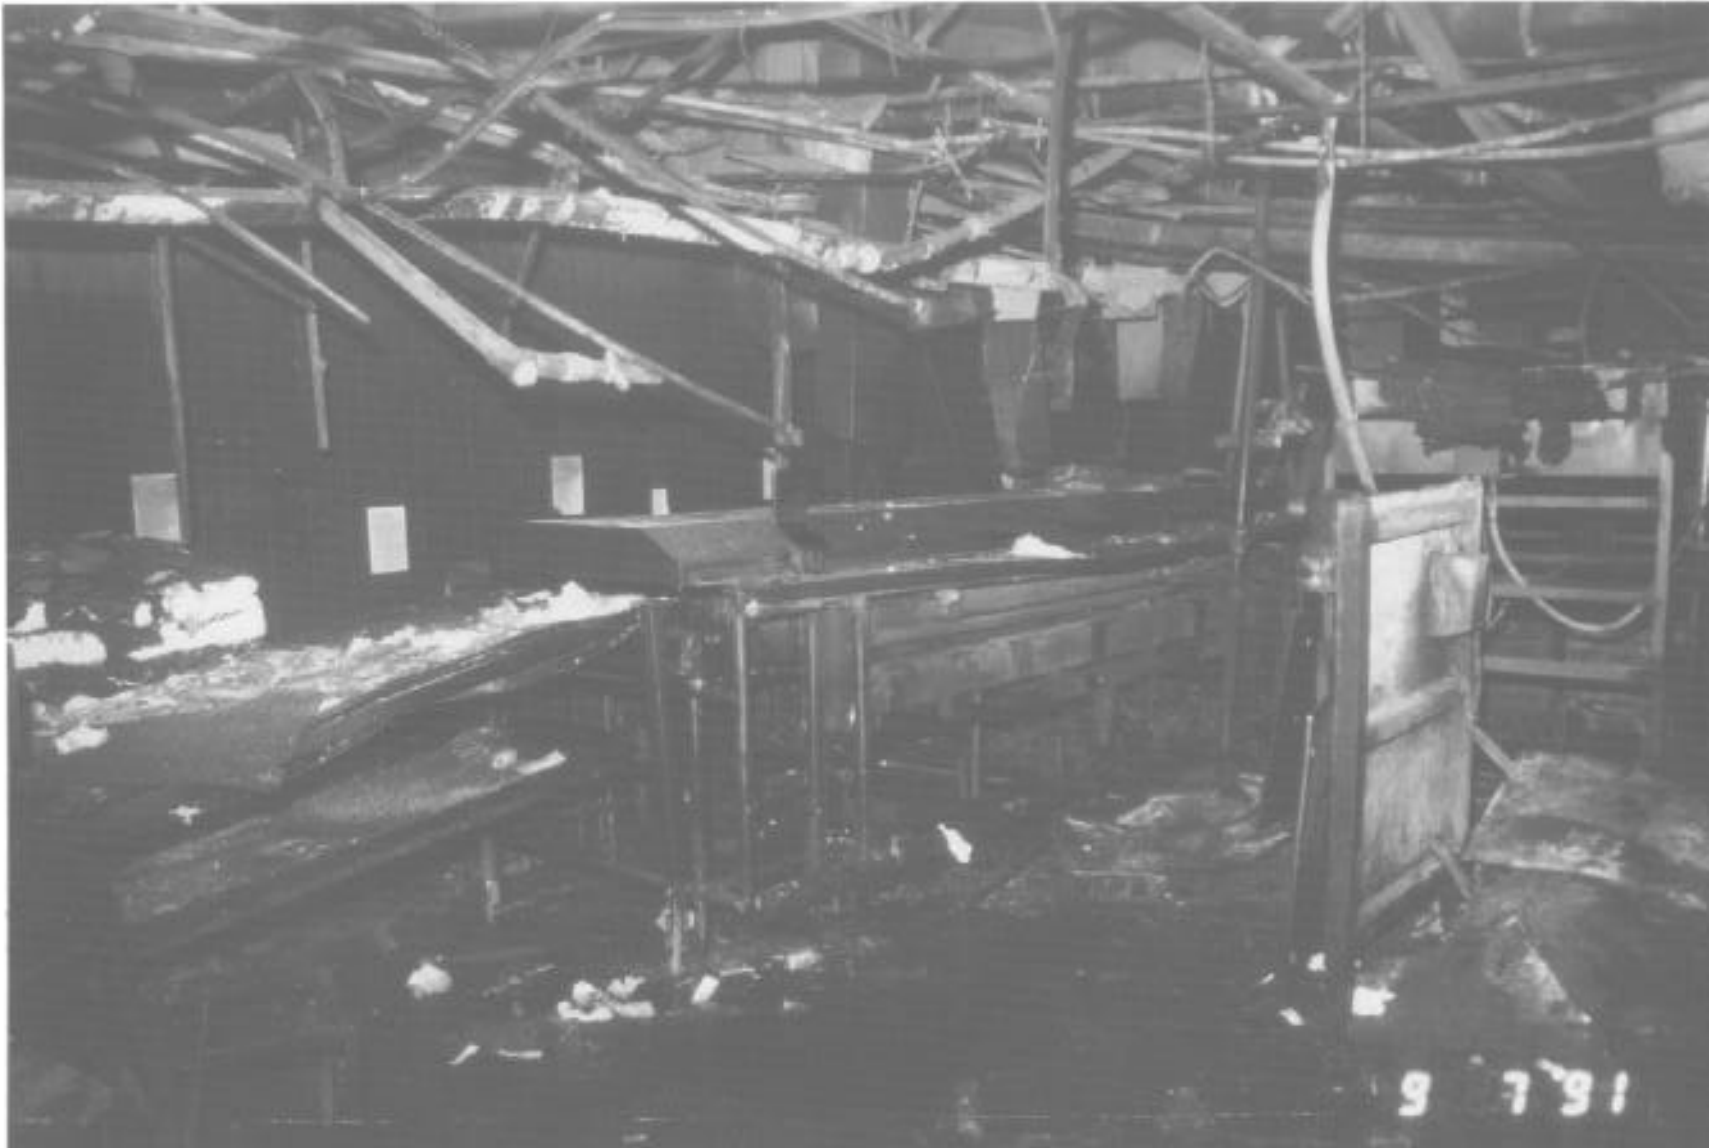
The area of origin viewed from the southeast to the northwest.

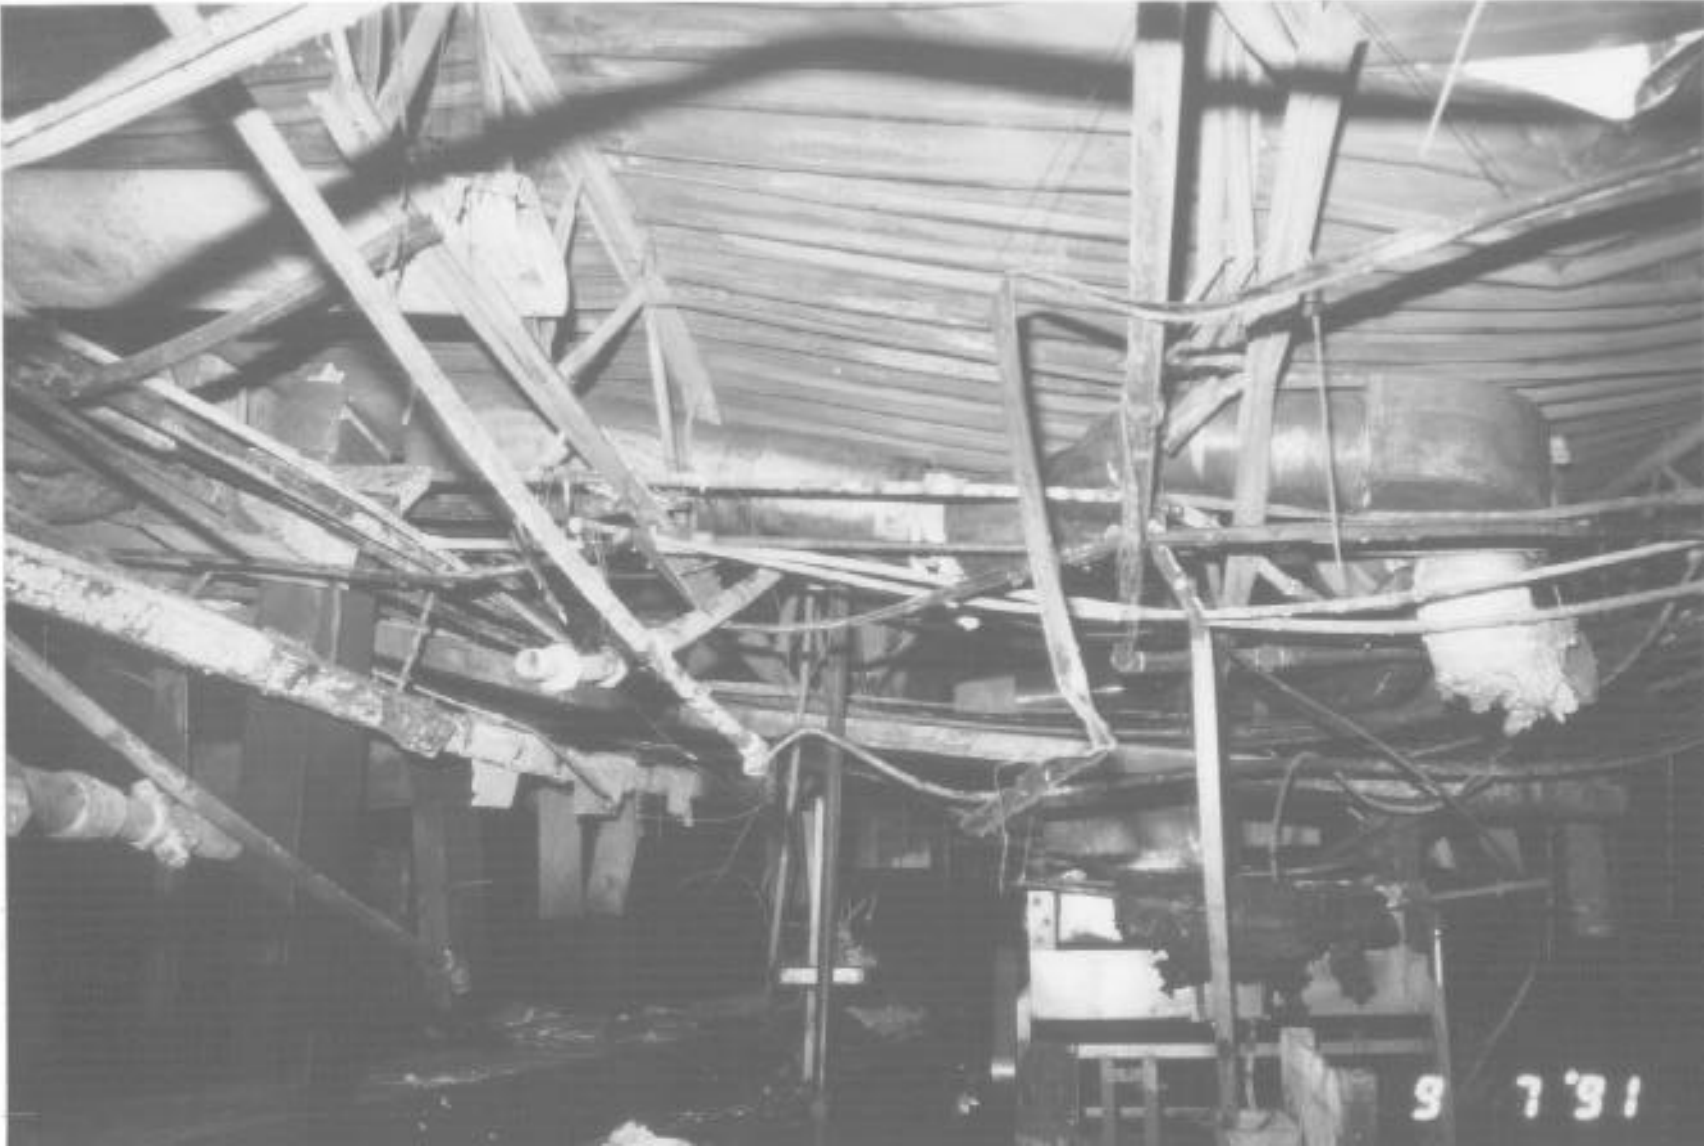
Damage to the steel girders and roof supports over the area of origin.
