Hurricane Straps Save a Roof

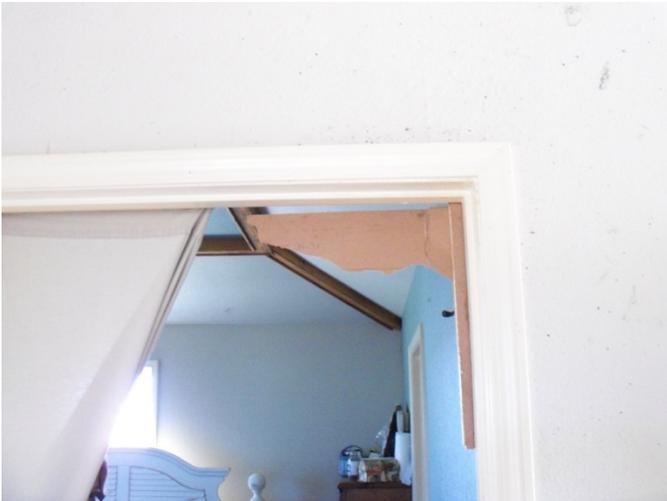
Inside the house, the winds had pulled kitchen cabinets from the wall, blown out all but two windows and torn bedroom doors off their hinges. Outside, the storm leveled their shed, wrecked two trucks, and did about \$5,000 in damage to the enclosed porch where they often entertained. The storm’s fierce winds had ripped the siding off the two-year-old, \$90,000 house and had torn away 90 percent of the roof’s shingles.

Photo of the remainder of the bedroom door

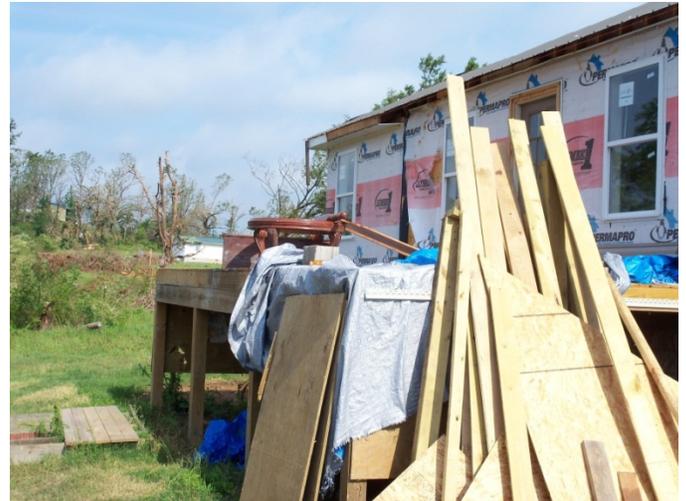
Photo showing the remainder of the porch

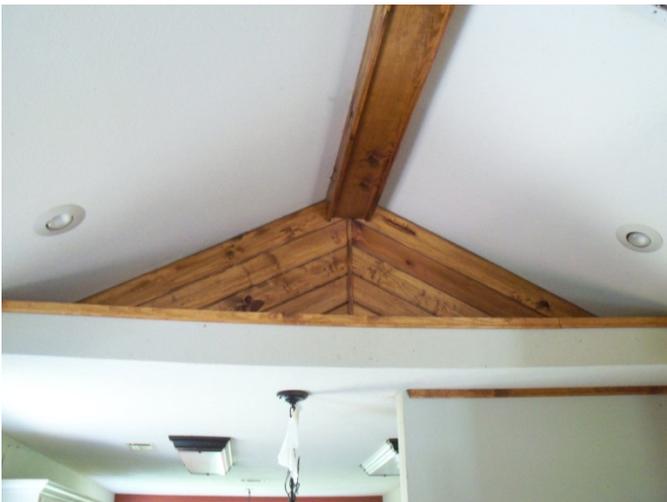
Photo of the interior ceiling

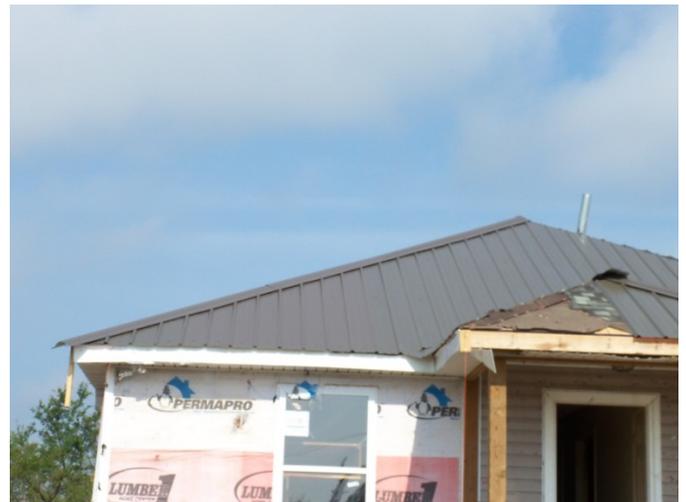
Nevertheless, the damage could have been far worse. The roof itself remained intact, thanks to the hurricane straps bolted onto each thick rafter and reinforced steel rods supporting the walls.

Photo showing the roof
