## The Curtain Goes Up...and the Building Stays Up: Seismic Retrofit Protects Historic Theater

**Charleston, SC:** Nestled in the middle of downtown Charleston, South Carolina, sits a little piece of history. The Dock Street Theatre originally opened in 1736, and was the first building constructed in the 13 colonies with the express purpose of serving as a venue for the performing arts. After numerous reconstructions and different uses over the years, the current theater facility underwent a major retrofit in 2010 that offers significant protection from both seismic and high wind damages.

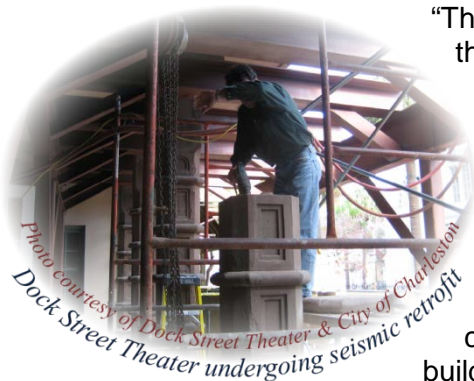
Damage from the original earthquake in 1886 had left the buildings in a severely weakened condition. Several of the wall facades had begun to pull away from the main structure by several inches, and were coming dangerously close to toppling entirely. The walls were mortared back in place as best as possible and earthquake bolts were installed, but that was all that was done to prevent their collapse. In addition, the four-story building that now houses the stage/backstage area and the fly-system (the series of pulleys and ropes used to move sets on and off the stage) was completely gutted, leaving only the three outer walls to provide support for the entire structure. Over time, the rear wall of this building had begun to lean hazardously over the property of the theater's neighbor.

*Photo courtesy of Dock Street Theater & City of Charleston  
Dock Street Theater undergoing seismic retrofit*

To address the concerns of collapse, the entire facility was shut down in 2008, and remained closed for three years while they performed the renovations. The stage building and most of the other walls of the complex were buttressed and then reinforced with steel, as well as concrete in some sections. Three brick chimneys on one of the stage building walls were still providing some degree of support to that structure.

These were reinforced with the addition of steel I-beams that were driven into the ground, and then the walls were pulled back into the I-beams and secured. Following the addition of the I-beams and buttressing, whole sections were then covered with gunite (also known as shotcrete) to provide added reinforcement.

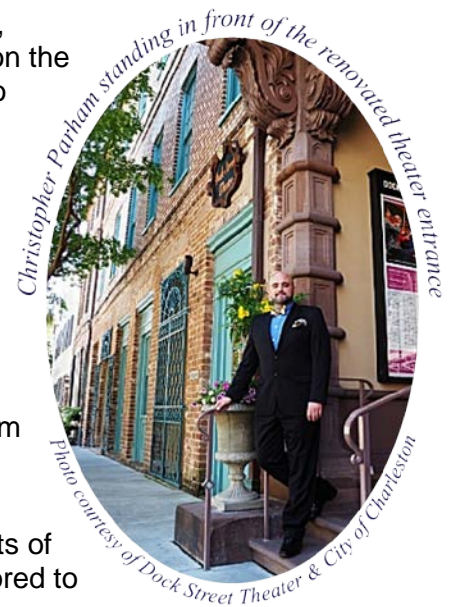
*Christopher Parham standing in front of the renovated theater entrance  
Photo courtesy of Dock Street Theater & City of Charleston*

On the front of the theater, a number of brownstone columns had been added during the 1930s renovation. These had seen considerable decay over the years, and were no longer providing adequate support to the front of the theater entrance. During the retrofit, the columns were rebuilt. Before being reinstalled, they were cored and steel beams were inserted into the masonry above and then run through the columns and embedded into the bedrock, more than 10 feet into the ground.
