Mitigation Means Peace of Mind for Perdido Key Family

Full Mitigation Best Practice Story

Escambia County, Florida

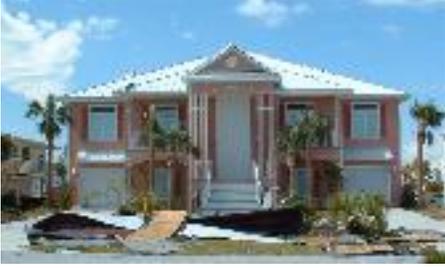
Roof from neighbor's house rests in the front yard of Palmer home.

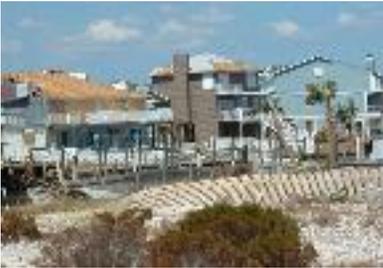
View of neighborhood shows severe damage to other homes built before strengthened code ordinance.
