Wood Truss Roof Collapse Claims Two Firefighters Memphis, Tennessee

Wood Truss Roof Collapse Claims Two Firefighters (December 26, 1992)

Investigated by: J. Gordon Routley

This is Report 069 of the Major Fires Investigation Project conducted by TriData Corporation under contract EMW-90-C-3338 to the United States Fire Administration, Federal Emergency Management Agency.

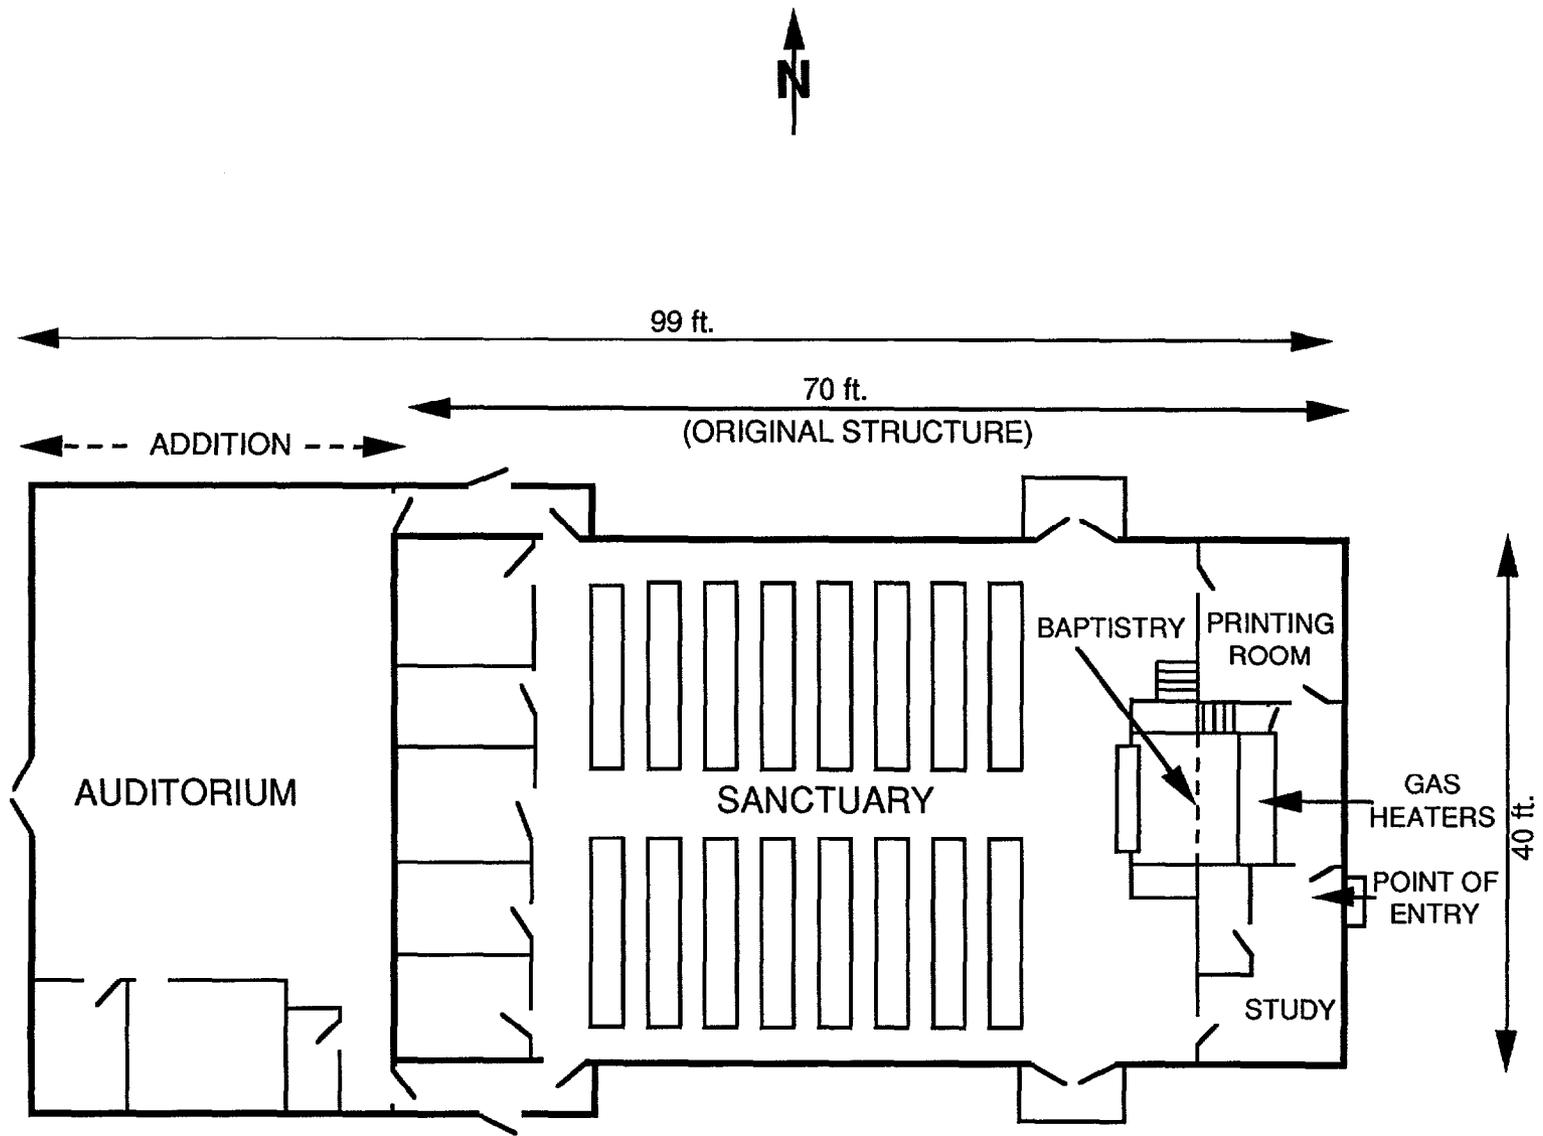
BUILDING PLAN

The suspect apparently made entry to the church during the late morning or noon hour on December 26 with the intent of committing a burglary. Entry was made through an opening in the east (rear) wall. The opening was originally a window, but it had been modified to provide a passage for an air duct that was connected to an exterior air conditioning unit. After loosening a section of the duct work, the suspect made entry to the study and printing rooms. (See building plan on Page 5.)

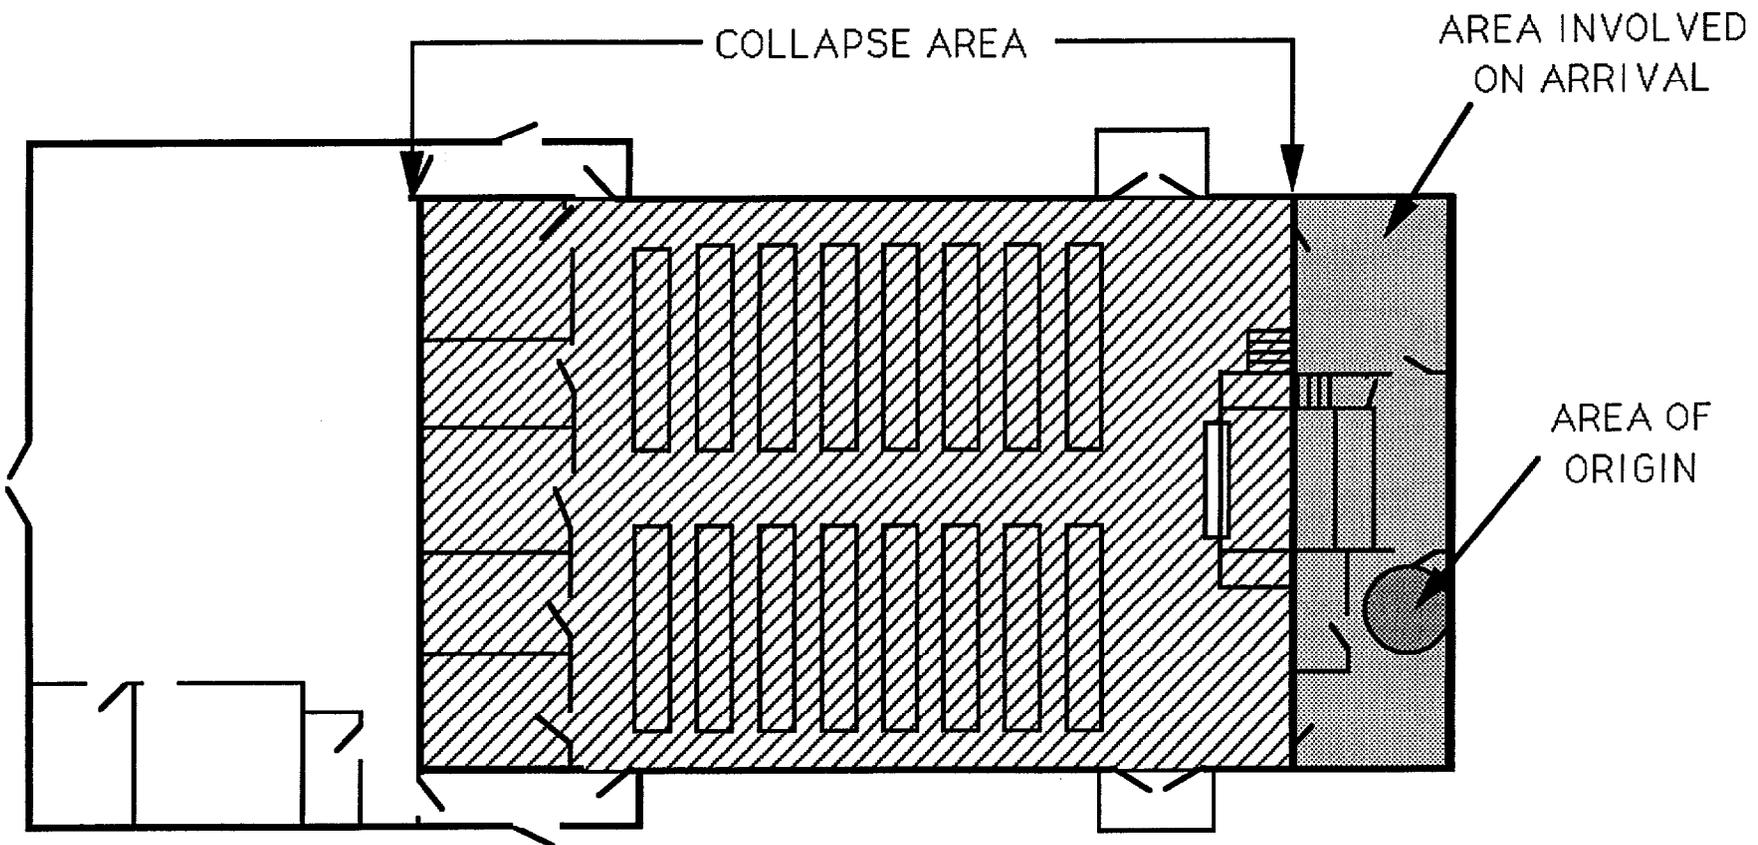
AREA OF FIRE INVOLVEMENT

A larger body of fire could be seen extending into the sanctuary at the opposite (south) side, near the south entry doors. The area where the fire was through the roof was entirely to the east of the sanctuary wall. The fire had melted connections in two of three gas lines, which supplied unit heaters located behind the wall, resulting in a particularly intense fire at the point of burn-through.

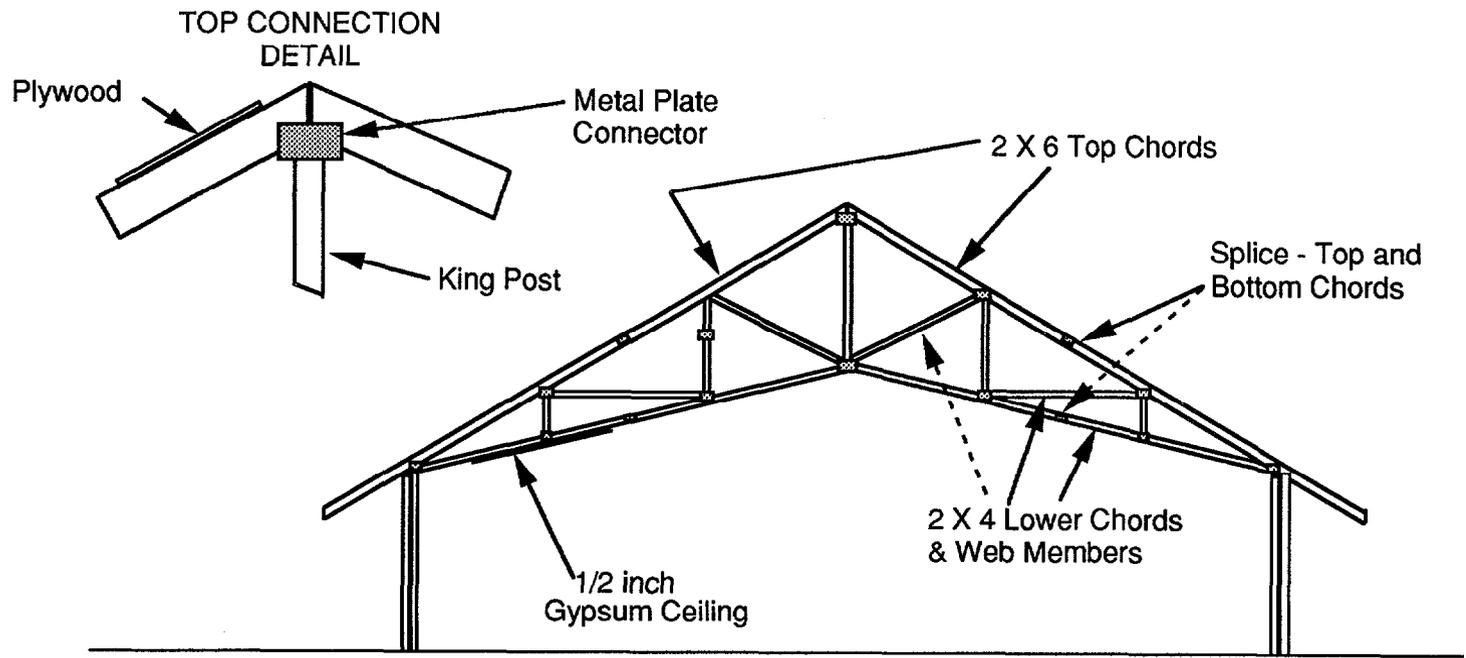
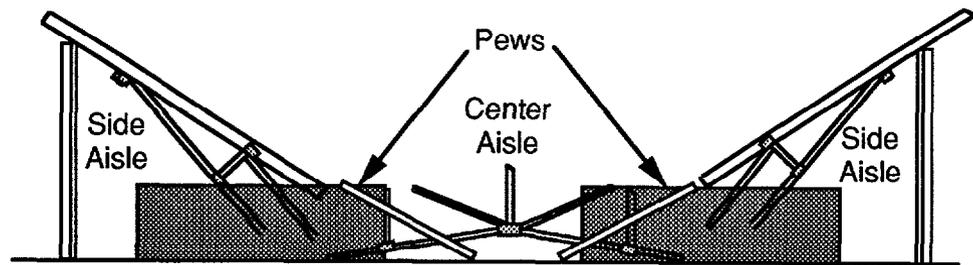
WOOD ROOF TRUSS DETAILS

The trusses were pre-engineered metal plate connected wood trusses, spanning a distance of 40 feet. The trusses over the main part of the church, where the collapse occurred, were scissors design (see diagram on the following page) to provide a slightly vaulted ceiling. The trusses over the adjacent areas were conventional peaked trusses with a horizontal bottom chord to create a flat ceiling. All of the trusses were spaced at 24 inch centers.

2X4 sections. All of the connectors were stamped metal gusset plates providing 3/8 inch penetration of the pointed ends into the wood. All observed connectors were fabricated with gusset plates on both sides of each connection point.

The attachment of the trusses to the 1/2 inch plywood roof decking maintained their alignment. There was no evidence of stringers or cross braces to maintain the spacing and redistribute loads among the trusses. Without cross bracing, the trusses were not constrained from roll-over, which can result in a “domino effect” collapse when a partial failure occurs. Cross bracing can allow a group of trusses to act as a system, with several trusses working together to support the load.

The fire appears to have travelled along the underside of the roof, following the peak from east to west. The tops of all of the trusses were completely burned away for approximately 12 to 18 inches below the top connection point and could not be retrieved from the rubble. All of the lower connections could be located and most were still in tact. The depth of char varied from almost full depth on the remnants of the higher members near the center of the span to almost no sign of burning on the lower and outer sections.

All of the top and bottom chords had splices near the mid-span points on each side of the trusses and most of these splices had failed, dropping the center section all the way to the floor, while the ends only rotated on their wall supports.

Many of the gusset plate connectors had failed, either by completely disengaging from the wood or by allowing one or more of the members to work free from a connection point. At the higher points the wood was charred beyond the depth of penetration of the gusset plate points, leaving empty pits in the charred wood where the gusset plates had been attached. As noted previously, virtually all of the top connection points were completely burned away. Some of the kingpost members were charred to a depth of more than 1/2 inch before the remaining unburned wood had broken; the diminished cross section of unburned wood fractured when it

The roof collapse can be directly attributed to failure of the top connection points of the trusses, where the kingpost meets the top chord sections. It cannot be determined precisely which truss failed first and whether the gusset plates came loose from the top connection or the kingpost snapped and pried the gusset plates loose. The top connection is a critical point in each truss and its failure would result in the failure of that truss. It appears that several trusses failed in rapid succession - almost simultaneously following the first. All of the trusses would have been close to the point of failure and unable to support any additional load, so the load shift that occurred with the first failure probably caused several more trusses to collapse.

Cross bracing the trusses can reduce the probability of a sudden catastrophic failure and is more likely to result in visible sag before collapse. Without such load transfer mechanisms, the failure of any one truss can be sudden and catastrophic and can initiate the failure of a series of adjacent trusses in rapid succession, particularly if they are partially weakened and already close to their own point of failure.
