Elevation is Cause for Elation When Damage is Avoided

Full Mitigation Best Practice Story

Owen County, Indiana

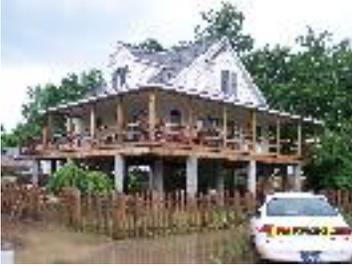
House elevated on 8-ft. "rebar" pillars

She found plans for a coastal-style house, hired an architect to draft the plans, and an engineer to design the reinforced-cement pillars that would hold the 2,000-square-foot house a total of eight feet above the ground. This would not only keep her safe from flooding but also allow her to plant some trees, a garden, and set aside an area with lawn furniture, which could be quickly moved upstairs. According to ICC regulations, the open area underneath the house has to remain unencumbered to allow floodwater to pass safely through.
