Multiple Measures Protected University from Floods

Full Mitigation Best Practice Story

Harris County, Texas

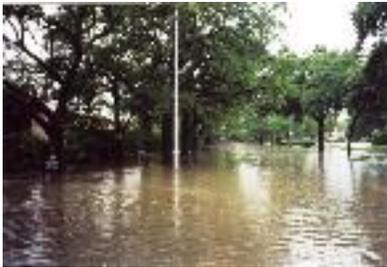
“Following Tropical Storm Allison, we had a lot of surface flooding,” continued Tomlinson. “We have a bunch of underground utility systems that provide services to the campus. We got some water in them, which migrated to some of the buildings. We had water come in through some basement level windows also. In some places the water got up as high as five feet. Street flooding was probably around two feet.”

Flooding at Gate 16 at Rice university following Tropical Storm Allison

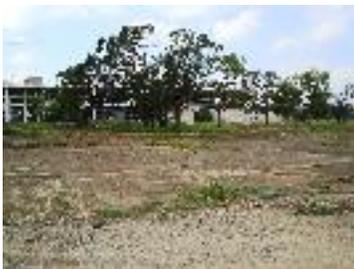
Overland water flows to a large detention pond

“The two biggest projects and the most expensive projects were, first, the overland flow channel to let water down to the detention pond easier and faster, and, second, the installation of an underground drain line that ties into the city line,” said Tomlinson.
