Coffee Break Training - Fire Protection Series

Building Construction: Metal Plate Connected Truss Inspections

No. FP-2014-11 March 18, 2014

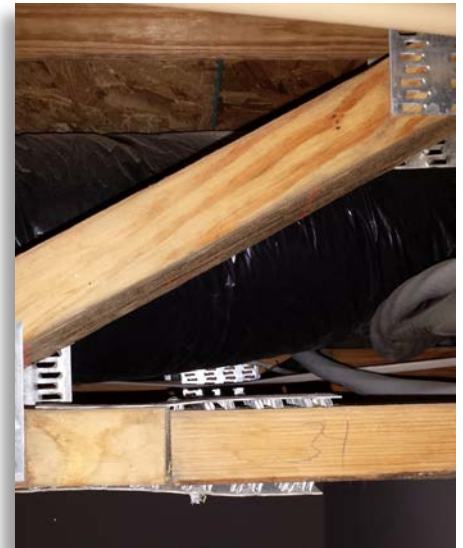
Firefighters and inspectors pay particular attention to modern lightweight construction. During a recent townhouse remodeling project, this metal plate connected floor truss was discovered to have lost the connection between the plate and lumber. These metal nailing plates sometimes are known as “gusset plates.”

The cause for this metal plate connection to pull out of the bottom chord is unknown, but it is a concern that should be addressed.

Metal truss plates should be properly installed to ensure that they perform as designed. Typically, adjacent framing members are tightly fitted, and metal plates are fully embedded in the wood members. The building owner should check with the truss manufacturer to determine if remediation is needed.
