Successful Rebuilding After Previous Ruidoso Flood Proves it Can be Done

Full Mitigation Best Practice Story

Lincoln County, New Mexico

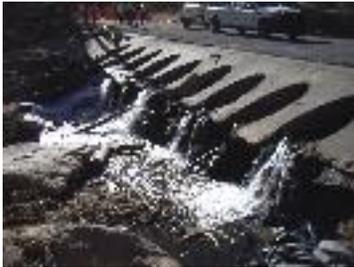
After the floodwaters subsided, village officials inspecting the bridge crossing discovered heavy debris clogging. A video camera extended into the 30-foot length of each corrugated metal culvert revealed the reasons. "What the camera showed was rusted metal with giant cavities around five of the culverts. The only thing holding the bridge [together] was the concrete on top of it," said J.R. Baumann, Street Director for the Village of Ruidoso. The Gavilan Canyon bridge was considered extensively damaged.

Gavilan Canyon Road bridge debris-clogged culverts after 2006 flood event.

In response, the Village of Ruidoso selected significantly larger prefabricated, concrete-box culverts to improve the bridge. The new culverts double the capacity to 500 cubic feet per second.

In March 2008, the crossing was closed to traffic and the damaged culverts removed. Three new culverts with a 3-foot by 5-foot capacity were installed. The river banks were widened and covered with gravel and the upstream side "straightened" and expanded to allow better flow. A new pedestrian walkway was added to the bridge with exterior handrails installed. However, custom guardrails for the interior that were ordered had not arrived in time for the Memorial Day weekend opening.

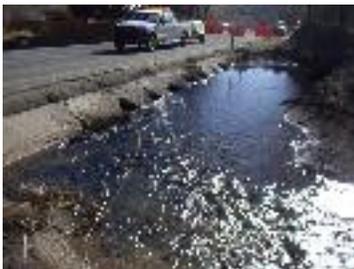
Gavilan Canyon Road bridge continued water pooling on upper-river side after 2006 flood event.

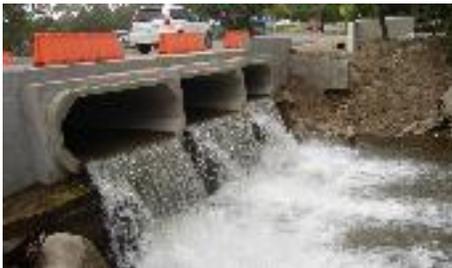
The Gavilan Canyon Road bridge new culverts after 2008 mitigation.

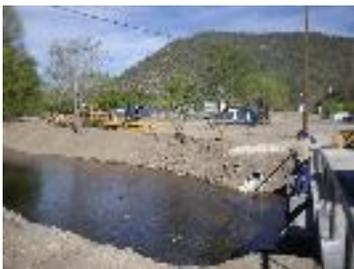
Dirt work expansion of upper-river side at Gavilan Canyon Road bridge after 2008 mitigation.
