U.S. Geological Survey
Marine and Coastal Geology Program

High-Energy Storms Shape Puerto Rico

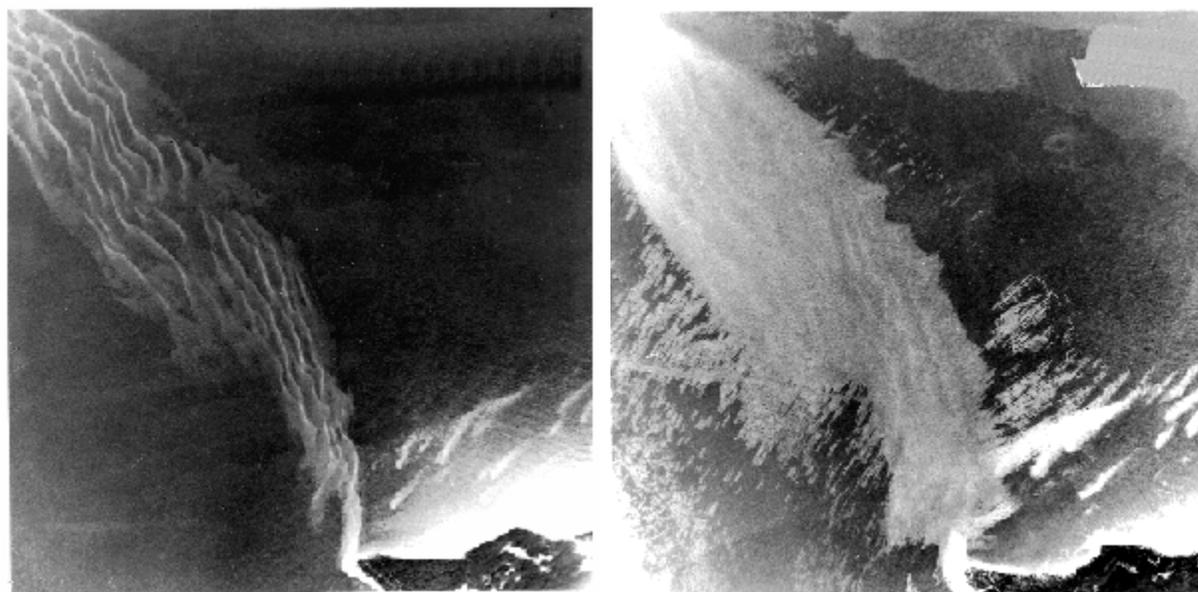
Aerial photographs of Escollo de Arenas, a shoal off the northeast corner of Vieques Island composed of 90 million cubic

meters of sand and gravel, before (left) and after (right) the impact of Hurricane Hugo. Note the sand ridges were suppressed by storm-induced currents and waves. The distance across the photographs from top to bottom is approximately 2 kilometers. Top is north.

USGS marine geologists studied aerial photographs of the Escollo de Arenas located off the northwest corner of Vieques Island. Later analysis of closely-spaced high-resolution seismic-reflection profiles, sediment cores, and grab samples taken across the deposit show large-scale changes affecting the volume and overall geometry of the sand and gravel deposit did not occur. In fact, new results indicate that less than 4 percent of the original volume of the Escollo was lost during the passage of Hurricane Hugo.

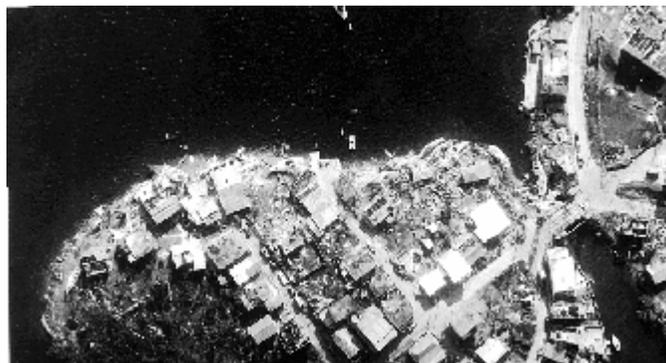
Aerial photograph of Ensenada Honda on the island of Culebra taken in early October, 1989, showing severe damage to coastal structures due to Hurricane Hugo. North is to the left. Approximately 100 vessels out of 300 that took shelter in the "hurricane-proof" harbor were destroyed and litter the shoreline as a result of the storm.
