# Landslide Hazards in Glacial Lake Clays - Tully Valley, New York

**USGS Fact Sheet 013-98**  
**April 1998**

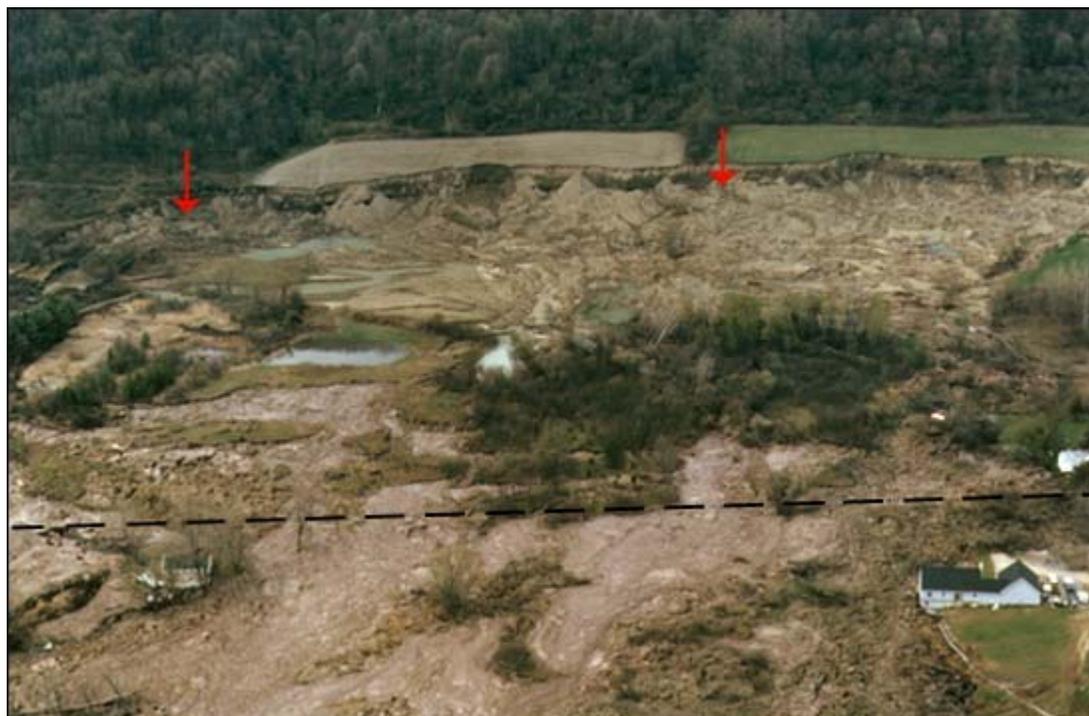
**Figure 1.** Oblique aerial view of the Tully Valley landslide taken April 30, 1993, 3 days after the slide. Debris moved toward the viewer, in the process covering Tully Farms Road (dashed line) up to 15 feet deep with reddish remolded clay. Three people were rescued by helicopter behind the white house (lower left) from the rapidly advancing landslide. Springs located between red arrows.

At approximately midday on April 27, 1993, a large landslide occurred along the foot of Bare Mountain in LaFayette, Onondaga County, New York, about 12 miles south of Syracuse (figs. 1, 2). The slide moved rapidly east toward the middle of the Tully Valley and impacted approximately 50 acres of land, destroyed three homes, and resulted in the evacuation of four other homes. Debris from the slide, consisting mostly of remolded clay, covered Tully Farms Road with up to 15 feet of earth for a length of some 1,200 feet. Springs that developed near the top of the slide discharged either freshwater or brackish water, which contained concentrations of dissolved evaporites (salt and gypsum) and other minerals. The total volume of earth moved by the slide is estimated to be about 1.3 million cubic yards. According to the New York State Geological Survey, this slide is the largest to have occurred in the State in more than 75 years. Most residents were away from their homes at the time of the slide, and so there were no fatalities or serious injuries caused by the slide.

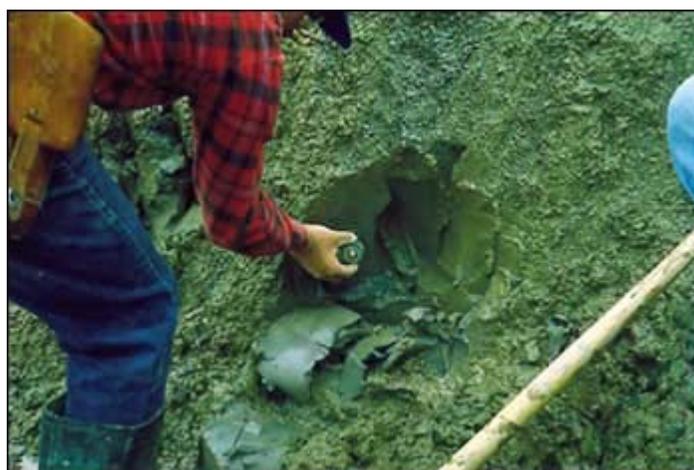
**Figure 4.** USGS and Syracuse University scientists using a vane shear device to measure undrained shear strength of an exposed stratum of glacial lake clay at the top of the 1993 Tully Valley landslide.

Profiles of soil stratigraphy before and after the 1993 landslide are shown in figure 3. A massive, red, soft to firm lacustrine silty clay deposit interfingers with coarse sandy soils and a varved clay sequence (fig. 4) that lies against the steeply dipping weathered shale bedrock. The upper thin cover of stiff silty clay traps artesian-pressured ground water in the coarse sand interfingers. Below the massive red clay and the coarse interfingers, a dense till confines and separates brackish water from the overlying freshwater in the coarse interfingers. A few local wells derive domestic water supply from this lower aquifer; however, the water quality has gradually degraded to a point where some wells were abandoned in the late 1980's.
