Search and Rescue Operations Following the Northridge Earthquake

January 17, 1994
Los Angeles, California

TECHNICAL RESCUE INCIDENT REPORT

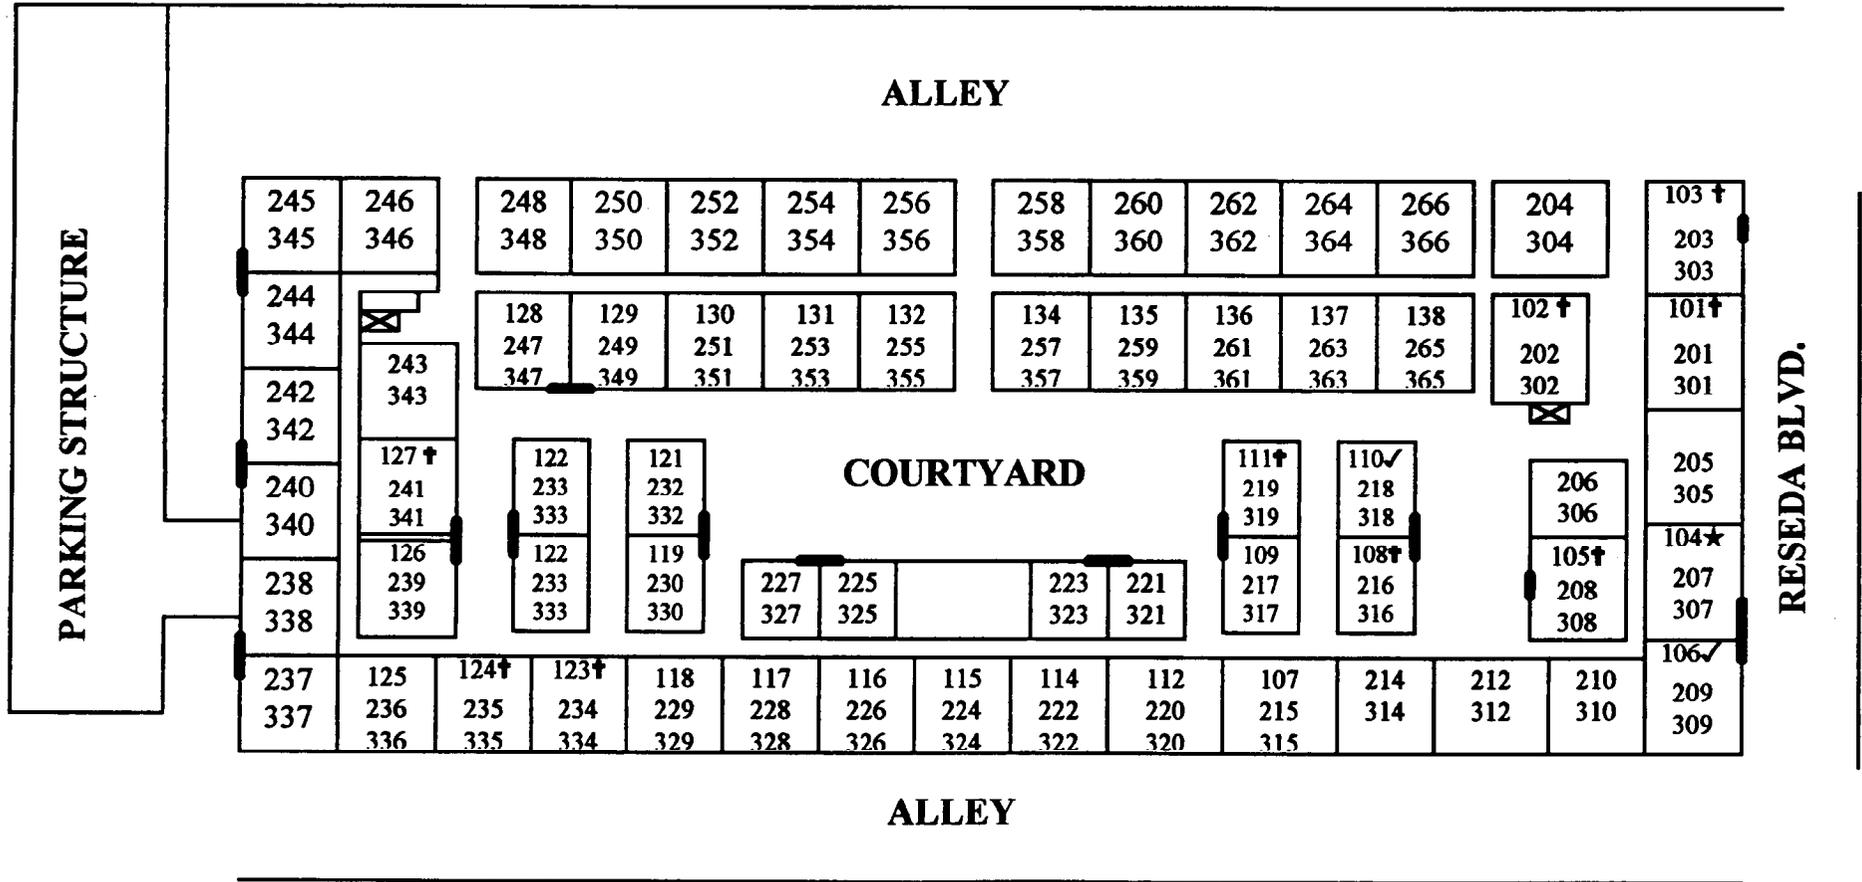
Overhead View of the Northridge Meadows Apartments

Fatality Locations †

Fatality/ Rescue ★

Key Rescues ✓

104 Robert Dorsey	106 Steve Langdon
106 Jerry Prezioso	110 Alan Hemsath

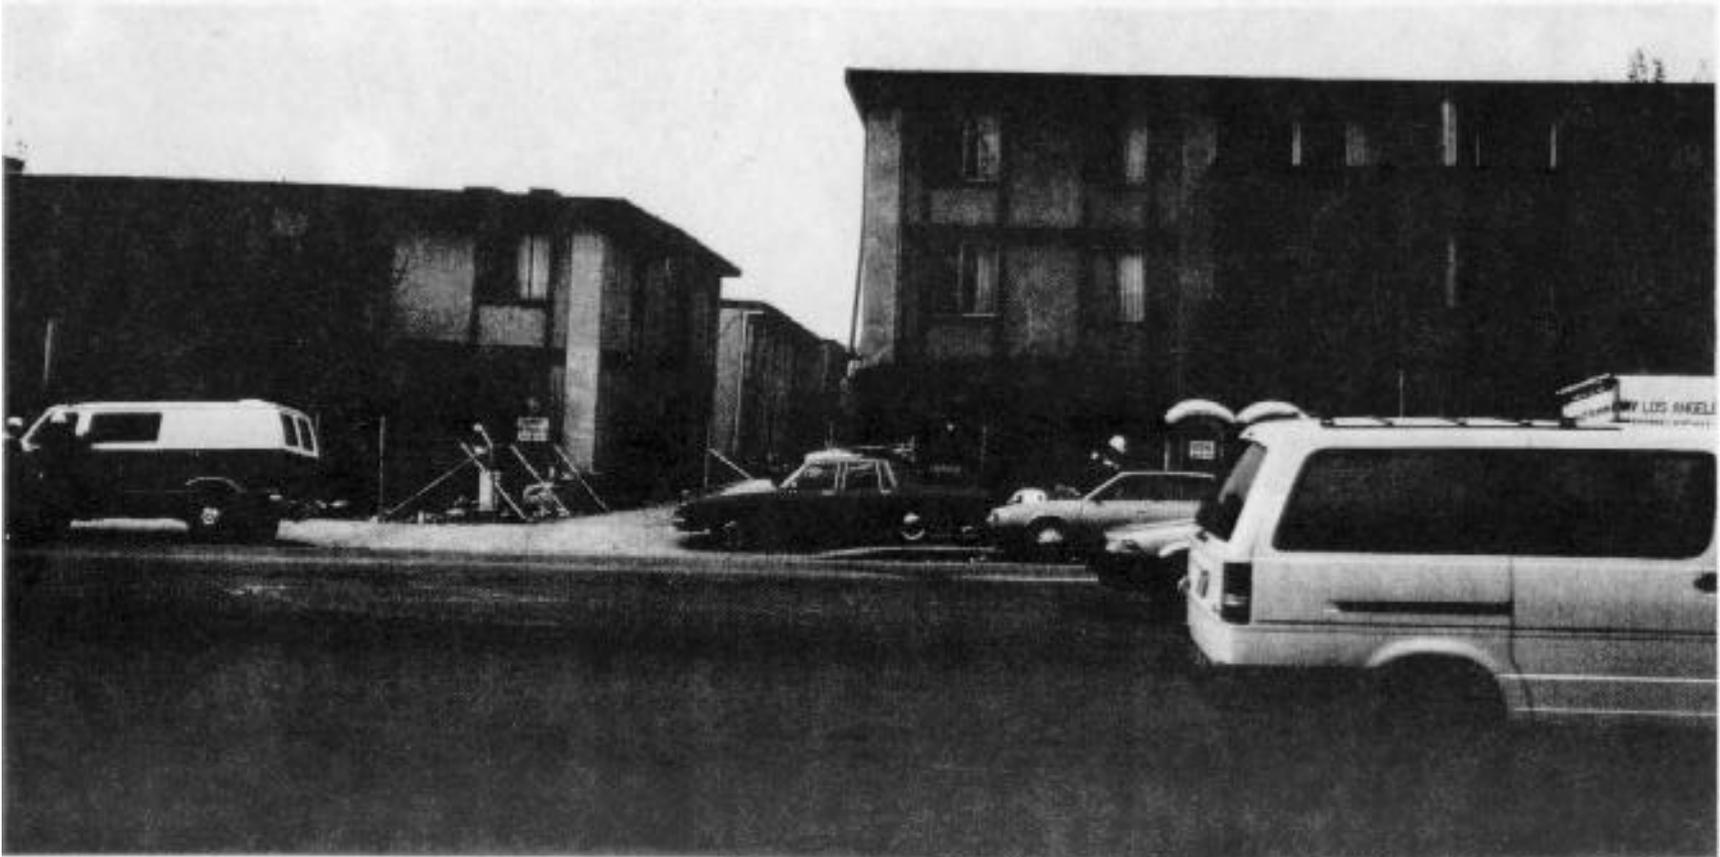
Initially firefighters thought that the Northridge Meadows Apartment building was a two-story structure. The building on the right is the original height of all the apartments.

The Northridge Apartments was a three-story wood frame stucco exterior construction apartment building. The initial earthquake caused the building to collapse. Because of the first floor “soft story” construction, the second and third floors “pancaked” down onto the first story apartments. On the initial drive-through by LAFD units, it was not even noticed that there had been a collapse of the building. The complete collapse of the first floor made the structure look like a two-story building. When first responders finally did realize there had been a collapse and many victims were involved, they requested additional resources and began rescue operations.

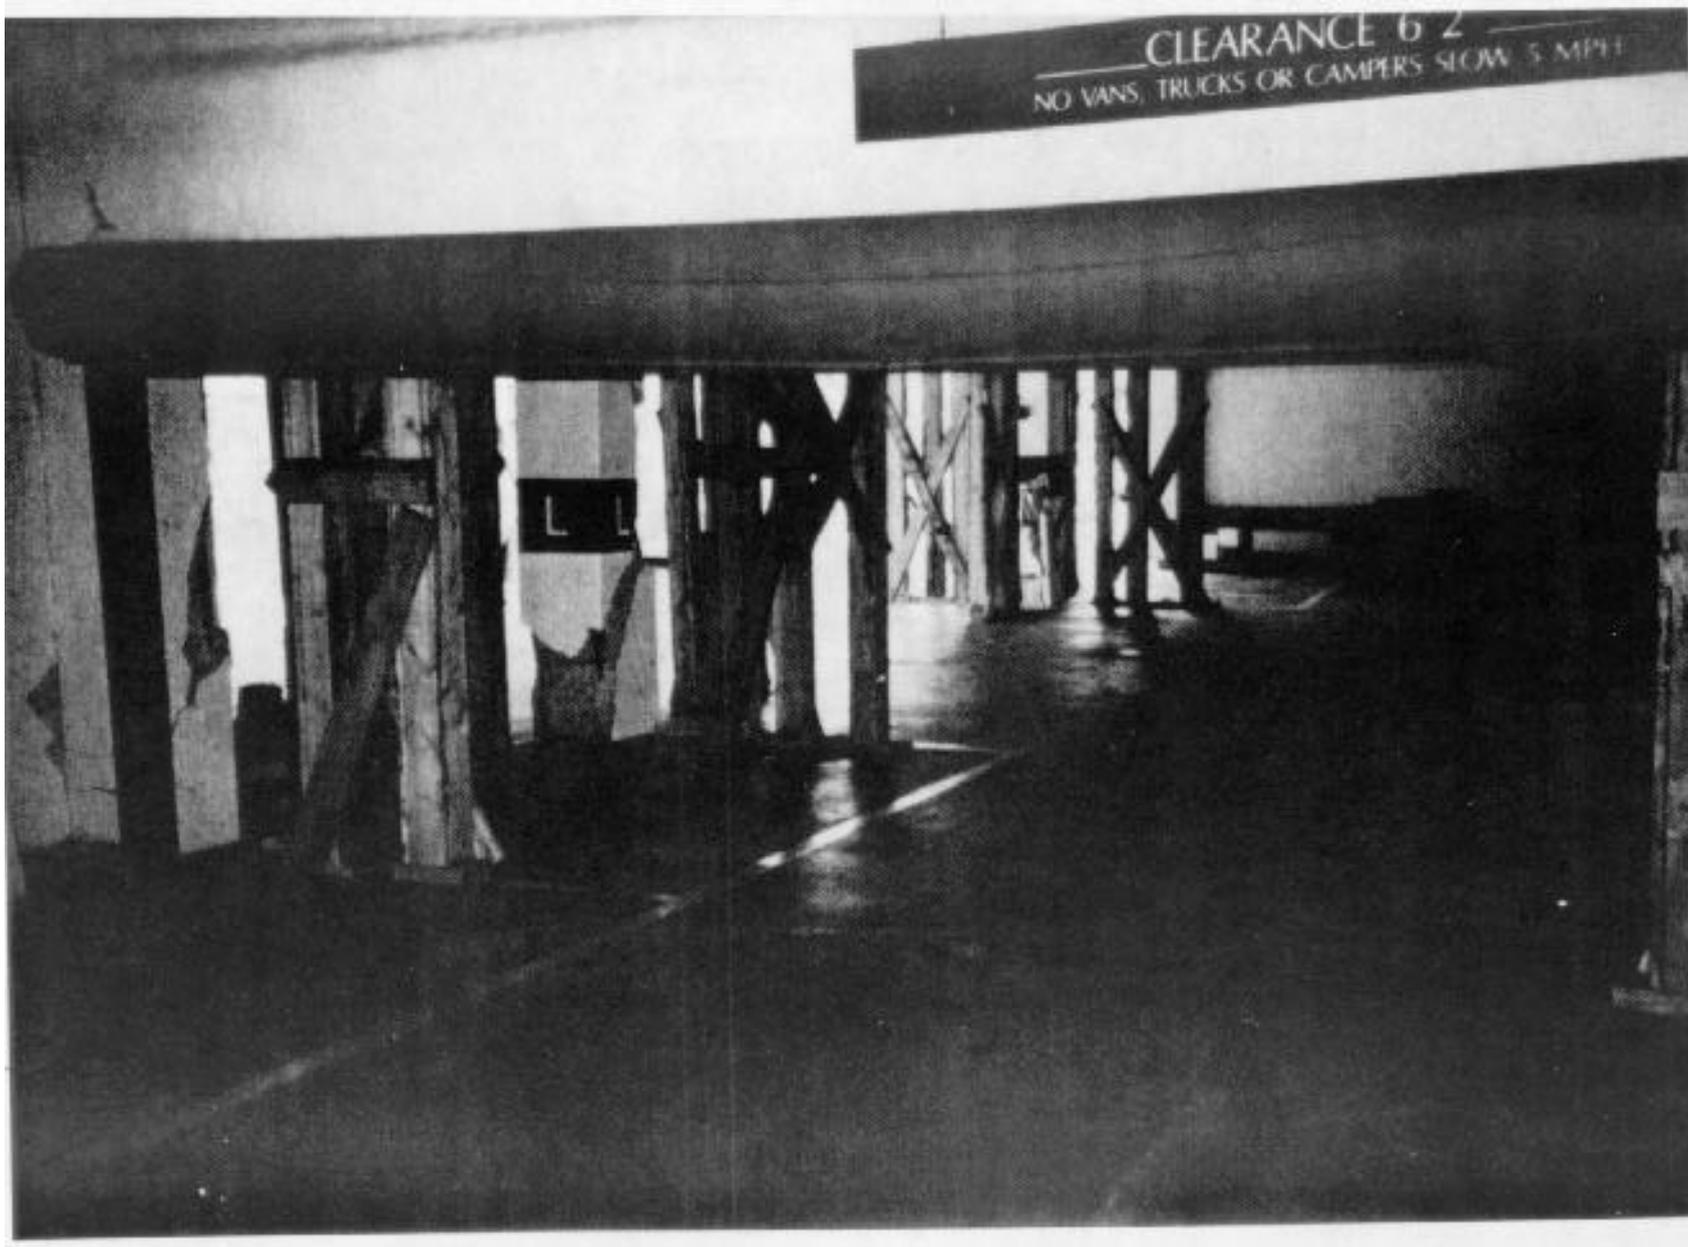
Example of shoring techniques used by the LAFD and the LACFD to prevent a secondary collapse of the high-rise hotel parking garage.

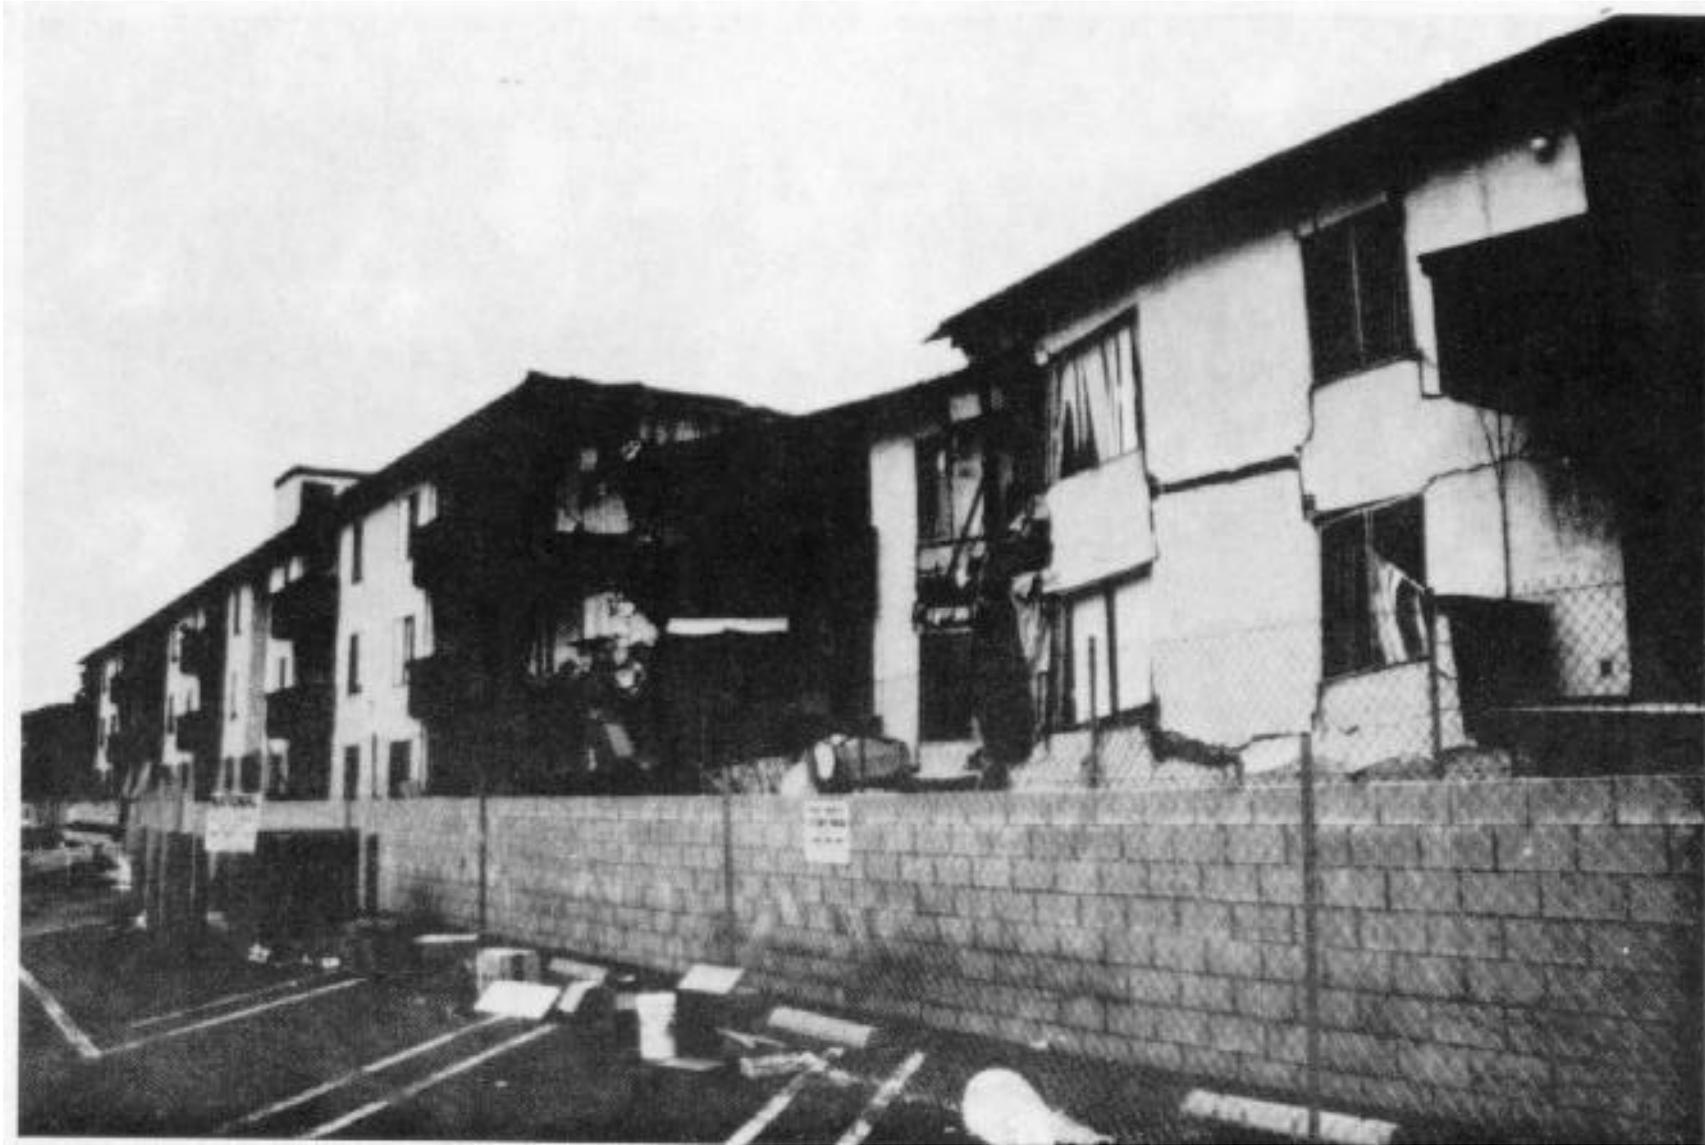
Collapsed portion of Northridge Meadows Apartments. Due to the soft story construction, the structure not only collapsed, but shifted 10 feet.

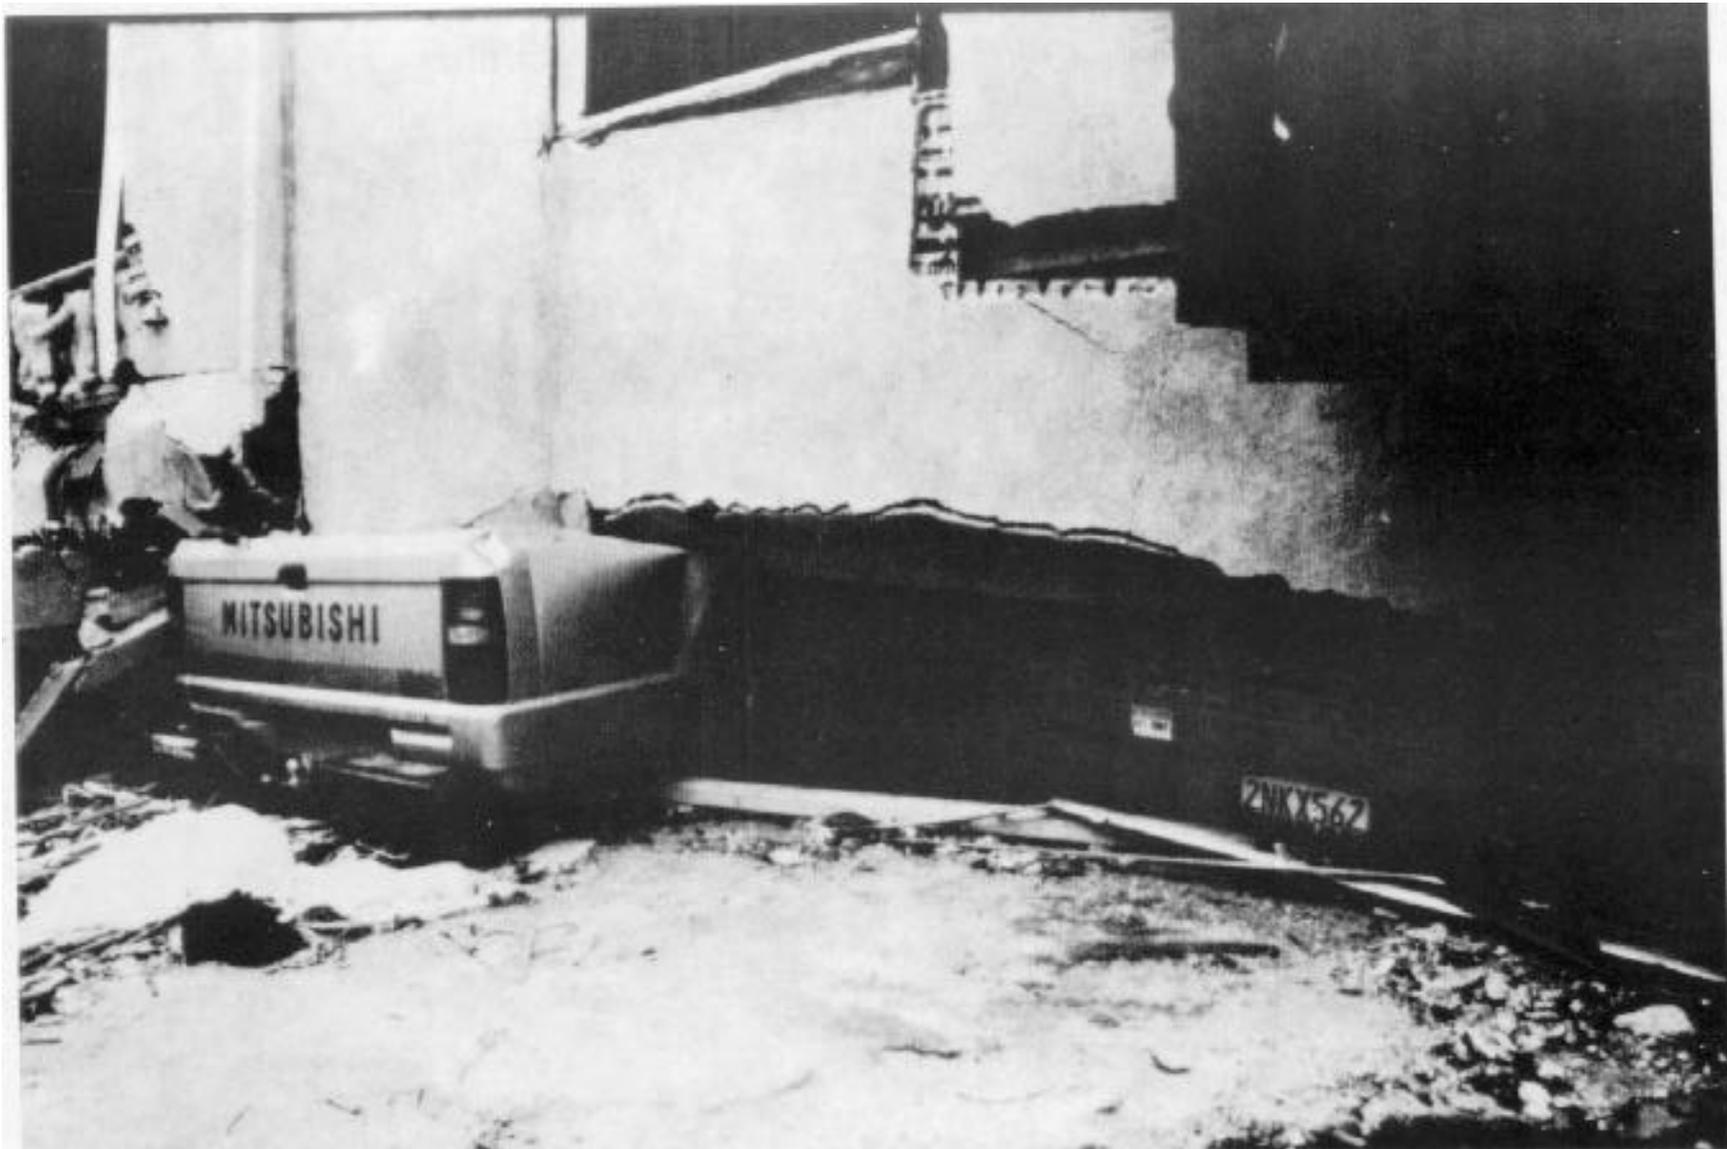
What remained of cars located in the parking garage below the Northridge Meadows Apartments.
