HAZUS User Group  
Success Story

# Eagle, Alaska Uses HAZUS

## to Map Safe Rebuilding Zones Following Ice Jam Devastation

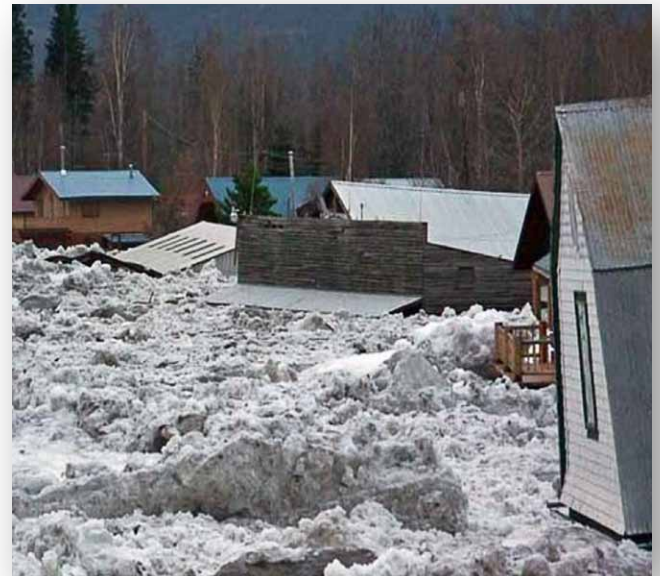
*Ice and debris flowing through Eagle, Alaska.*

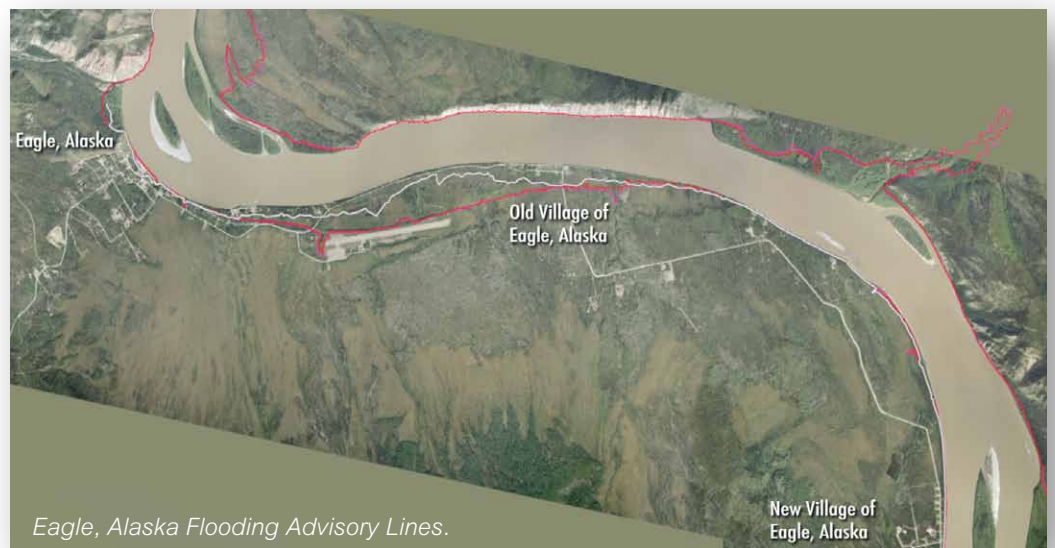
*Eagle, Alaska Flooding Advisory Lines.*

The GIU team created several maps to illustrate to business and home owners the safe zones for rebuilding. The bright white line on the photograph above represents the extent of ice movement on the Yukon River in Eagle, Alaska in early May 2009. The last "great ice jam" recorded occurred in 1937. Actual data on the severity and extent of the flooding were sparse. Anecdotal reports indicated they were comparable to that in 2009. Therefore, it can be concluded that any structures built within the area of ice movement during the 2009 disaster are subject to damage or destruction in future flooding caused by ice jams.

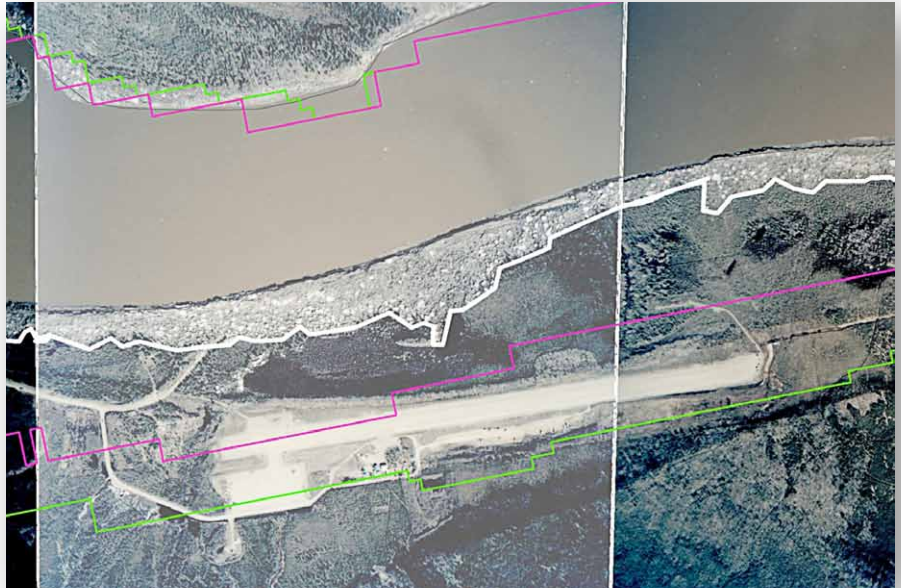
The pink line in the photograph is the extent of a 100-year flood modeled by the GIU using the HAZUS flood model and

*Acceptable levels of risk from ice-jam flooding.*

an assumed river discharge of 575,000 cubic feet-per-second (cfs). The green line is the result of a HAZUS simulation that assumed a discharge twice as large, approximately 1.2 million cfs.

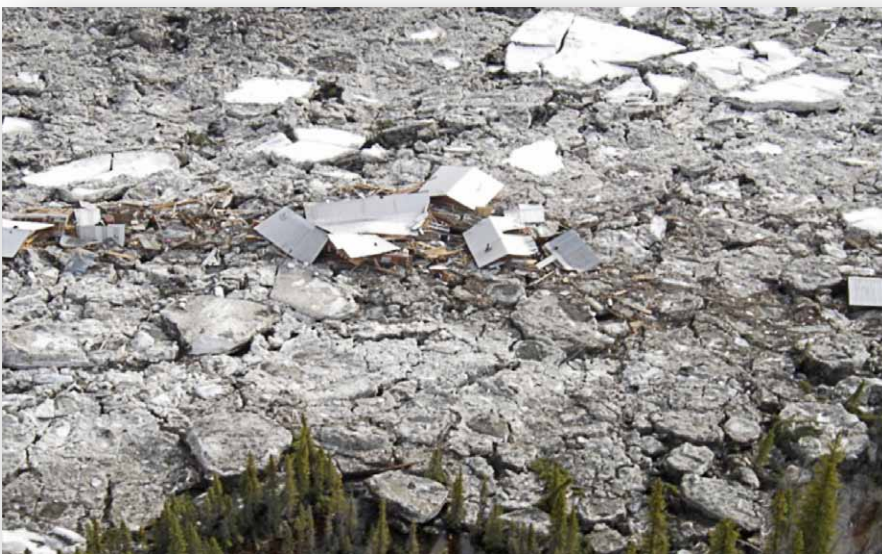
*Aerial view of devastation in Eagle, Alaska.*
