Fukushima Nuclear Disaster

Congressional Research Service

R41694

CRS Report for Congress

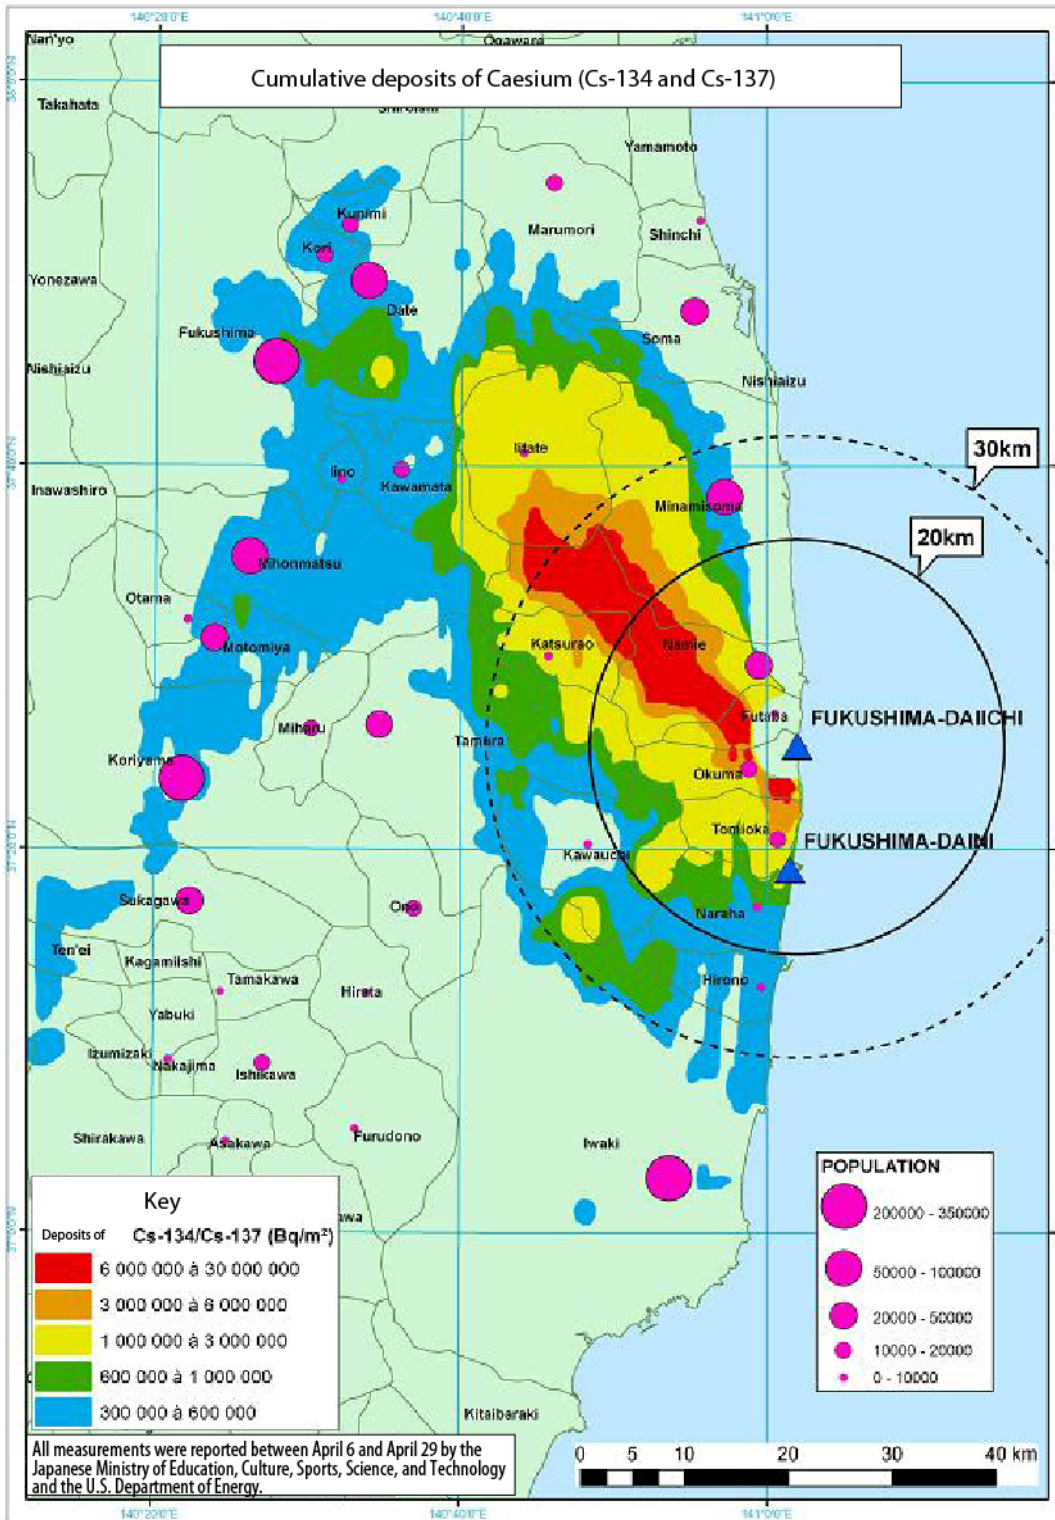
Figure 3. Cesium Depositions Around Fukushima-Daiichi

Note: 1 becquerel (Bq) = 27 picocuries (pCi)

Contamination of the land around the Fukushima plant was concentrated to the northwest, leaving large areas uninhabitable, as shown in **Figure 3**. Most of that contamination occurred when prevailing winds that had been carrying the plant's atmospheric releases over the Pacific Ocean shifted to the northwest during two days in mid-March and heavy rains washed the radioactive material from the air.⁴⁰ The depositions of radioactive cesium (the primary long-term land contaminant) are "comparable with the most contaminated areas of Chernobyl, even beyond the initial 20 km-radius evacuation zone around the Fukushima plant," according to the French Institut de Radioprotection et de Surete Nucleaire (IRSN). However, the amount of land around Fukushima with cesium deposits greater than 600,000 becquerels (16.2 microcuries) per square meter was estimated to be "only 8.5% of that of Chernobyl."⁴¹
