Fukushima Nuclear Crisis

Congressional Research Service

R41694

Summary of the Crisis

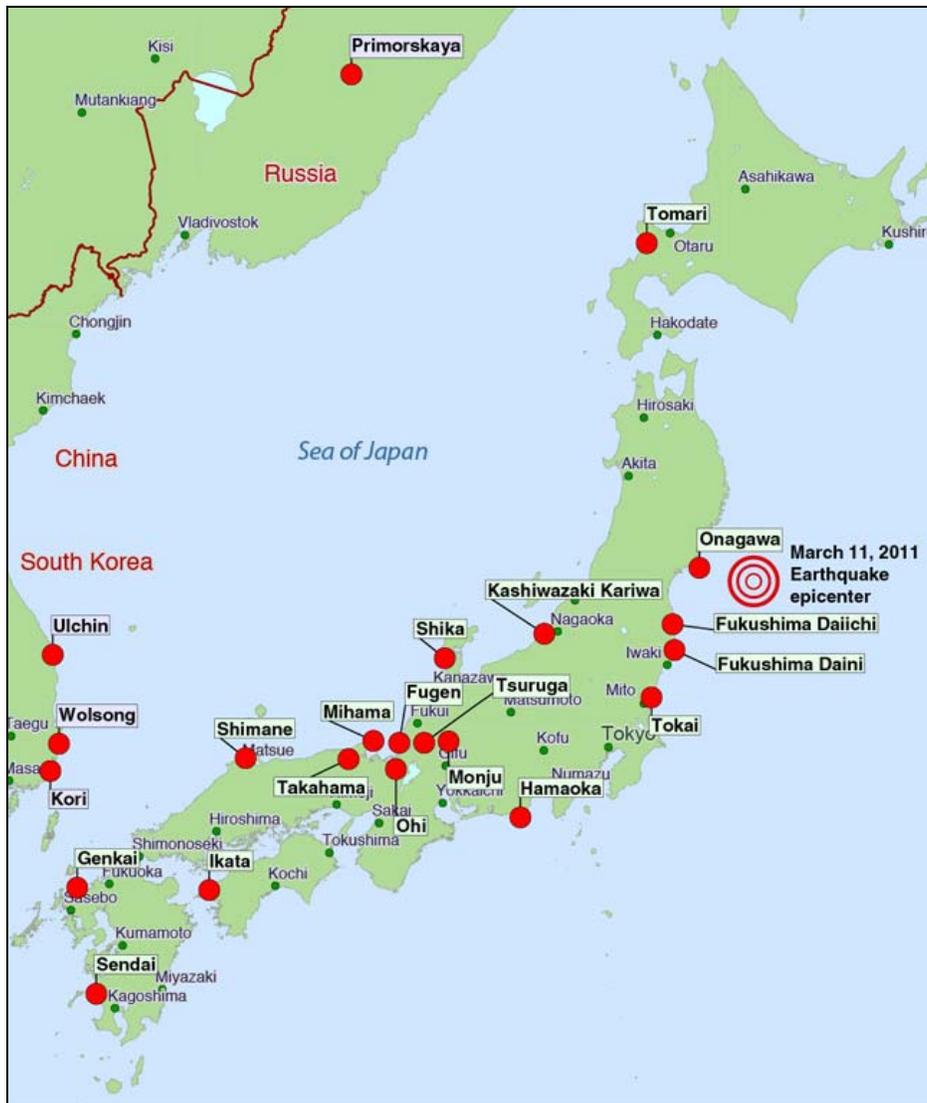
Figure 1. Japan and Earthquake Epicenter

The earthquake on March 11, 2011, off the east coast of Honshu, Japan’s largest island, reportedly caused an automatic shutdown of eleven of Japan’s fifty-five operating nuclear power plants.¹ Most of the shutdowns proceeded without incident. However, the plants closest to the epicenter, Fukushima and Onagawa (see **Figure 1**), were damaged by the earthquake and resulting tsunami. The Fukushima Daiichi plant subsequently suffered hydrogen explosions and probable nuclear fuel damage, releasing significant amounts of radioactive material into the environment.

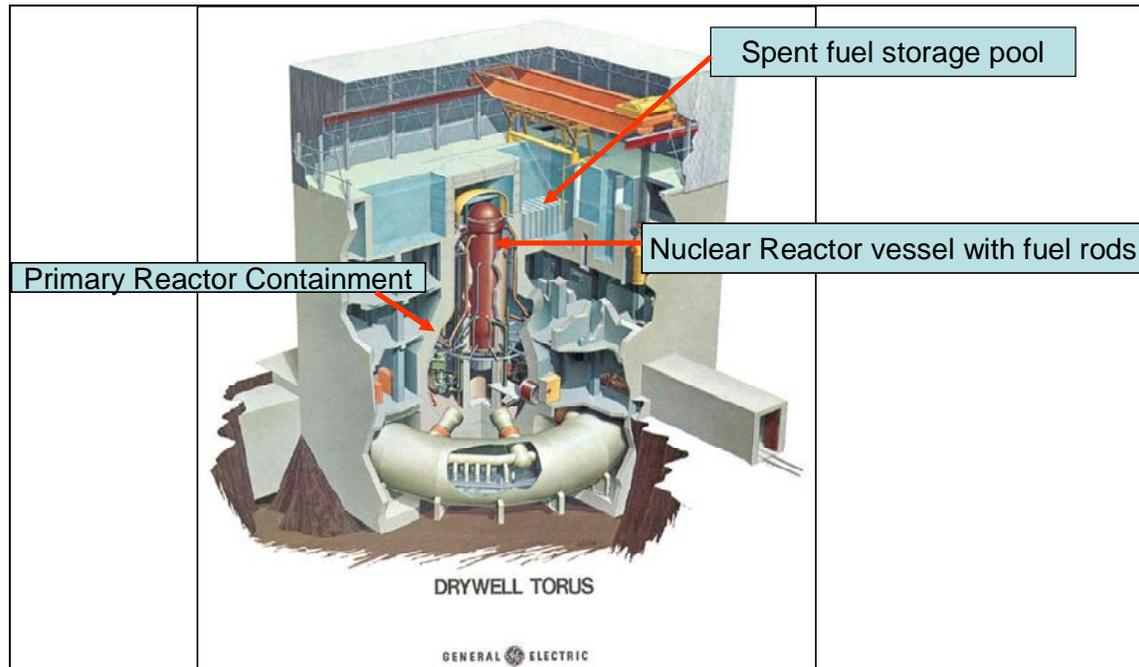
Figure 2. General Electric Mark I Boiling Water Reactor and Containment Building

Source: <http://www.nrc.gov/>.

Loss of cooling capacity also affected the plant's spent fuel pools (shown in **Figure 2**), which hold fuel rods that have been removed from the reactors after their ability to sustain a nuclear chain reaction has diminished. Although much of the radioactivity in the spent fuel has been decaying for many years, the large volumes of spent fuel in the pools represent a significant total heat load. If water in the spent fuel pools boils away or leaks out, the spent fuel rods may overheat and release radioactive material into the air.
