- Cesium-137 Release
- Goiânia, Brazil
- Recovery

**Lessons Learned
Information Sharing**
www.LLIS.gov

Radiological Incident Response: Establishing a Temporary Storage Site for Contaminated Material

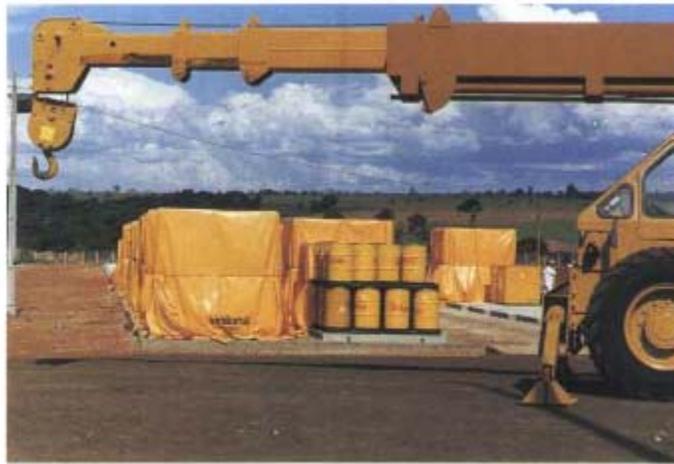
Boxes and Drums of Waste Stacked and Covered at the Temporary Storage Site
(From: IAEA Report, *The Radiological Accident in Goiânia*. 16 Sep 1988.)

The selected waste site was meant to store the radioactive materials for up to two years, while a permanent repository was prepared. Armed guards patrolled the premises around the clock. Emergency response organizations built six semi-absorbent concrete platforms to accommodate the waste containers and retain contamination spills. The most radioactive packages were placed in the center of each platform to minimize dose rates in the access corridors and at the security fence. The containers were covered with plastic sheets to protect them from rainfall. Each receptacle was numbered and its content described on an inventory card.

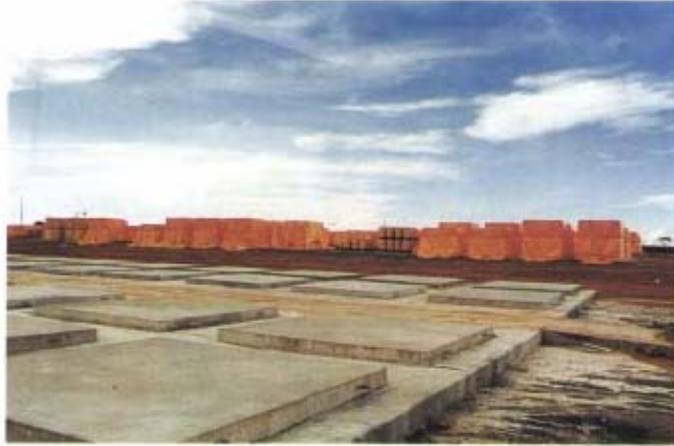
Temporary Storage Site: Showing Concrete Bases with Runoff Sampling Channels.
(From: IAEA Report, *The Radiological Accident in Goiânia*. 16 Sep 1988.)

A monitoring system was created to screen workers, soil, vegetation, surface water, sediments, and air at all times. Thermoluminescent dosimeters were employed at the security fence. A sampling system was also set up to monitor water dripping from the platforms during thunderstorms. Several barriers and a small embankment were built to slow the draining water flow and increase the absorption of Cs-137 within the depository area.
