Flood Best Practices

Bay Head Elevated Home Undamaged by Sandy Surge

Flood Vents, Elevation, and Compliance: Homeowners Protect Their Investment

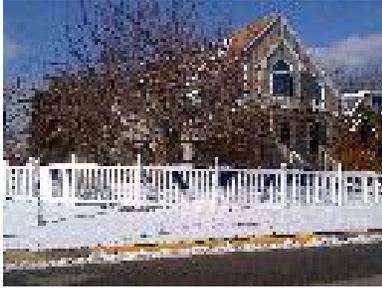
Elevated Bay Head Home

When she built her home in 1997, Wojcik had the home's living space elevated two feet higher than what Bay Head's floodplain ordinance required because she knew historic storms had flooded the town in the past. Sandy's storm surge brought high waves that flooded her neighbors' homes and left longstanding floodwaters, but the interior of Wojcik's home was left dry and undamaged.

Wojcik's home, which sits less than 80 feet from a saltwater lake that connects to the bay and a short distance from the ocean, received almost four feet of water in her home's crawlspace and garage from the storm surge. She had elevated the furnace and hot water heater on a platform in the garage when she built her home, and those appliances were undamaged by the flooding.

Her home's ductwork and electrical system were also elevated when the two-story home was built and were undamaged in the flood. Wojcik's flood insurance paid for repairs caused by flooding to her crawlspace and garage, which were minimum flood repairs compared to her neighbors.

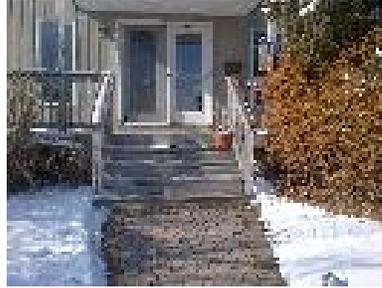
Home elevated with private funds

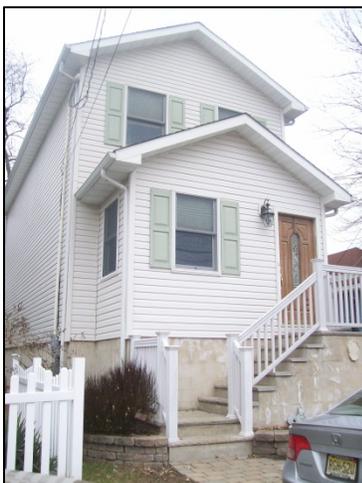
Front view of elevated home

The first floor is now measured at 77 inches above the street and about 14 feet above sea level and the foundation consists of cement filled block with flood vents. All of the utilities, except for the outside air conditioning unit, were elevated, leaving nothing in the five foot high enclosure. Taking another additional step to protect their home, Greg had hurricane straps attached from the roof to the foundation.

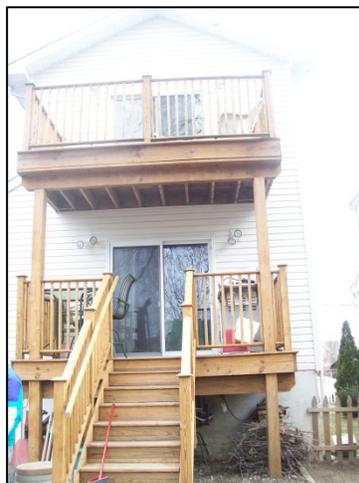
Rear view of elevated home

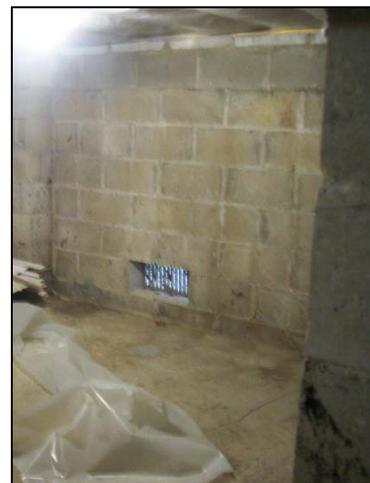
Flood vents

As for the house, they found that the flood waters had reached the bottom of the floor joist in the enclosure soaking the insulation, but did not enter the house. The flood vents worked perfectly, allowing the flood water to drain out. The decision to raise the home an additional 17 inches made all the difference in the amount of damage and in the speed of their recovery.
