## Screen Barriers Protect Orange County Firehouses

### Full Mitigation Best Practice Story

#### Orange County, Florida

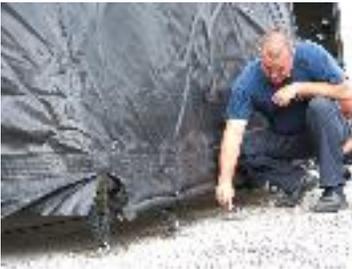
Firefighter Dunn unfurls the screen

Fire Station No. 66 firefighter screws metal eyebolts into imbedded anchor sites in the cement driveway,

The barrier screens are polypropylene, woven monofilament, geotextile fabric, customized for an exact fit at each opening. They are engineered to reduce wind speed and water penetration by 90 percent, and prevent windborne debris from impacting the doors. “Other great advantages of the screen barriers are that they allow us to see outside, have fresh air and a cooling breeze,” said firefighter/paramedic, Dan Bracewell. Screens, at Fire Station No. 66, slope away 2 feet from the base of the bay doors. This helps to channel wind and rain away from the building. The flexibility of the material absorbs the impact of windborne debris and keeps it from hitting the doors. Bolted top and bottom, to rustproof metal anchors, the screens flex, but stay secured. When not in use, the screens are rolled up and secured above the door.
