**NIST NCSTAR 1A**
Federal Building and Fire Safety Investigation
of the World Trade Center Disaster

# Final Report on the Collapse of World Trade Center Building 7

NIST NCSTAR 1A

November 2008

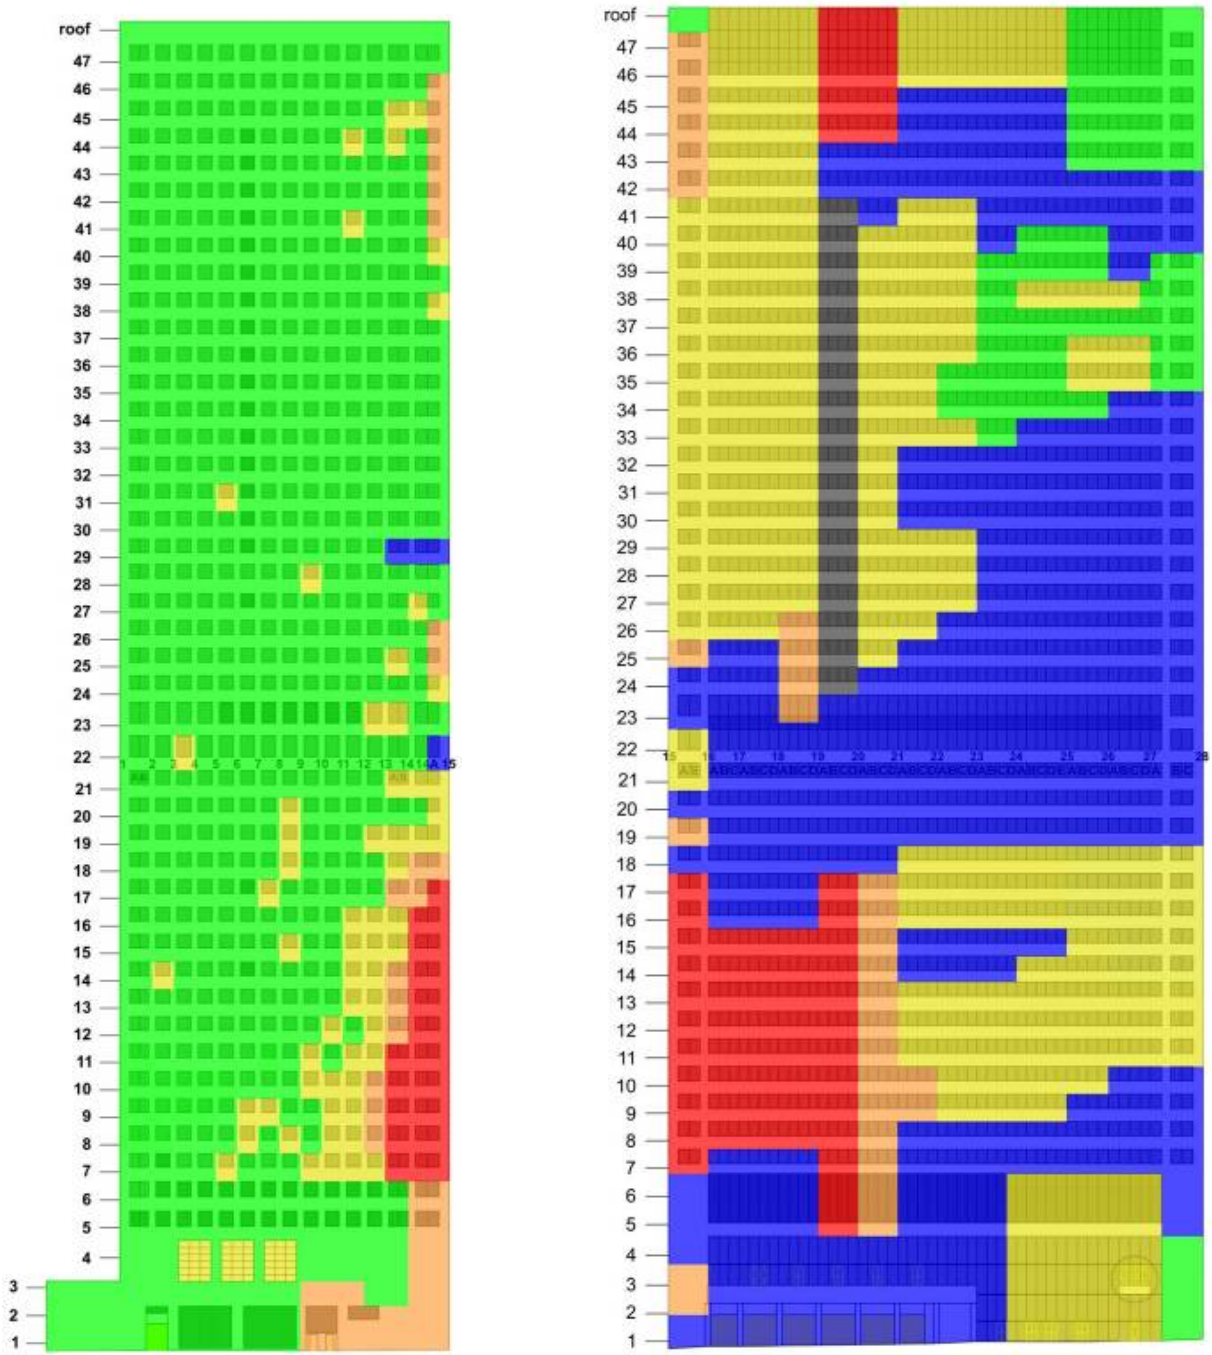
When WTC 1 collapsed at 10:28:22 a.m., most of the debris landed in an area not much larger than the original WTC 1 building footprint. However, some fragments were forcibly ejected and traveled distances up to hundreds of meters. Pieces of WTC 1 hit WTC 7, severing six columns on Floors 7 through 17 on the south face and one column on the west face near the southwest corner. The debris also caused structural damage between Floor 44 and the roof. The damage to the building face is depicted in Figure 2–1. Based on photographic evidence, witness accounts, and engineering judgment, it is likely that the structural damage (steel and floor slabs) did not penetrate beyond the perimeter of the building core. At the southwest corner, the structural damage extended only about one-third of the distance from the exterior wall to the building core. The debris also broke a large number of windows on the south face. Compared to the airplane impact damage to the WTC towers, there was relatively little damage to the interior of WTC 7. For instance, damage to the sprayed fire resistive material (SFRM) was limited to the immediate vicinity of the WTC 1 debris impact. There was no superficial or structural damage to the north and east faces (NIST NCSTAR 1-9, Chapter 5, Section 5.5.2).

**Figure 2–1. Observed damage to WTC 7 following the collapse of WTC 1.**
West face (left) and south face (right)

The damage is color coded as follows: green (■)- no visible damage, yellow (■) – window glass broken, orange (■) – granite and underlying truss damage, red (■) – damage to exterior structural steel, gray (■) – possible structural damage, and blue (■) – not visible due to smoke, dust, and intervening buildings.

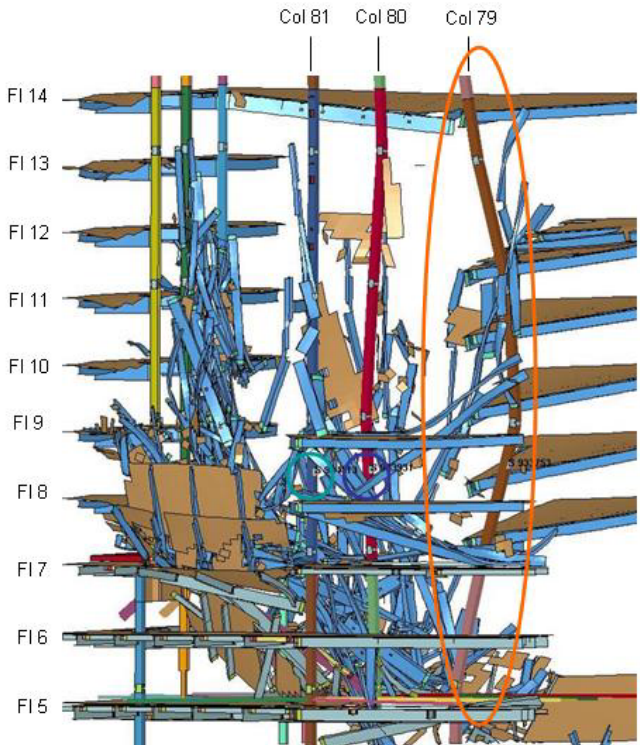
Fire-induced thermal expansion of the floor system surrounding Column 79 led to the collapse of Floor 13, which triggered a cascade of floor failures. In this case, the floor beams on the east side of the building expanded enough that they pushed the girder spanning between Columns 79 and 44 to the west on the 13th floor. (See Figure 1–5 for column numbering and the locations of girders and beams.) This movement was enough for the girder to walk off of its support at Column 79.

The unsupported girder and other local fire-induced damage caused Floor 13 to collapse, beginning a cascade of floor failures down to the 5th floor (which, as noted in Section 1.2.3, was much thicker and stronger). Many of these floors had already been at least partially weakened by the fires in the vicinity of Column 79. This left Column 79 with insufficient lateral support, and as a consequence, the column buckled eastward, becoming the initial local failure for collapse initiation.

**Figure 2–2. Eastward buckling of Column 79, viewed from the southeast.**

Due to the buckling of Column 79 between Floors 5 and 14, the upper section of Column 79 began to descend. The downward movement of Column 79 led to the observed kink in the east penthouse, and its subsequent descent. The cascading failures of the lower floors surrounding Column 79 led to increased unsupported length in, falling debris impact on, and loads being re-distributed to adjacent columns; and Column 80 and then Column 81 buckled as well. All the floor connections to these three columns, as well as to the exterior columns, failed, and the floors fell on the east side of the building. The exterior façade on the east quarter of the building was just a hollow shell.

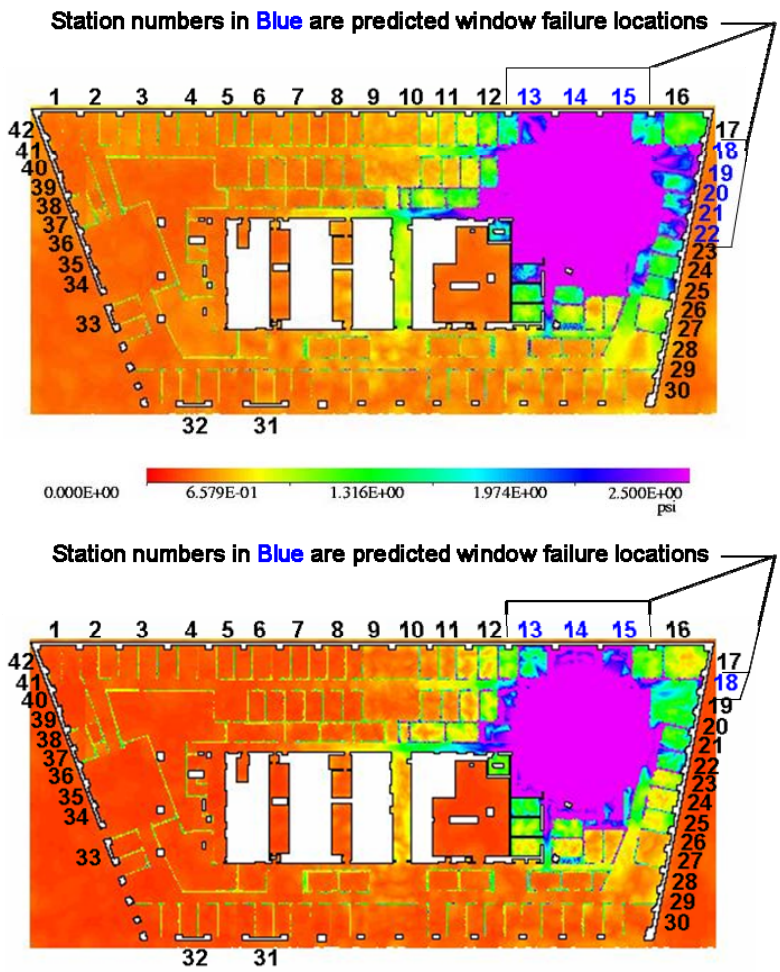
Figure 3–1 shows the results for the two shaped charges applied to Column 79 on a tenant floor that was highly partitioned, such as Floor 12. Nearly all the windows on the northeast section of the floor subjected to a blast would have been broken, even by the smaller charge. Simulations for a floor that was not highly partitioned led to more extensive window breakage.

**Figure 3–1. Peak overpressure and broken window locations.**

Top: 9 lb shaped charge; bottom: 2 lb charge.

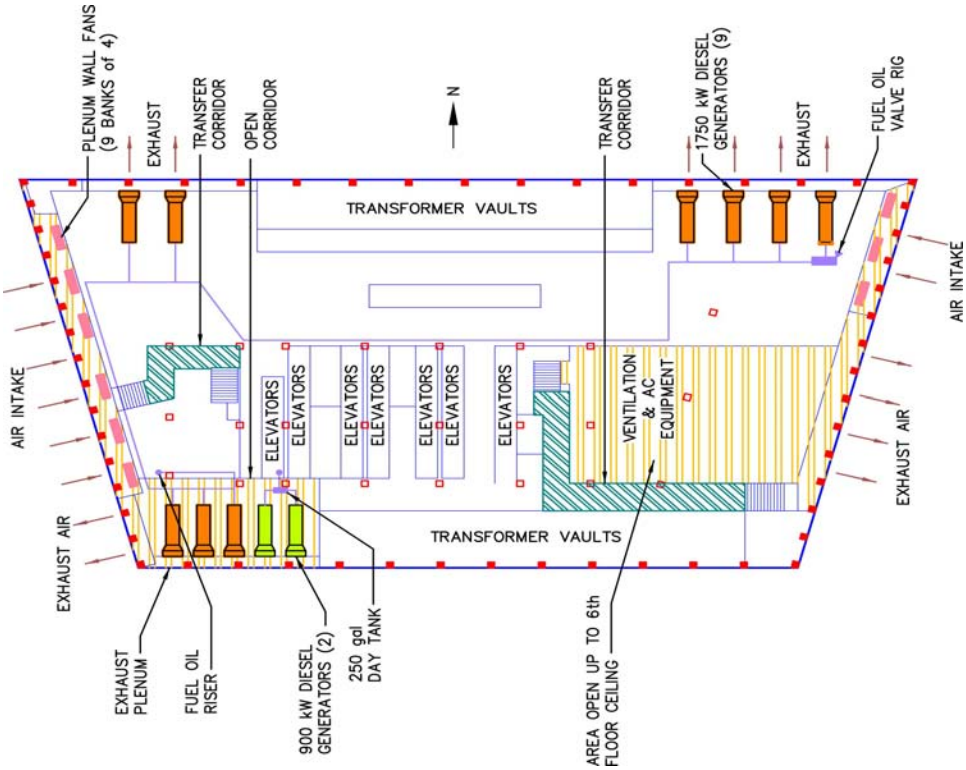
**Figure 3–4. Schematic layout of the 5th floor of WTC 7 showing the locations of the emergency power system components.[1]**

NIST determined that a spray fire of the diesel fuel would have been less damaging than a pool fire, even though the spray fire temperature would have been a few hundred degrees higher. A fuel spray would have resulted from a small leak in the fuel supply piping, so the fuel escape rate would have been far less than in the over-ventilated pool fire scenarios. Had this small burning spray hit Column 79 directly, it would only have heated a small area of the column. NIST calculations (NIST NCSTAR 1-9, Chapter 4) showed that even if the entire column had been immersed in a 1400 °C (2550 °F) flame, it would have taken 6 h to heat the column to the point of significant loss of strength and stiffness.

NIST also evaluated the possible contribution of diesel fuel from the day tanks on Floors 7 and 9 to the fires on those floors. The amount of fuel available within the day tanks was insignificant compared to the mass of other combustibles on those floors. Nearly all the diesel fuel in the tanks that supplied the day tank on the 9$^{th}$ floor was recovered months after the WTC 7 collapse. The diesel fuel could have contributed to the initial ignition and spread of the fire on the south side of Floor 7 and on the west side of Floor 9, but these fires would have been far removed from the critical structural systems on the east side of WTC 7.

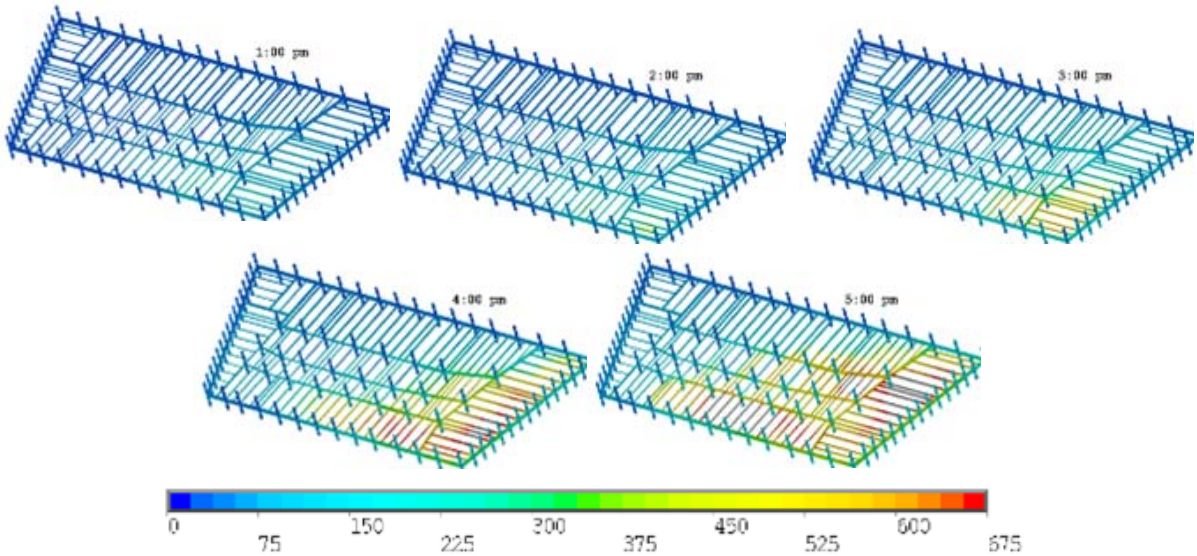
Figure 3–7 shows the calculated heating of the structural steel on the lower 16 floors of WTC 7 for the Case B temperatures from the fire simulation. The floor slabs have been removed from the figure for clarity. Figure 3–8 is a typical rendition of the calculated heating of the top of a floor slab as a result of the Case B fire.

**Figure 3–7. Computed temperature distribution (ºC) of Floor 13 steel framing at five different instants in time.**

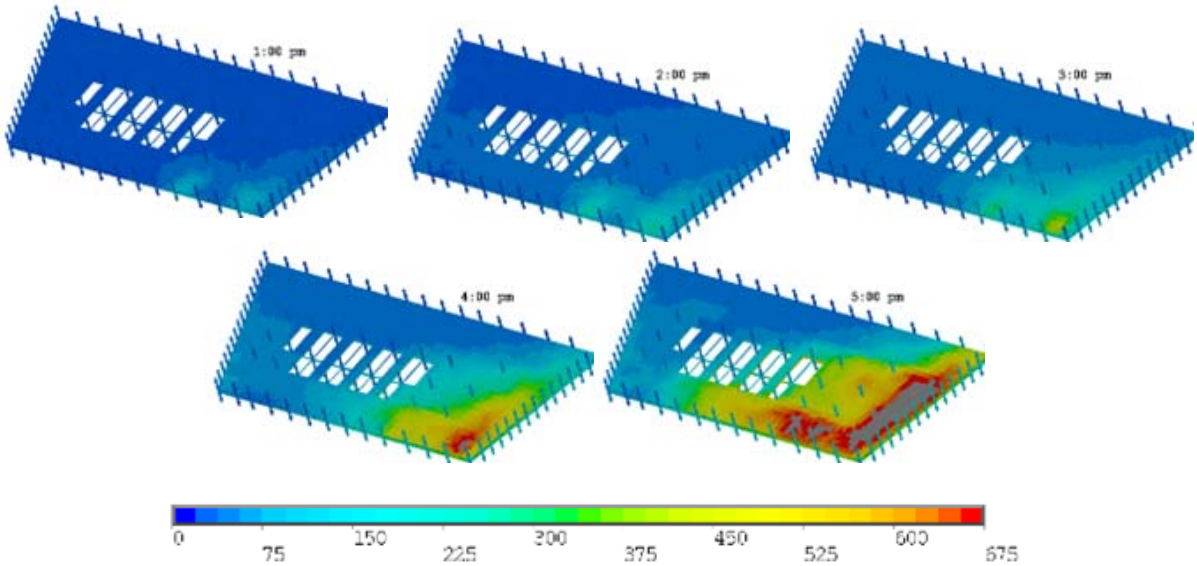
**Figure 3–8. Computed temperature distribution (ºC) in the top layer of the concrete slab of Floor 12 at five different instants in time.**
Grey shading indicates temperatures >675 ºC

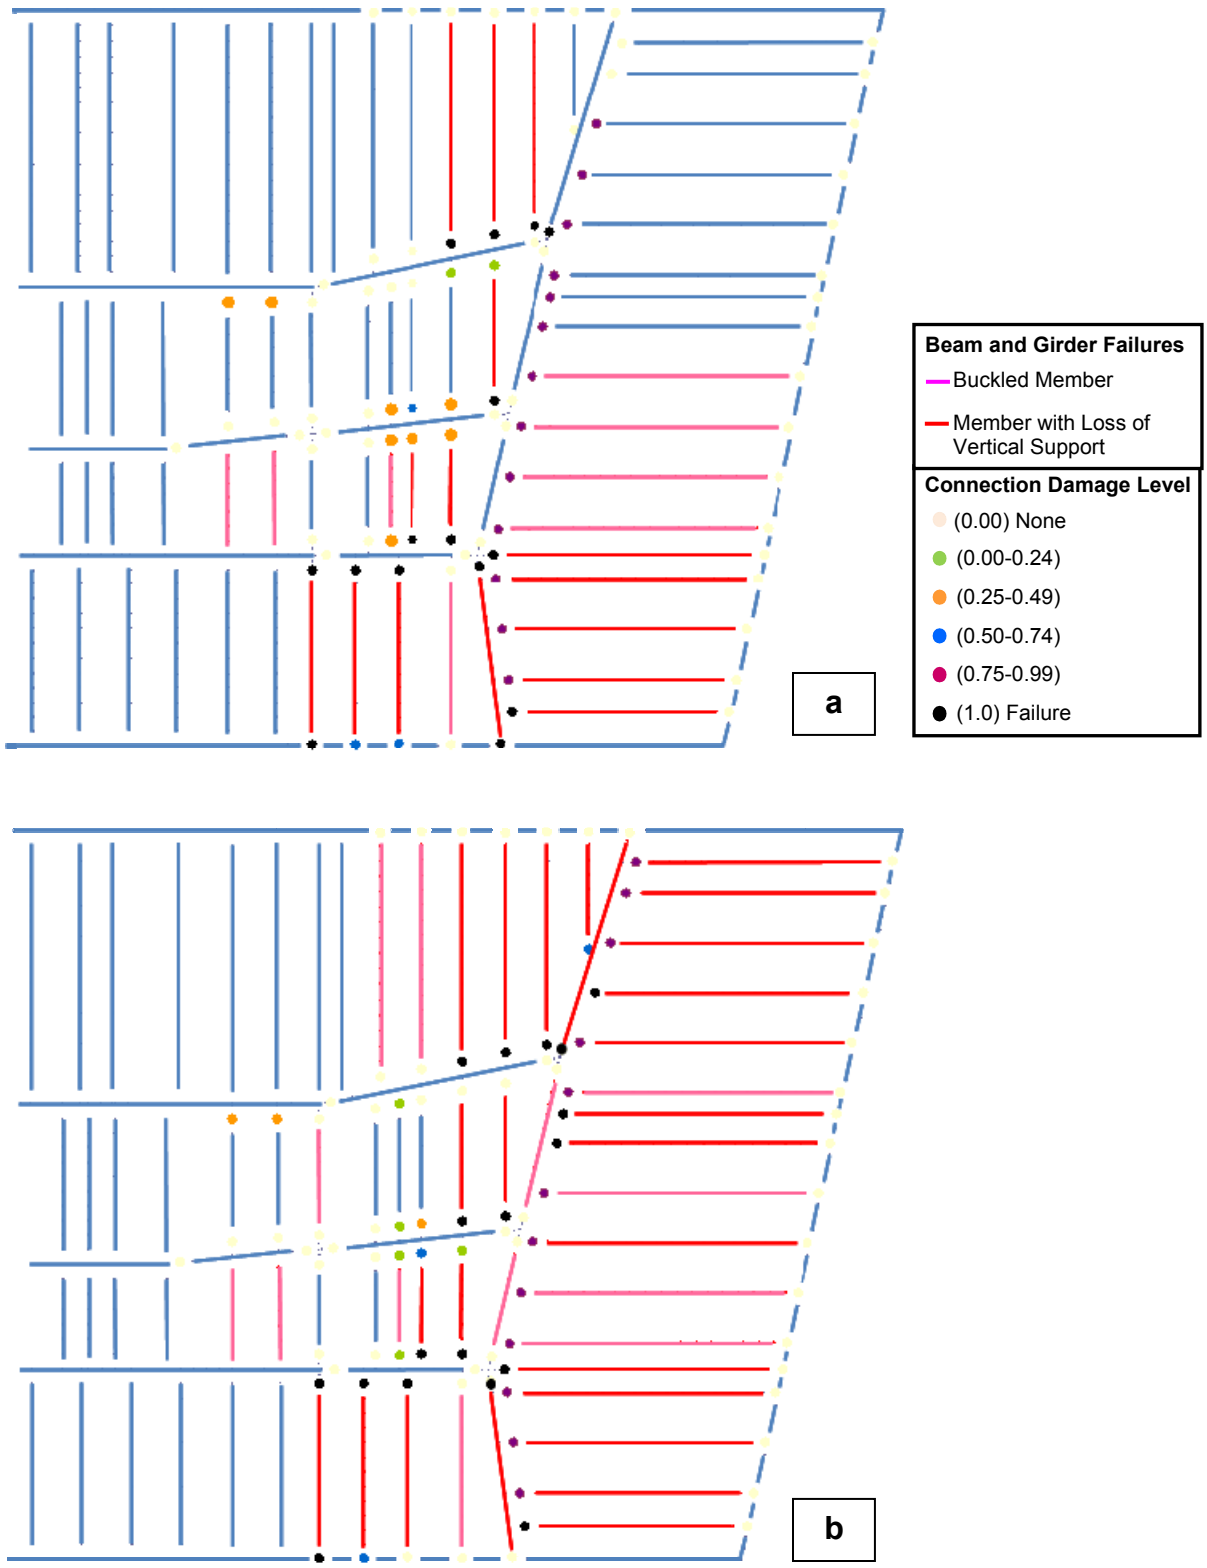
Figure 3-9 shows an example of the extent of structural damage from the fires, in this case for the 13$^{th}$ floor. At both 3.5 h and 4.0 h, connections, floor beams, and girders were damaged or had failed at steel temperatures that were approximately 400 °C (750 °F) or less, primarily due to the effects of thermal expansion. After 4.0 h of heating, there was substantially more damage and failures in the WTC 7 structural floor systems than at 3.5 h of heating.

The ANSYS results were input to the LS-DYNA analysis when it appeared that an initial failure event might be imminent. Damage diagrams for the 16 floors modeled in ANSYS, such as those shown in Figure 3–9, indicated some degree of uncertainty in selecting the time and damage state for the transition. However, it appeared likely the critical damage state occurred between 3.5 h and 4 h. Accordingly, as shown in the next section, LS-DYNA analyses were performed for both of these damage states.

**Figure 3–9. Damage state of connections in Floor 13 for Case B temperatures.**
a: at 3.5 h; b: at 4.0 h

The second LS-DYNA analysis (lesser degree of fire-induced damage) did not lead to a collapse-initiating event, despite the extensive damage shown in Figure 3–9a.

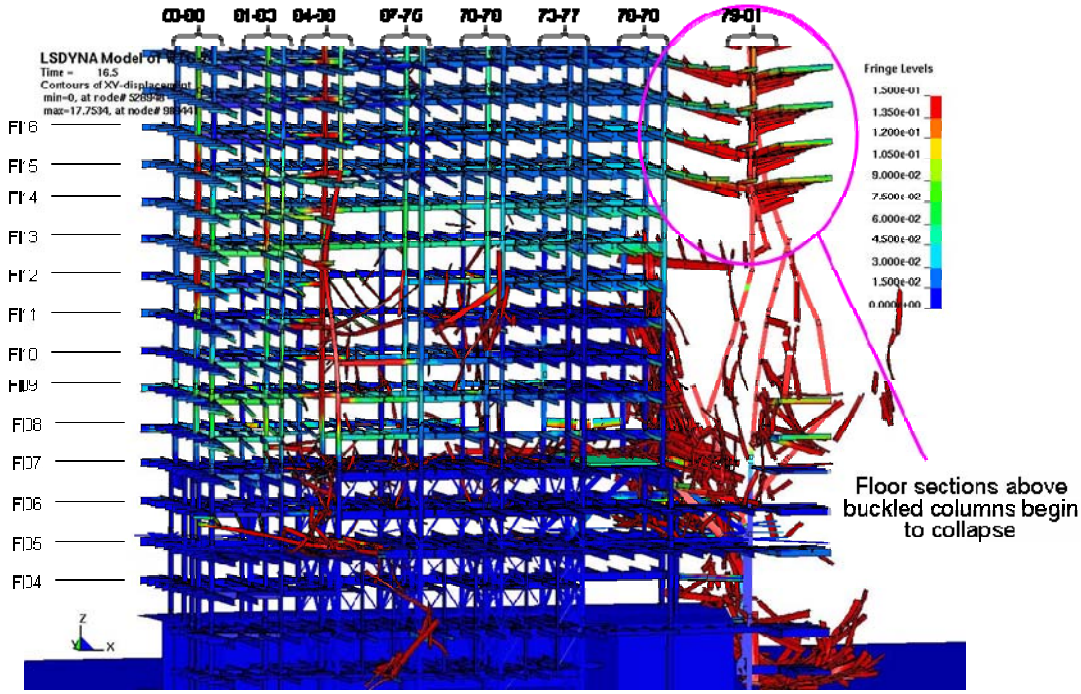
**Figure 3–10. Vertical progression of failures on the east side of the building at 0.5 s following the initiation of the collapse.**

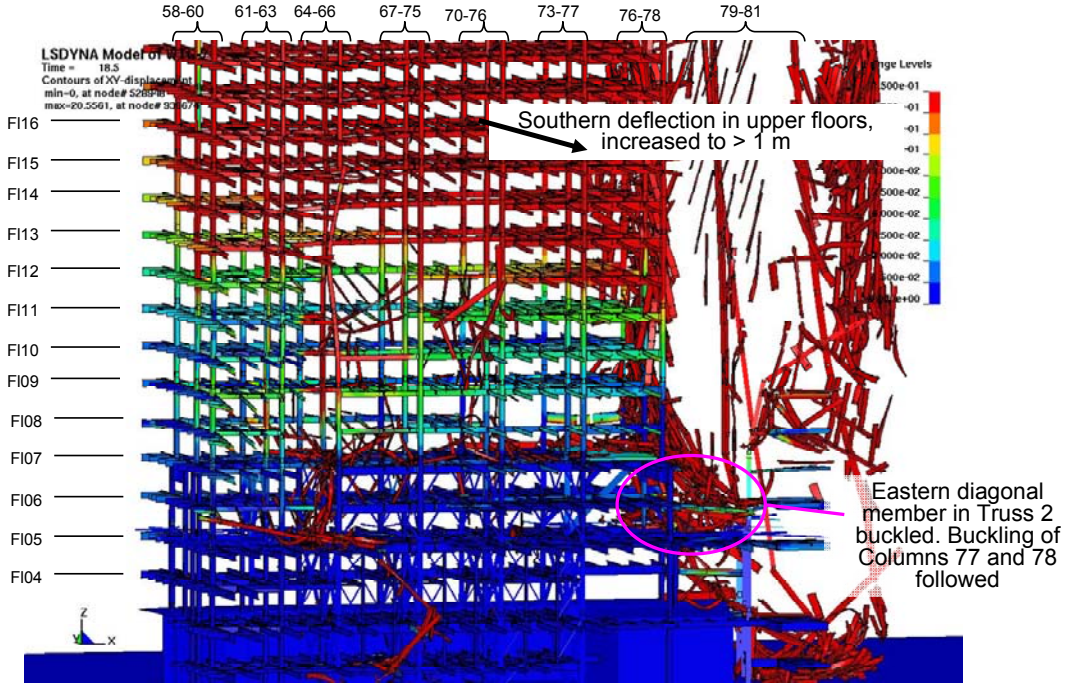
**Figure 3–11. Failure of Columns 77 and 78 due to failure of Truss 2 fails from debris impact at 2.5 s following the initiation of the collapse.**

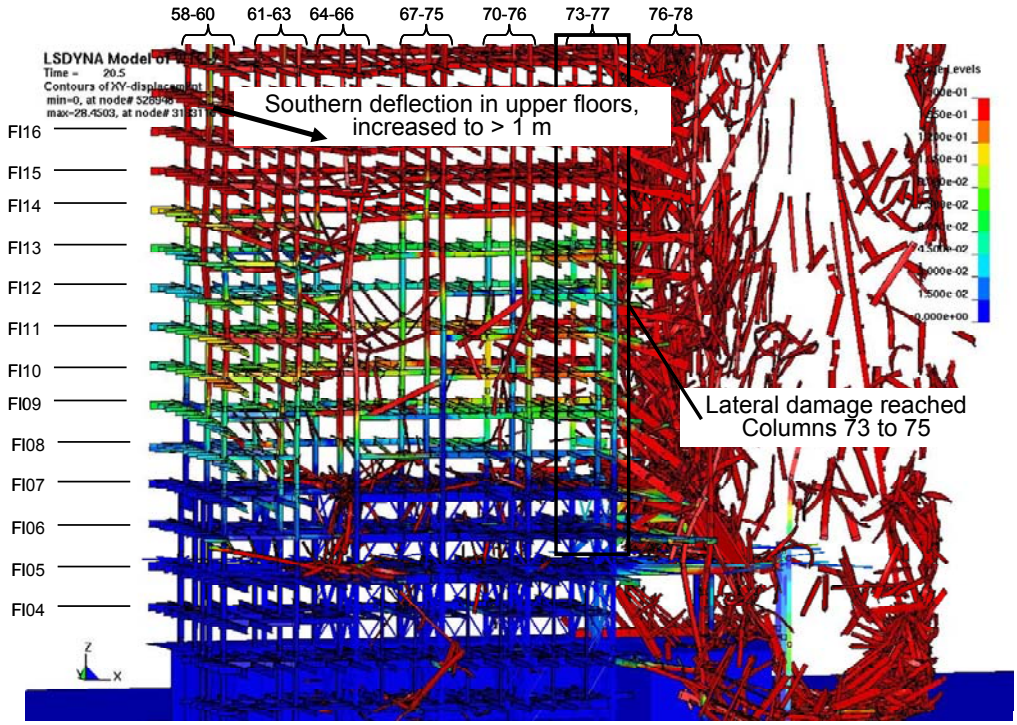
**Figure 3–12. Failure of Columns 73 to 75 from the load redistribution and debris impact at 4.5 s following the initiation of the collapse.**

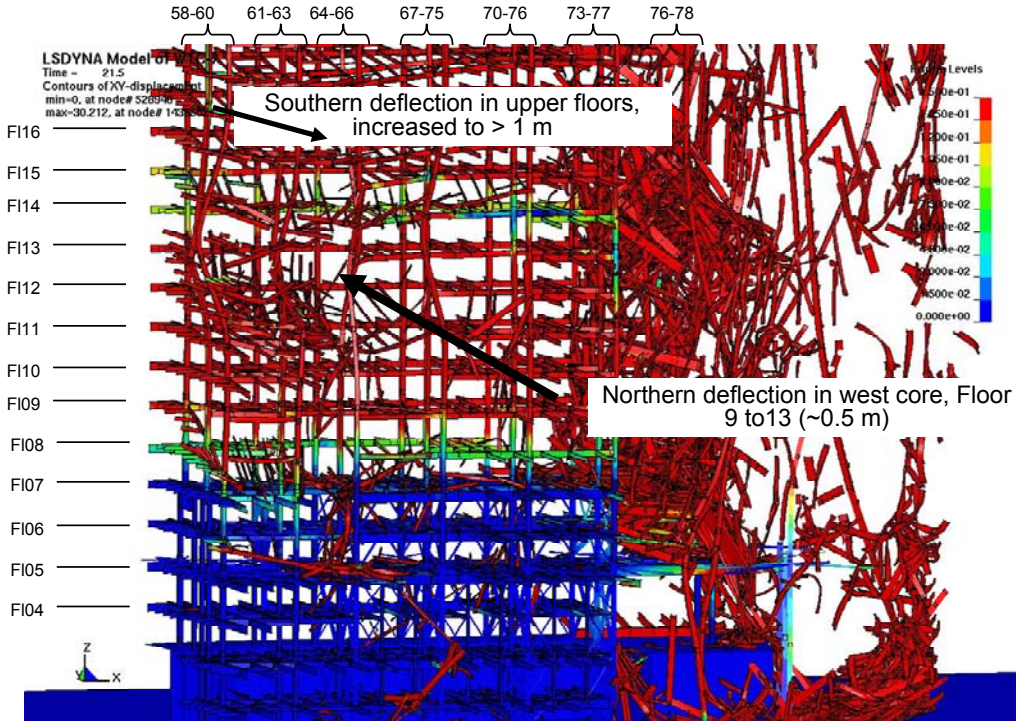
**Figure 3–13. Buckling of all interior columns at 6.5 s following the initiation of the collapse.**

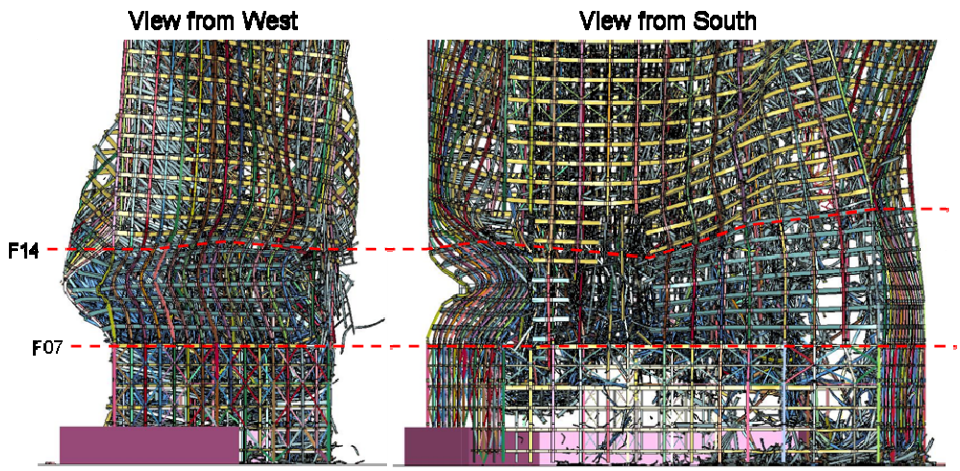
**Figure 3-14. Buckling of the lower exterior columns within 1 s of Figure 3–13.**

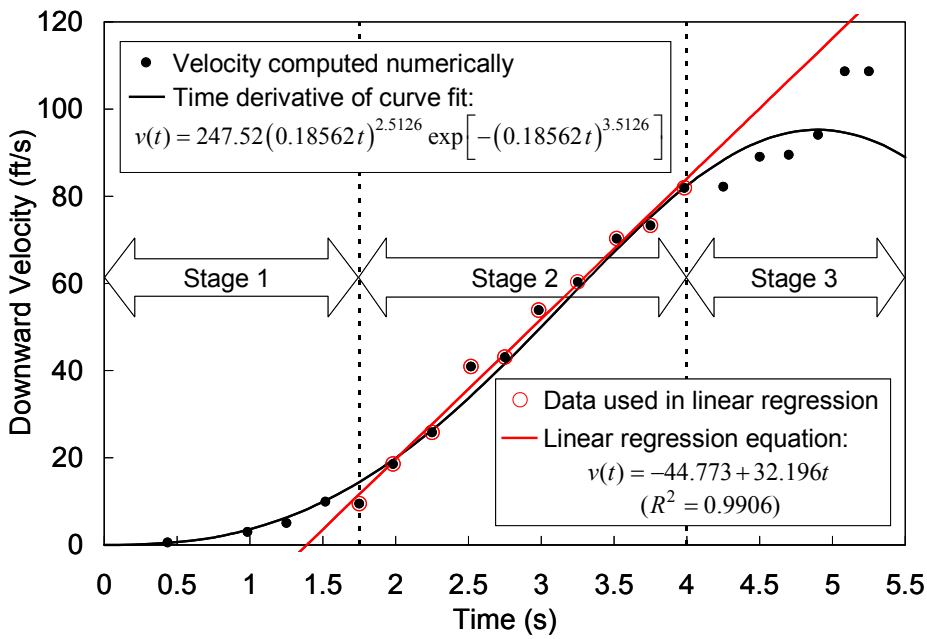
**Figure 3–15. Downward velocity of north face roofline as WTC 7 began to collapse.**

[3] A function of the form $z(t) = A\{1 - \exp[-(t/\lambda)^k]\}$ was assumed, which satisfies the initial conditions of zero displacement, zero velocity, and zero acceleration. The constants $A$, $\lambda$, and $k$ were determined using least squares fitting.

[4] The central difference approximation is given by $v_{i+½} \approx (z_i - z_{i+1})/(t_i - t_{i+1})$, where $z_i$ and $z_{i+1}$denote the displacement at time $t_i$ and $t_{i+1}$, respectively.
