Mitigation Assessment Team Report

Hurricanes Irma and Maria in Puerto Rico

Building Performance Observations, Recommendations, and Technical Guidance

FEMA P-2020 / October 2018

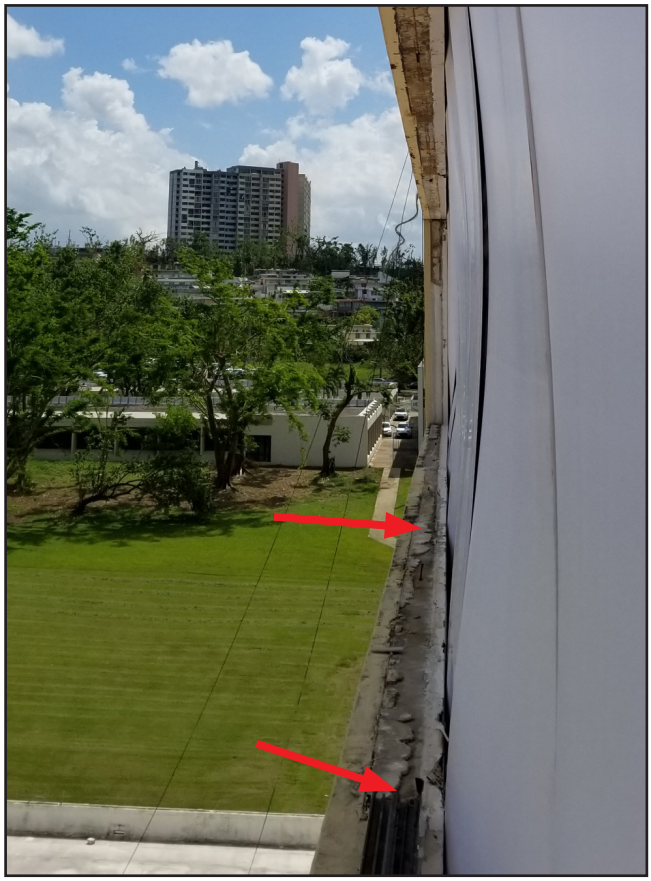
Figure 5-17: Only two fasteners were observable restraining the lower section of the missing 25-foot (7.6-meter) section of window system at Dr. Ramon Ruiz Arnau University Hospital (red arrows).

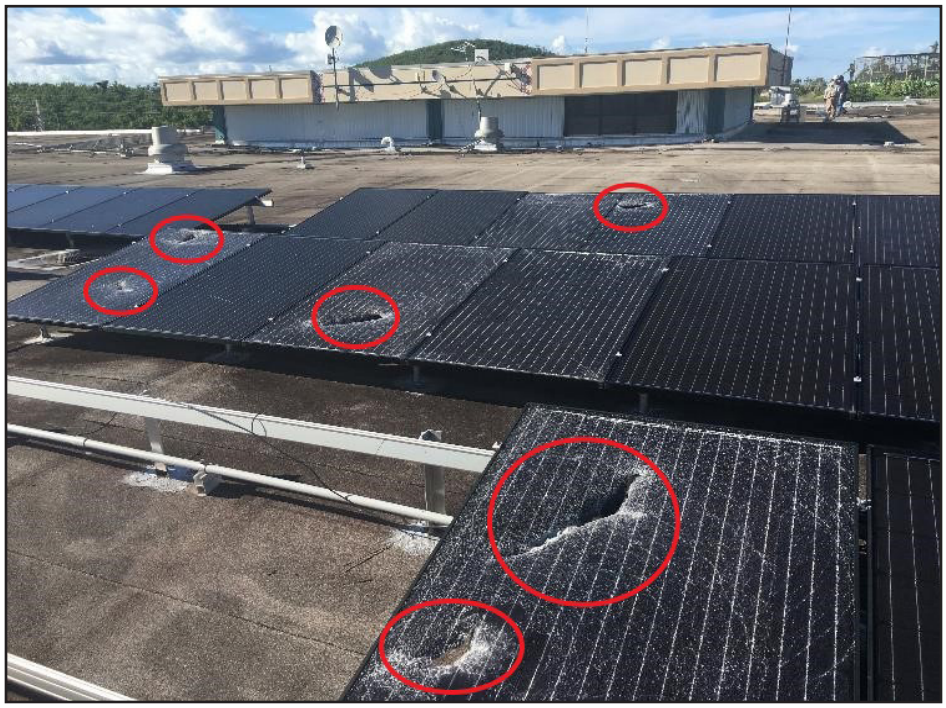
Figure 5-32: Rooftop solar array at east corner of hospital roof showing damage from wind-borne debris impacts (red circles).

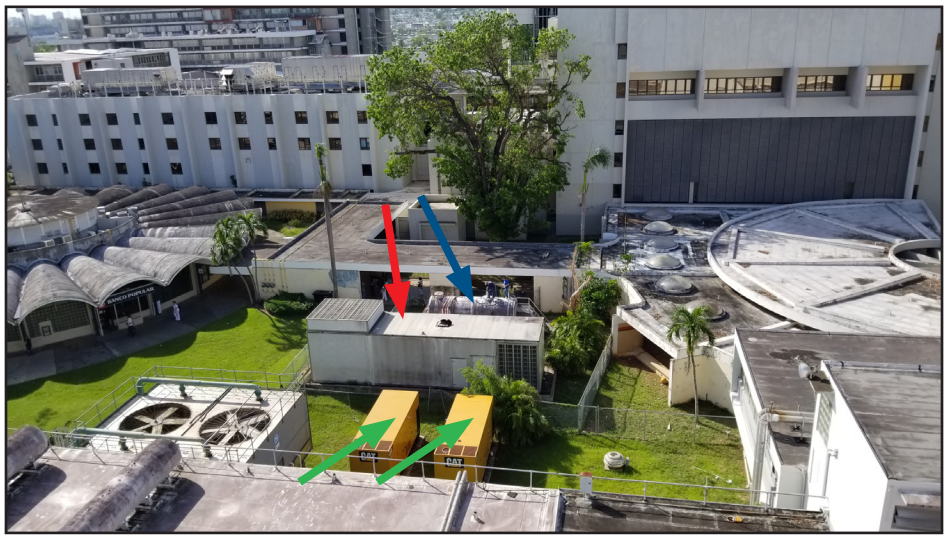
Figure 5-34: View of one of the standby generators (red arrow), two of the backup generators (green arrows), and a fuel tank (blue arrow) at San Juan University Pediatric Hospital.

San Juan University Pediatric Hospital has four generators that can provide 100 percent of the hospital's power requirements (Figure 5-34). Tower One has a 1,700 kilowatt (kW) standby generator, and Tower Two has a 1,250 kW standby generator. There are two 750 kW backup generators for the towers as well (Figure 5-35).

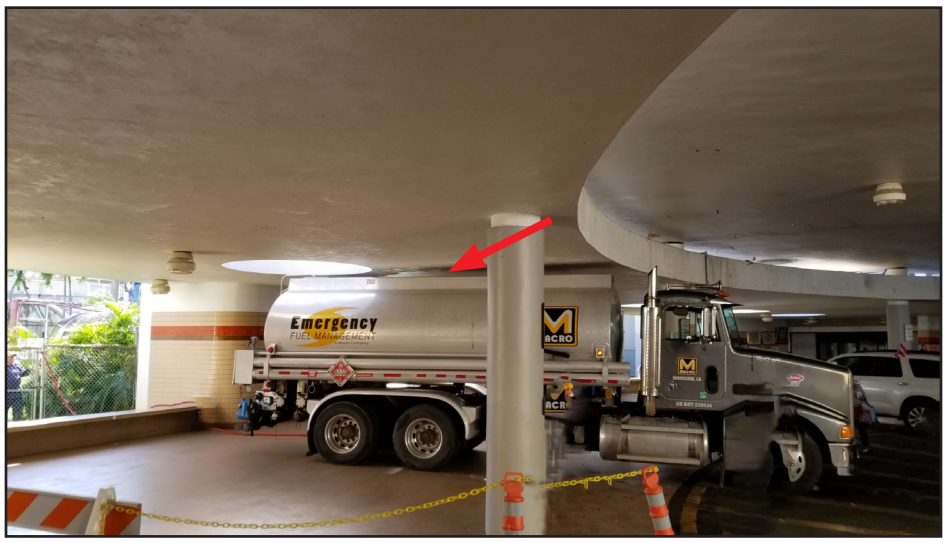
Figure 5-35: View of fuel truck refilling the fuel tank for University Hospital Tower One. Note the tight clearance between the porte-cochere ceiling and the top of the tanker truck (red arrow.)

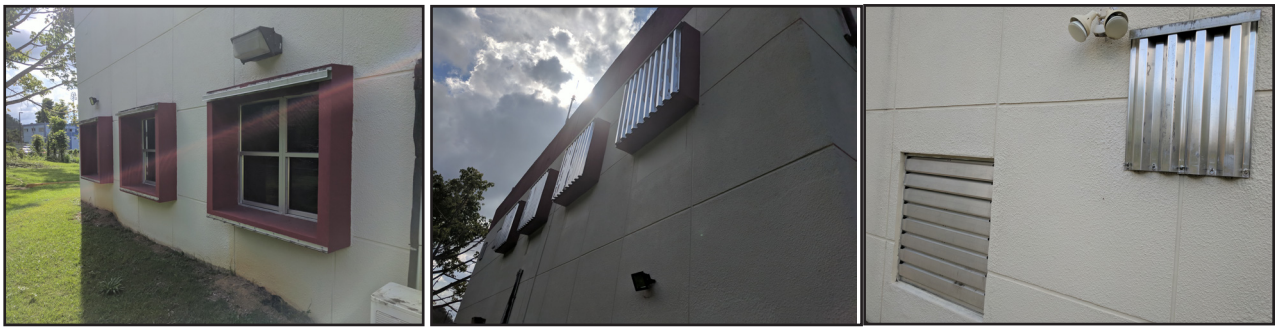
Figure 5-50: Metal shutters installed at the Florida Fire Station successfully protected the facility's openings.

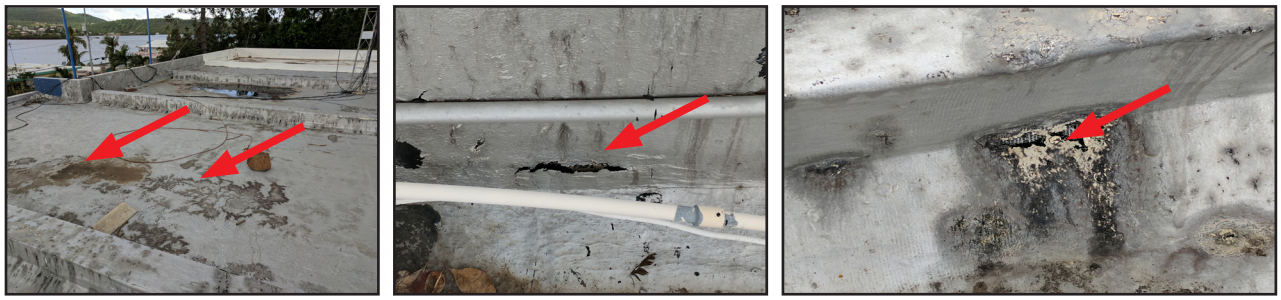
Figure 5-53: Ponding and roof damage (red arrows) at the Culebra Police Station.

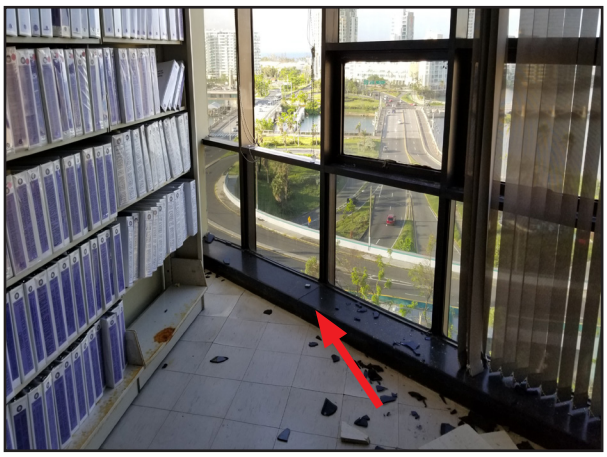
Figure 5-70: Left, shutters protecting lower floor windows pulled off the PRDOJ building, exposing the glass behind; right, the anchors were undersized, of the wrong type, and too few in number.

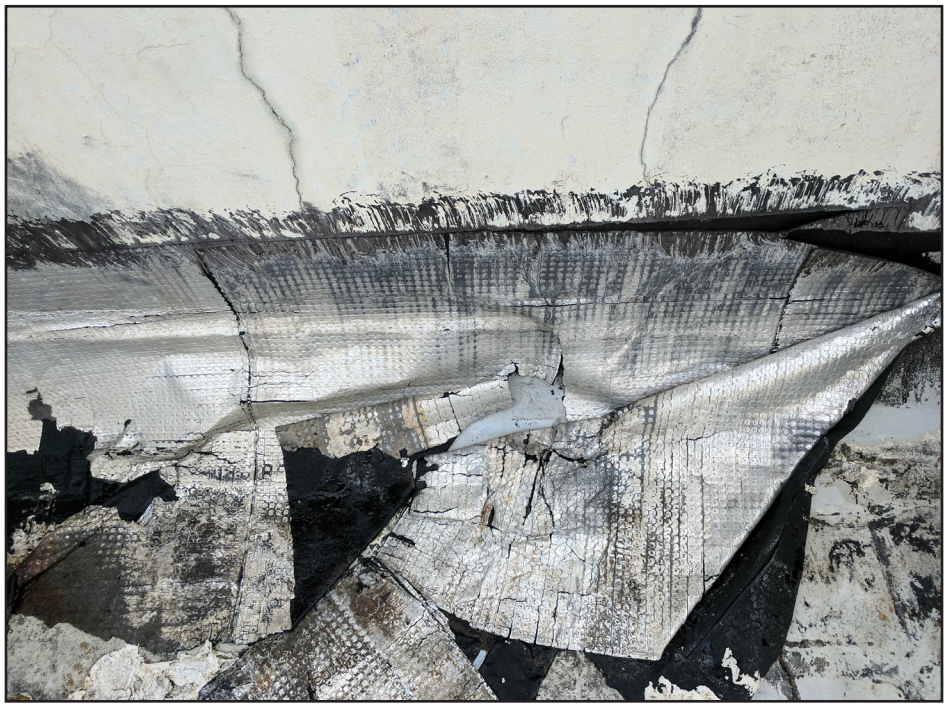
Figure 5-75: Vega Alta Municipal Building had roof leaks. Flashing can be seen displaced at the mechanical area of the roof. Water entered this location as well as others.

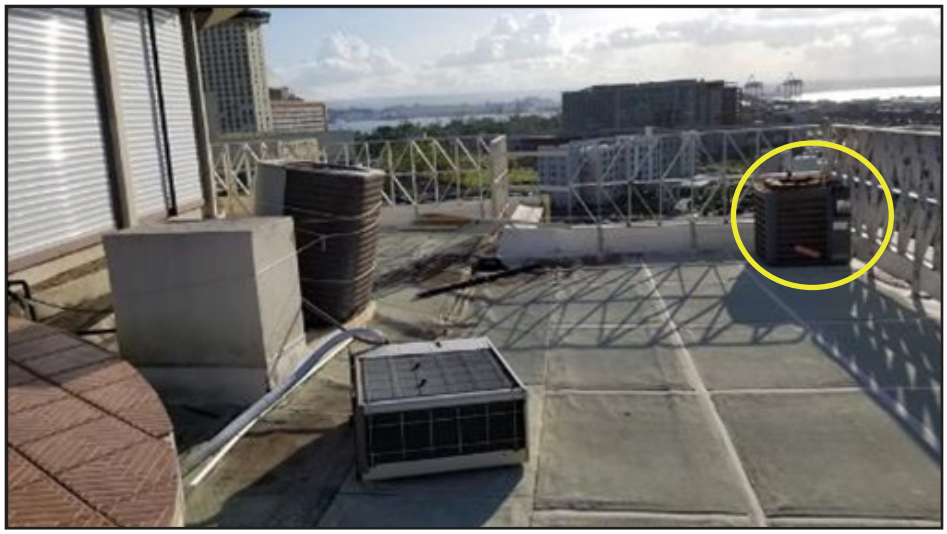
Figure 5-79: HVAC equipment was blown off equipment pads at the roof level of the PRDOJ building. One HVAC condenser has been blown to the edge of the building (yellow circle).

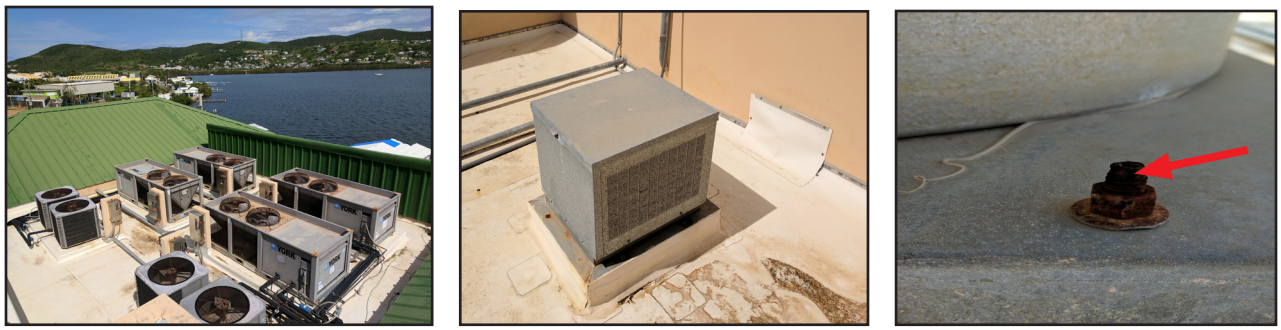
Figure 5-84: Mechanically attached rooftop equipment performed well at Culebra Municipal Building. Some fasteners were corroded (red arrow) but did not fail.

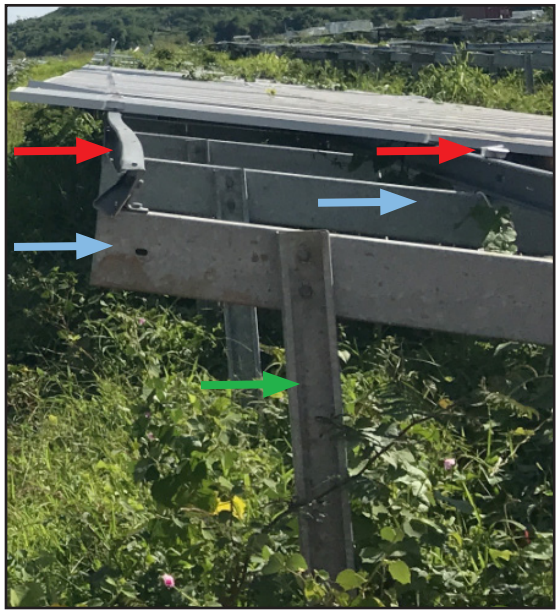
Figure 6-3: Reden solar array in Humacao, with ground-mounted posts (green arrow), sloped beams (blue arrows), and lateral rails (red arrow), that directly support the PV panels. In this image some of the panels have been lifted off the ground-mount structure, with the failure occurring at the panel clips.

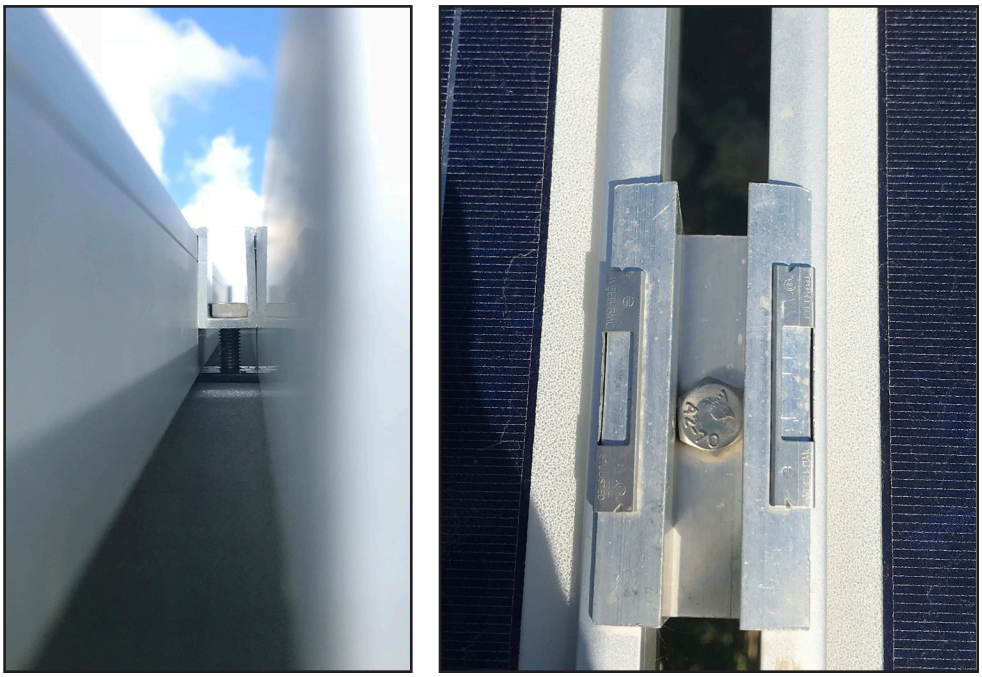
Figure 6-4: Reden solar array in Humacao: Left, side view of a hat-shaped clip showing its bolted connection to the lateral rail member underneath. Right, top view showing that a single bolt secures it to the rail.

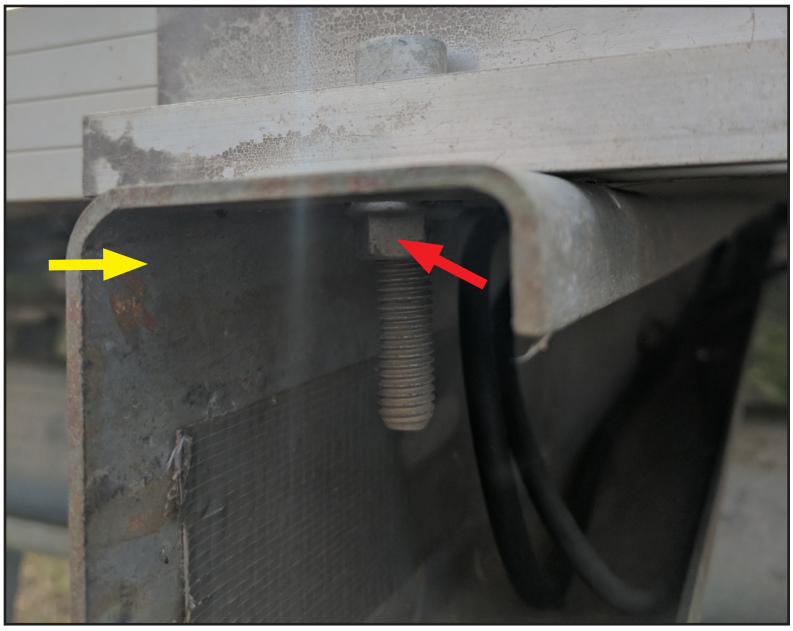
Figure 6-14: Oriana Solar Array 1: Steel lateral rail (yellow arrow) still bolted to the clip which secures the PV panel to the ground-mount system. Notice the single steel nut (red arrow) which could back off the bolt.

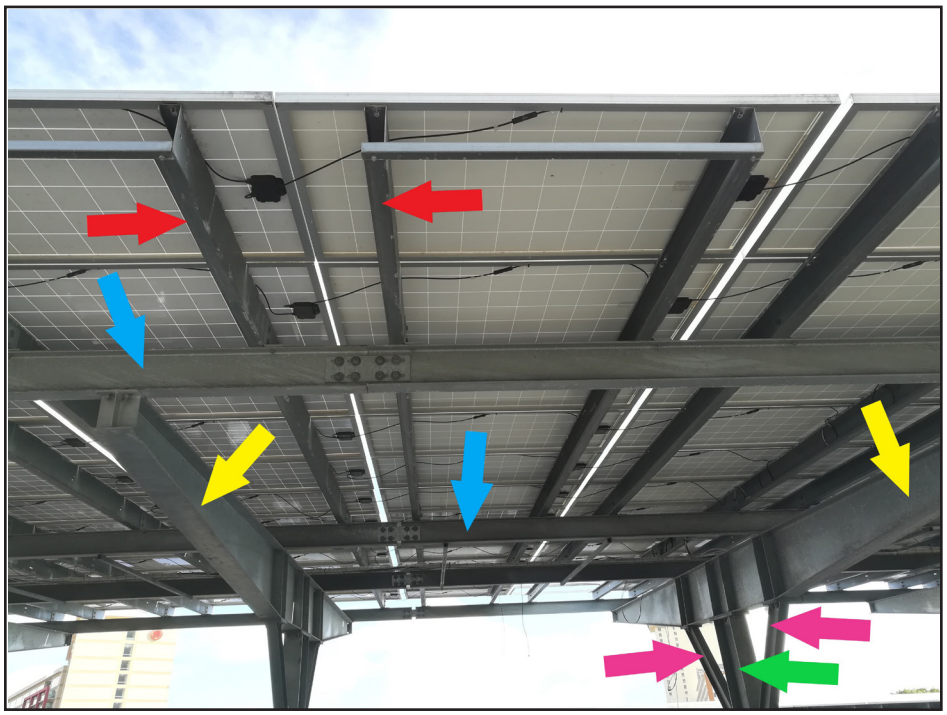
The ground-mount structures at the site are predominantly composed of a single steel column supporting a steel girder with a tapered cross-section. The girder cantilevers beyond the column in each direction with assistance from steel kickers. Each girder then carries four steel beams, which hold steel lateral rails that directly support the PV panels (Figure 6-16). The PV panels were connected to the steel rails at four locations using a steel bolt, a washer, and a nut. As mentioned in previous sections, the use of only a single nut raises concerns that the nut could loosen in high winds, allowing the panels to flutter. No damage was observed to the structure.

Figure 6-16: Puerto Rico Convention Center Solar Array, showing structural members supporting the solar array looking from the underside of the canopy. The arrows designate the following structural members: steel column (green arrow), tapered steel girder (yellow arrows), steel kickers (pink arrows) supporting girder, steel beams (blue arrows) running perpendicular to the girder, steel lateral rails (red arrows) directly supporting the PV panels.

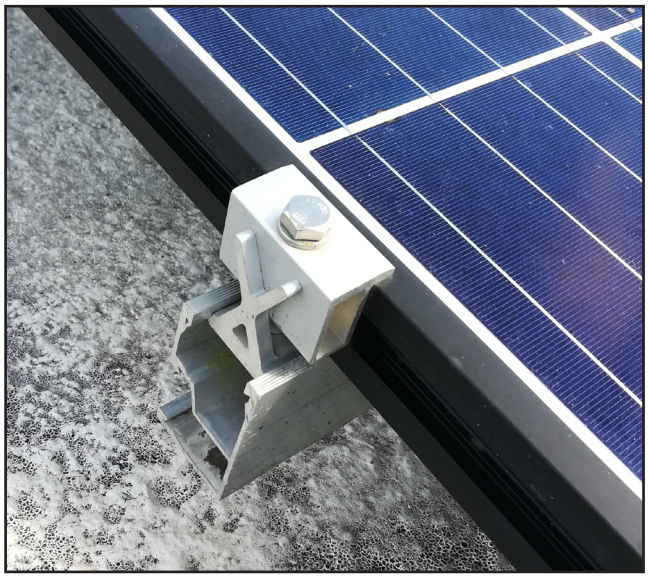
In Caguas, the MAT observed a one-story concrete house with a PV system installed on the roof (Figure 6-24). In this case, there was no wind damage to the PV panels, although there was wind damage to the clay roof. Figure 6-25 is a close-up view of the clamp joining the PV panel to the aluminum framing. Figure 6-26 shows the anchoring system of the aluminum framing to the concrete roof. The front portion of the house has an inclined roof with aesthetic ceramic roof tiles; some of the tiles were damaged by high winds, but ceramic tile debris did not damage the PV panels. The homeowner told MAT members that the system had no battery bank and that the house, therefore, had no electrical power at the time of assessment. The homeowner relied on portable gas power generators.

Figure 6-25: Left, PV power system anchored to a flat concrete roof slab in Caguas; right, closeup of bolted connection.

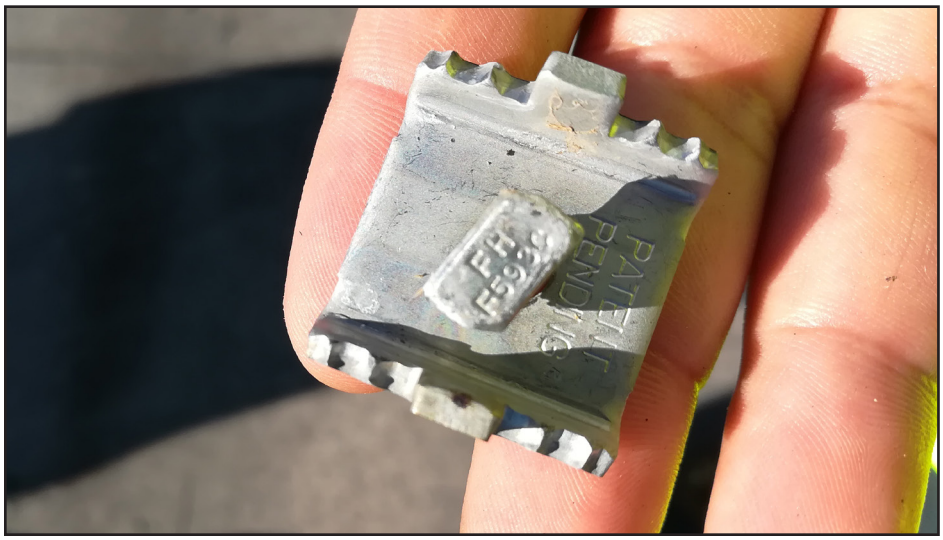
Figure 6-29: Clamp used to hold adjacent PV panels to frame.
