# **EPA CHEMICAL ACCIDENT INVESTIGATION REPORT**

**Pennzoil Product  
Company Refinery  
Rouseville, Pennsylvania**

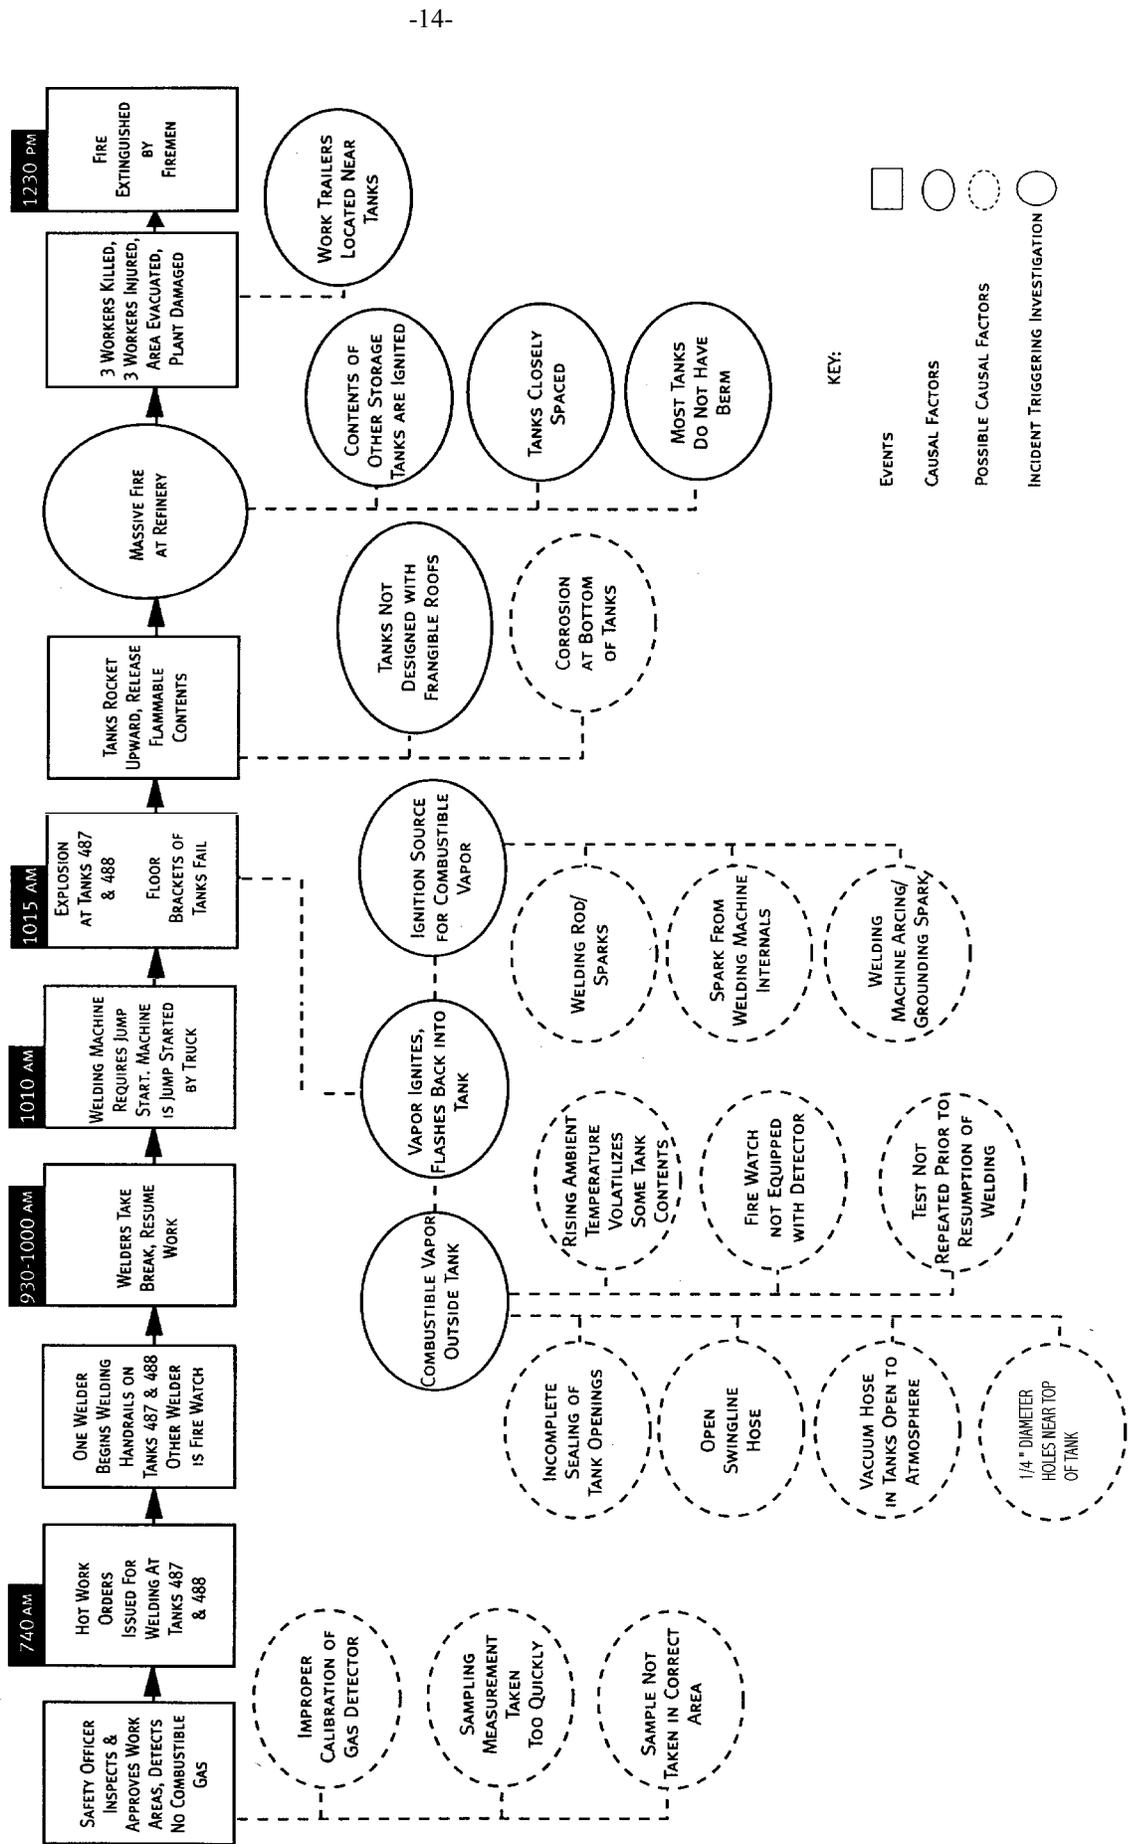
**EXHIBIT 6**  
**EVENT AND CAUSAL FACTORS DIAGRAM**  
**OCTOBER 16, 1995 EXPLOSION OF TANKS 487 & 488 AT**  
**PENNZOIL REFINERY - ROUSEVILLE, PA**

- Following ignition of vapors, the storage tanks failed along their bottom seam and lifted off their base, releasing their contents.

- Once released, the burning liquid flowed without restriction to other areas nearby involving trailers, storage tanks and other equipment in the fire; and
- Tool and work break trailers were spotted in the vicinity of storage tanks 487 and 488.

The immediate cause of the fire was the ignition of flammable vapors in storage tank 487. Although the CAIT could not determine the exact mechanism, there are at least two likely scenarios: undetected flammable vapors emitted from tank 487 were ignited by an ignition source which then flashed back into the tank; or an electrical discharge in the tank 487, generated by the arc welding, ignited flammable vapors in the tank.

When the flammable vapors in storage tank 487 ignited, its combustion likely caused a rapid pressure increase inside the tank. The tank failed along its bottom seam and shot up into the air, instantaneously releasing its entire contents. The burning liquid released from tank 487 apparently caused the ignition of flammable vapors in the adjacent tank, tank 488. Tank 488 also failed along its bottom seam and shot up, releasing its contents. Since these two storage tanks have no secondary containment, the burning liquid released from these two tanks quickly spread the fire through the refinery.
