Driving Apparatus on Flooded Roadways Safely and Effectively

David Wade

Virginia Beach Fire & Rescue, Virginia Beach, Virginia

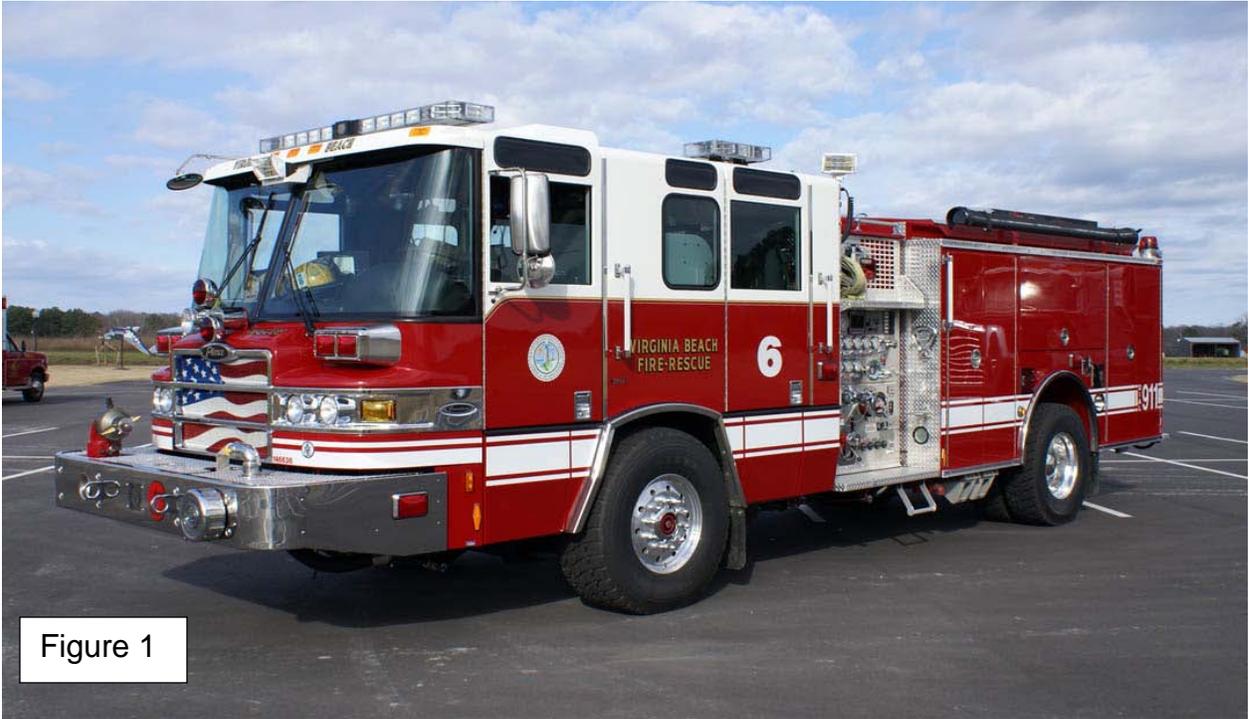
The problem that was experienced with the flood water and the Pierce Quantum custom apparatus used in Virginia Beach is not a new one. The Quantum chassis first appeared in the VBFD fleet back in 1996 and this water intrusion anomaly was studied at that time without a solution being offered by the manufacturer. The picture in Figure 1 demonstrates the current Quantum cab configuration used by the VBFD. The location of the air intake on the Quantum chassis is behind the bumper under the driver.

San Antonio, Texas, was able to work with Pierce Manufacturing to develop two options to address the water entering the air intake. The first option must be performed while the truck is being manufactured at the plant. This option adds a cost of \$3,500 to

the unit and moves the air intake to the side of the truck over the passenger side front wheel (high side option). This option also includes the movement of the electrical junction box distribution nodes and the “can bus” nodes into a compartment of choice. The new nodes box is usually mounted in the top of a compartment to alleviate equipment banging into it and causing damage and provide easy access by mechanics. This option is not retro-capable to current units in the fleet. This option also takes up space in the cab that must be considered. This option is pictured in Figure 2 on the Tierra Verda Fire District apparatus.
