PB90-916405
NTSB/MAR-90/04

NATIONAL TRANSPORTATION SAFETY BOARD

MARINE ACCIDENT REPORT

GROUNDING OF
THE U.S. TANKSHIP EXXON VALDEZ
ON BLIGH REEF, PRINCE WILLIAM SOUND
NEAR VALDEZ, ALASKA
MARCH 24, 1989

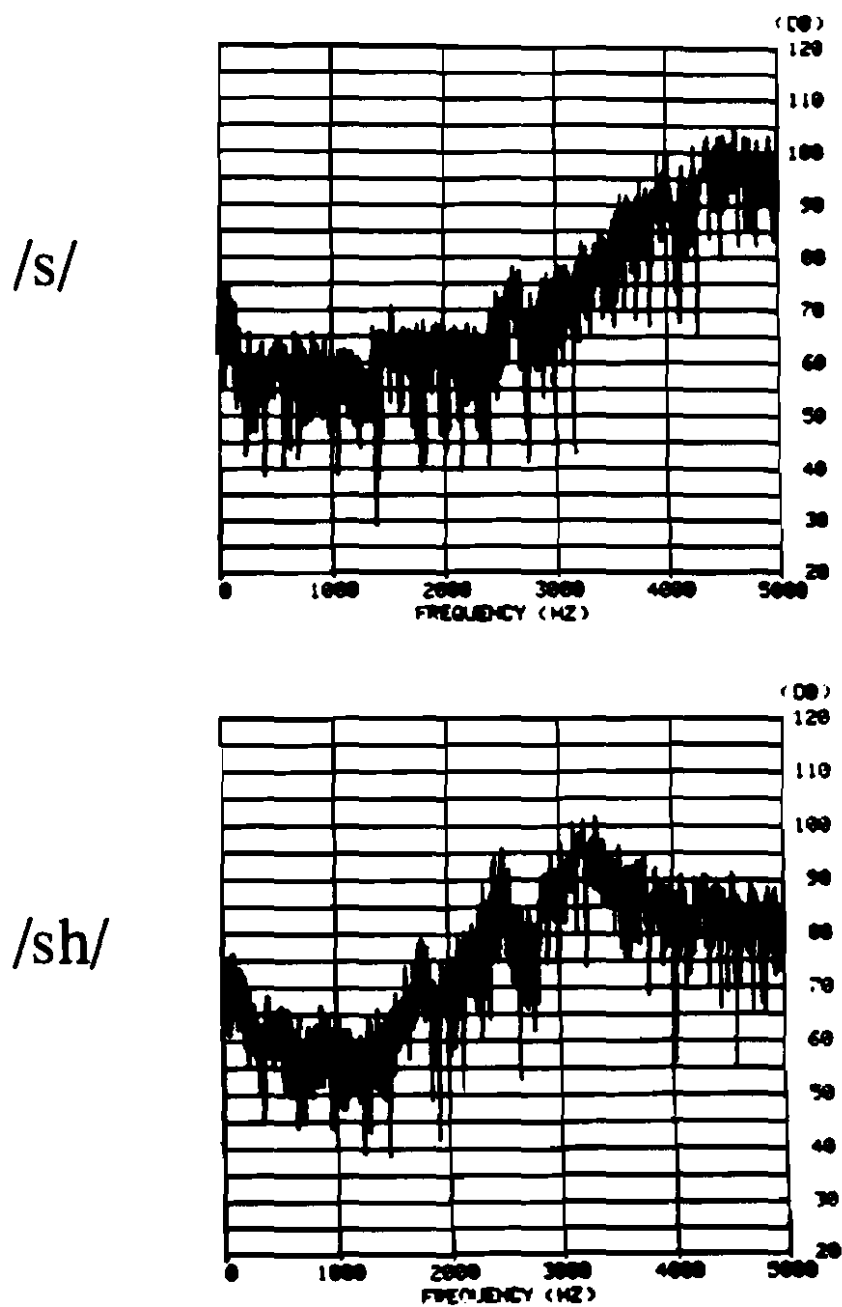
Figure 1 shows power spectra of /s/ and /sh/ produced by the first author (KJ). The horizontal axis in these graphs shows frequency from 0 to 5000 Hz and the vertical axis shows amplitude in decibels. Many speech sounds (including /s/ and /sh/) can be distinguished by their amplitude spectra because they have differing amounts of energy at different frequencies. In particular, /s/ is characterized by a peak of energy in the range from 4000 to 5000 Hz, while /sh/ has a lower frequency peak (in the range from 3000 to 4000 Hz) and a lower amplitude peak of energy in the range from 2000 to 3000 Hz. The spectra in Figure 1 illustrate what the power spectra of /s/ and /sh/ look like in recordings which have a high signal-to-noise ratio and frequency information up to 5000 Hz (see also Borden and Harris, 1984, p. 189).

Figure 1. Power spectra of /s/ (top) and /sh/ (bottom) produced by KJ in a quiet recording booth with recording equipment responsive up to 5000 Hz.

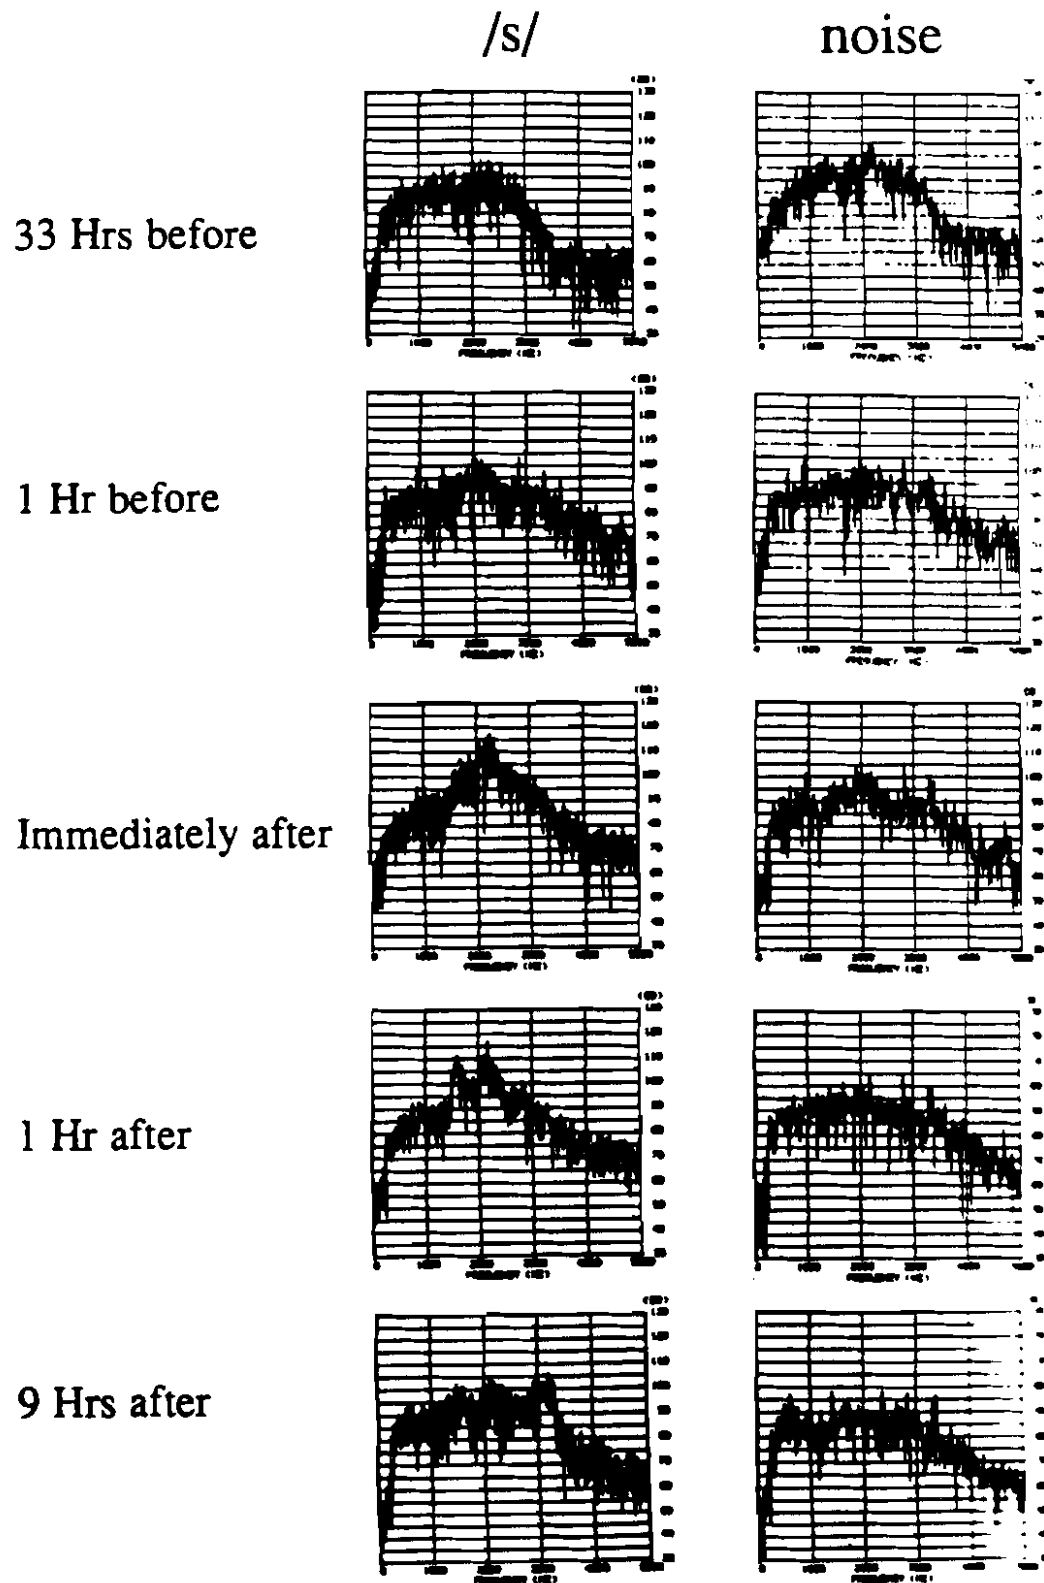
Figure 3 shows power spectra of the /s/ of *sea* (or *see*) from the five different recordings paired with spectra of background noise from the same recording. The noise spectra were taken from nearby, open-mike background noise. On average the noise segments were 1.3 seconds from the /s/ segments⁸. The /s/ spectrum from the earliest recording (33 hours before the accident) has the same basic shape that the background noise has, suggesting that the /s/ is buried beneath the noise, or more accurately, that the main spectral energy for /s/ is not within the frequency range of the transmission system. The same is true for the /s/ of *sea* recorded one hour before the accident. The spectra of /s/ from the recordings made immediately after the accident and one hour after the accident have peaks of energy (relative to the background noise) in the region from 2000 to 3000 Hz. Finally, the spectrum of /s/ recorded 9 hours after the accident does not have a peak of energy in the region from 2000 to 3000 Hz. We interpret the peaks in the /s/ spectra from samples recorded immediately before the accident and one hour after the accident as evidence for a segmental change from /s/ to /sh/. There is no evidence in these spectra, nor in the other /s/ spectra which we examined, for this segmental change between the earliest recording and the one made one hour before the accident. These spectral changes reflect a change in the articulation of /s/ which has been observed in earlier studies of the effects of alcohol on speech production (Lester & Skousen, 1974; and Trojan & Kryspin-Exner, 1968).

Figure 3. Power spectra of /s/ paired with spectra of nearby open-mike pauses from each of the NTSB recordings.
