**Landslides  
and  
Landslide  
Hazards in  
Washington  
State Due  
to February  
5-9, 1996  
Storm**

**U.S. Geological Survey Administrative Report**

# **Landslides and Landslide Hazards in Washington State Due to February 5-9, 1996 Storm**

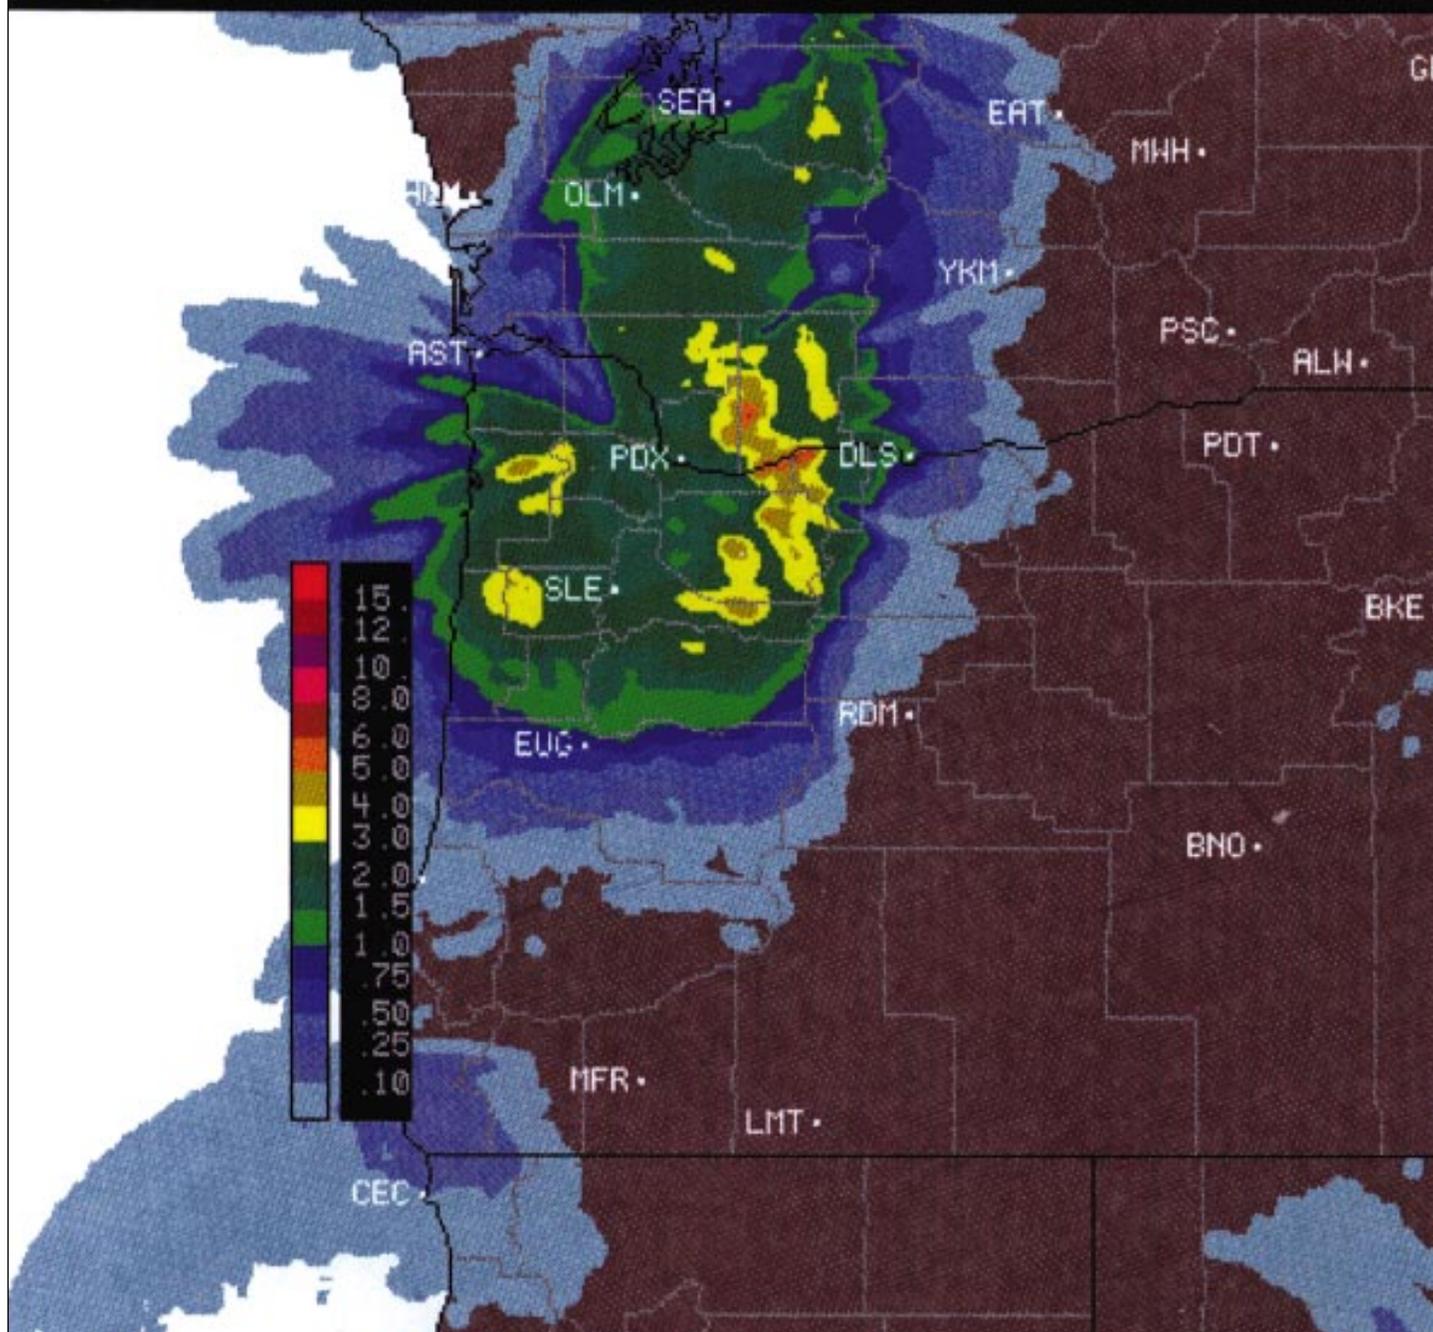
Figure 6 shows that, just southeast of Mount St. Helens, the maximum amount of estimated precipitation (5-6 in) for February 7 occurs in this area of high debris-flow concentration. Here we see a good correlation between the radar imagery of precipitation patterns and the landslide patterns. This is an area where the effect of high rainfall on debris-flow generation were added to by rapid snowmelt as a result of the rain on a deep snowpack.

Figure 6. Radar imagery for February 7, 1996 showing high estimated-precipitation cells centered southeast of Mount St. Helens and along the Columbia River gorge near Dodson, Oregon where several large debris flows damaged houses and closed both I-84 and the Burlington Northern rail lines (Reprinted courtesy of WSI Corporation).

As previously mentioned, the radar imagery for February 7, 1996, from the National Weather Service (Figure 6) shows cells of high intensity rainfall that correlate well with high concentrations of landslides in western Washington. The highest rainfall levels shown in figure 6 are 5-6 in. One of these cells is roughly circular and located just southeast of Mount St. Helens where the highest concentrations of landslides in western Washington occurred immediately southeast of Mount St. Helens. Although not previously discussed in this report, another area of similar rainfall level is along the Columbia Gorge near Dodson, Oregon. This area is one of elongated coalescing cells that corresponds well with the occurrence of numerous destructive debris flows that originated from the steep cliffs of the gorge that destroyed one house, damaged several others, and closed both I-84 and the Union Pacific Railroad tracks.
